Experimental Study ND 2010-01

**Evaluation of Wet-Reflective Elements for  
Pavement Markings**

**Evaluation 2**

IM-6-029(075)129 & SNH-6-002(079)337

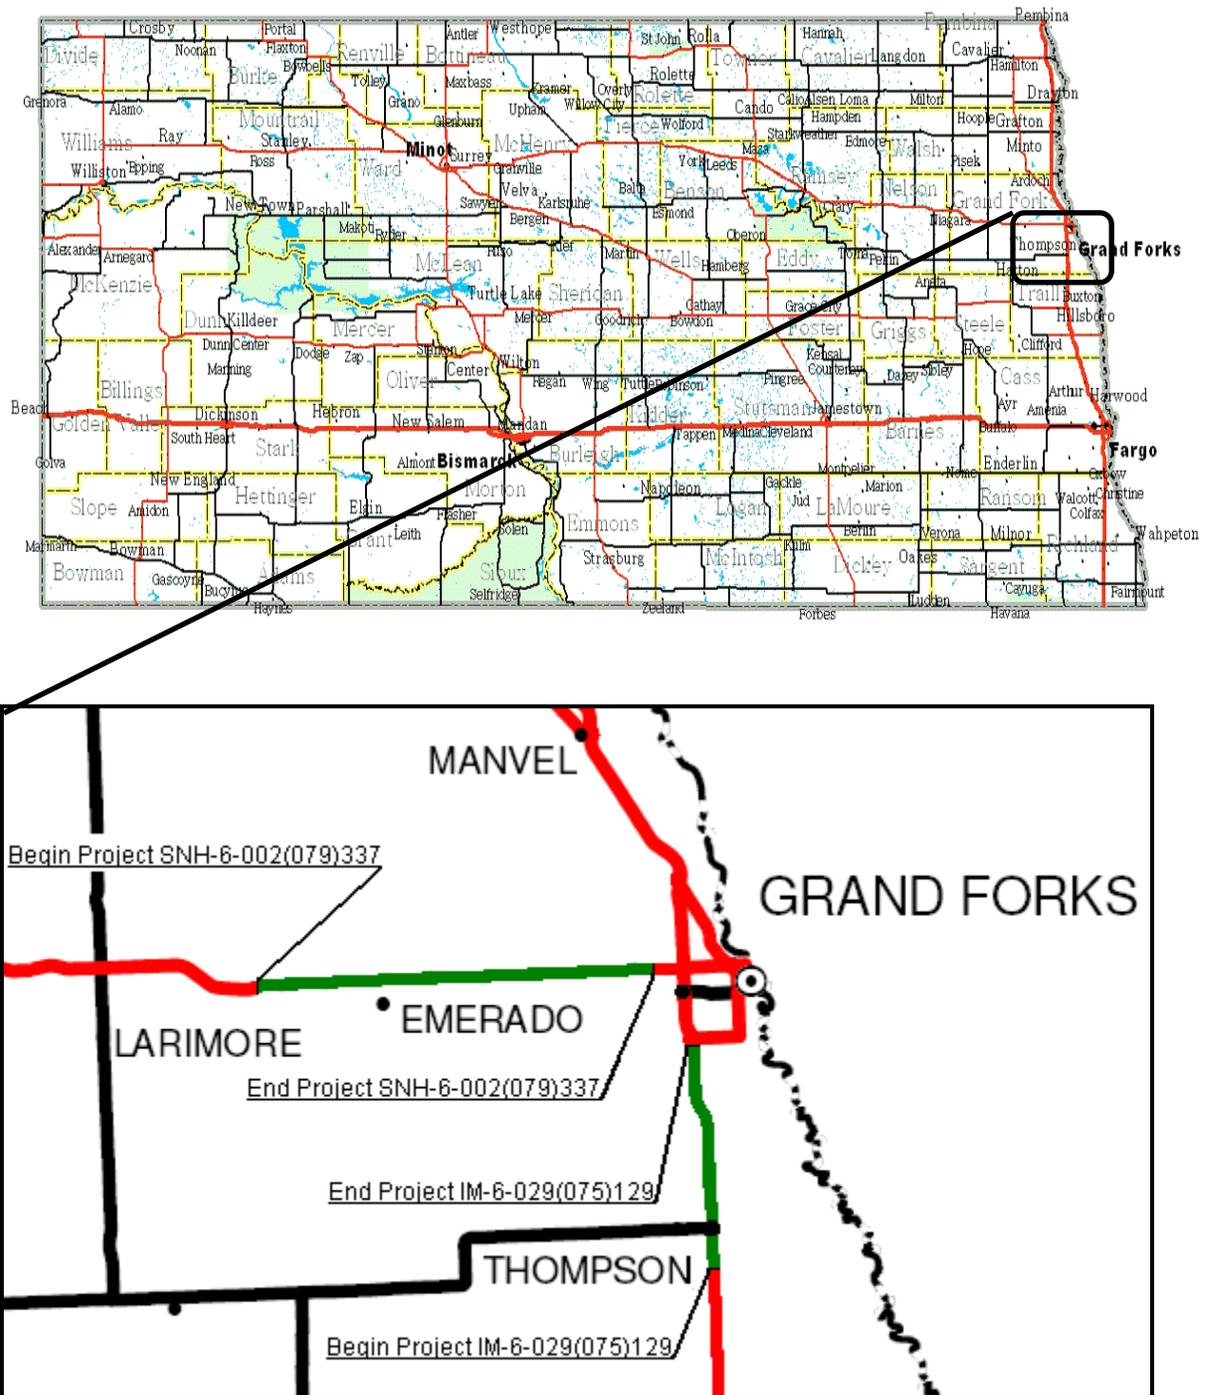
NDDOT plans to incorporate wet reflective optics as part of project IM-6-029(075)129 and SNH-6-002(079)337. These projects are located near Grand Forks on I-29 and US 2 respectively. This report will be split into two sections to discuss each project separately.

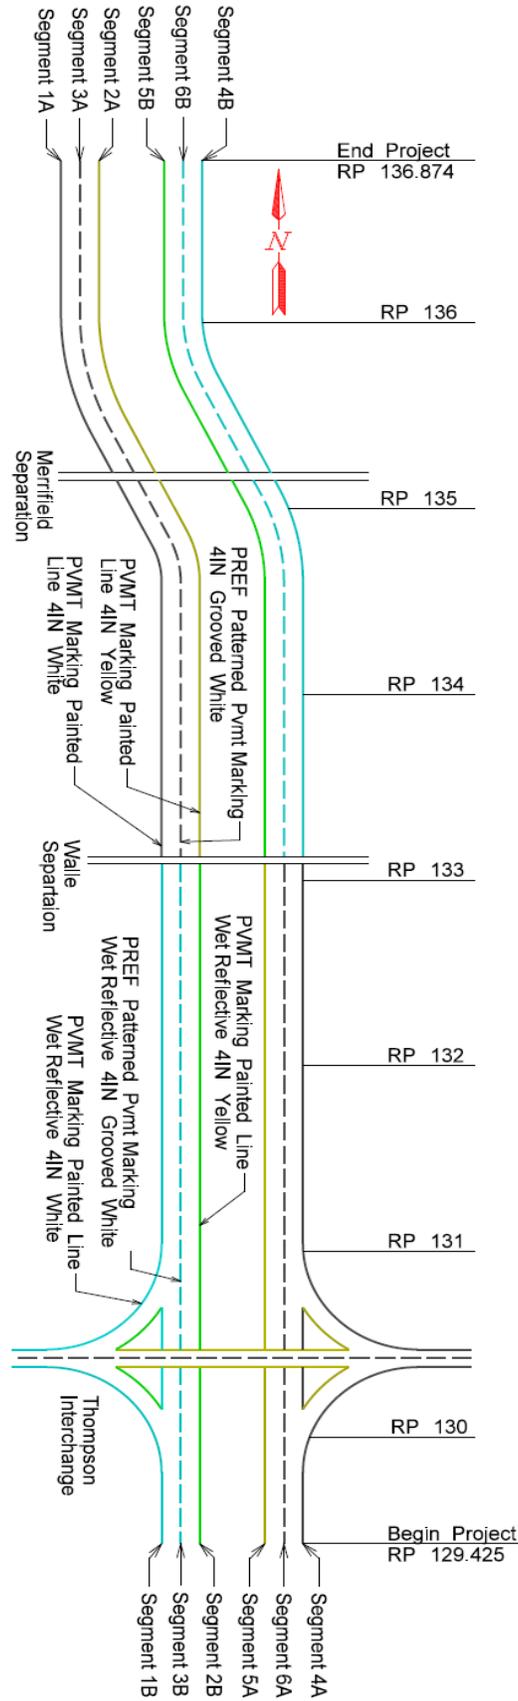
The table above is illustrated on the following page. Details for the installation of the experimental features were included in the plans by a plan note.

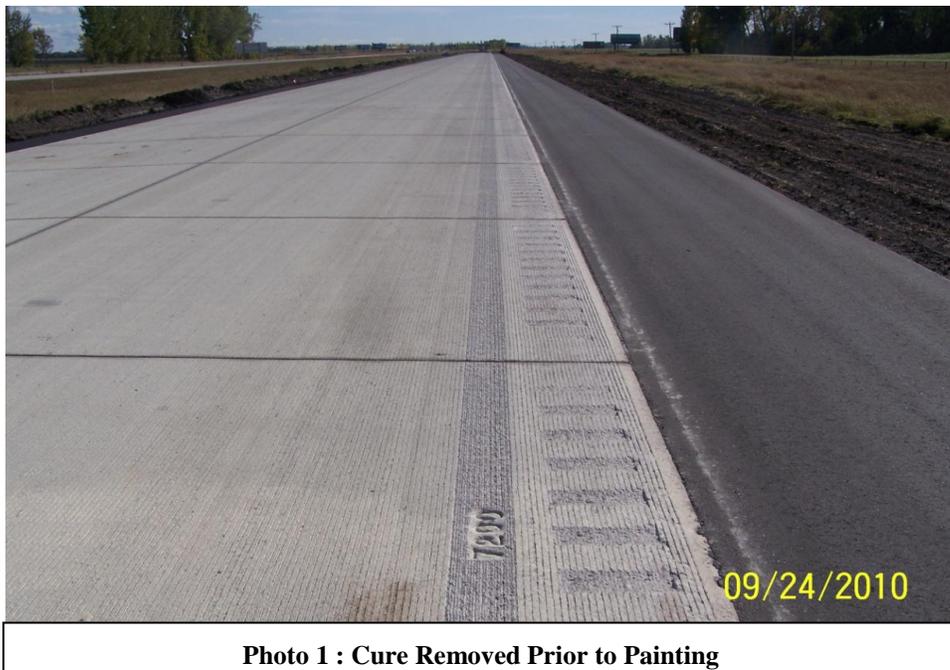
The curing compound from the new concrete pavement was removed prior to the application of water-based paint. The contractor elected to use a rotomilling machine to accomplish this task. The rotomilling machine has the ability to remove the curing compound and other surface debris without cutting a groove into or otherwise damaging the new pavement. Photo 1 below shows the pavement surface with the curing compound removed where the edge line would be placed.

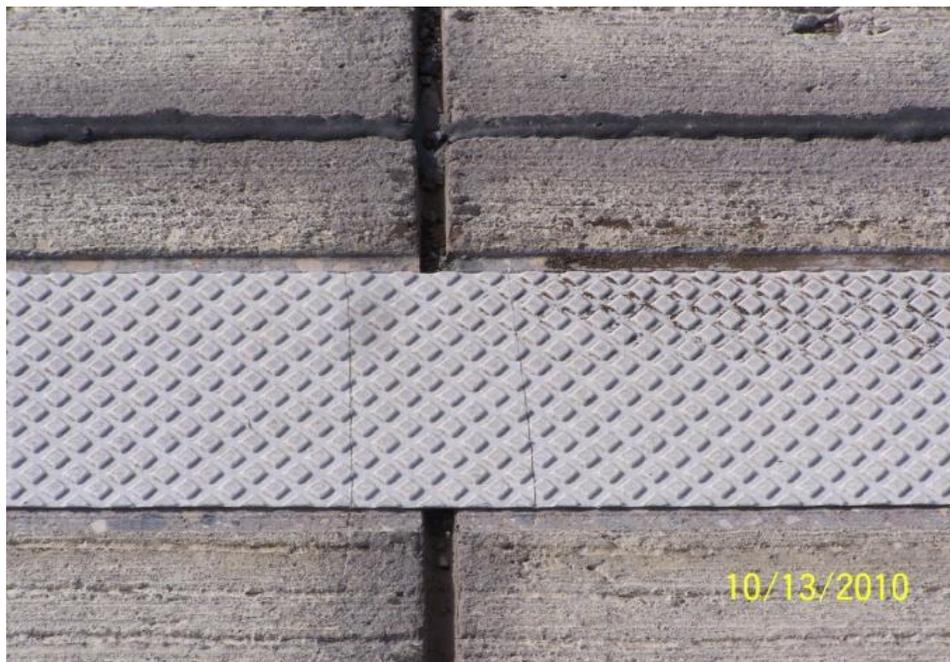
**Photo 4 : Southbound Standard Tape**

The following photos show a comparison of the two preformed patterned tape materials. There is pearlescent ring around the patterns on the 3M All Weather Tape (difficult to see in the photo). This ring contains the wet reflective properties. However the pearlescent ring can cause the tape to have a similar appearance to concrete pavement during the day.

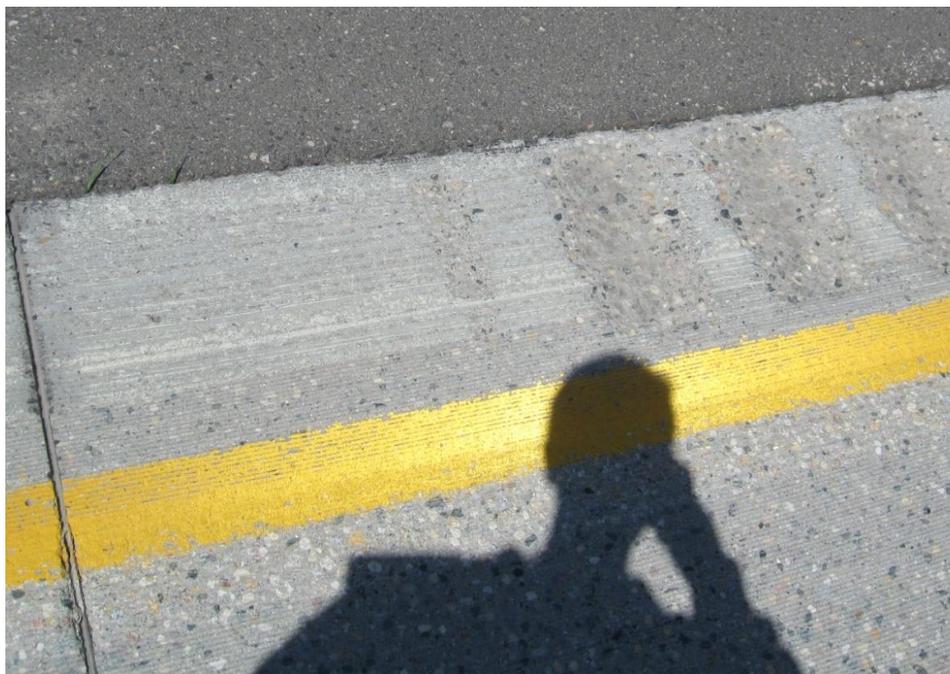
The I-29 project was evaluated for the first time on May 19, 2011. This allowed the markings to be exposed to winter conditions, (snow, ice, salt, sand, and snow plows). The painted lines have performed well. The only damage/loss of material has occurred at the 'peaks' of the surface profile where the line is most susceptible to traffic and snow plow damage, see photo 6 below:

**Photo 6 : Loss of Material on Peaks of Surface Profile**

This profile was the result of a rotomilling machine which was used to remove the curing compound from the roadway surface. The grooved centerline preformed patterned tape markings show no wear in either standard tape or 3M All Weather Tape segments.

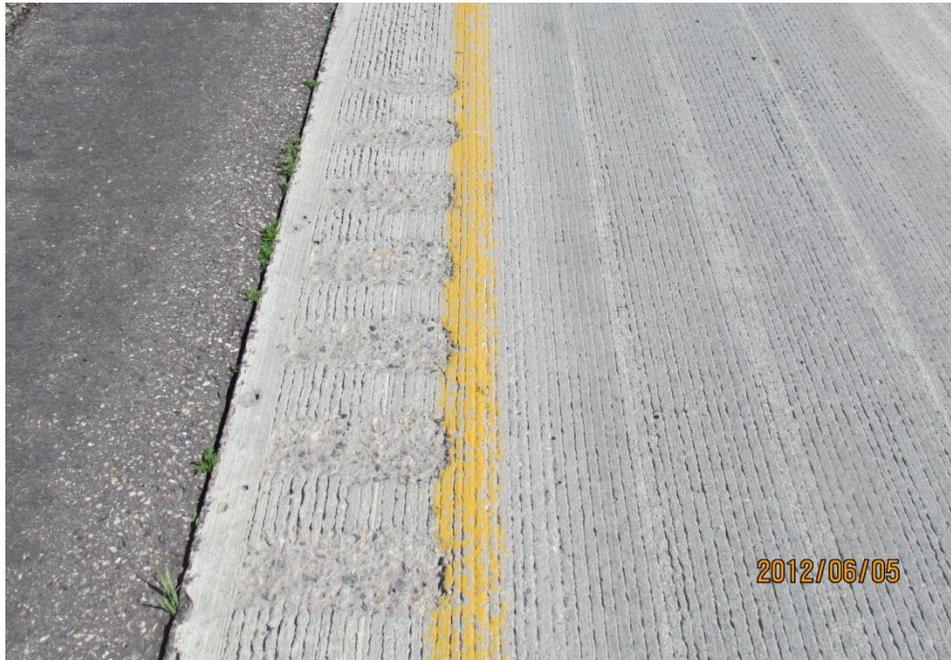
The I-29 project was evaluated for the second time on June 5, 2012. After two winter seasons, the surface applied water-based markings are beginning to show distress. The photos below illustrate the loss of material of the painted lines.

**Photo 7 - Yellow Edge-line with Standard Glass Beads**

The previous photos also show the difference in the distresses that are accumulating on the painted control markings vs. the 3M AW painted markings. About 50% of the paint was gone from the white edge-line in the south bound direction from RP 135 to RP 136. As described earlier, this segment was slightly damaged during other construction

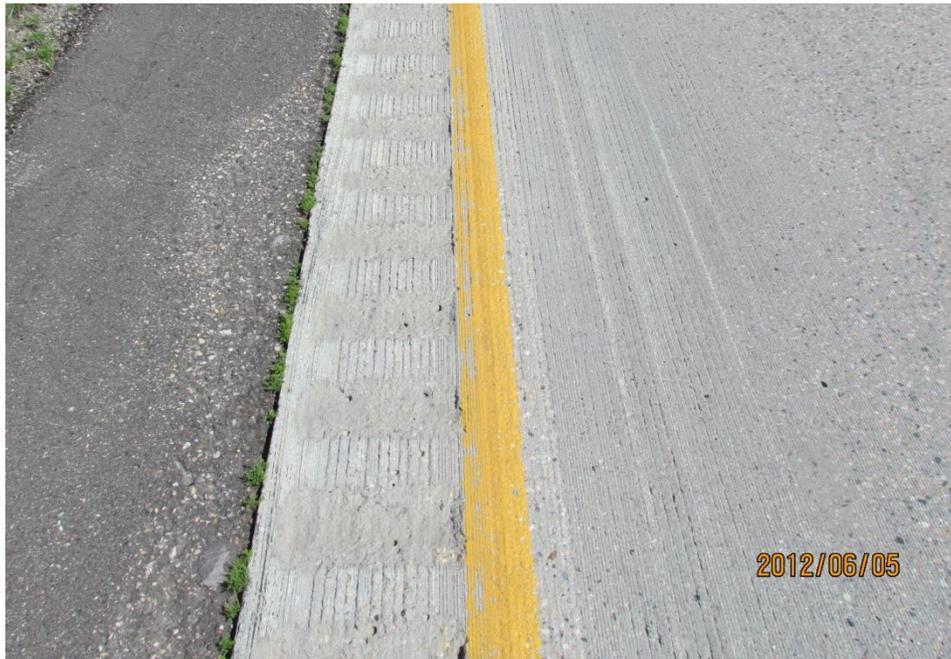
**Photo 8 - Yellow Edge-line with 3M Optics**

activities on the project. Under a magnifying glass, it appears that about 25% to 50% of the beads are missing from both standard glass and AW segments. Also, some AW Elements were gone completely while others experienced some loss of the 3M Optics from the ceramic core.

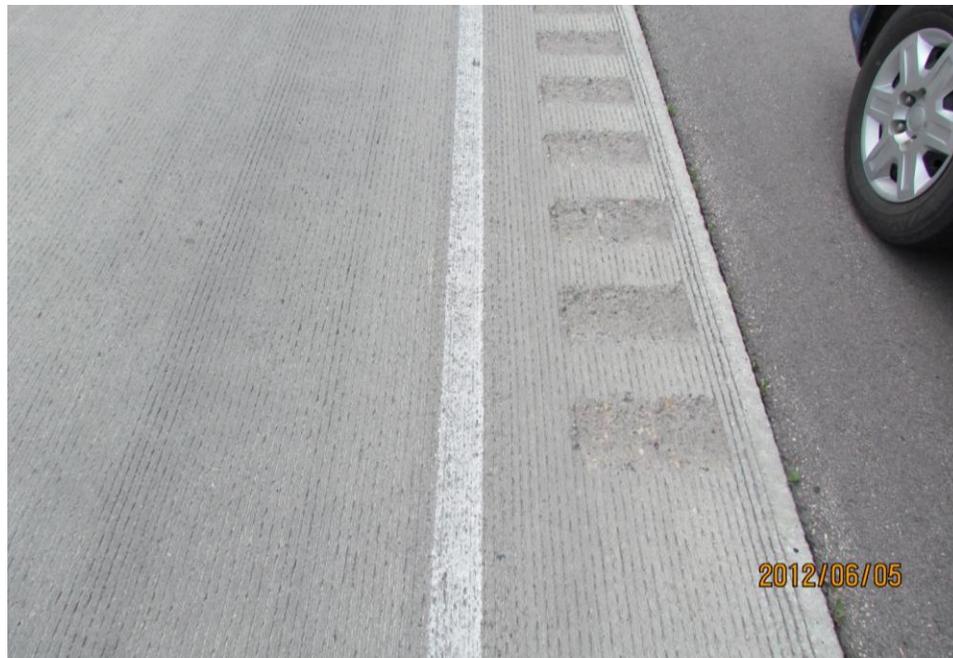
**Photo 9 - White Edge-line with Standard Glass Beads**

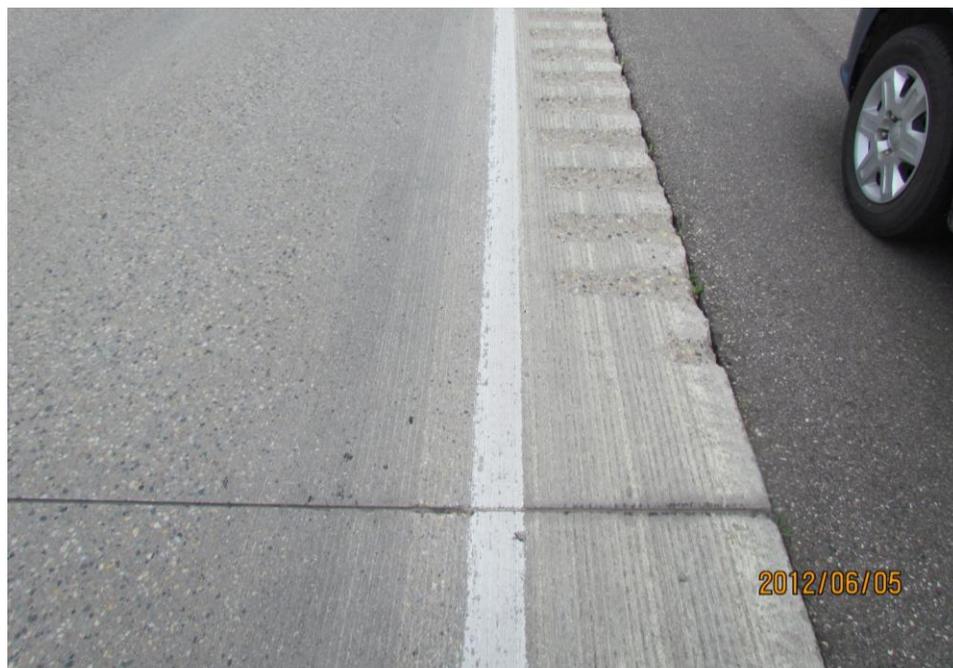
**Photo 10 - White Edge-line with 3M Optics**

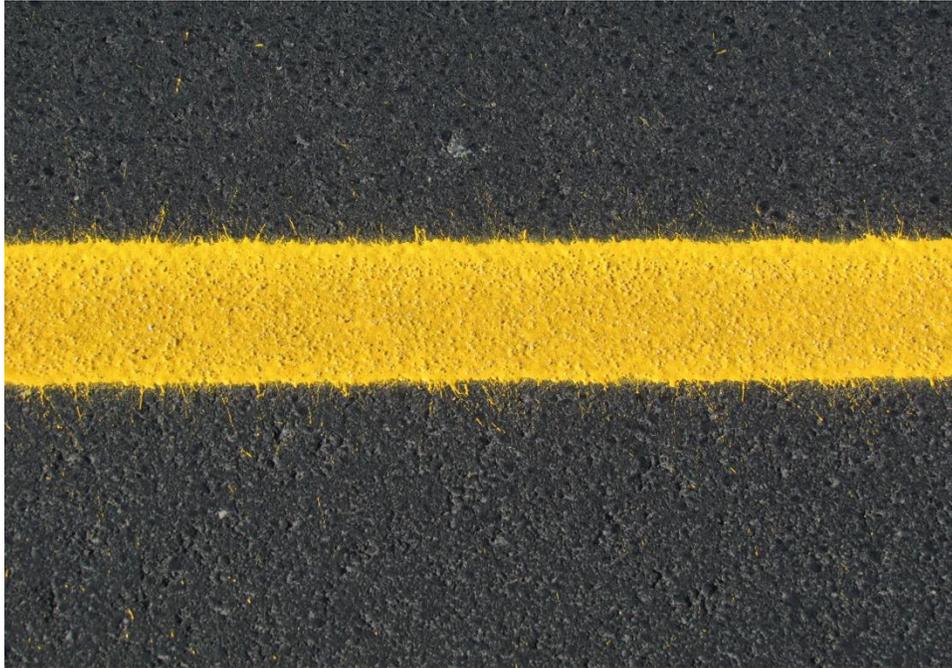
uniform and no defects could be detected visually. Photos 11 and 12 below show a typical yellow line and a typical white line from this project.

**Photo 11: Westbound Yellow AW Paint with AW Elements**

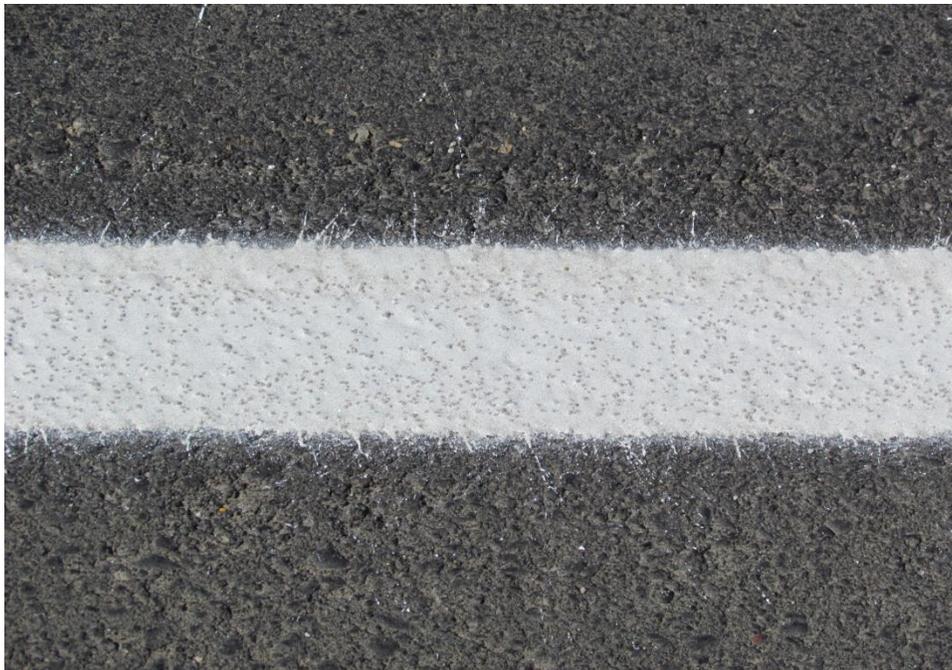
**Photo 12: Westbound White AW Paint with AW Elements**

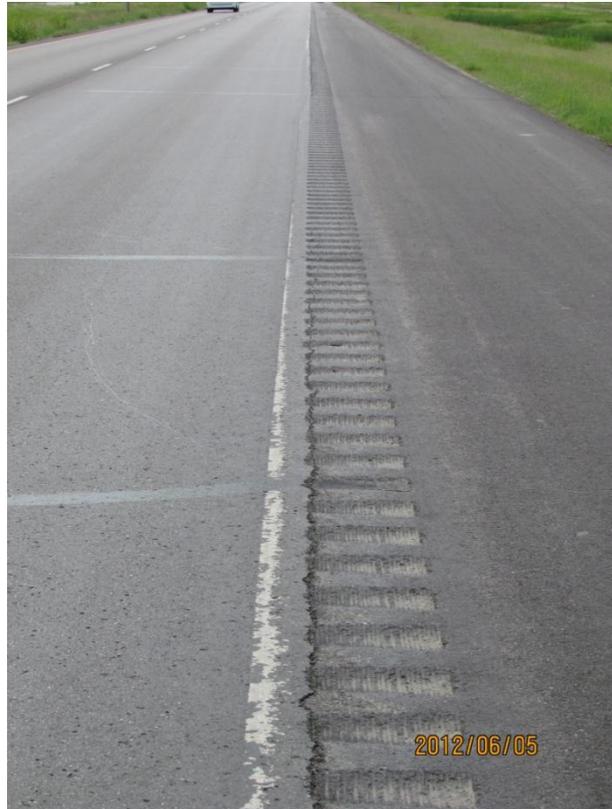
The US 2 project was evaluated for the first time on June 5, 2012. After one winter the pavement markings are showing distress. As shown in photo 13 below, a segment of the white edge-line was nearly undetectable. The remaining portions of the white edge-line were also damaged to a degree that it was recommended to restripe it and terminate the research on the white edge-line.

**Photo 13: Damaged White Edge-line**

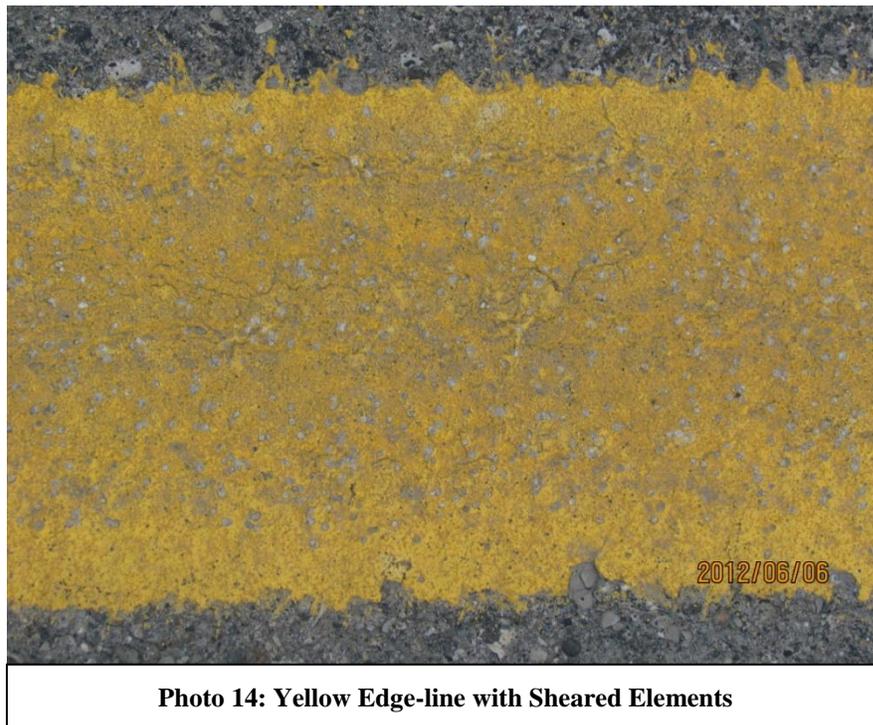
The white center-line and yellow edge-line are showing signs of distress. Photo 14 below shows a segment of yellow edge-line with 3M Elements. The white/cream dots on the line are what remains of the 3M Elements. The 3M Elements were sheared in half from the snow plows, exposing the white ceramic core of the Elements.

This occurrence was common in the segments with 3M Elements. All line types are showing some loss of paint.
