Experimental Study ND 03-01

**Comparison of Rehabilitation Strategies on
Long Term Ride Performance**

3rd Evaluation Report

Projects NH-6-081(053)192 &
NH-6-081(055)204

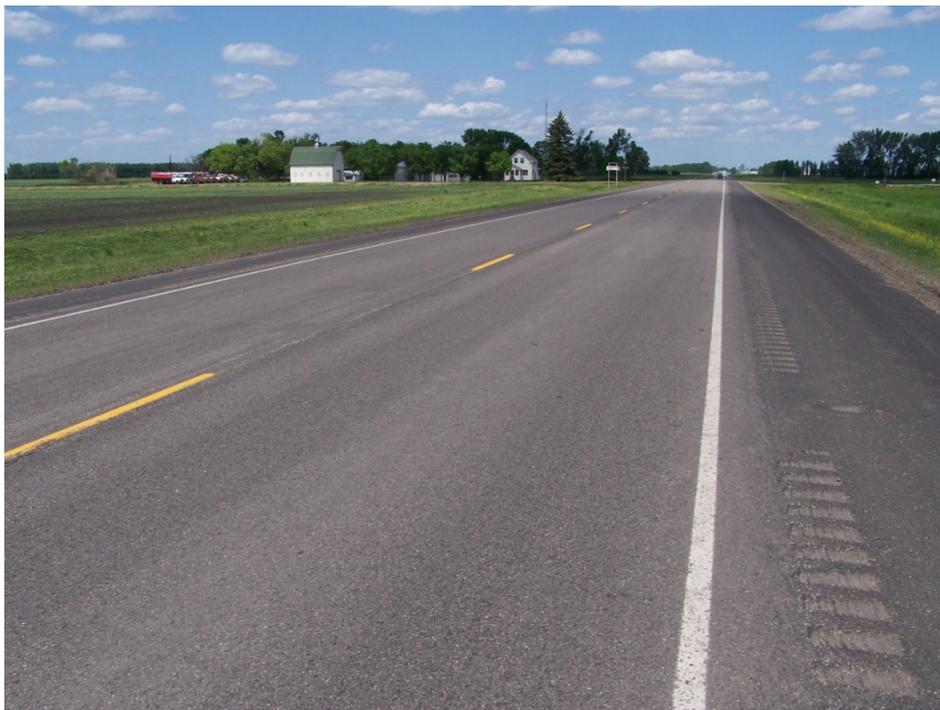
Photo 1 – Overview of Section 1

The first lift of the overlay sections was placed as a leveling course, and placed by blade leveling. The remaining lifts were placed with a paver equipped with automatic height adjustment. An overview of Section 1 is show in Photo 1.

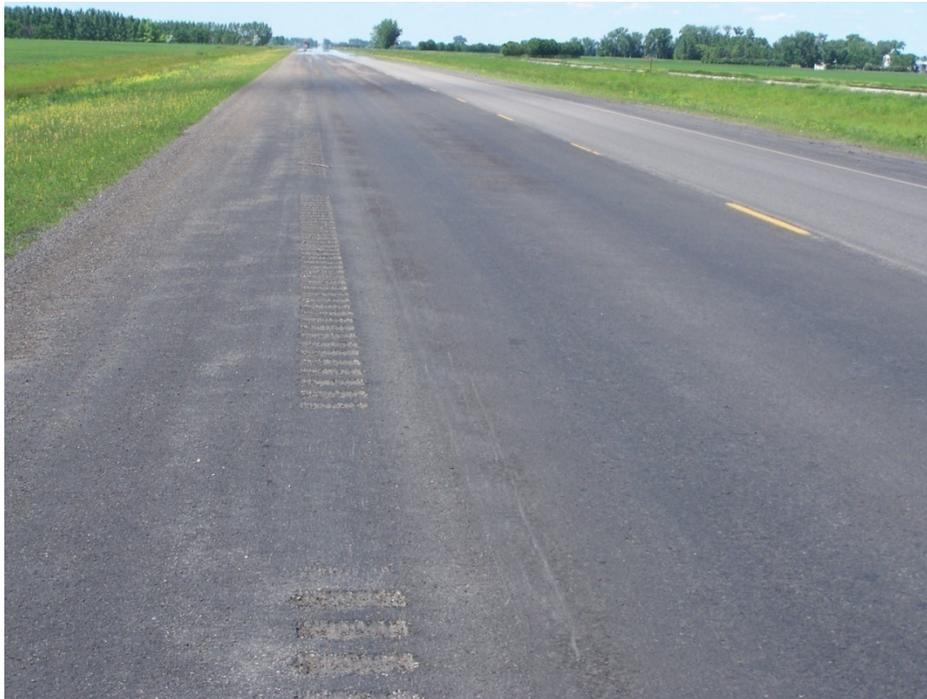
Photo 2 – Blade patching after final paver lift.

There were three areas of patching over the length of the project. These patches span from reference points 194.119 to 194.383, 194.497 to 194.516, and 197.452 to 197.471. The patches were results of a malfunction of the automatic height adjust on the paver during the final lift of paving. The patches were needed to achieve the minimum pavement thickness. All of the patches were in the southbound lane. An area that required blade patching after the final paver lift is shown below in Photo 2.

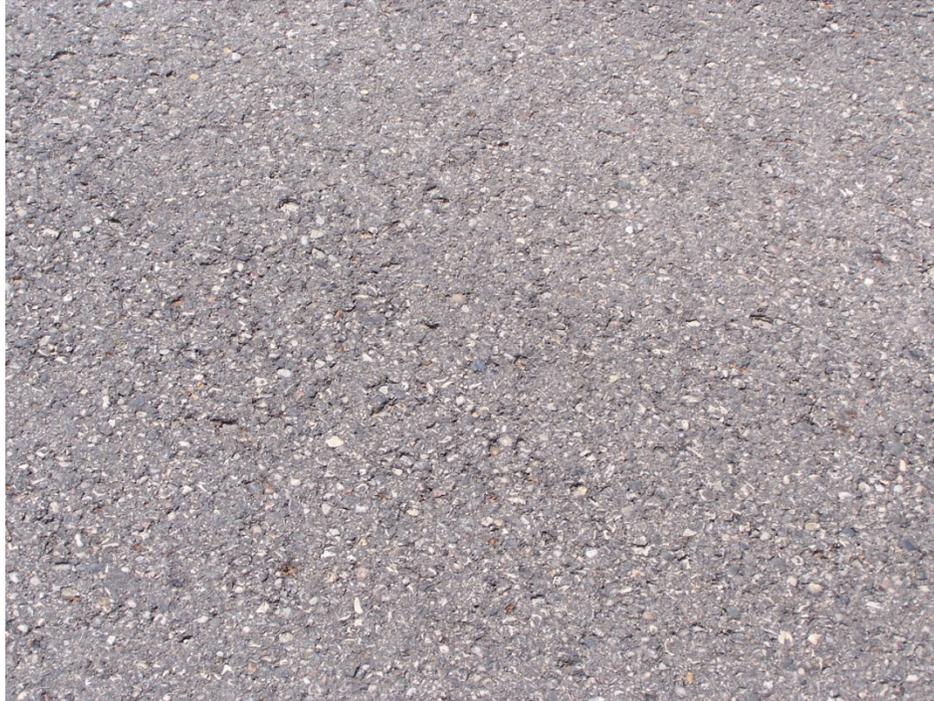
Photo 3 – Area where pneumatic roller tires picked up asphalt

The southbound lane also had areas where the pneumatic tire roller had picked up asphalt from RP 193.0 to 194.5. This section of roadway was paved on an afternoon that was unseasonable cold and windy, which made it difficult to maintain a consistent temperature on the roller tires. There were no other surface deformations present at the time of the evaluation.

that Section 1 has the highest IRI values in both the northbound and southbound lanes of the three sections. Areas between RP 193.0 and 194.5 in the southbound lane where the pavement was being picked up by the pneumatic roller did seem to increase the IRI numbers in the southbound lane of Section 1. These problems that were experienced during paving should not affect the overall performance of the pavement.

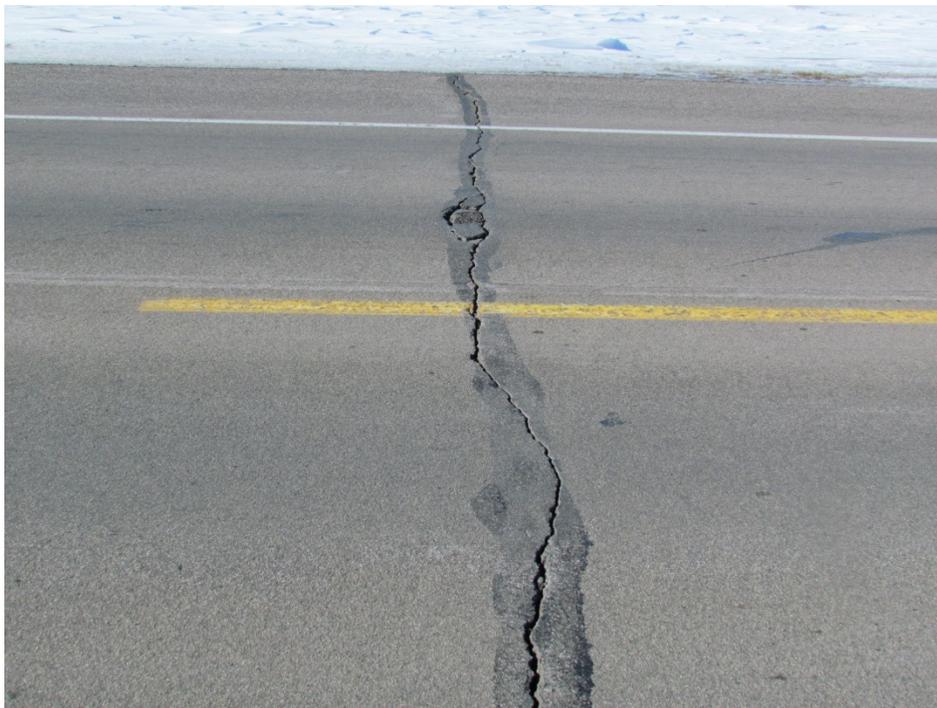
Photo 4 – Transverse Crack in Section 1

No rutting was observed in this section of roadway. 358 transverse cracks were counted in this section, or 100 cracks/mile. This was an increase compared to the 2010 evaluation, which had 307 transverse cracks, or 86 cracks/mile. Some of the transverse cracks in this section were over an inch wide and were also starting to break up some along the edges of the cracks. Photo 3 below shows one of these transverse cracks:

No rutting was observed in this section of roadway. 358 transverse cracks were counted in this section during the 2013 evaluation, or 100 cracks/mile. This was an increase compared to the 2010 evaluation, which had 307 transverse cracks, or 86 cracks/mile. Some of the transverse cracks in this section were over an inch wide and were also starting to break up some along the edges of the cracks.

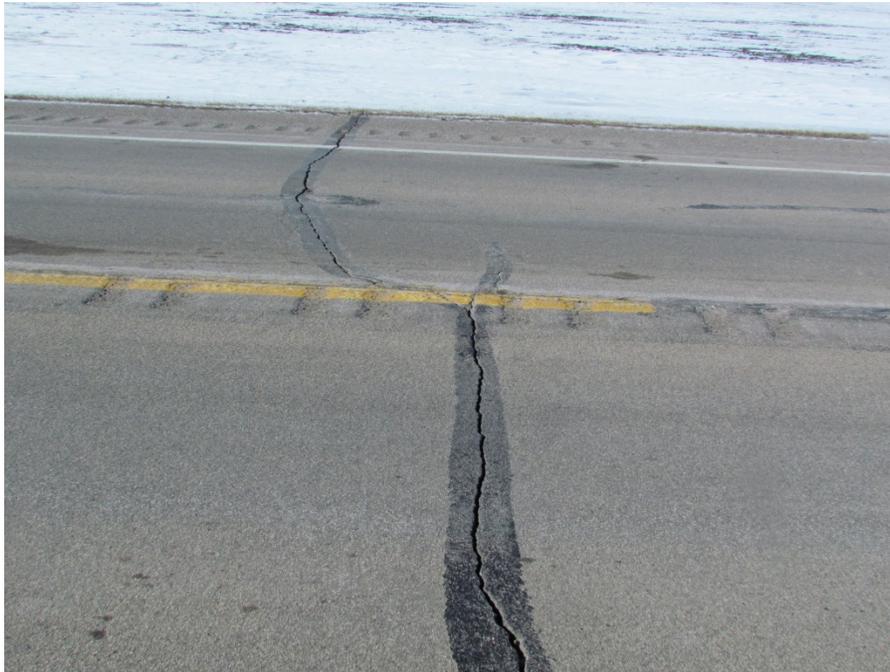
Photo 5, Transverse Crack in Section 2

No rutting was observed in this section of roadway. 389 transverse cracks were counted in this section, or 56 cracks/mile. This was an increase compared to the 2010 evaluation, which had 307 transverse cracks, or 44 cracks/mile. Some the transverse cracks in section 2 were almost an inch wide. Photo 5 below shows one these cracks:

No rutting was observed in this section of roadway. 389 transverse cracks were counted in this section during the 2013 evaluation, or 56 cracks/mile. This was an increase compared to the 2010 evaluation, which had 307 transverse cracks, or 44 cracks/mile. Some the transverse cracks in section 2 were almost an inch wide.

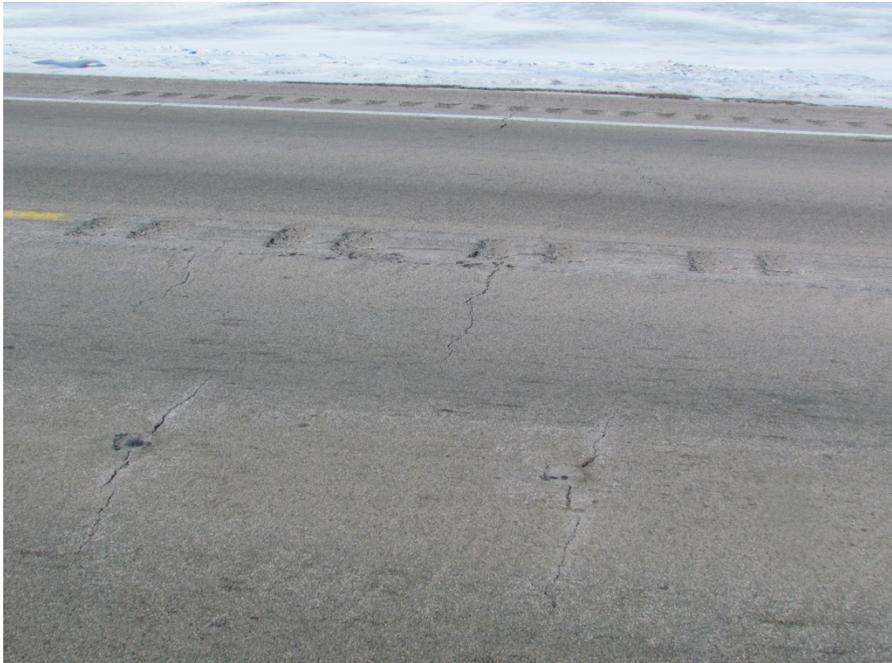
Photo 6, Block Cracking in Section 3

No rutting was observed in this section of roadway. 14 transverse cracks were counted in this section, or 9.6 cracks/mile. This was an increase compared to the 2008 evaluation, which had 9 transverse cracks, or 6 cracks/mile. It was observed in the mine and blend section that there seemed to be some minor forms of block cracking beginning in this section. Photo 5 below shows this cracking:

No rutting was observed in this section of roadway. 14 transverse cracks were counted in this section during the 2013 evaluation, or 9.6 cracks/mile. This was an increase compared to the 2008 evaluation, which had 9 transverse cracks, or 6 cracks/mile. It was observed in the mine and blend section that there seemed to be some minor forms of block cracking beginning in this section.

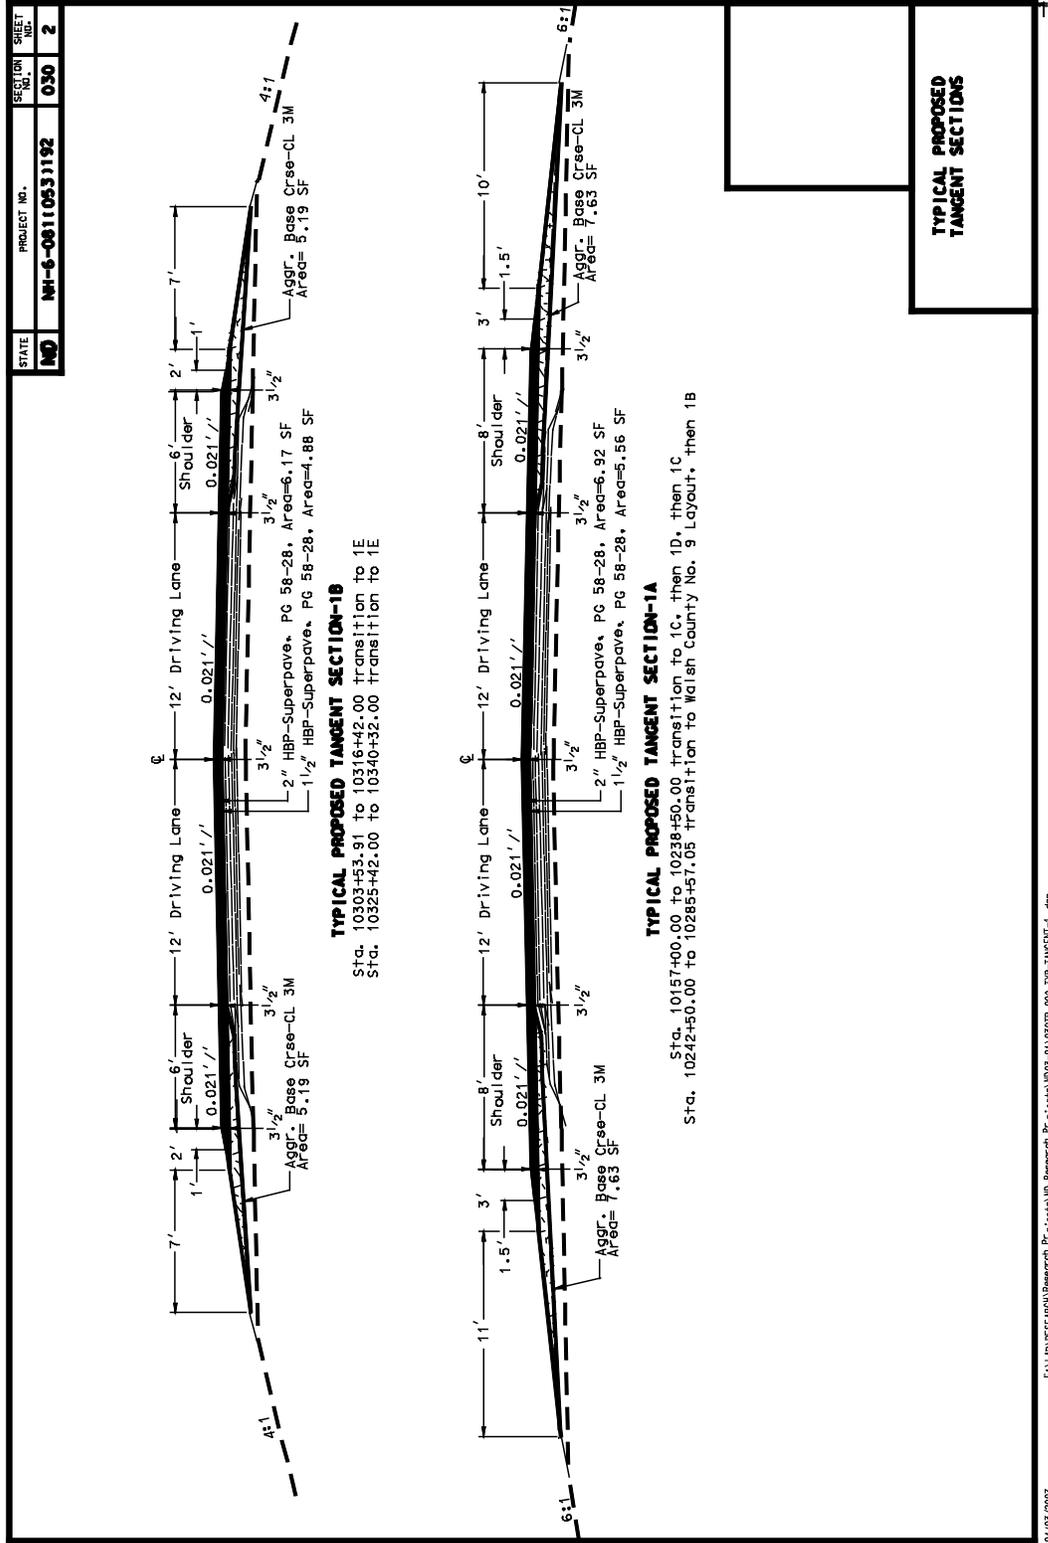
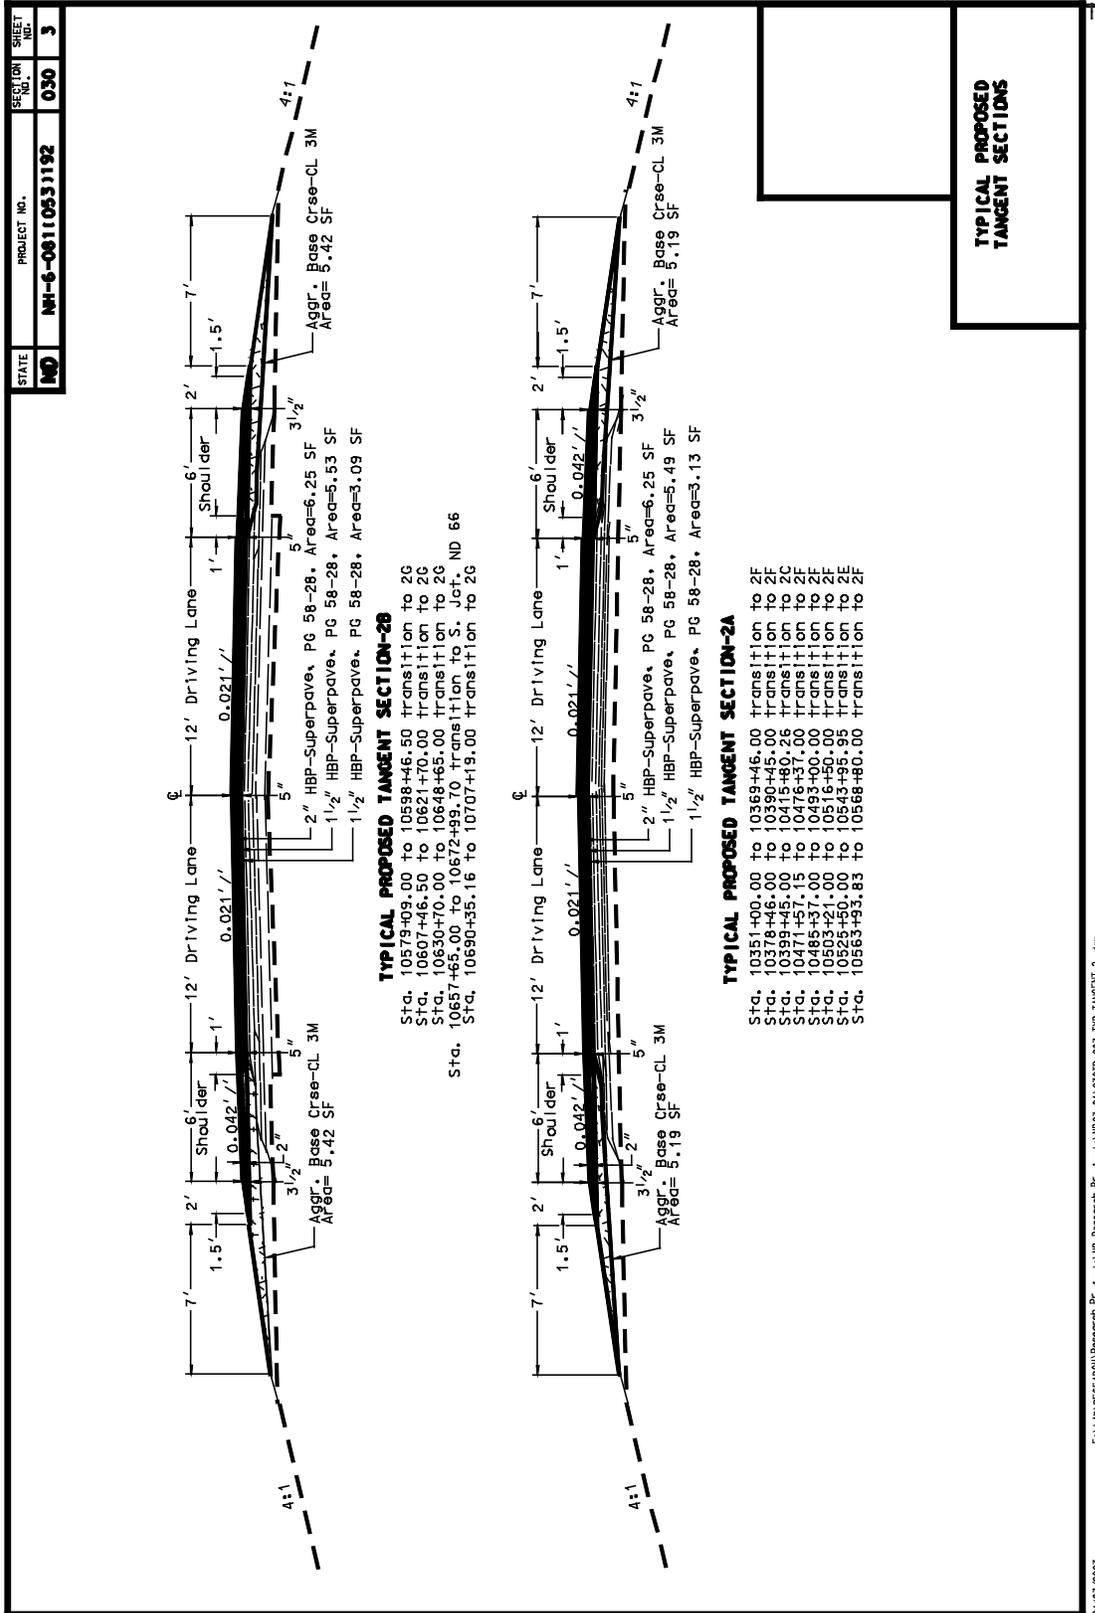
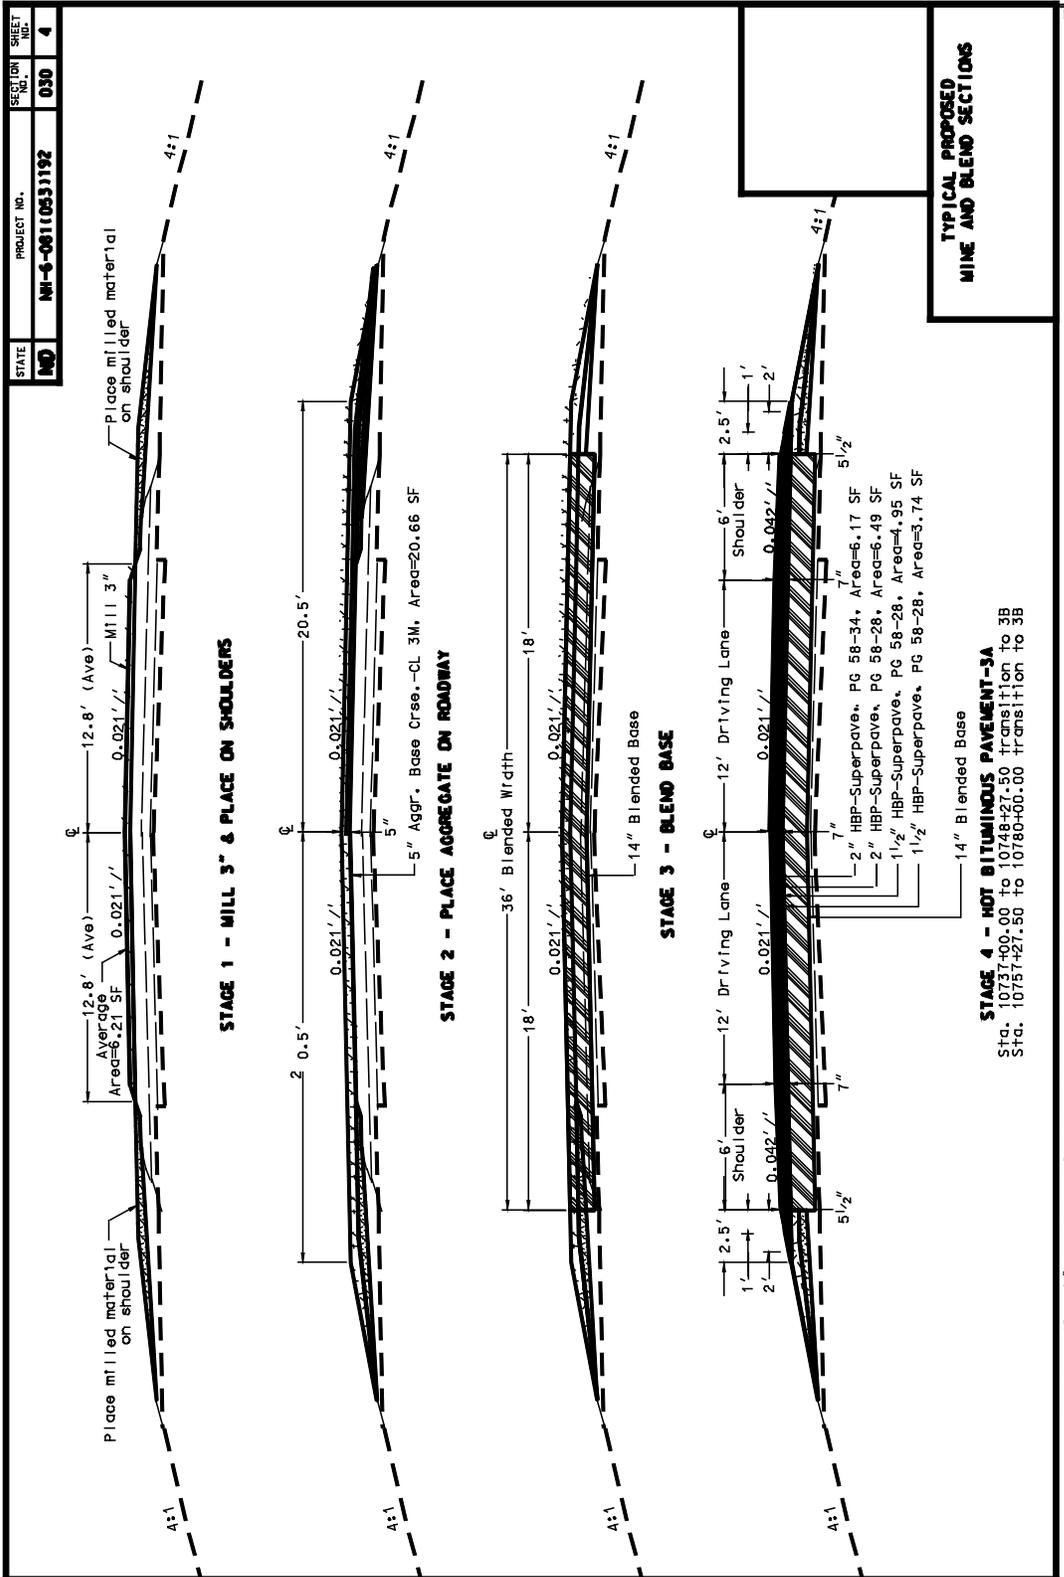
Proposed Typical Sections

The 3.5" overlay will be from RP 192.427 to RP 196.000, the 5.0" overlay will be from RP 196.000 to RP 203.000, and the mine and blend section will be from RP 203.000 to RP 204.453. The proposed typical sections are located in Appendix A.
