Broadway Viaduct Bridge Replacement

February 28, 2018

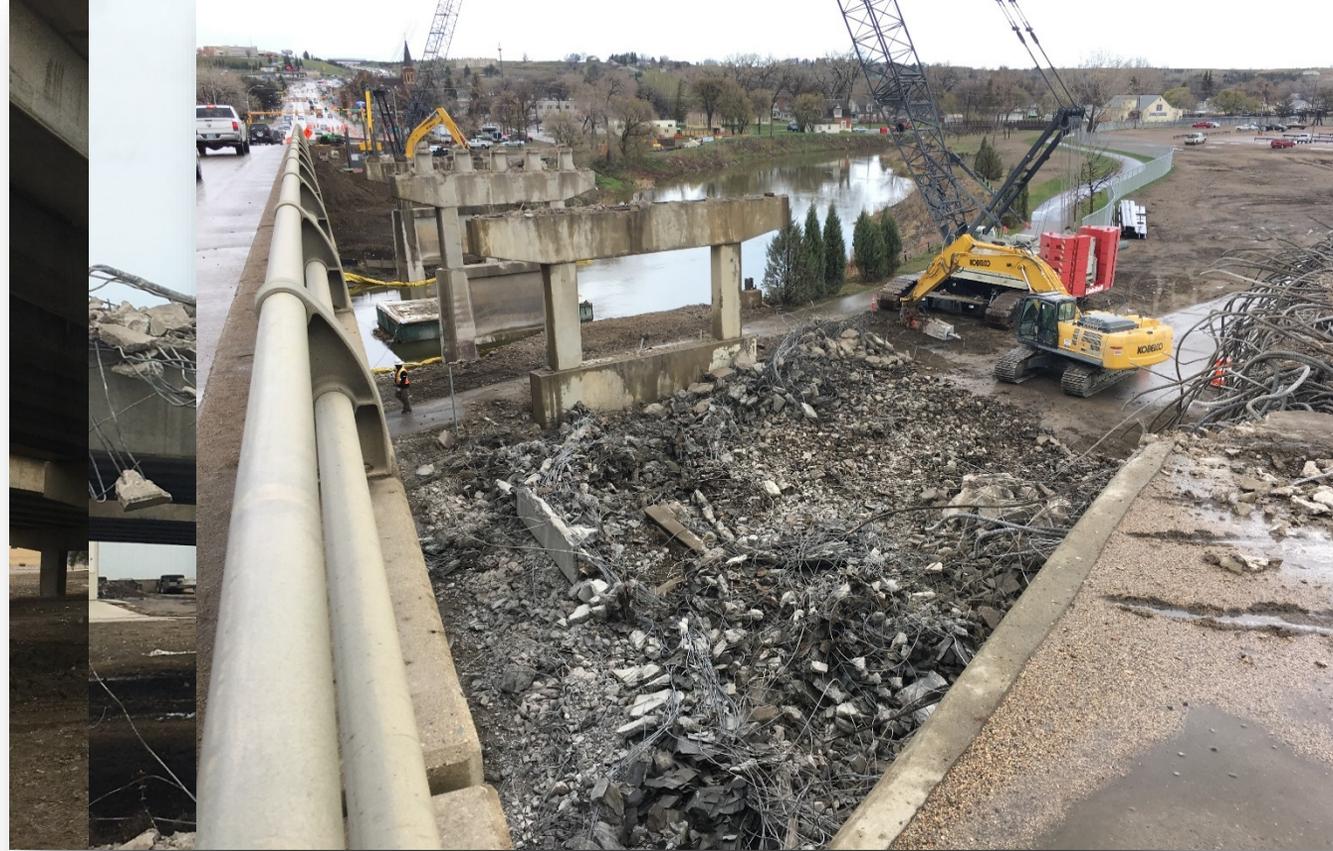
Bridge Demo

- Started on the north and worked to the south

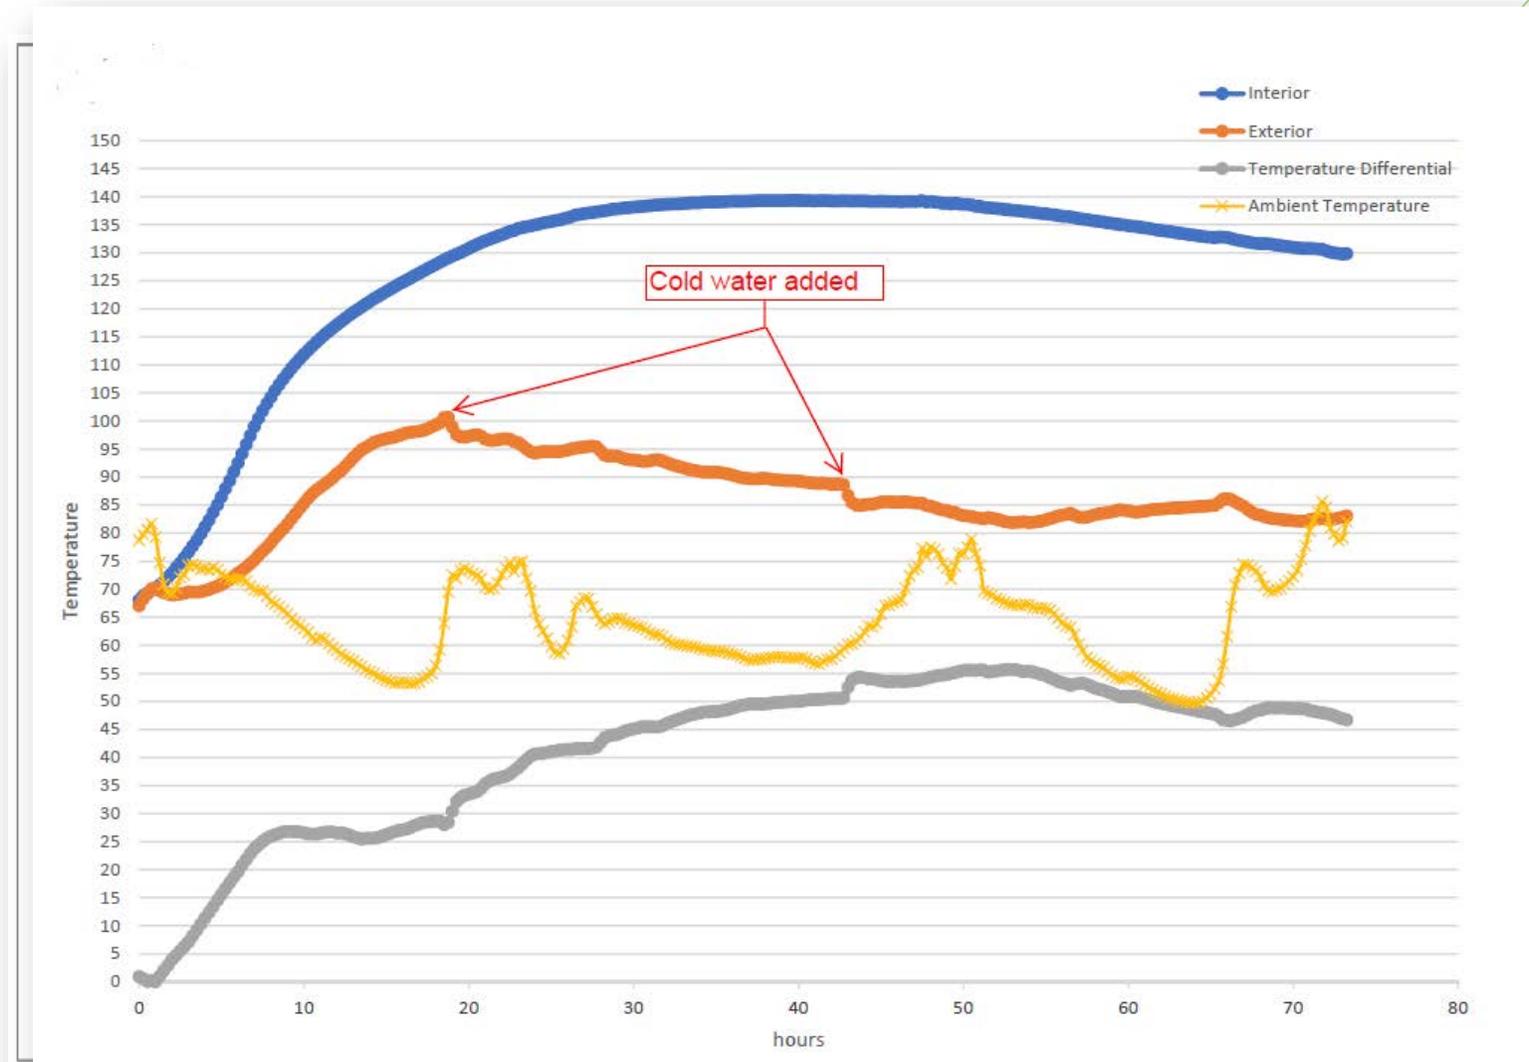
Mass Concrete - Substructure

- Maximum temperature 150° F
- Max differential temperature 35° F

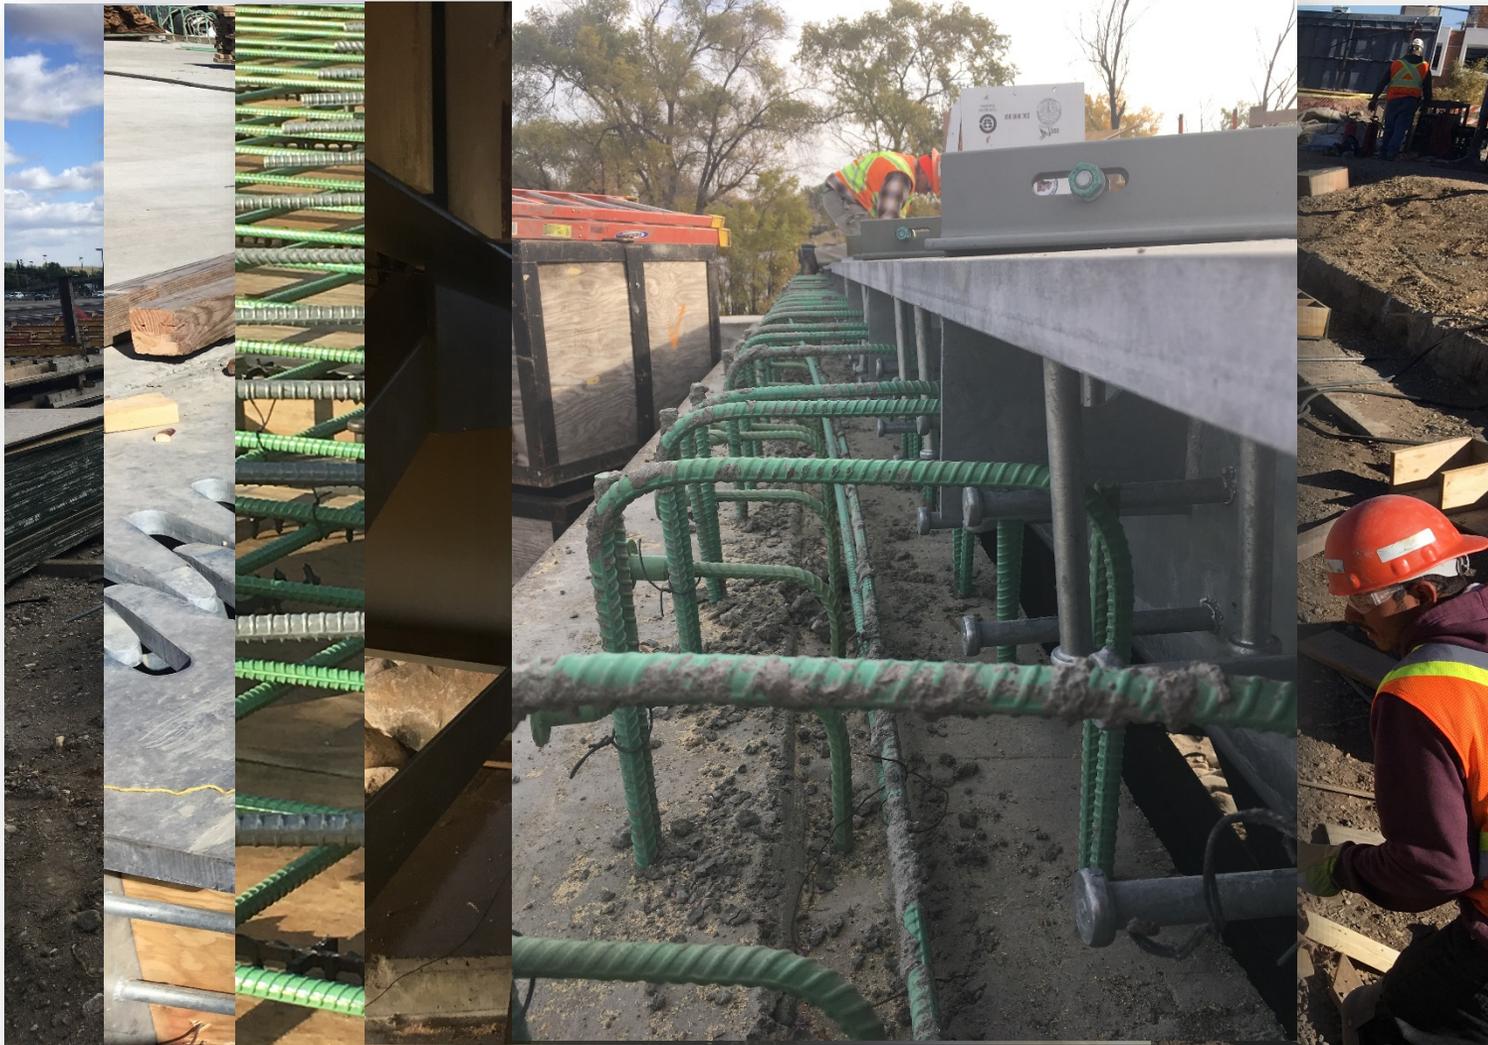
Finger Joint

- **Early July weekly meeting – “Everything is going to be pushed back 1 to 1 ½ months – Hard to finish the bridge this year.”**
 - **Bearings are going to arrive 3 weeks late (mid August)**
 - **Finger Joint is 20 weeks out (December)**
- **We indicated that they should work with their suppliers to accelerate their schedules**
- **Mid July weekly meeting –**
 - **Bearings arrive mid-August**
 - **Fingers arrive in September**
- **Special September 6 meeting to discuss schedule and how the contractor is going to finish the bridge this year**
- **Add extra crews, work 7 days a week, night shift, paint girders onsite, cold weather plan, open to traffic on November 17**
- **Bearings arrived on September 4 (Labor Day)**
- **Finger Joints arrived on August 30 and September 20**

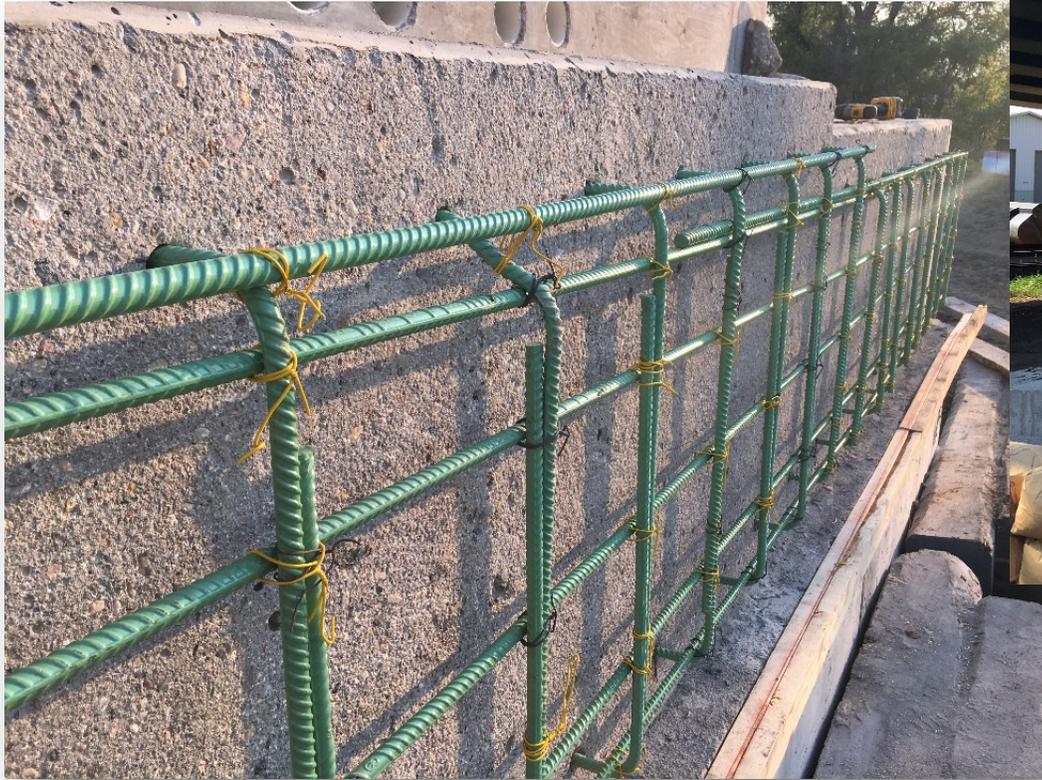
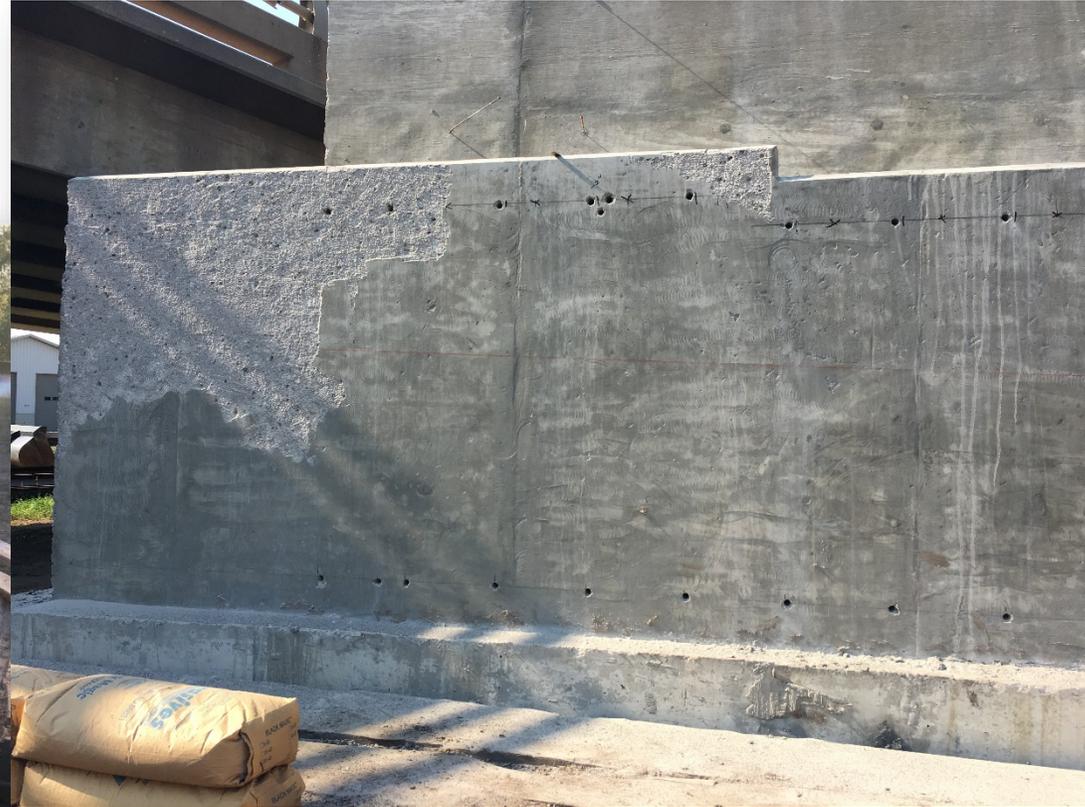
Abutment 8 Build Up

July 11 – during the review of the SB shop drawings the EOR discovered that the cord lengths were not properly detailed in the shop drawings for the NB structure. The detailer used horizontal lengths and not chord lengths to determine the actual length of the girder.

Big deal? For the southern half of the structure it didn't matter due to the almost 0% profile grade. The northern half was a big deal. It was estimated that the beams would be about 4 to 7 inches short depending on temperature and dimensioning. But no one could be exactly sure without fitting up the beams.

- Options:
- 1) Re-manufacture correct length beams.
 - 2) Get the beam stretcher and extend the beams.
 - 3) Extend the beam seat on the abutment.

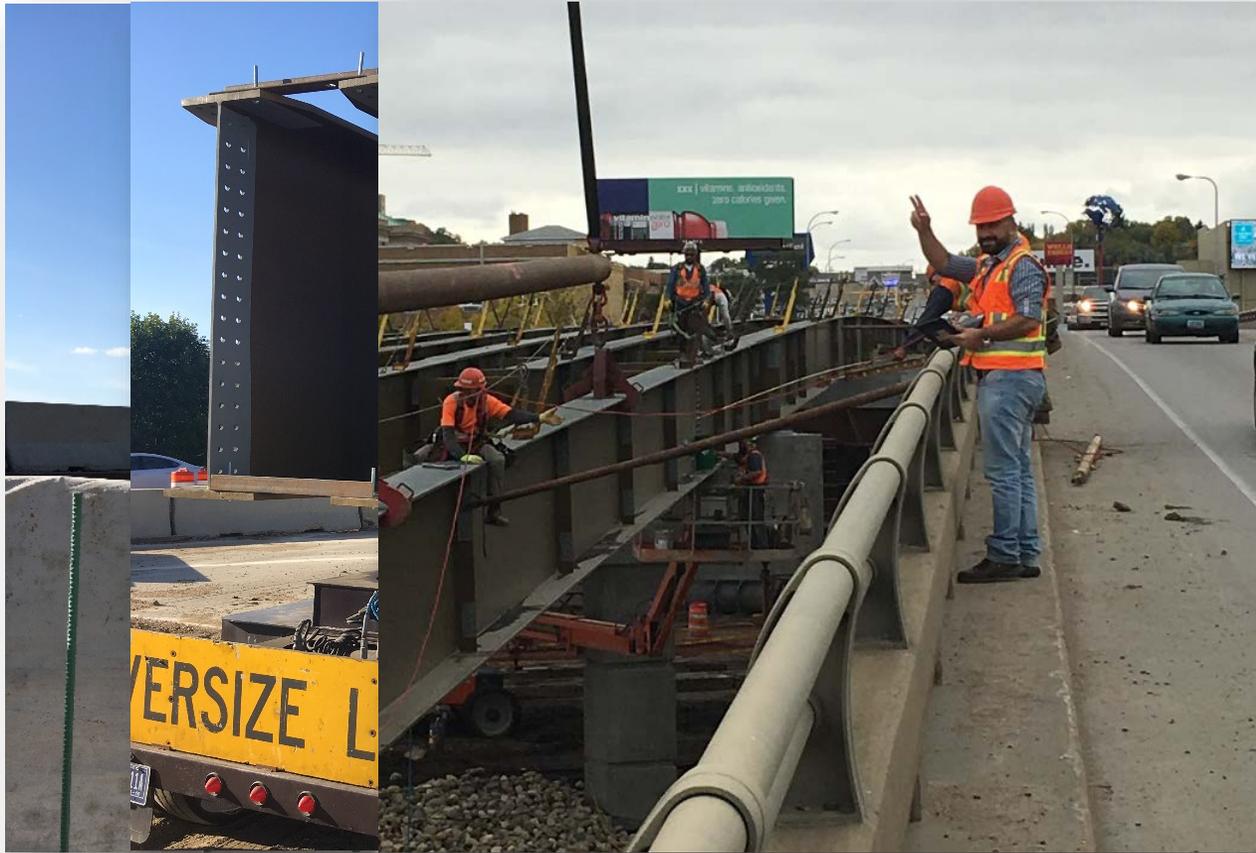
Steel Girders

- September 5 – Girders first started to arrive, about 3 months behind the original schedule and about 2 weeks behind their revised July schedule
- September 11 – We were notified that the supplier was not going to make their schedule of all girders installed by September 21 due to paint drying conditions
- September 22 – We were provided a plan with 8 girders to be placed onsite with primer only and will be field painted in the 2018 construction season
- Of course the beams are over the river! At least they are not over the RR
- Last beam was erected on September 27

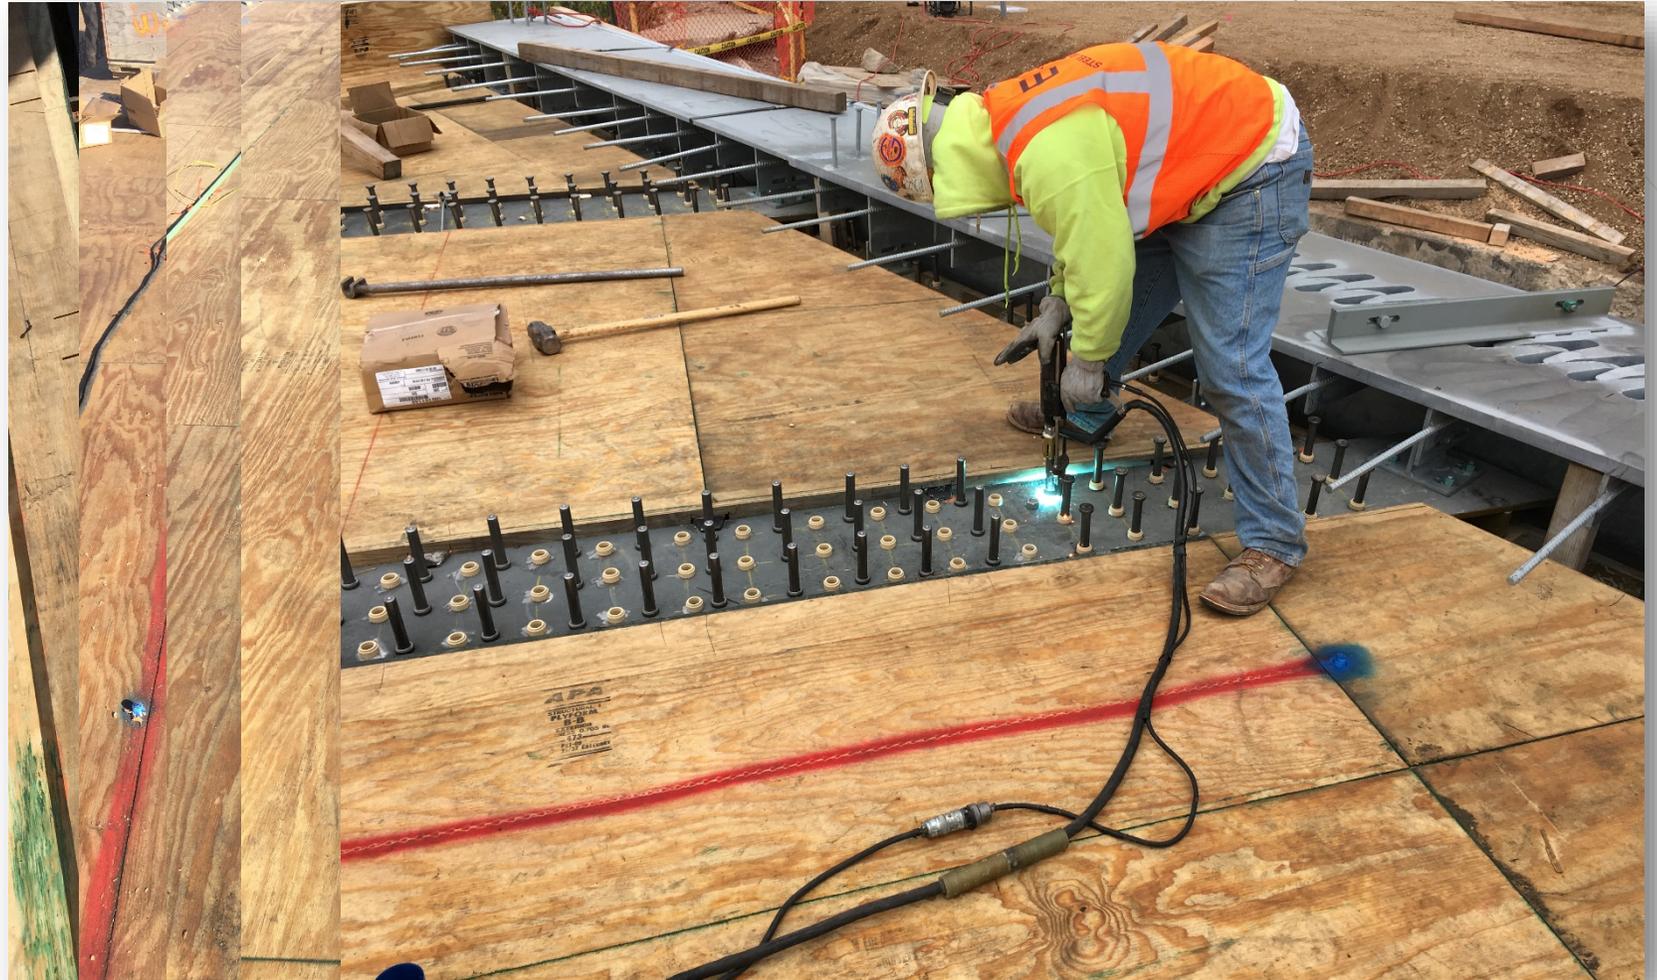
Girder Studs

- John N. installed 15,848 studs in 6 days. Ouch my back!!!

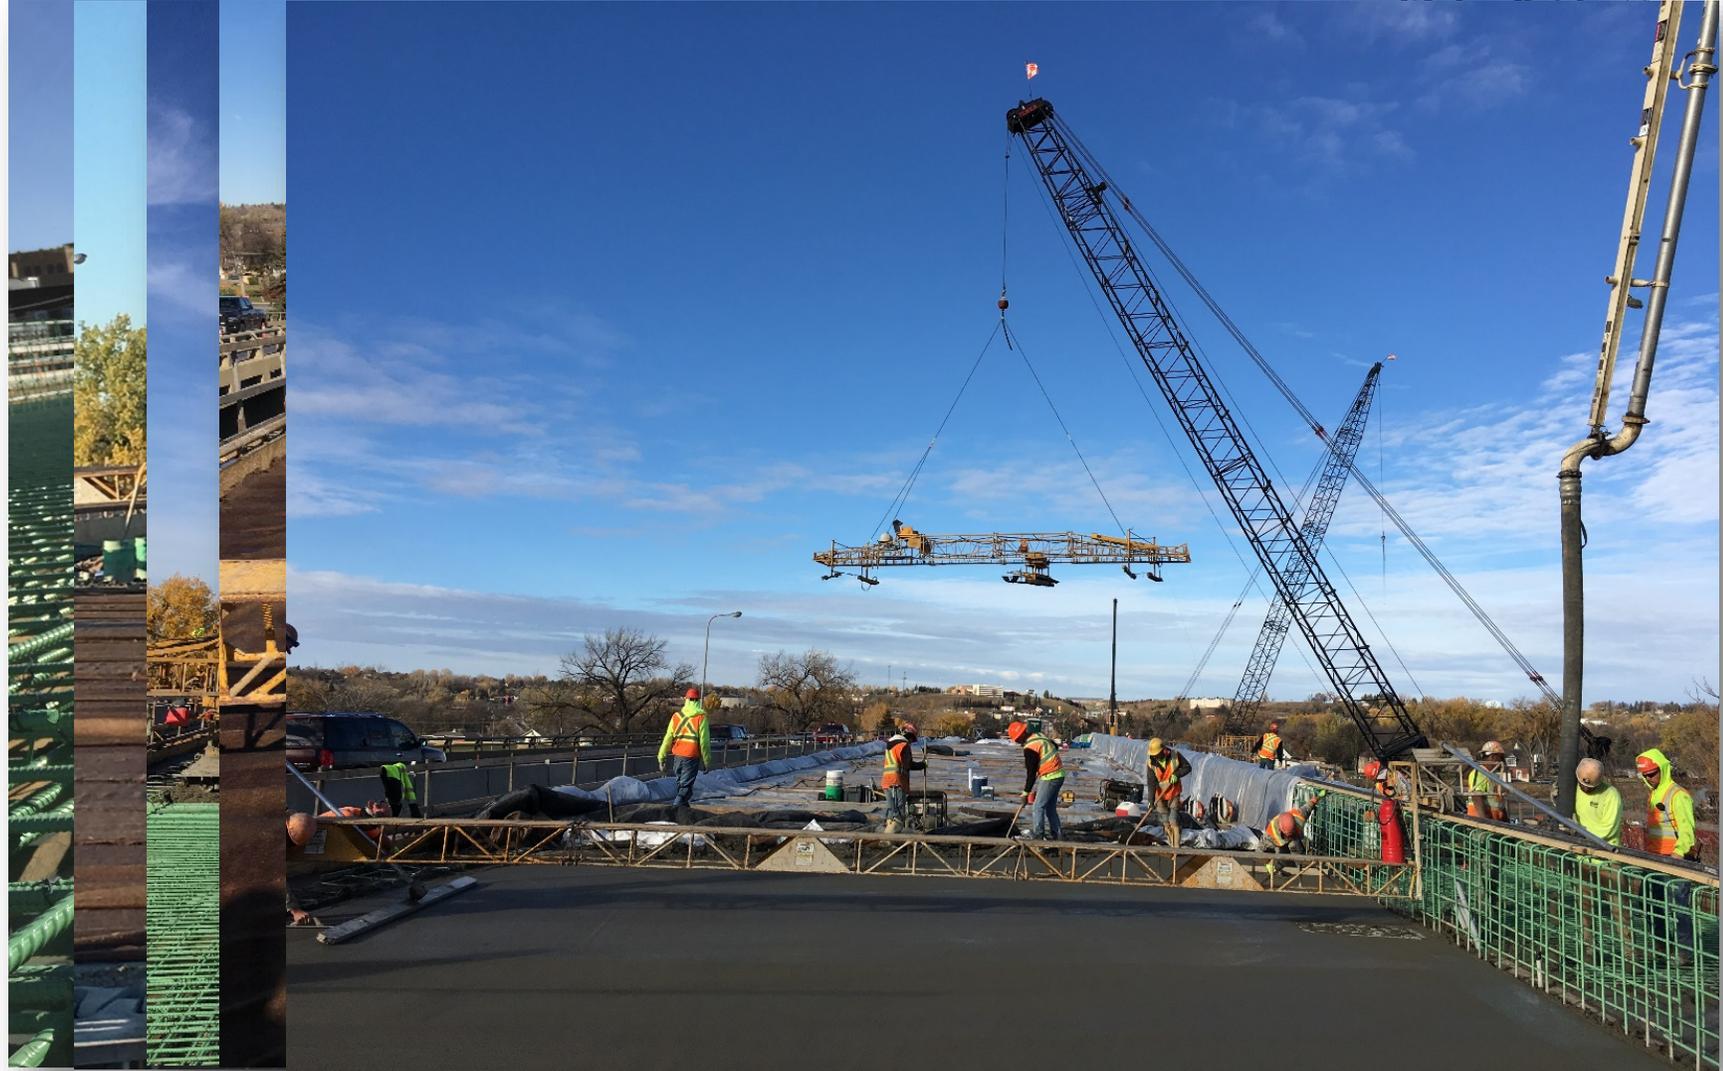
Deck Pours

- Plan indicated 4 deck pours
- Contactor did it in 3 pours to save time
- 1st pour 10/6 – 70 yd
- 2nd pour 10/19 – 540 yd
- 3rd pour 10/24 – 365 yd

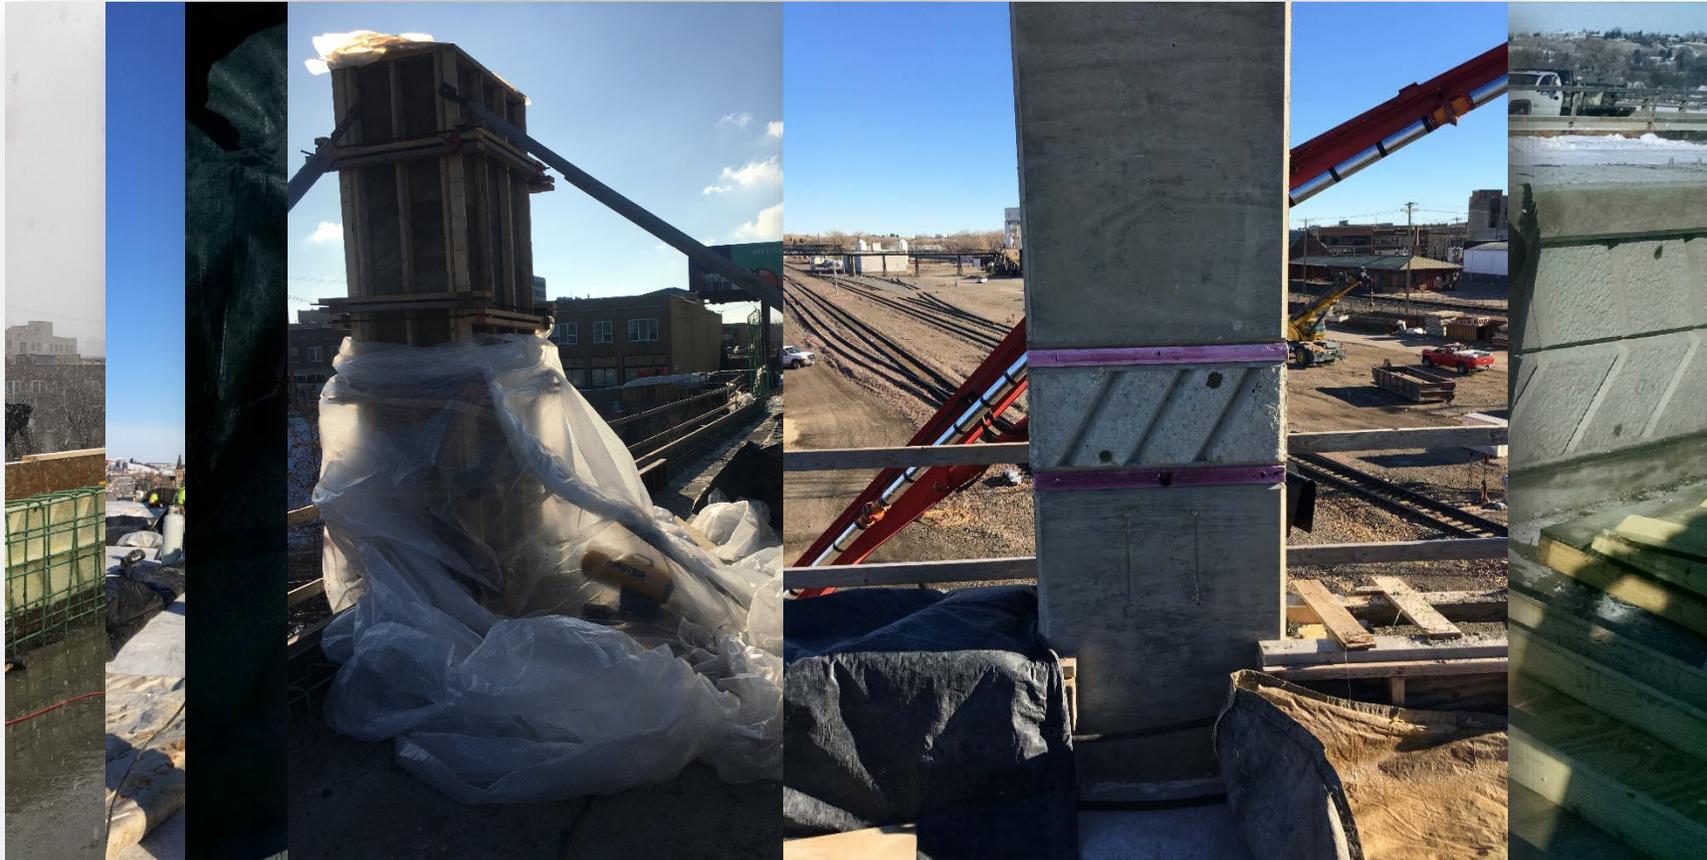
Barrier

- First pour Nov 7
- Last pour Dec 1
