**NORTH DAKOTA
DEPARTMENT OF TRANSPORTATION**

Experimental Study ND 2004-01

**Maximum Percentage of Asphalt Material
in a Blended Base**

Project NH-5-012(027)034

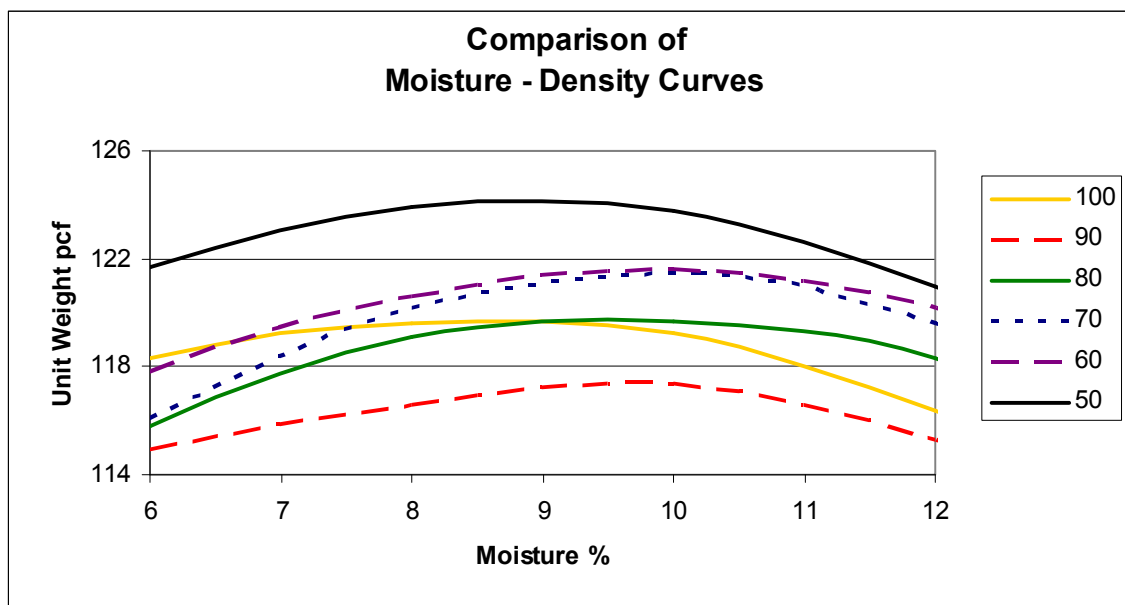
Chart 1

The resulting graph of moisture-density curves is given below. It was expected that a large percentage of salvaged asphalt material would result in a relatively lower unit weight because of the increase in the amount of asphalt cement which has a relatively low specific gravity. The results generally follow expectations except for the sample with 100% salvaged asphalt material. This is probably because the actual amount of moisture was greater than the moisture test showed. An adjustment for this type of error would shift the curve downwards and to the right to its expected position.

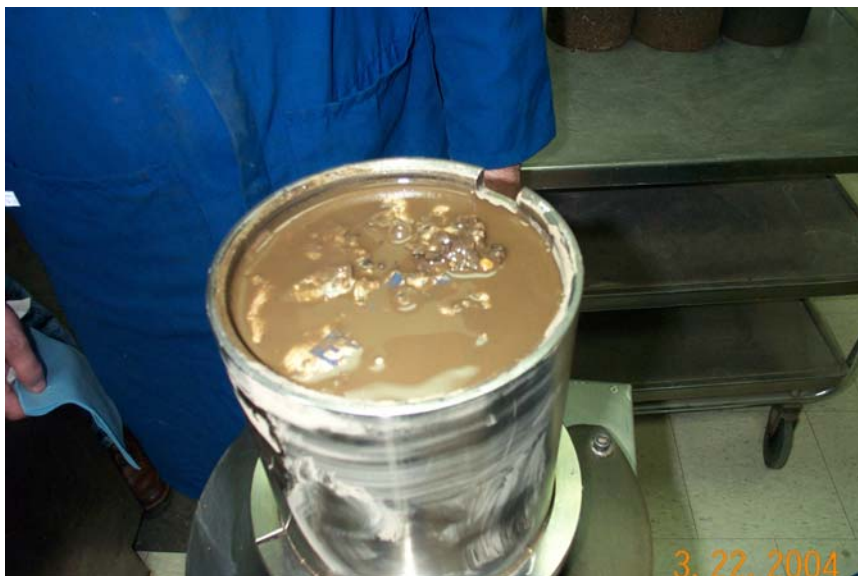
Photo 1 – Water on the surface of a gyratory compactor sample as it is being pushed out of the mold.

The gyratory compactor applied a seating force of 600 kPa or 87.02 psi and then applied 150 gyrations to the test sample. The gyratory compactor recorded the number of gyrations and the height of the sample. On completion of the gyrations the samples commonly had standing water on top of them that contained a large amount of fines. An example of a compacted sample is shown in Photo 1.

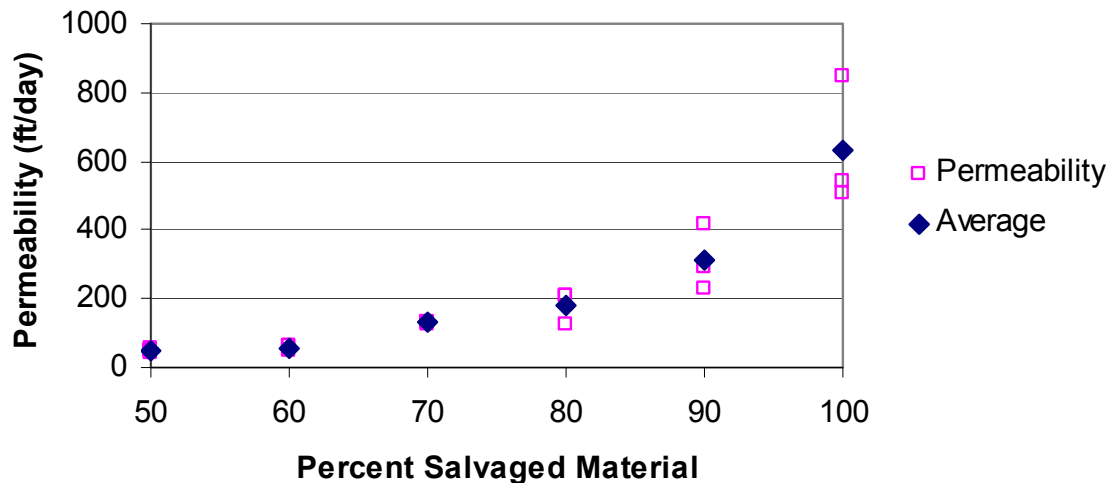
Chart 4

The results are shown in Chart 4. The graph includes both the average permeability of each sample of material (3 trials) and the average permeability of all three samples of material (9 trials). The results show a relatively linear relationship between permeability and the percent of salvaged HBP that the samples contained. This is probably because the salvaged HBP has a coarse gradation and provides many voids for the water to flow through. Also the asphalt material appears to repel water and this may help the material to drain faster.

**Percent Salvage Material
vs Permeability**

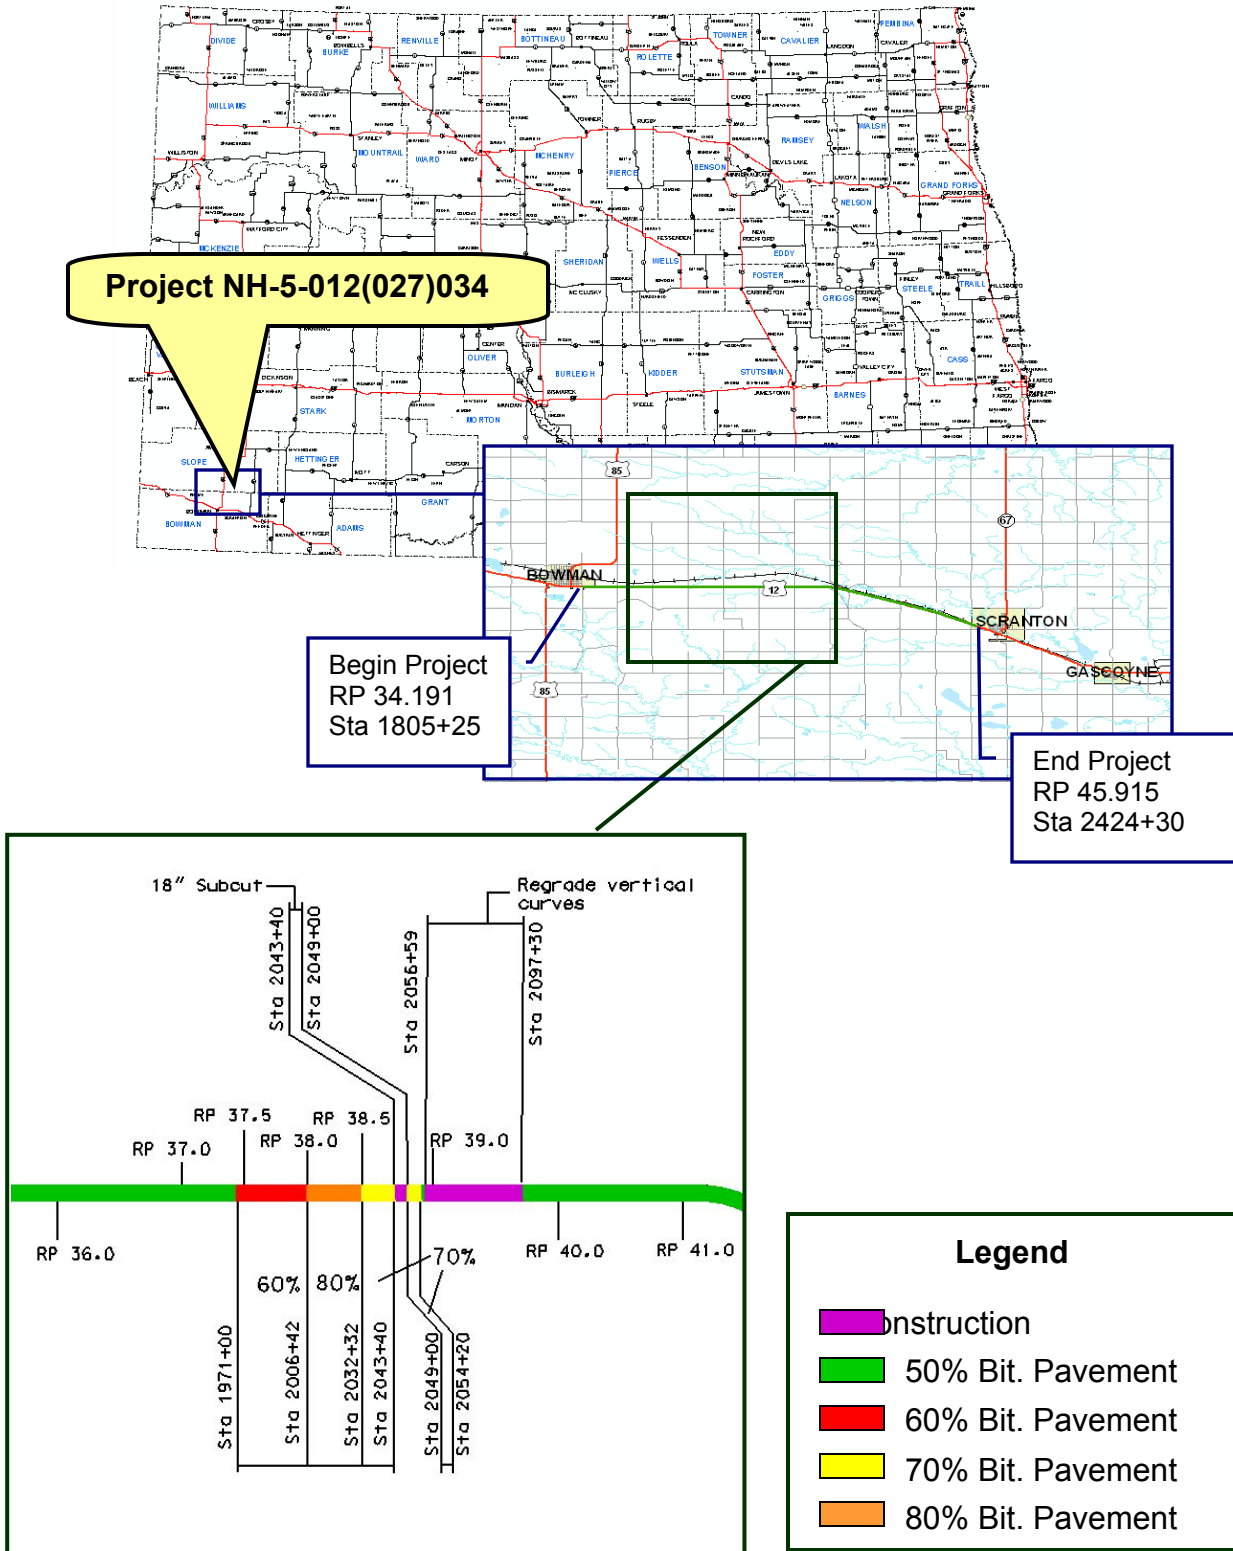
Figure 1 – Project Location

Test segments were constructed to evaluate the performance of pavement sections with base material that contain greater than 50% salvaged HBP. The test segments were constructed as part of the rehabilitation of US 12, project NH-5-012(027)034, with a Mine and Blend. The test segments were constructed with blended base that contain 60%, 70%, and 80% salvaged HBP. The project and test segments are shown in Figure 1.

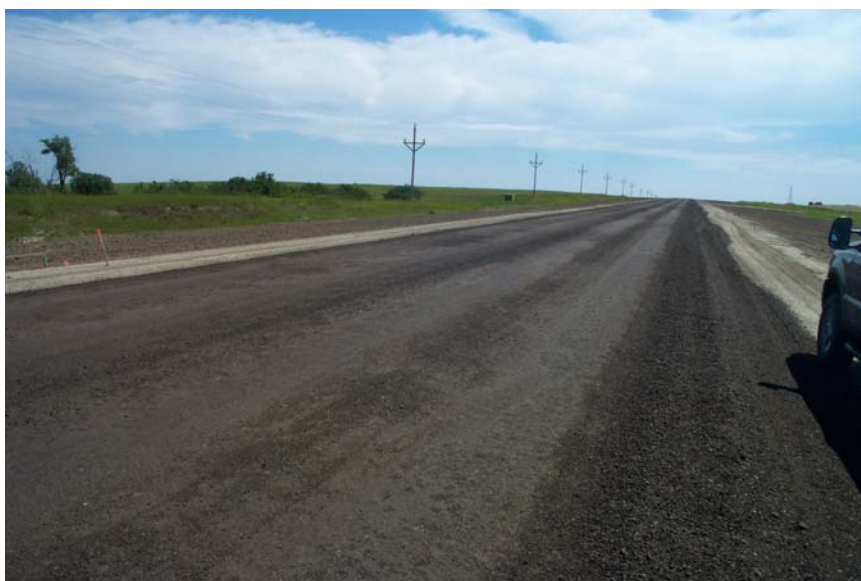
Photo 4 – Test segment with salvaged HBP on top of the pavement.

Construction of the control and test segments began with widening the graded shoulder. Virgin Class 3M aggregate was placed on the shoulders to provide the base for the widened pavement and onto the pavement surface of the control section. When salvaged HBP was available from the construction of the regraded segment, it was placed onto the surface of the pavement in the test segments. Traffic was allowed to travel over the surface of the added aggregate and salvaged HBP during construction. Photo 4 shows the test segment with the salvaged HBP on top of the pavement and Class 3M aggregate on the shoulders.

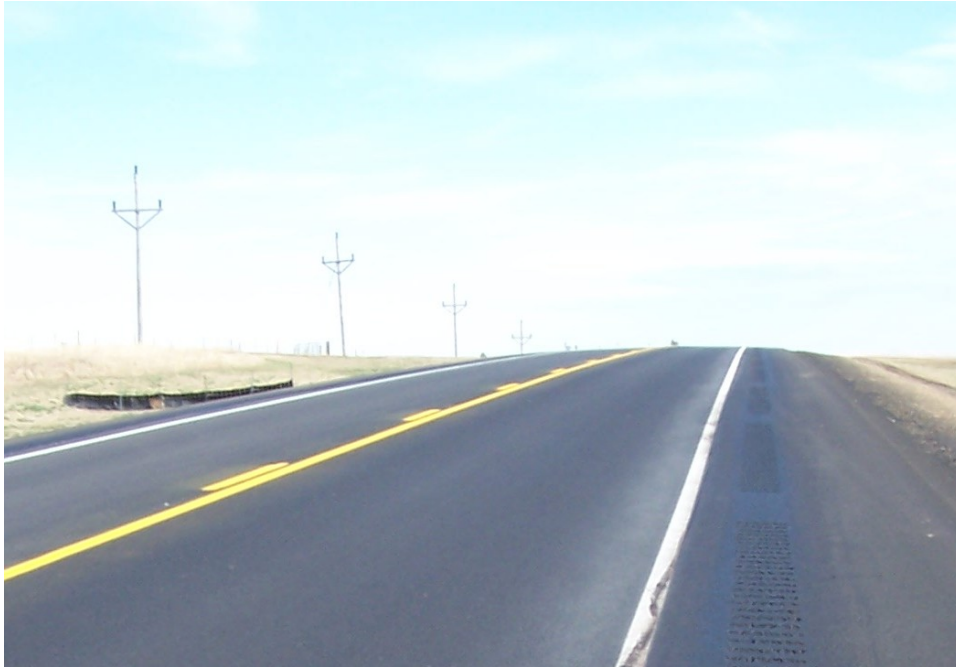
Photo 5 – US 12 just after placement of pavement markings and shoulder rumble strips.

After the blended base was primed, 2 lifts of superpave HBP were paved for a total thickness of 4.5". The paving was completed October 15, 2005. Photo 5 shows the completed pavement surface just after application pavement markings and shoulder rumble strips.

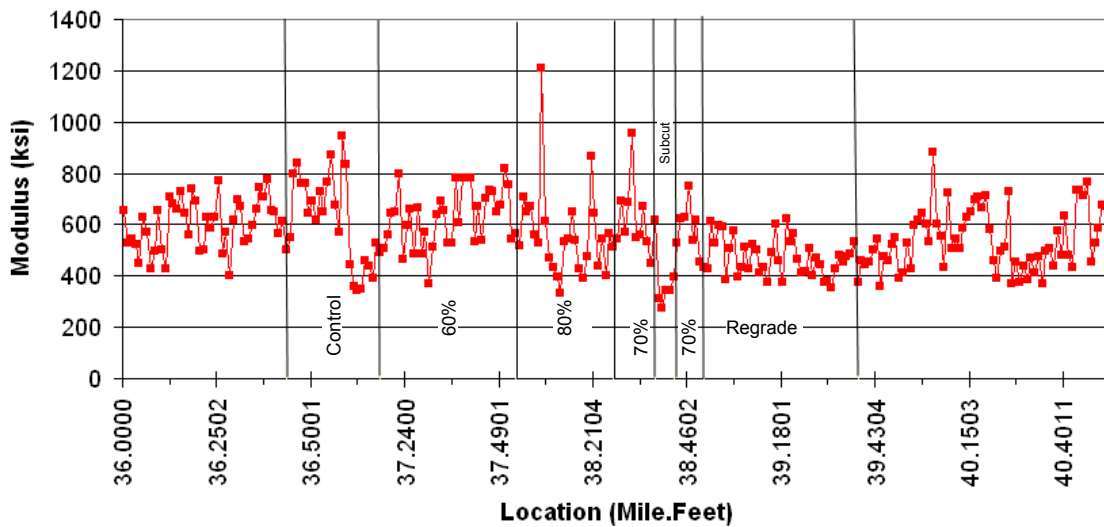
Chart 6

Pavement Modulus

The FWD data shows that the regrade section has the strongest overall pavement section. This section has the lowest sensor deflections and the highest back-calculated base and subgrade modulus. These results are likely because this section was reconstructed instead of Mine and Blend. As part of reconstruction, the subgrade was compacted and the base was compacted in lifts. Also, some of the base material in this section is virgin Class 5.

The FWD data shows the subcut section as having unusually strong subgrade modulus and low pavement modulus. This is likely an error of the back-calculation software caused by the unusually thick base section in the subcut section.

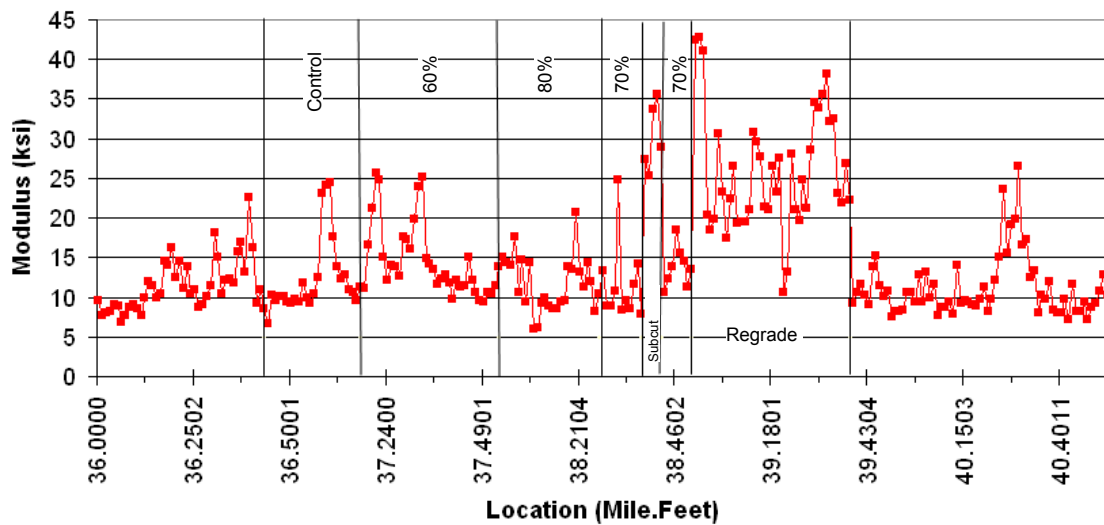
Chart 8

Subgrade Modulus

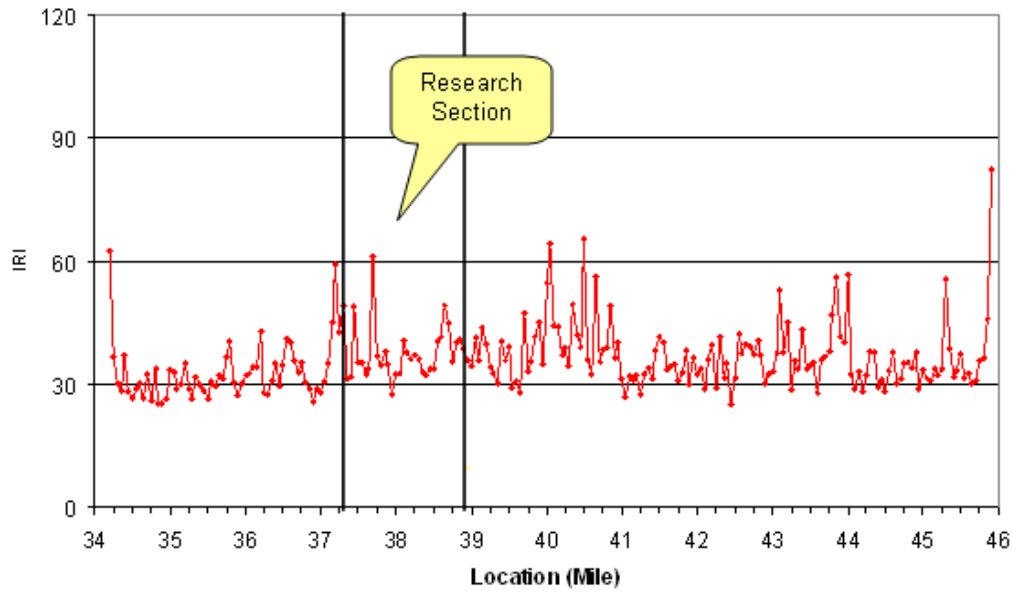
Chart 9

IRI
Project NH-5-012(027)034 WB

IRI data was collected with both the “Pathways Van” and with a LWP. The average IRI of the entire project was 35.4 according to the “Pathways Van” and 35.8 according to the LWP. The LWP also collected the IRI from the research section separately. The IRI collected by the LWP for the entire project is shown in Graphs 9 & 10 in 264’ increments and the IRI collected separately from the test segments is shown in Graphs 11 and 12 in 100’ increments.

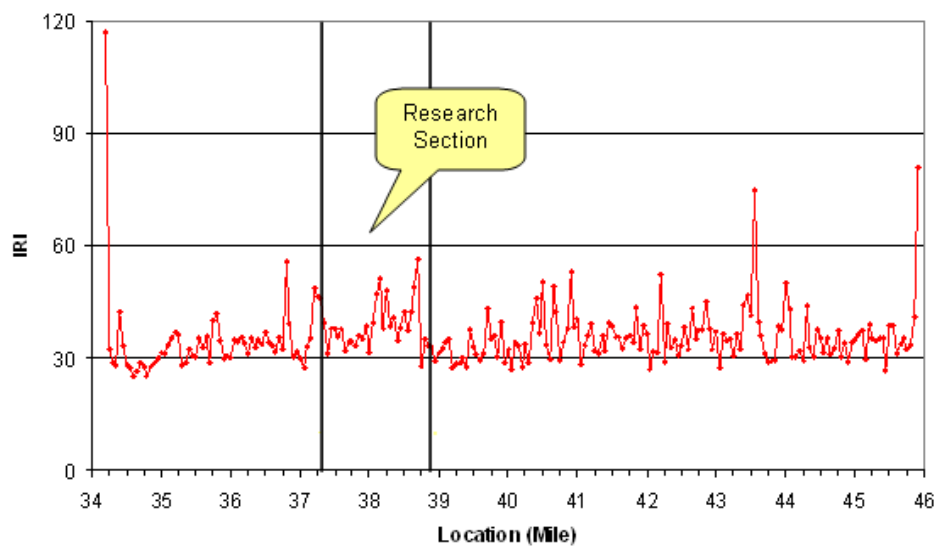
Chart 10

IRI
Project NH-5-012(027)034 EB

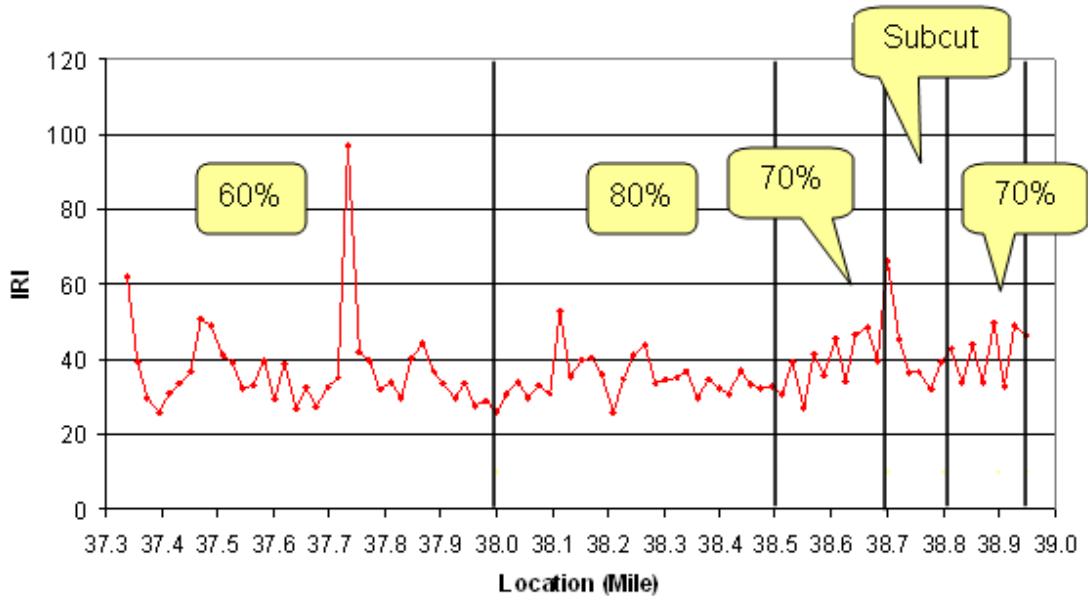
Chart 12
IRI
Research Section WB

There doesn’t appear to be any difference in the IRI from the test segments and control segments. Graph 12 shows that there does appear to be a significant bump in the 60% salvaged HBP section in the WB direction and Graph 11 shows a smaller bump in the 80% WB segment. From Graphs 11 and 12 it appears that there may be a bump across both lanes at the boundary of the 70% salvage HBP segment and the Subcut segment.
