Experimental Study MR 96-02

**Evaluation of Polysulfide Rubber Joint
Sealant in Concrete Joints**

Final Report

Projects NH 6-005(013)312 & SS-6-018(033)224

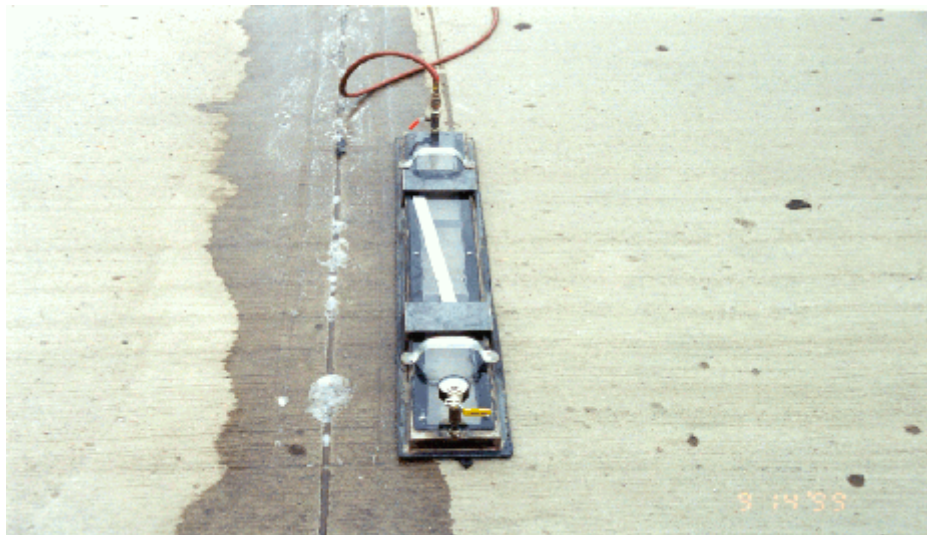
Photo 1: I-Vac testing chamber and leaking areas.

Test locations are shown on plan sheet pages 62, 63, 96, 97, and 98. These plan sheets are found in Appendix C. The polysulfide joints on the plans have been darkened to make them easier to see. The joint leakage tests were conducted using the Iowa Vacuum (I-Vac) chamber. Testing was done across the lane and included the parking lane. Photo 1 shows a view of the I-Vac testing chamber and bubbles revealing areas that leak.

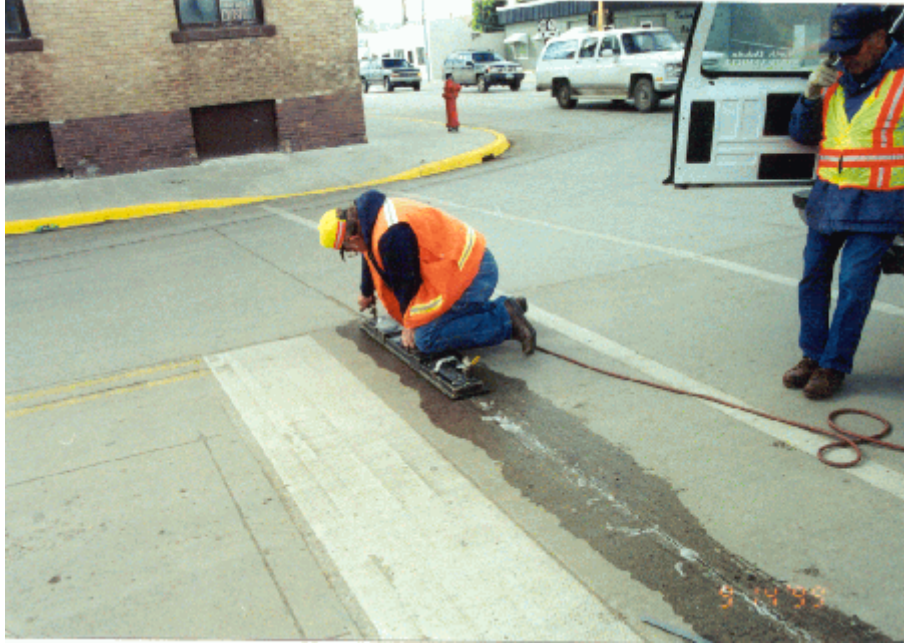
Photo 2: I - Vac test.

The I-Vac testing chamber is 4 feet long. To test across the driving lane and parking lane requires five separate tests. The type and number of leaks were not recorded this year. Instead, the lineal footage of leaks was measured at each joint. It is often difficult to determine the exact cause of each failure. To run a test, the pavement surface is first sprayed with soapy water. The I-Vac is placed over the joint and vacuum is applied. If the joint leaks at any point within the chamber, bubbles will appear as air is drawn up through the joint. The I-Vac has a soft rubber seal that contacts the pavement surface. Small or large leaks can be determined. Photo 2 shows a test in progress. Photo 3 shows the leaks from testing. Just by looking at the joint condition, you can tell which areas or spalls might leak.

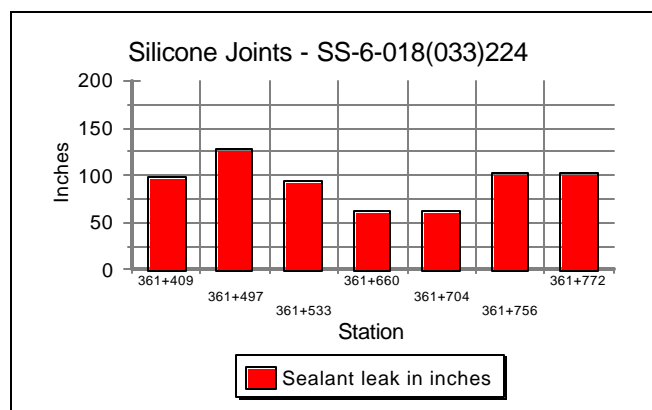
Graph 1

In the 1999 evaluation with the I-Vac system, the number of leaks was changed to leak lengths. This results in a better comparison between the two materials. A total of 1680 lineal inches of silicone joints were tested. The detected leaks totaled 650 linear inches and represent a failure rating of 38.7 percent. A total of 1620 lineal inches were tested in the Polysulfide joints and 528 inches of leaks were detected. This represents a failure rate of 32.6 percent. The polysulfide sealant is performing a little better than the silicone. A comparison of the total length of sealant leaks on the two projects is shown in graphs 1 and 2.

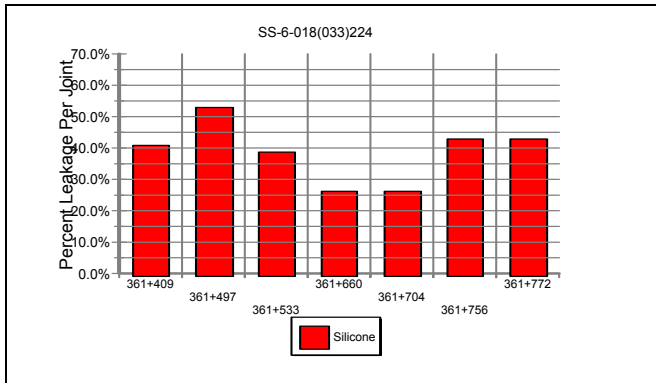
Graph 3

A comparison of the percent leakage per joint of the two sealants is shown in graphs 3 and 4.

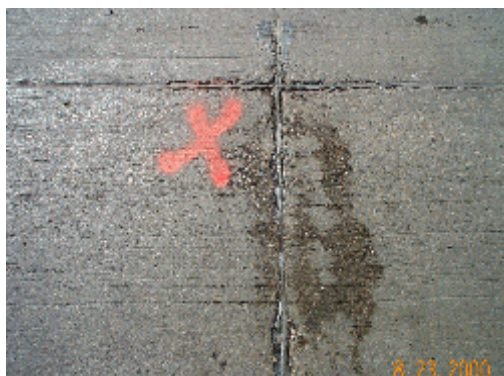
Photo 4 Typical Joint.

The total per cent of leaks has increased by 10% from 1999 to 2000. Both sealants are performing much the same at this time. Photos 4 and 5 show some typical joint conditions in 2000.

The failures in the silicone section are about equal with 50% adhesion and 50% spalls. The silicone is very dirty, but is still soft. More spall failures were noticed in the Polysulfide section than adhesion and they were larger in size. The Polysulfide sealant is whiter looking than the silicone, but is harder or less flexible. Both sealants are staying in the joint and do keep most of the incompressible material out. The joints in the intersection exhibit the most lineal leakage.
