Experimental Study MR 98-01

Evaluation of Water-Borne Pavement Marking Paints

Final Report

October 2001

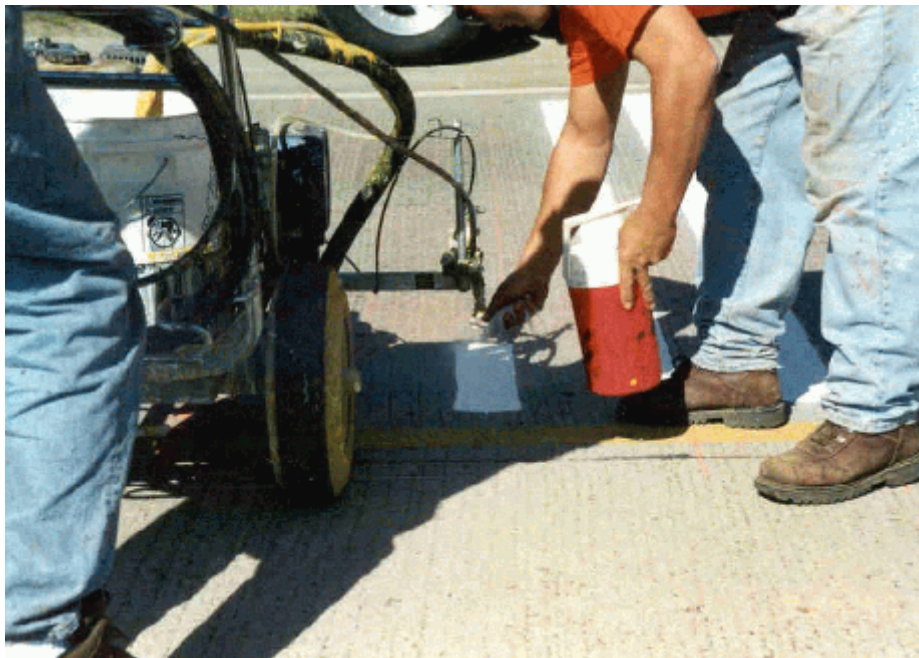
Photo 1 depicts TSS applying the latex E-3427 and the glass beads. The method used to apply the glass beads resulted in uneven application.

Photo 1 - Contractor applying white latex E-3427 paint stripes followed by glass beads. Stripes installed on PCC surface.

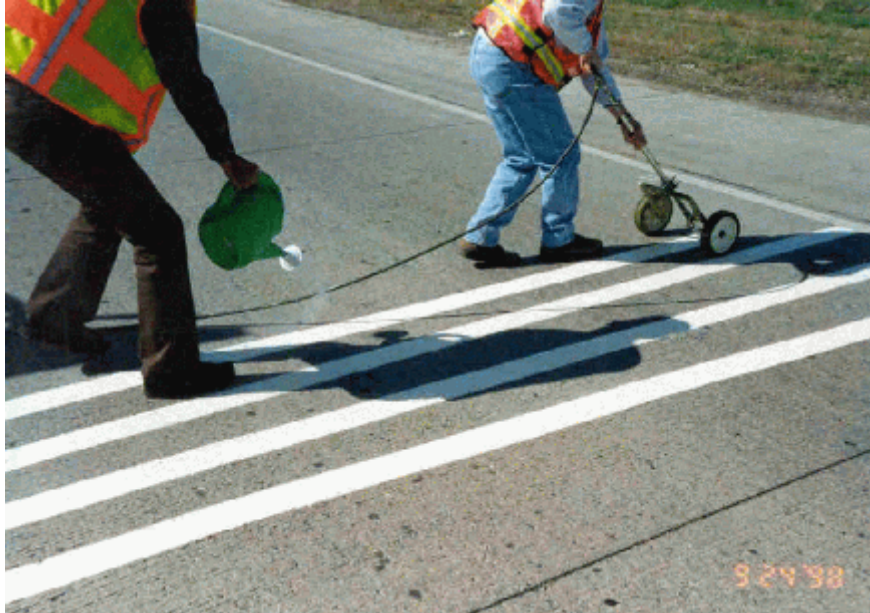
Photo 2 depicts NDDOT maintenance forces applying white solvent-borne paint followed by the glass beads. Maintenance force's method of applying the glass beads resulted in a more uniform distribution. The beads used for this experimental project were Flex-o-lite 70/30 dualcoated beads - Brite Blend.

Photo 2 - Maintenance forces applying white solvent-borne paint stripes followed by glass beads. Stripes installed on PCC surface.

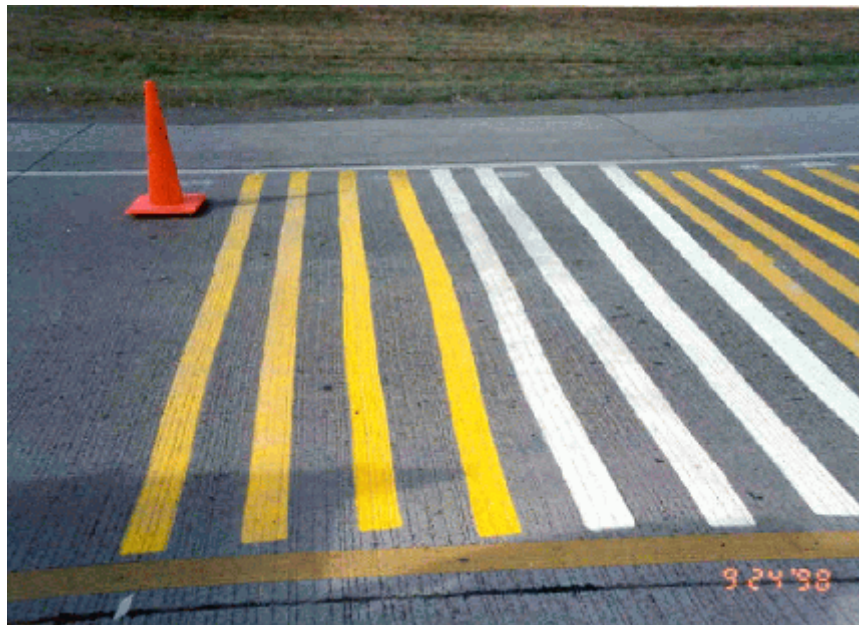
Photo 3 shows eight test stripes located in the concrete test section taken immediately after construction. The four yellow stripes on the left side of the photo are painted with solvent-borne paint and the four white stripes on the right are painted with solvent-borne paint. For each set of four stripes the left two stripes has an application of glass beads.

Photo 3 - Eight test stripes on concrete test section. Four yellow solvent-borne paint stripes (left side). Four white solvent-borne paint stripes (right side).

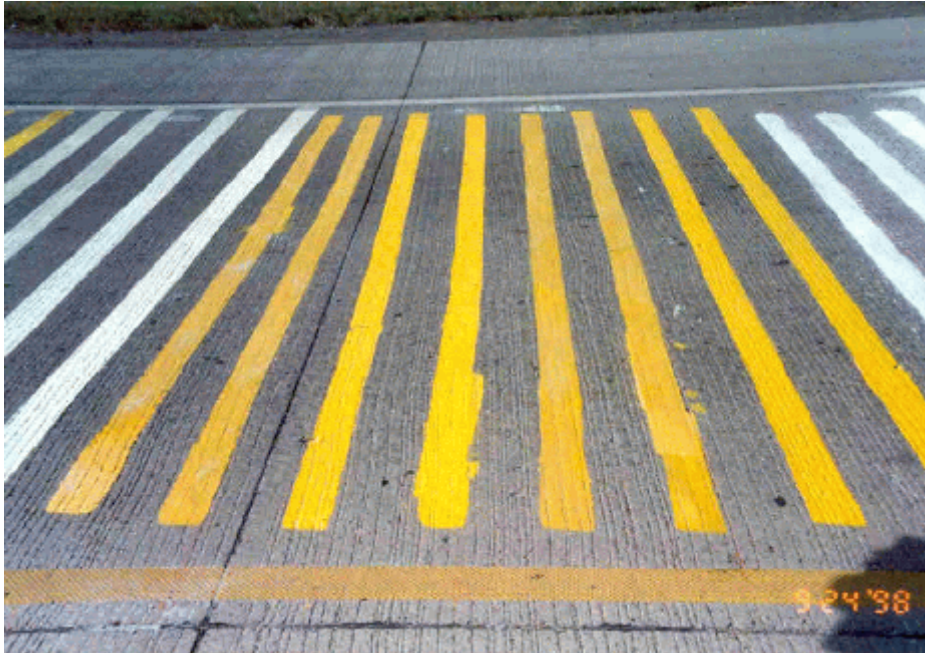
Photo 4 depicts the middle eight stripes located in the same concrete test section taken immediately after construction. The four yellow stripes on the left side of the photo are painted with latex E-2706 and the four yellow stripes on the right are painted with latex E-3427.

Photo 4 - Middle eight stripes on concrete test section. The four yellow latex E-2706 stripes (left side). Four yellow latex E-3427 stripes (right side).

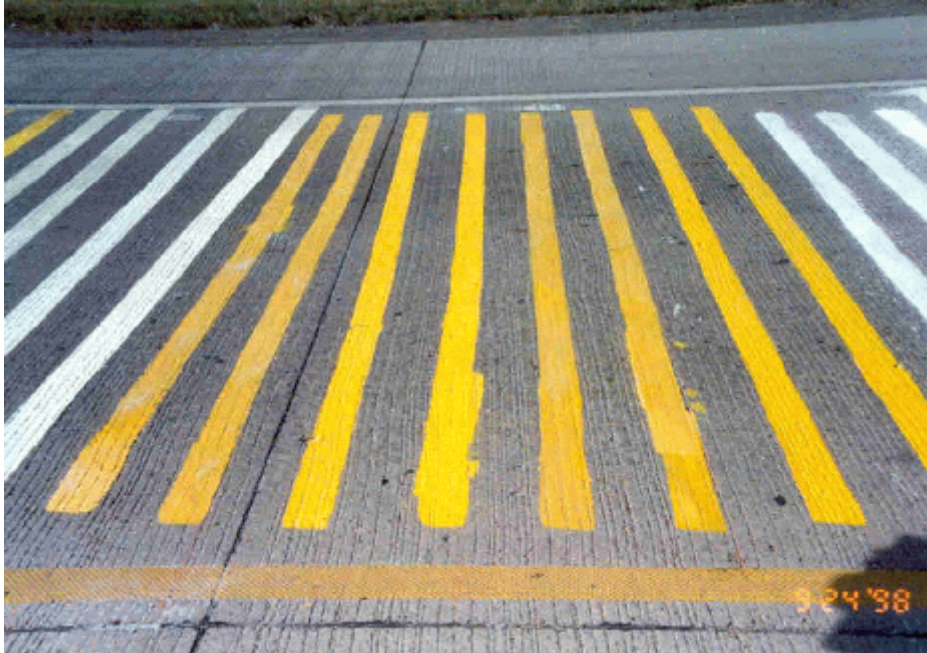
Photo 5 depicts the final eight test stripes located in the concrete test section taken immediately after construction. The four white stripes on the left side of the photo are painted with latex E-2706 and the four white stripes on the right are painted with latex E-3427. The latex E-2706 was applied too heavy because the contractor was having problems with the sprayer.

Photo 5 - Final eight test stripes on concrete test section. Four white latex E-2706 stripes (left side). Four white latex E-3427 stripes (right side).

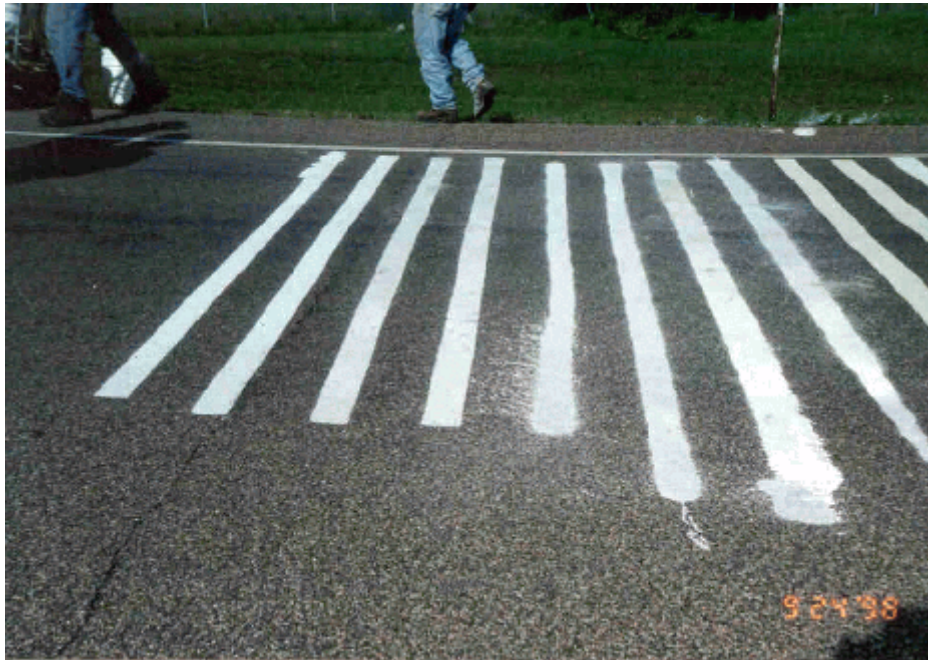
Photo 6 depicts eight white test stripes applied to an asphalt pavement. This photo was taken immediately after construction. The four stripes on the left side of the photo are painted with latex E-3427 and the four on the right are painted with latex E-2706. For each set of four stripes, the right two stripes, have an application of glass beads.

Photo 6 - Four latex E-3427 stripes (left side). Four latex E-2706 stripes (right side). Stripes installed on AC surface.

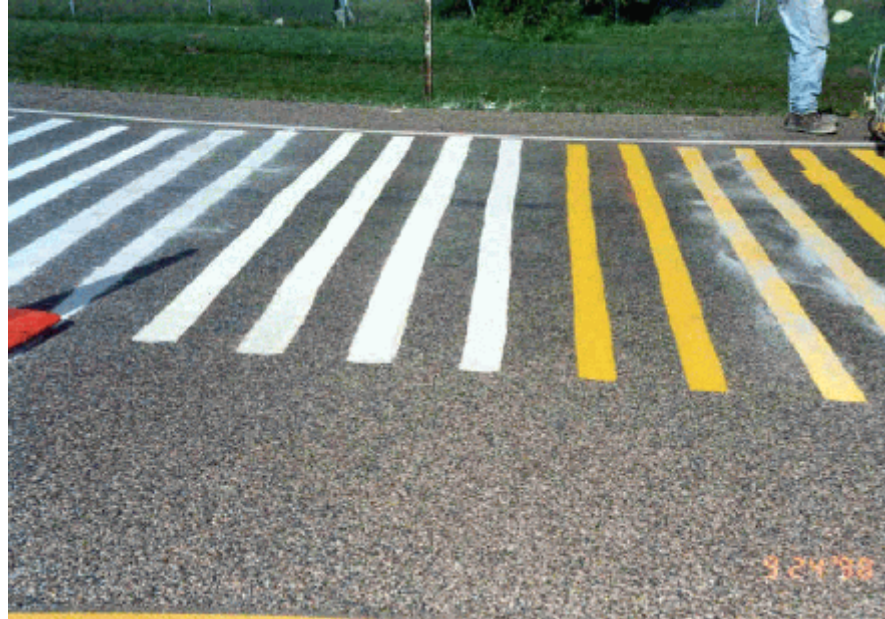
Photo 7 depicts the middle eight stripes located in the same asphalt test section taken immediately after construction. The four white stripes on the left side of the photo are painted with solvent-borne paint and the four yellow stripes on the right are painted with latex E-3427. Notice on the yellow latex stripes the excess application of beads.

Photo 7 - Middle eight stripes of asphalt test section. Four white solvent-borne paint stripes (left side). Four yellow latex E-3427 stripes (right side).

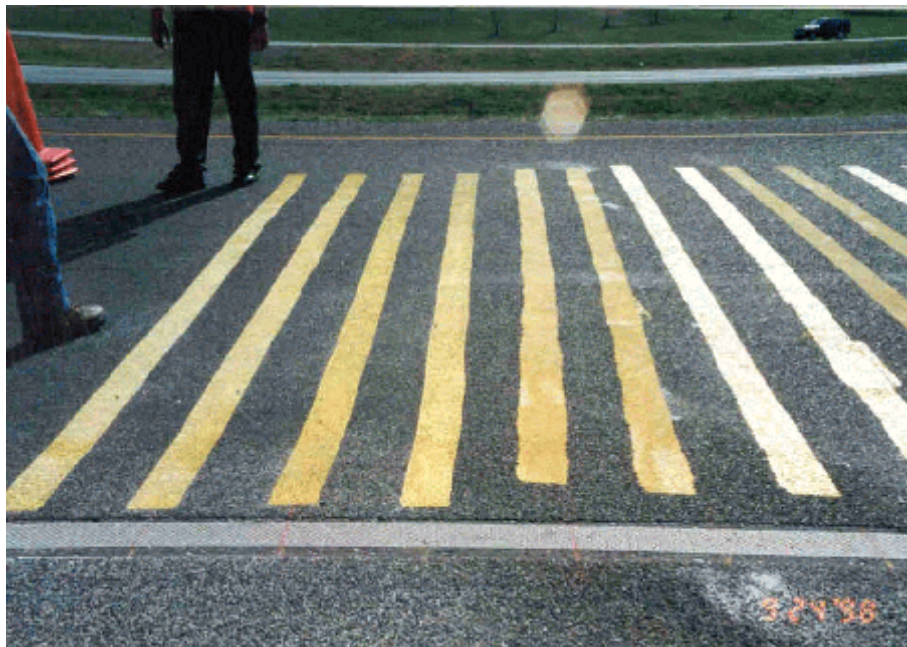
Photo 8 depicts the final eight test stripes located in the asphalt test section taken immediately after construction. The four yellow stripes on the left side of the photo are painted with solvent-borne paint and the four yellow stripes on the right are painted with latex E-2706.

Photo 8 - Final eight test stripes on asphalt test section. Four yellow solvent borne paint stripes (left side). Four yellow latex E-2706 paint stripes (right side).

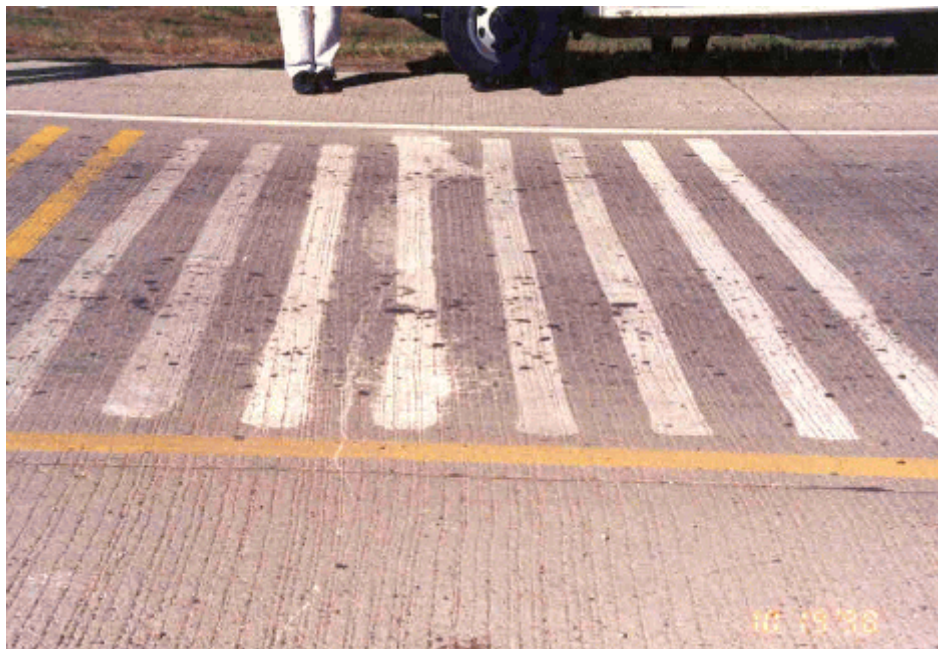
The first, second, and third evaluations were conducted after approximately 26, 66, and, 261 days of exposure to traffic. Photo 9, (taken during the first evaluation), depicts the four latex E-2706 stripes (left hand) and the four latex E-3427 stripes on the concrete pavement 26 days after installation.. The E-2706 material appeared to be holding up, however, the thick application rate, as previously mentioned, may have had some bearing on the performance. The latex E-3427 stripes also appeared to be in good condition.

Photo 9 - First evaluation of stripes on concrete test section. 26 days after installation. Four white latex E-2706 (left), and four white latex E-3427 (right) test stripes.

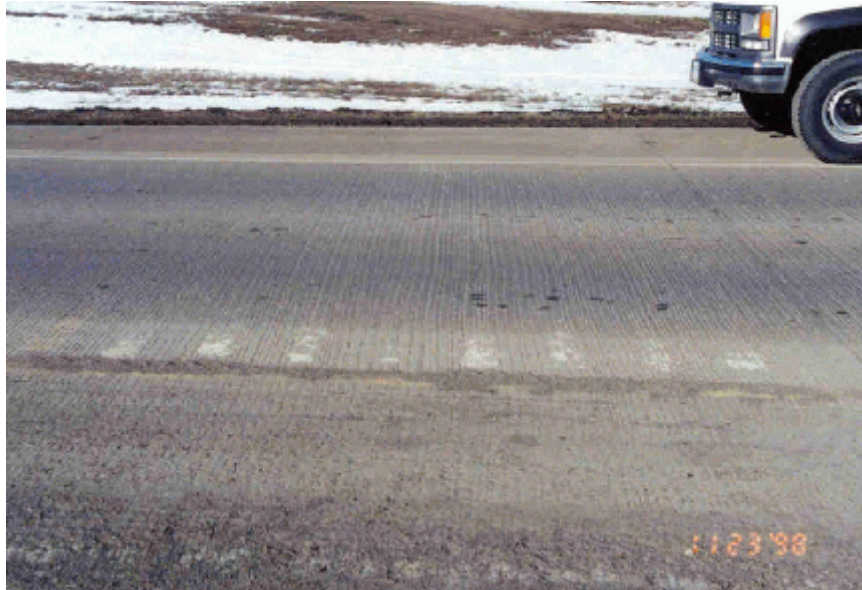
Photo 10, (taken during the second evaluation), depicts the same test stripes approximately 66 days after installation. The white latex E-2706 and the E-3427 material have completely worn away except near the edges of the PCC pavement.

Photo 10 - Second evaluation of E-2706 (left), and E-3427 (right), white latex test stripes. 66 days after installation.

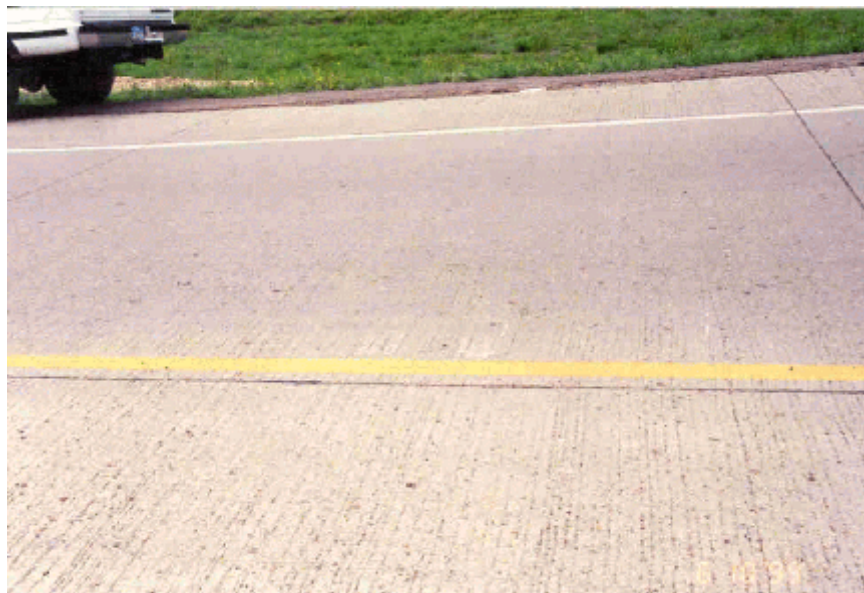
Photo 11, (taken during the third evaluation), depicts the test stripes approximately 261 days after installation. The photo indicates that only minor traces of the white latex E-2706 and the E-3427 material remain near the edges of the PCC pavement.

Photo 11 - Third evaluation of E-2706 (left), and E-3427 (right), white latex stripes. 261 days after installation.

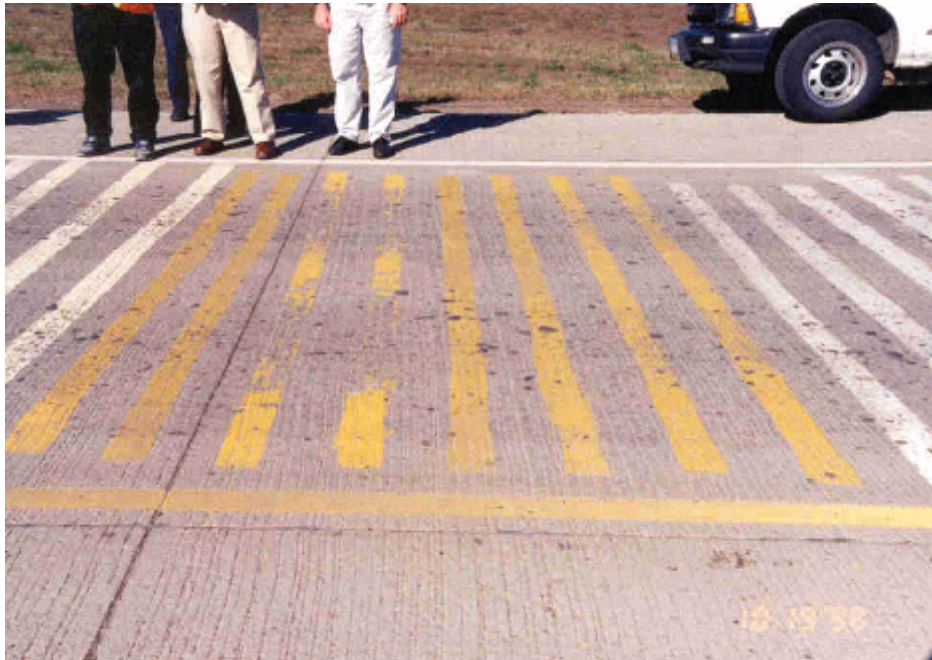
Photo 12 (during the first evaluation), depicts the yellow latex E-2706 (left four stripes) and the yellow latex E-3427 stripes in the PCC pavement 26 days after installation. During this time the E-3427 (right) material appeared to be performing better than the E-2706 (left) material.

Photo 12 - First evaluation of stripes on concrete test section. 26 days after installation. Four yellow latex E-2706 (left), and four yellow latex E-3427 (right) test stripes.

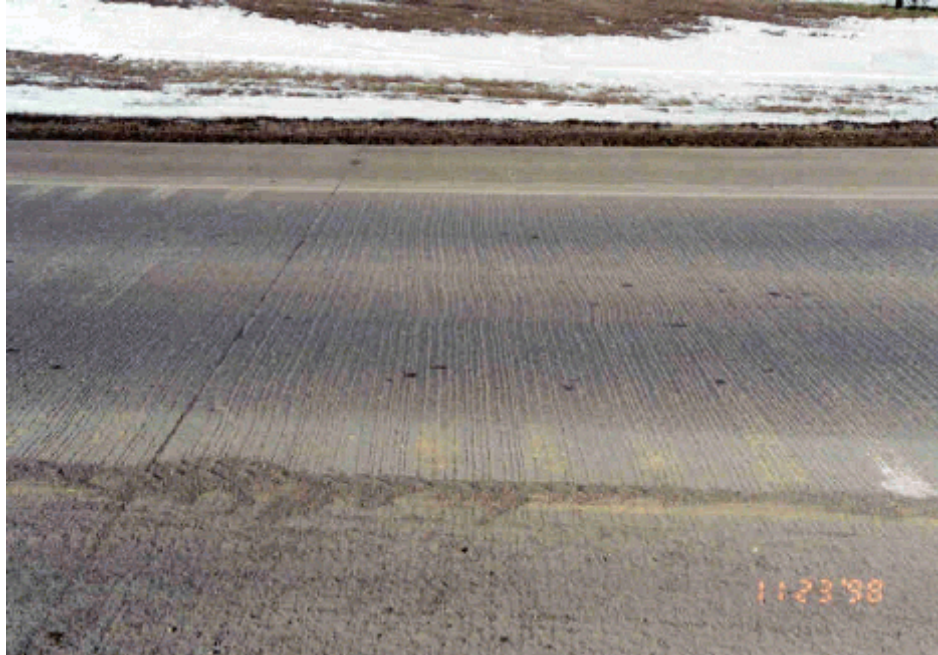
Photo 13, (during the second evaluation) depicts the test stripes approximately 66 days after installation. As with the white water-borne materials, both the yellow latex E-2706 and the yellow latex E-3427 material have completely worn away except near the edges of the PCC pavement.

Photo 13 - Second evaluation of E-2706 (left), and E-3427 (right), yellow latex test stripes. 66 days after installation.

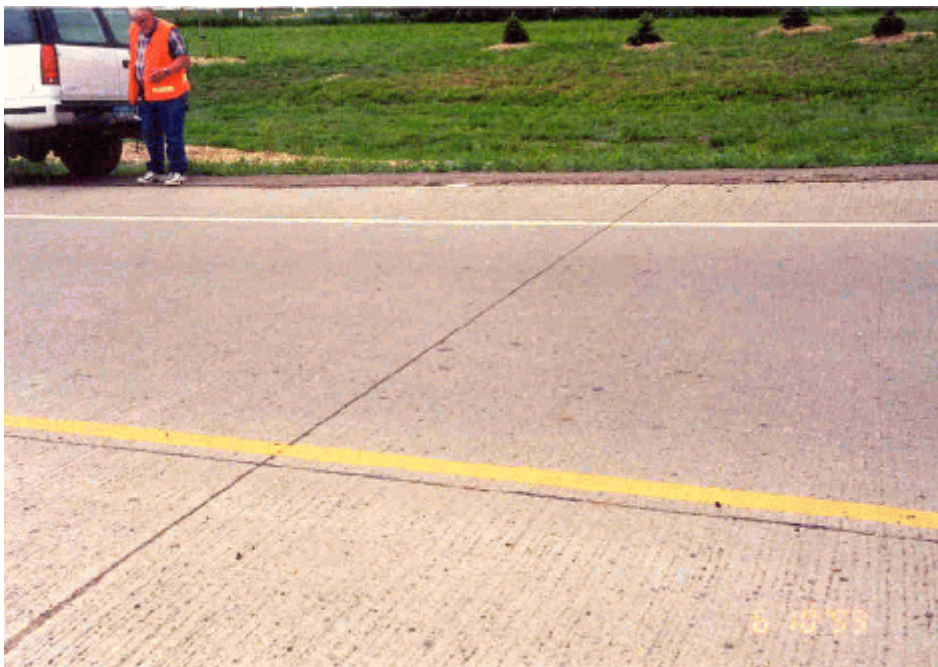
Photo 14, (taken during the third evaluation), depicts the test stripes approximately 261 days after installation. The photo indicates that only minor traces of the yellow latex E-2706 and E-3427 material remain near the edges of the PCC pavement.

Photo 14 - Third evaluation of E-2706 (left), and E-3427 (right), white latex test stripes. 261 days after installation.

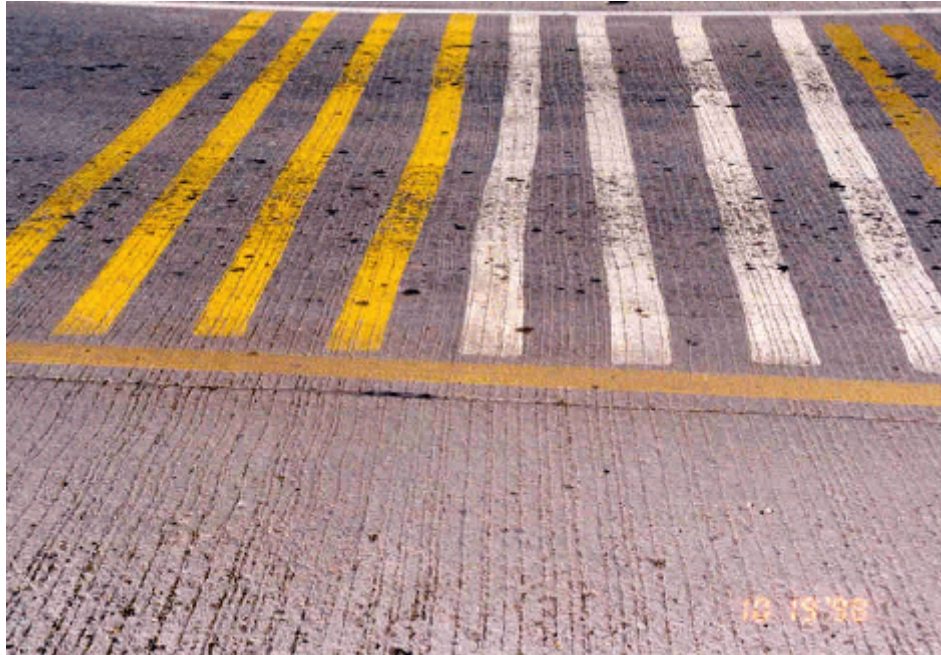
Photo 15, (taken during the first evaluation) depicts the solvent-borne yellow and solvent-borne white material as they appeared during the first evaluation. During this time it appeared that both of the paints were experiencing limited wear, however, some of the darker areas exhibited was mud stuck to the pavement surface. It was also apparent that the latex E-3427 material appeared comparable in performance to the solvent-borne material.

Photo 15 - First evaluation of yellow and white solvent-borne test stripes. 26 days after installation.

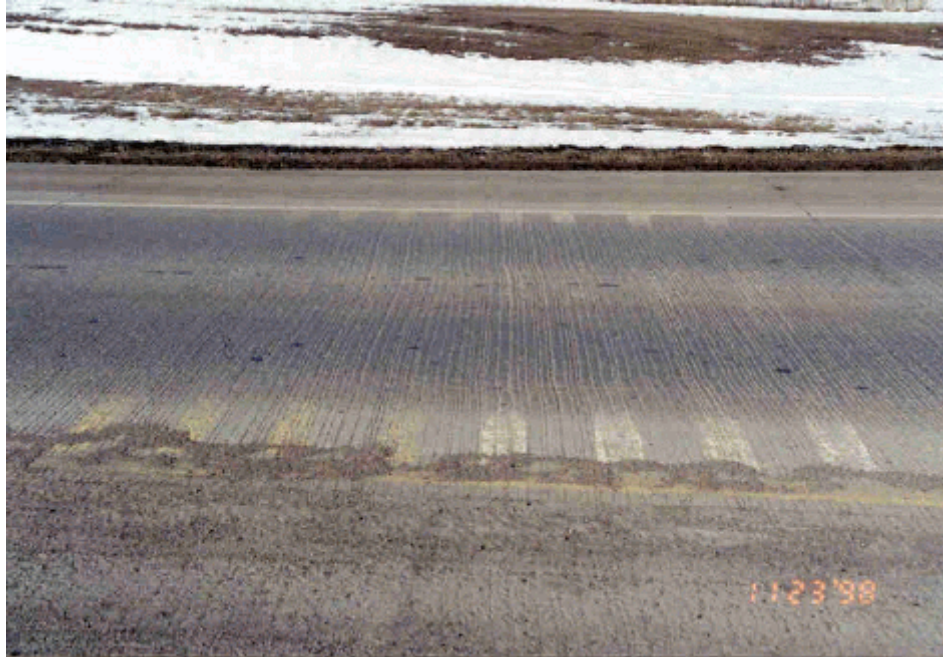
Photo 16, (taken during the second evaluation), depicts the test stripes approximately 66 days after installation. Both solvent-borne materials have completely worn away except near the edges of the pavement.

Photo 16 - Second evaluation of yellow and white solvent-borne test stripes. 66 days after installation.

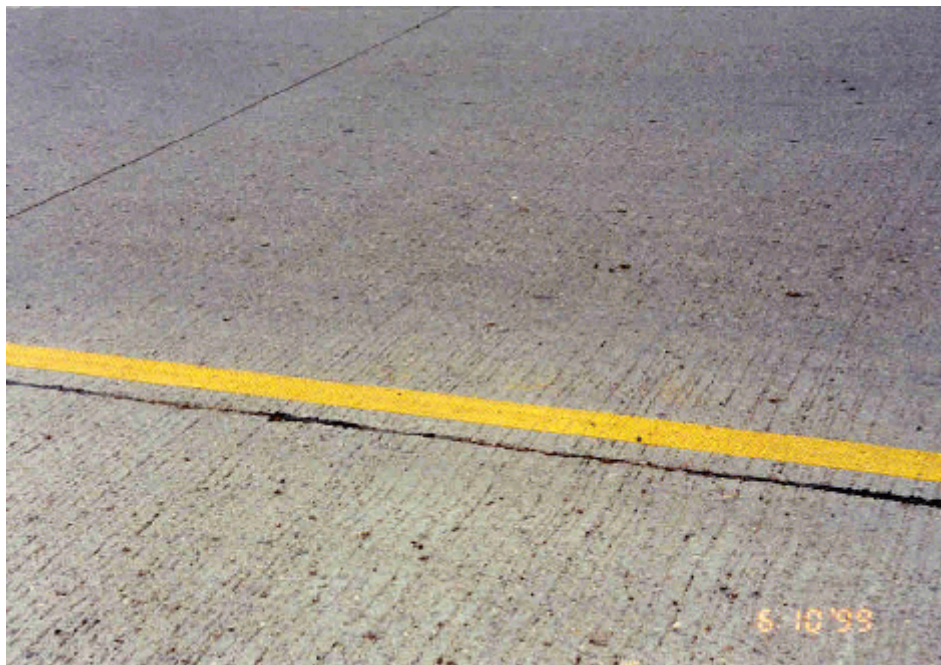
Photo 17, (taken during the third evaluation), depicts the test stripes approximately 261 days after installation. The photo indicates that only minor traces of the solvent-borne material remain near the edges of the PCC pavement.

Photo 17 - Third evaluation of yellow and white solvent-borne test stripes. 261 days after installation.

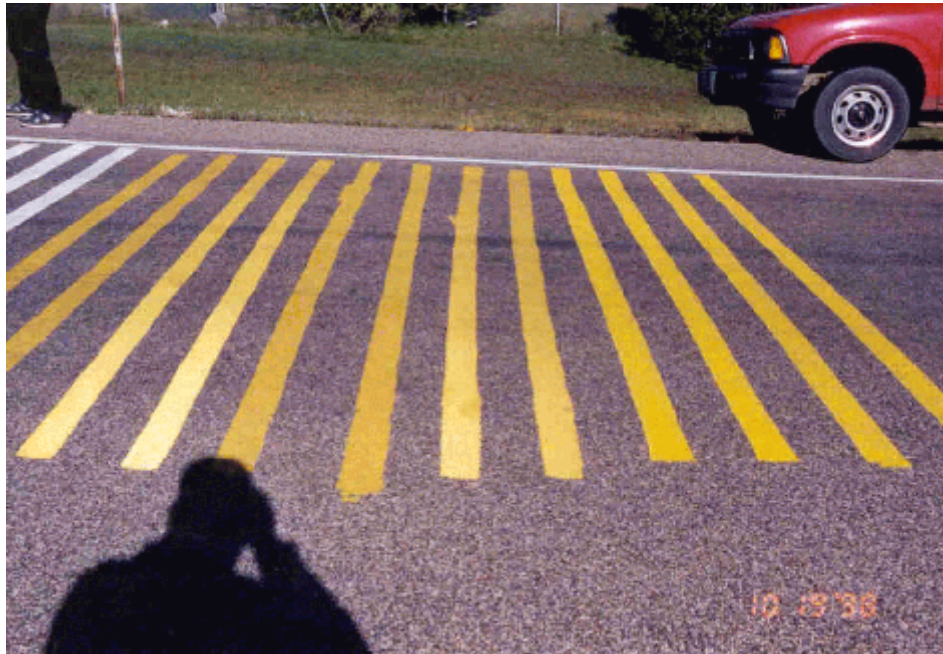
Photo 18, (taken during the first evaluation), depicts a view of all of the yellow paint stripes in the asphalt test section 26 days after installation. Beginning from the left, the photo depicts the first four latex E-3427 stripes, the middle four latex E-2706 stripes, and the final four solvent-borne stripes. During this time it appeared, from a distance, there was no significant difference in performance from a wearing standpoint. However, upon closer inspection, the solvent-borne material exhibited isolated areas of wear on the tops of some of the larger aggregate chips more subject to traffic. The color of the solvent-borne yellow appeared to stand out slightly more than the both latex materials which appeared to fade.

Photo 18 - First evaluation of yellow paint stripes on the asphalt test section. 26 days after installation.

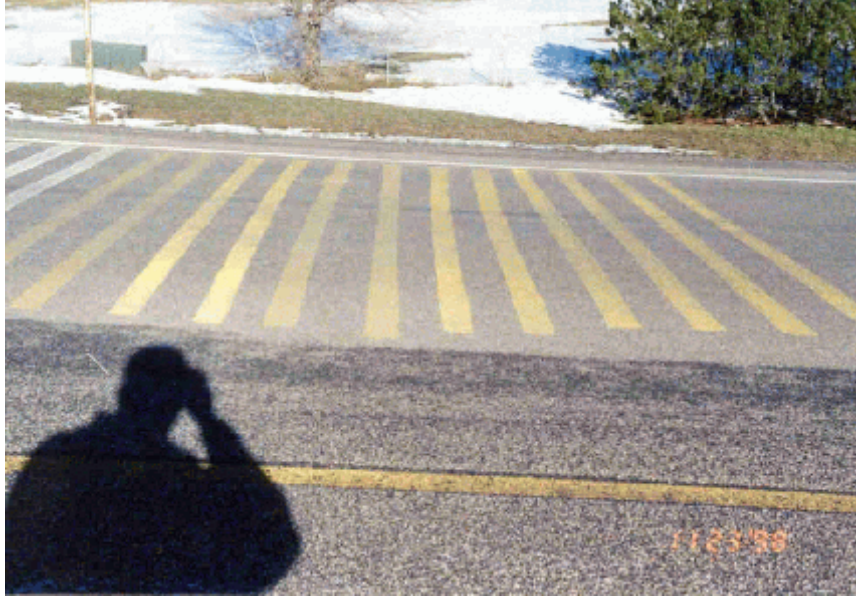
Photo 19, (taken during the second evaluation), depicts the test stripes approximately 66 days after installation. The photo indicates that although there is no significant difference in performance between the different paint systems; all of the yellow test stripes have begun to wear and fade.

Photo 19 - Second evaluation of yellow paint stripes on the asphalt test section. 66 days after installation.

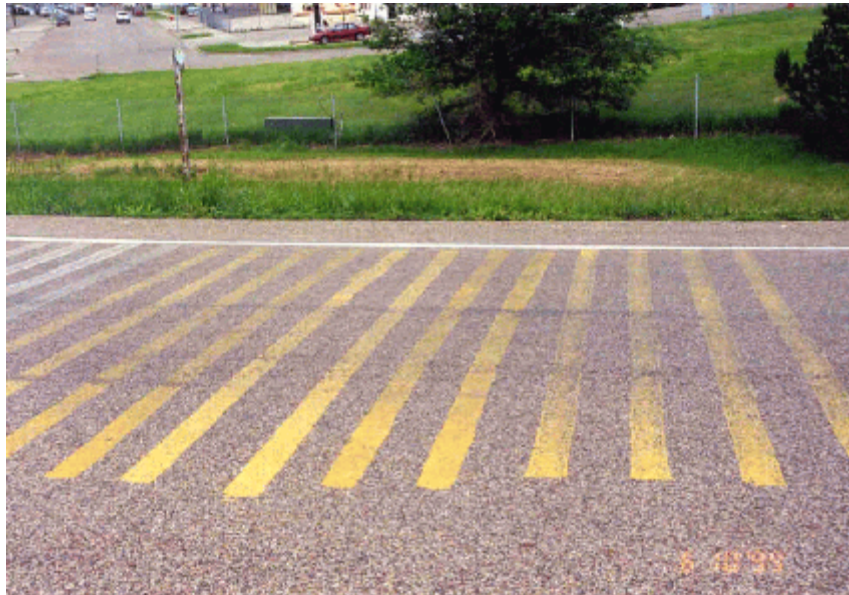
Photo 20, (taken during the third evaluation), depicts the test stripes approximately 261 days after installation. The photo indicates that all yellow stripes can be observed. Ranking the materials by visual observation; (1) E-2706 latex stripes, (2) solvent-borne stripes, and (3) E-3427 latex stripes. Retroreflectivity readings were taken to compare the current condition of the paint systems. The data is included in Appendix A.

Photo 20 - Third evaluation of yellow paint stripes on the asphalt test section. 261 days after installation.

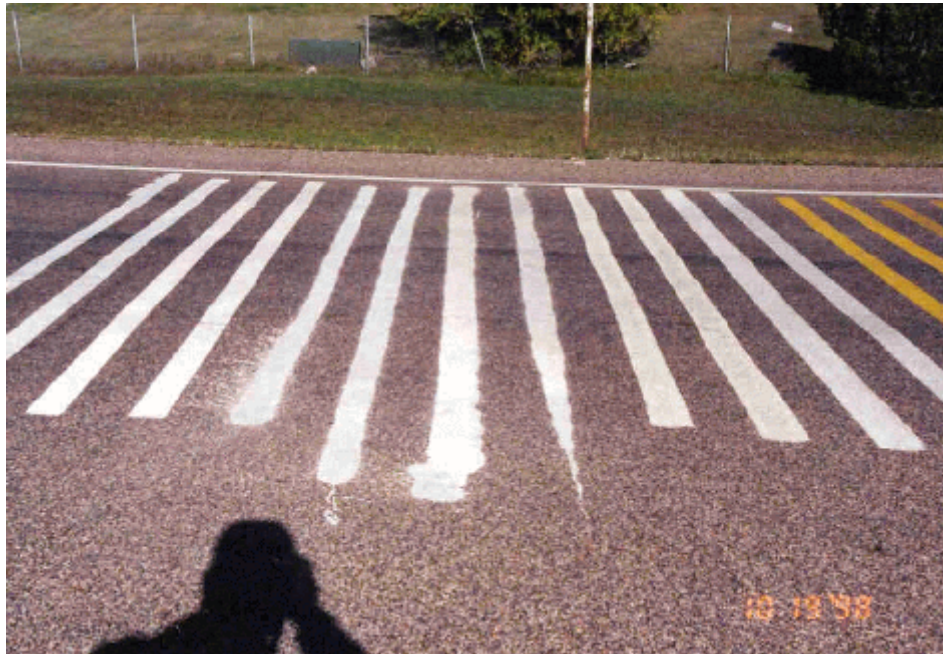
Photo 21, (taken during the first evaluation), depicts all of the white test stripes located on the asphalt section as they appeared approximately 26 days after installation. The photo depicts, beginning from the left, the first four latex E-3427 stripes, the middle four latex E-2706 stripes, and the final four solvent-borne stripes.

Photo 21 - First evaluation of white paint stripes on the asphalt test section. 26 days after installation.

The first evaluation indicated no significant difference in performance from a wearing standpoint. However, upon closer inspection, the solvent-borne material exhibited isolated areas of wear on the tops of some of the larger aggregate chips that are more subject to traffic.

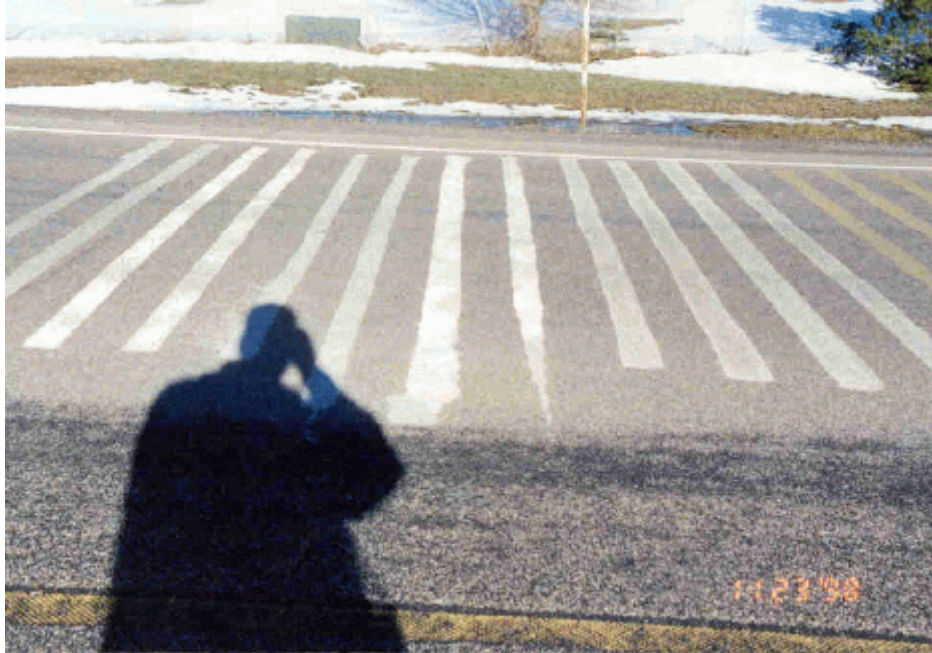
Photo 22, (taken during the second evaluation), depicts the test stripes approximately 66 days after installation. The photo indicates that, (similar to the yellow materials on this test section), although there is no significant difference in performance between the different paint systems, all of the white test stripes have begun to wear and fade.

Photo 22 - Second evaluation of white paint stripes on the asphalt test section. 66 days after installation.

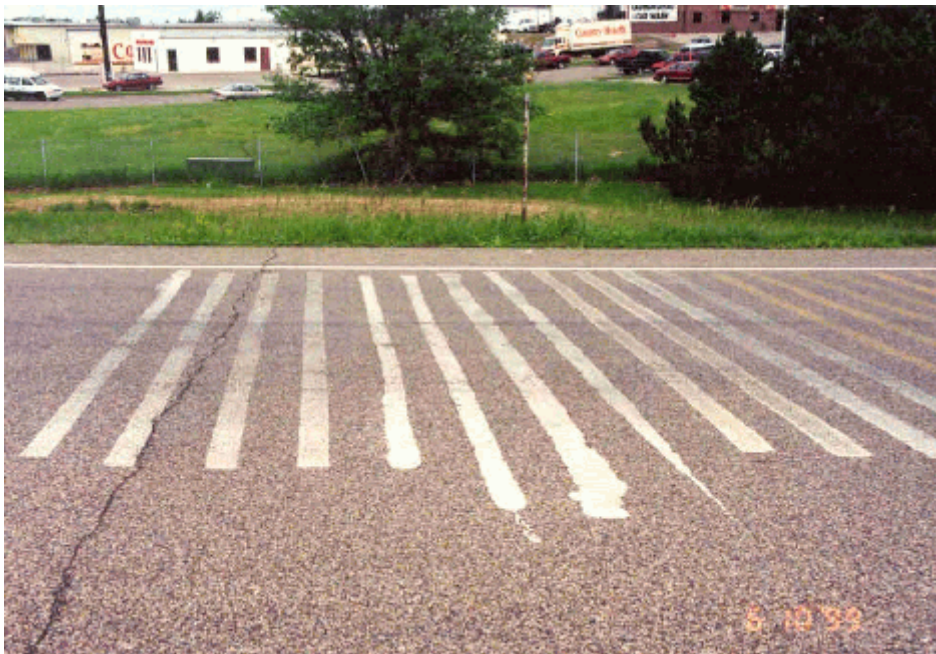
Photo 23, (taken during the third evaluation), depicts the test stripes approximately 261 days after installation. The photo indicates that all white stripes can be observed. Ranking the materials by visual observation; (1) E-2706 latex stripes, (2) solvent-borne stripes, and (3) E-3427 latex stripes.

Photo 23 - Third evaluation of white paint stripes on the asphalt test section. 261 days after installation.
