14. Supplementary Notes Heart River Bridge Number 94-915.101; East Abutment and Concrete Girder Ends			
15. Abstract Purpose and Need The NDDOT has typically used "sacrificial" coatings or treatments on concrete surfaces to aid in graffiti removal. Research is needed to evaluate products that make graffiti removal faster and easier, without compromising a structure's aesthetics. It would be desirable to use products that were non-sacrificial; thereby eliminating the need to re-treat surfaces after the removal of graffiti. This project proposes an evaluation of American Polymer's <i>Graffiti Solution System® (GSS)</i> , a non-sacrificial anti-graffiti coating. Objective The objective of this research is to determine the effort required to install the GSS anti-graffiti system, observe the effectiveness of recommended products and methods used in graffiti removal from GSS treated surfaces, and evaluate the condition and appearance of post-removal surfaces. The research will involve observing both the product installation and multiple graffiti removals. The GSS® product will be evaluated over ten years, the length of time the manufacturer guarantees their product without re-application

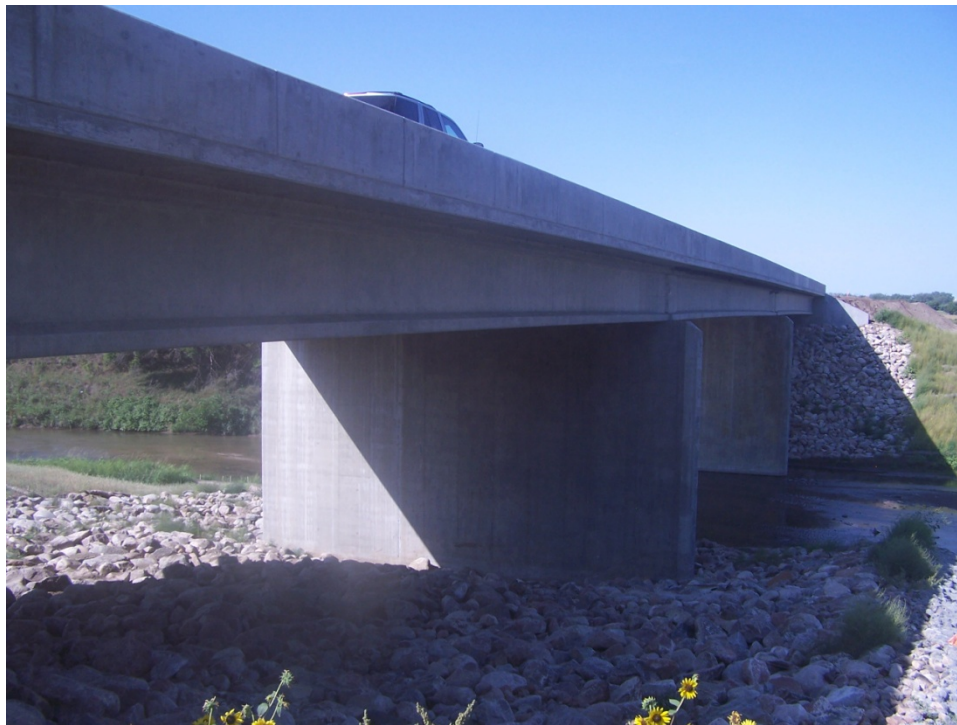
Photo 1: Heart River Bridge, looking West

GSS® product application and evaluation will take place on the east abutment of the Heart River Bridge in Mandan, ND. The Heart River Bridge was rebuilt during the summer of 2008. In the past, the old structure was frequently vandalized.

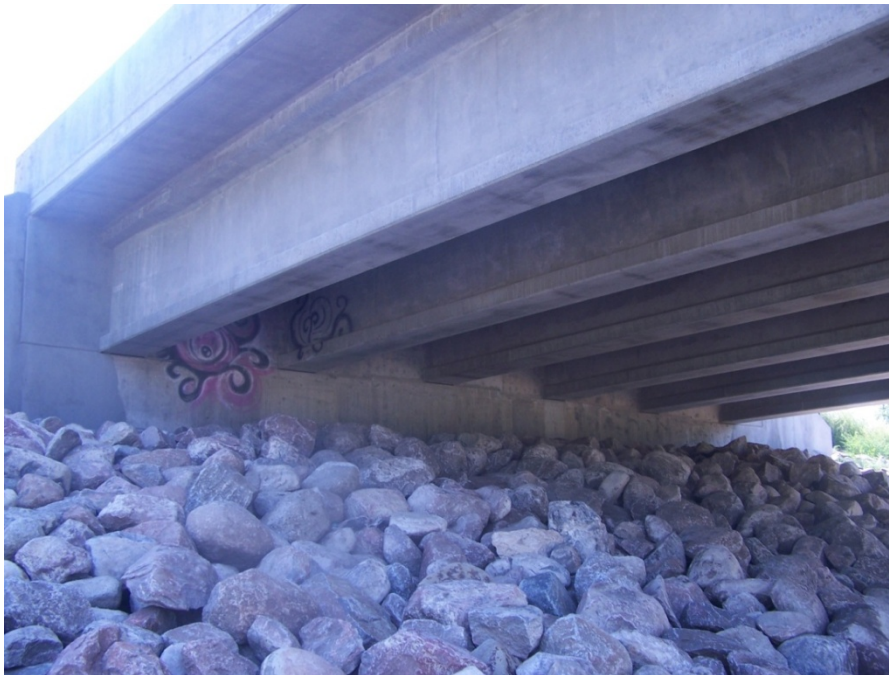
The new bridge (bridge number 94-915.101) is a 3-span concrete bridge with its east abutment serving as the anti-graffiti test area. The appropriate polymer coatings will be applied based on the American Polymer representative's recommendation for a concrete substrate.

Photo 2: Heart River Bridge: East Abutment

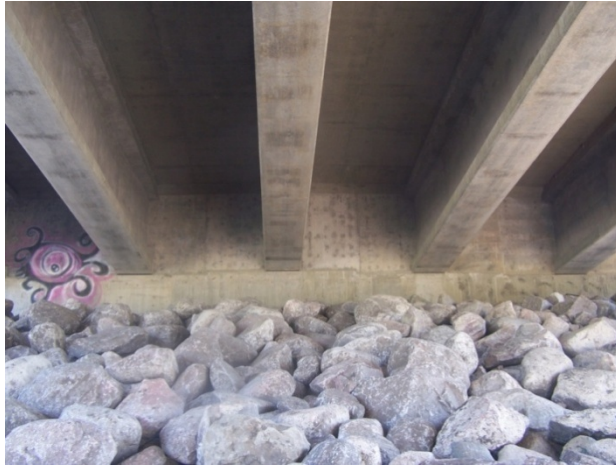
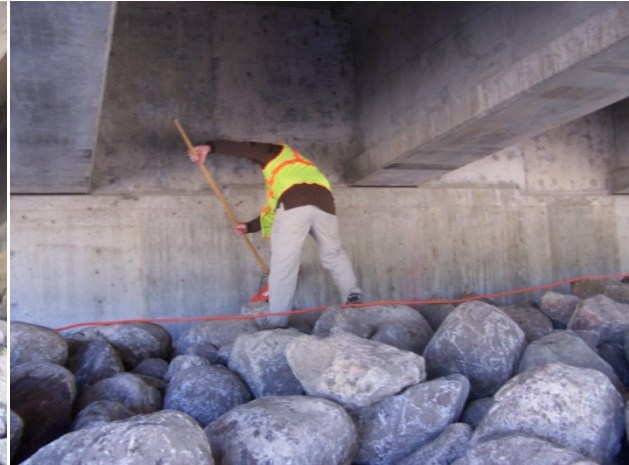
The process at the Heart River Bridge began with using a push broom to remove loose dirt on the abutment. Since the bridge was quite new, this was an effective method of cleaning and preparing the surface. See Photos 3 & 4. In other situations, the surface should be cleaned off with highly pressurized water the previous day and allowed to dry.

Photo 3: Test area

Photo 4: Brooming off debris from abutment

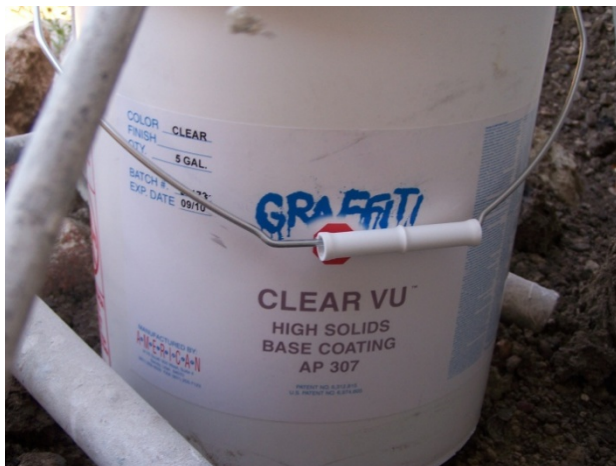
Photo 5: Base Coat

Next, the base coat “Clear VU High Solids Base Coating AP 307” was mixed up with a wooden paint stick. The base coat can also be mixed up by pouring it repeatedly between 2 buckets to ensure uniformity. The intake of the paint sprayer was placed into the base coat bucket, the generator turned on, and the paint sprayer primed and pressurized.

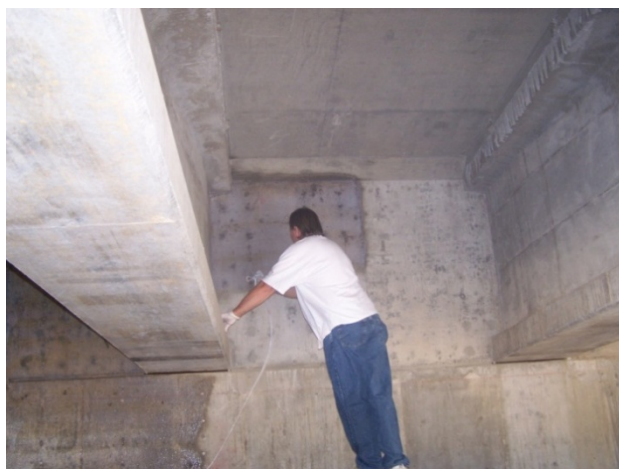
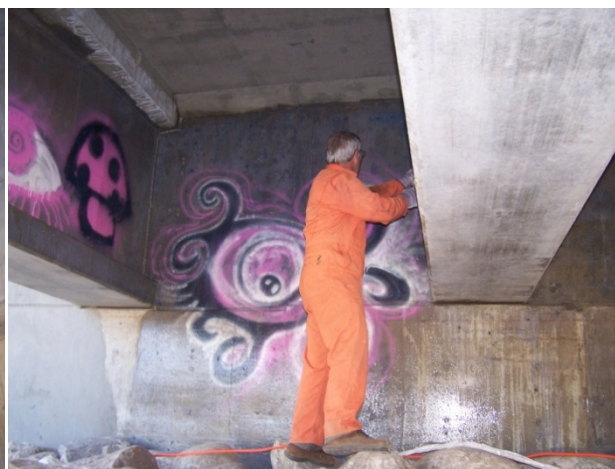
The manufacturer's representative sprayed on the base coat in a horizontal fashion starting at the top of the abutment to the bottom, and then vertically from left to right. M & R personnel vertically back-rolled the coating immediately after it was sprayed on using a paint roller and extension handle. See Photos 6 & 7.

Photo 6: Base coat application

Photo 7: Backrolling base coat

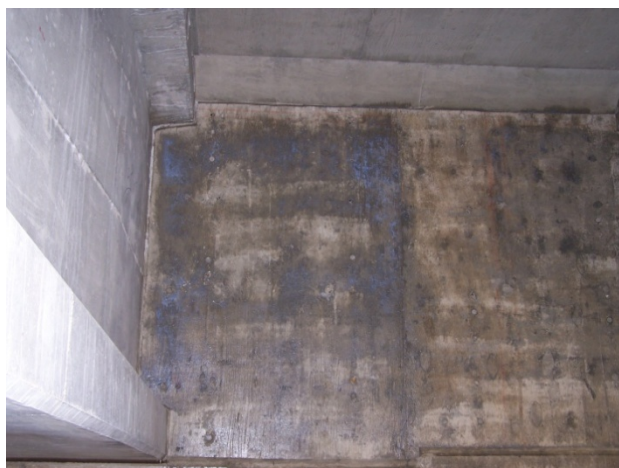
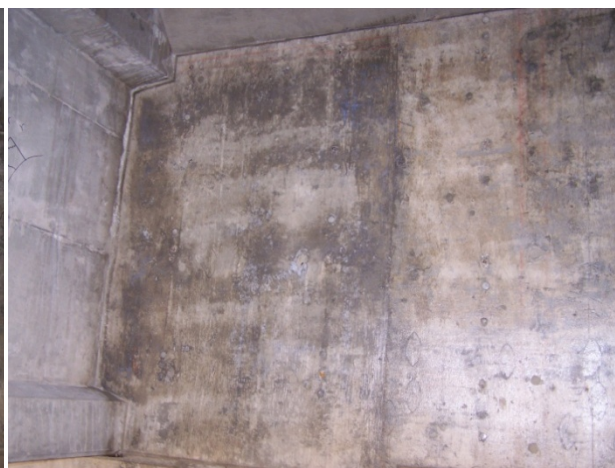
The base coat seals porous substrates, protects the color and texture, and improves the adhesion and coverage of the top anti-graffiti coat. Concrete substrates demand a base coat, although others such as steel may need only the top coat to fulfill the system's purpose. The first base coat took 20 minutes to apply, or about 22.5 ft²/min. The coating turned a translucent blue where there was residual moisture in the wall. This happened on one area of the abutment. See Photo 8. The manufacturer's representative assured that some blue coloring was acceptable and it would most likely diminish shortly. After about 10 more minutes the blue was barely visible. See Photo 9.

Photo 8: Blue tinted residual moisture

Photo 9: Diminished blue tint ≈10 min later

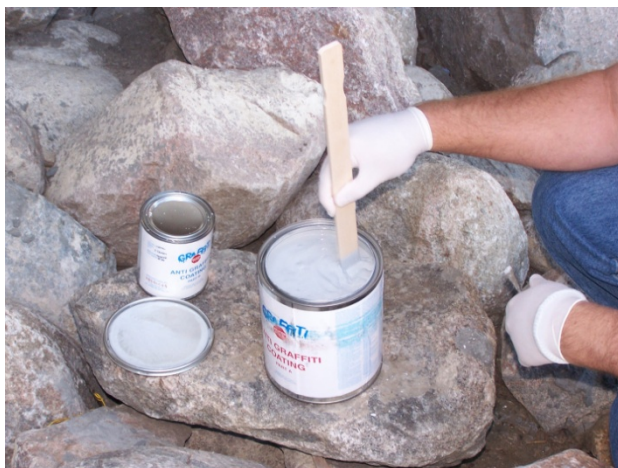
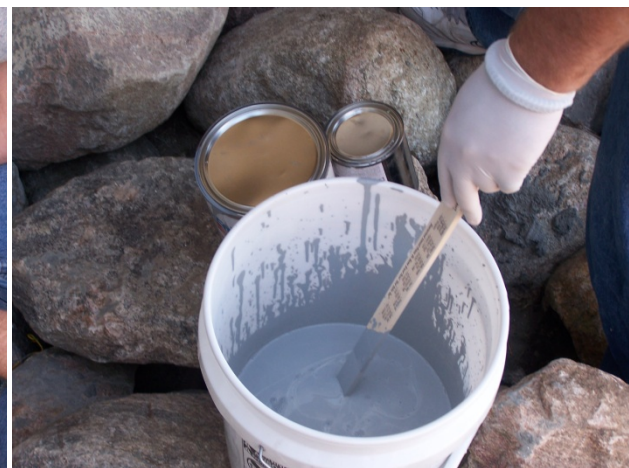
The paint sprayer, paint rollers, cans of top coat and buckets were moved close to the abutment atop the rip rap. The first top coat mixture was pigmented a gray color in order to cover up an area of about 42 ft² of existing graffiti on the abutment. The gray color was not an exact match to the color of the abutment, but for this study an exact match was not requested. The top coat had two components, consisting of 4 parts "Part A" and 1 part "Part B" mixed together in a bucket with a wooden paint stick. See Photos 10 & 11.

Photo 10: "Part A" & "Part B" of pigmented top coat

Photo 11: Mixing "Part A" & "Part B"

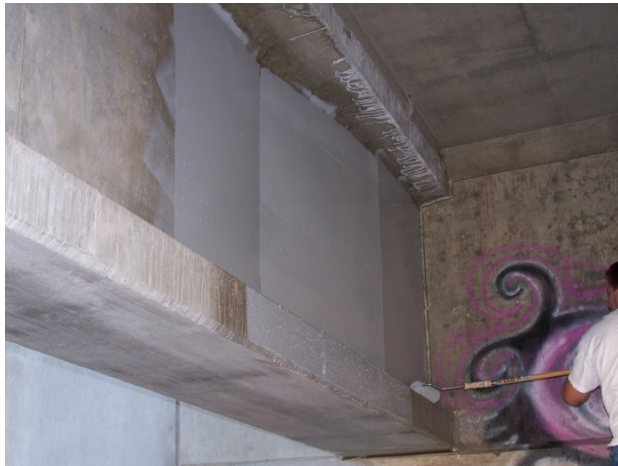
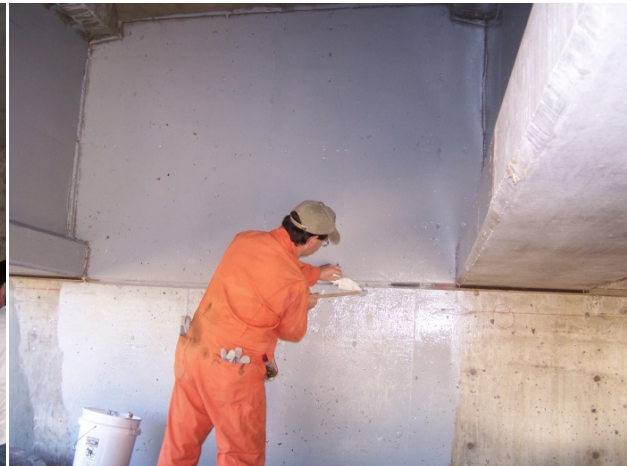
The pigmented top coat application began at 9:40 a.m. and was rolled on in a cross-hatched pattern, first horizontally, and then vertically. The paint sprayer was not used due to the small area receiving the pigmented coating and so as not to contaminate the clear top coat – to be used shortly – with the pigmented coating inside the sprayer. The graffiti-tagged area was covered with its first pigmented coat by 10:16 a.m., 36 minutes later, at a rate of 1.17 ft²/min. See Photos 12 & 13. The dry time needed between coats is approximately 1 hour, just until the first coat is slightly “tacky” to the touch.

Photo 12: Rolling on pigmented coat

Photo 13: Touching up Joint

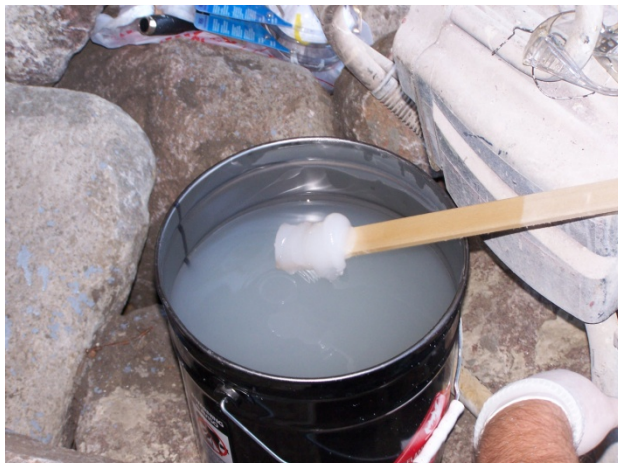
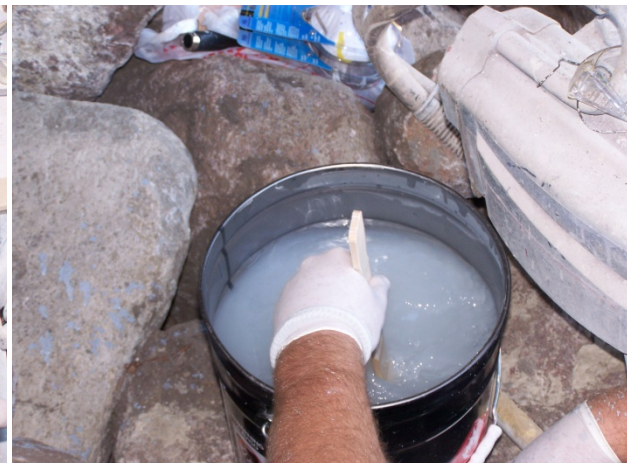
Next was the application of the first clear top coat. The large can of clear top coat was opened and mixed with a wooden paint stick in order to redistribute the flattening agent that had settled to the bottom. See Photos 14 & 15. This mixing was to last for about 5 minutes, or the solution could have been mixed by pouring it between buckets 5 times.

Photo 14: Settled flattening agent

Photo 15: Distributing flattening agent

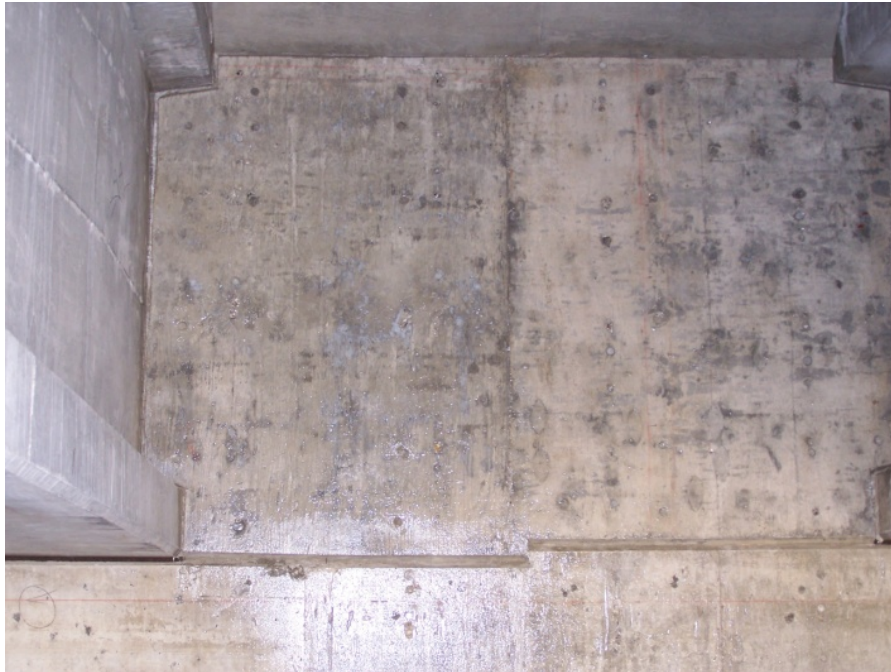
The first clear top coat application took 21 minutes on an area of 408 ft², an application rate of 19.43 ft²/min. Once again it was applied in a cross-hatched fashion with a clean roller-brush for backrolling. At this point it was noticed that there was still some blue from yesterday indicating residual moisture. See Photo 16.

Photo 16: Faint blue on one wall

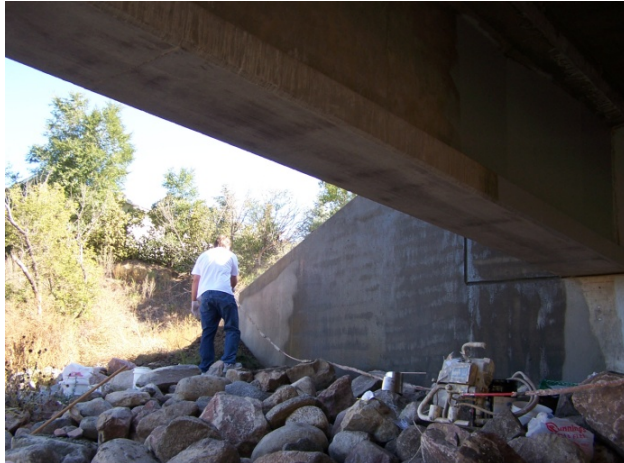
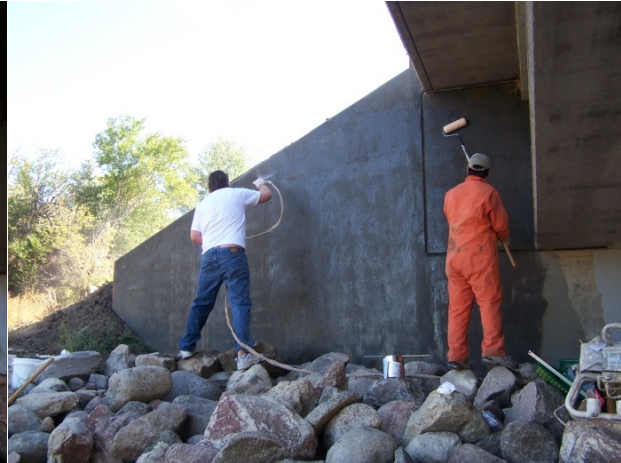
It was also decided to spray and backroll some of the excess top coat onto the south wing wall to see how the anti-graffiti properties worked without a base coat. The wing wall consisted of highly texturized concrete and had a Surface Finish 'D' already on it. The manufacturer's representative indicated that GSS® is compatible with most surface finishes. See Photos 17 & 18.

Photo 17: Spraying Top Coat on wing wall

Photo 18: Backrolling wing wall

The only exception to this success was the north wing wall of the east abutment, the wall that had received only the top coat. The lack of a base coat on this texturized surface made graffiti removal a challenge. This area was sprayed with pressurized water; however there was still some remaining graffiti, even after repeated spraying and scrubbing.

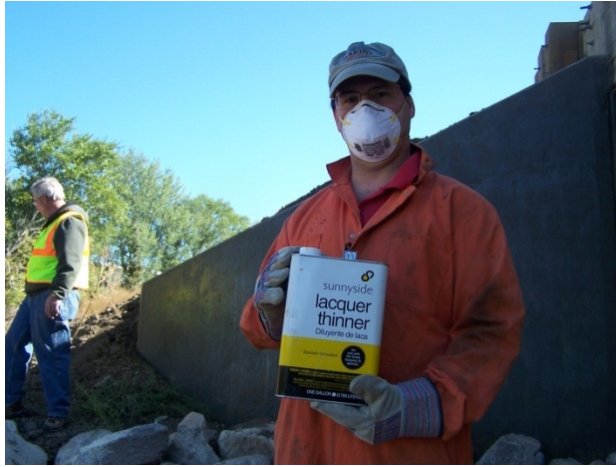
Photo 18: Laquer thinner

Lacquer thinner was passed through the paint sprayer to remove the solvent-based top coatings, although the preferred solution to use is methyl ethyl ketone (MEK). See Photos 18 & 19. The supplies were gathered and loaded into the truck and the project was completely finished by 12:30 p.m. On a side note, the paint sprayer that was used to apply the top coats had some residual reddish material in it, possibly deck stain, which may have gotten into the product.

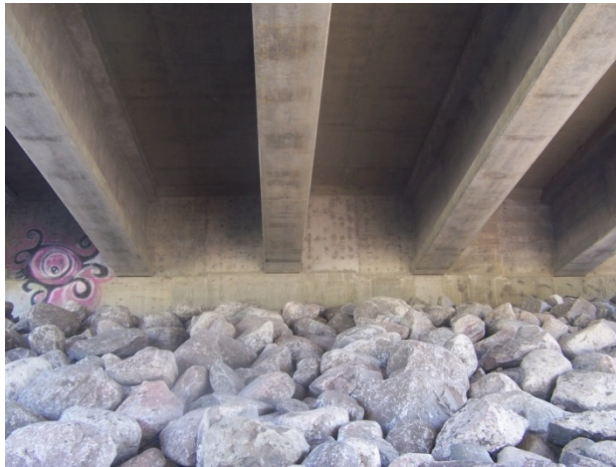
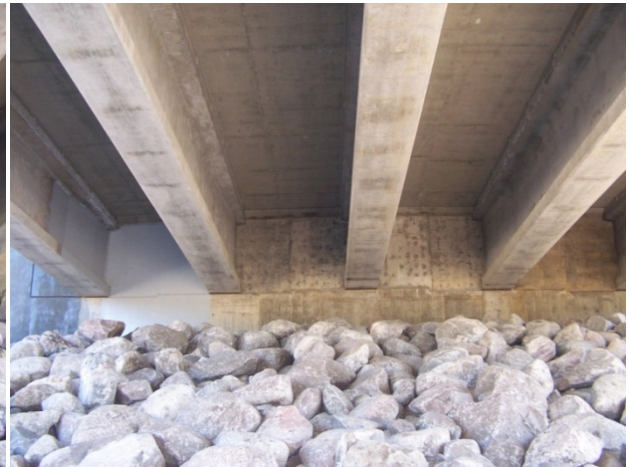
Photos 20 & 21 illustrate the abutment before and after the product application.

Photo 20: Before Product Application

Photo 21: After Product Application

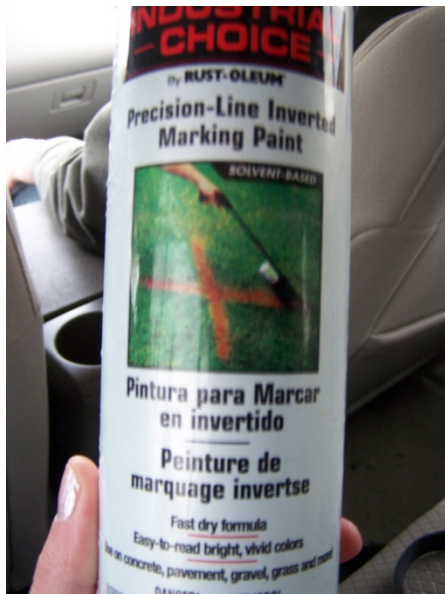
Photo 22: Solvent-based Paint

Six days after application of the GSS®, Materials & Research personnel went out to the Heart River Bridge to apply graffiti on the test area. This was to test the product's ability to allow graffiti removal even when the area is tagged before the cure time has passed. Four areas on the abutment were tagged with orange, solvent-based spray paint, including the north wing wall with no base coat. Starting on the south end of the east abutment, the applications were marked from 1 to 4 along with the date. See Photos 22-25.

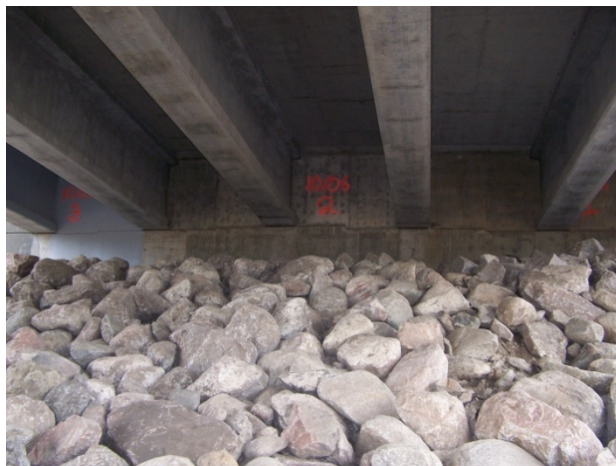
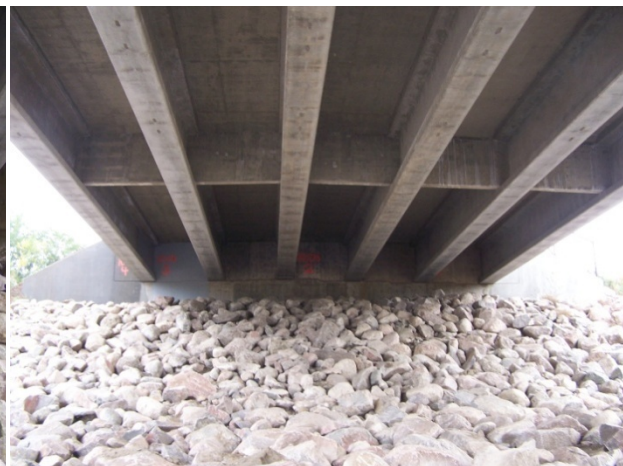
Photo 24: Test Graffiti

Photo 25: Test Graffiti

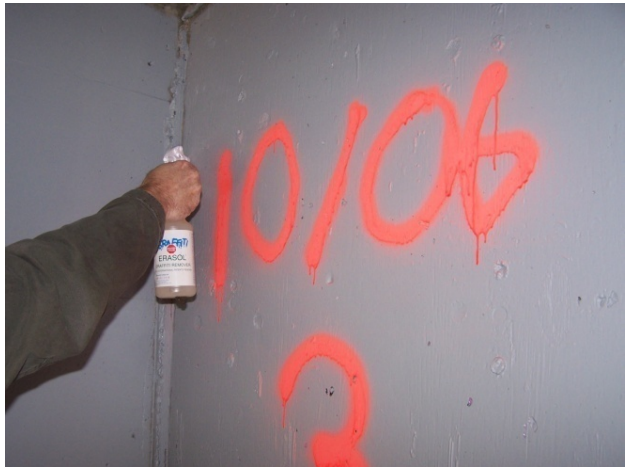
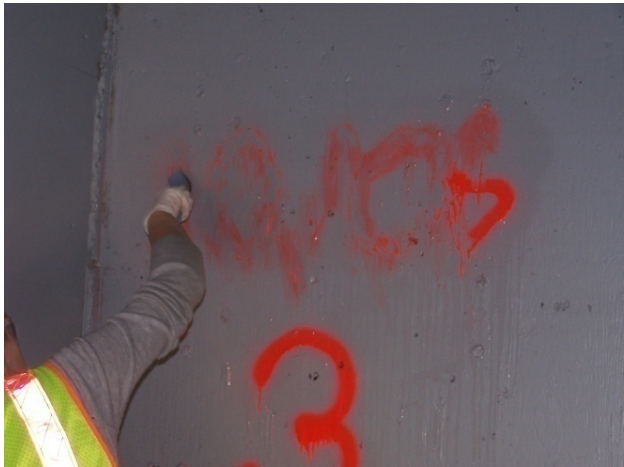
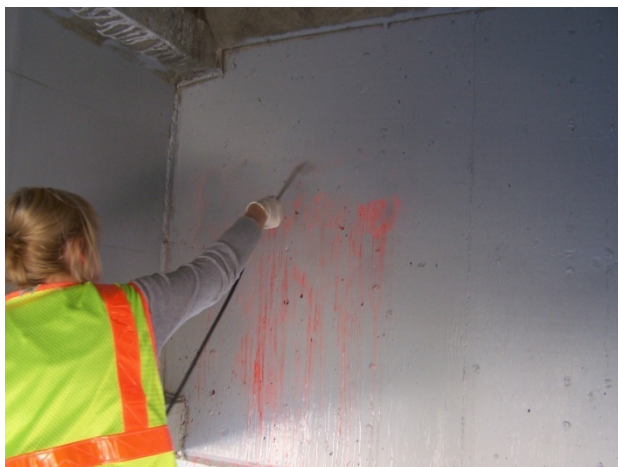
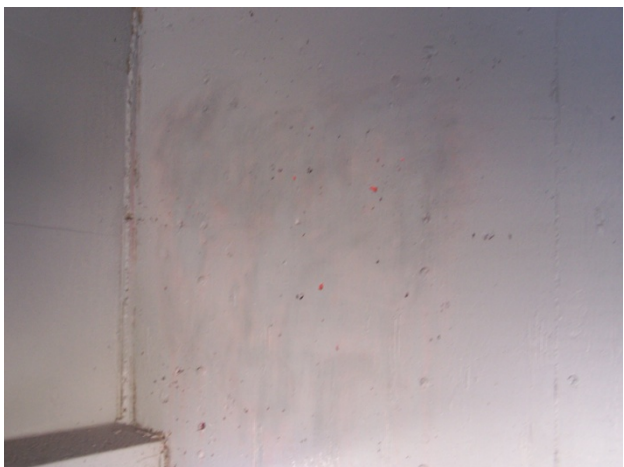
First, *Erasol*® was sprayed on according to the GSS® Application Guide, starting at the top on the section marked "10/06 3". See Photo 26. The entire tagged area was sprayed and the solvent-based paint was broken up with a brass-bristled brush. The graffiti lifted off the substrate, and any further scrubbing simply spread the paint residue around. See Photo 27.

Photo 26: Spraying *Erasol*®

Photo 27: Brass brushing off graffiti

Photo 28: Rinsing with low-pressure

Photo 29: Graffiti removed

Next, water was sprayed on with a Hudson hand-pump sprayer. See Photo 28. This did remove most of the graffiti, yet a faint dark shadow still appeared. See Photo 29. It appeared as though more *Erasol*® along with additional brushing and a water sprayer with higher pressure would likely remove the graffiti completely. Since *Erasol*® neutralizes on contact with water, further work couldn't be done on the wet surface and the area was left to dry. Materials & Research personnel agreed to return the following week with a higher pressure water source.

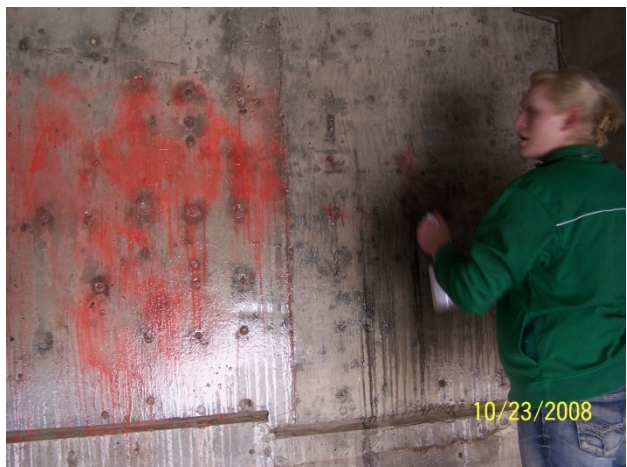
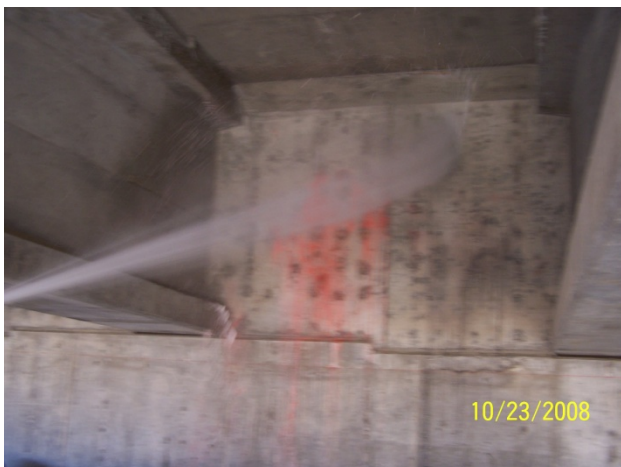
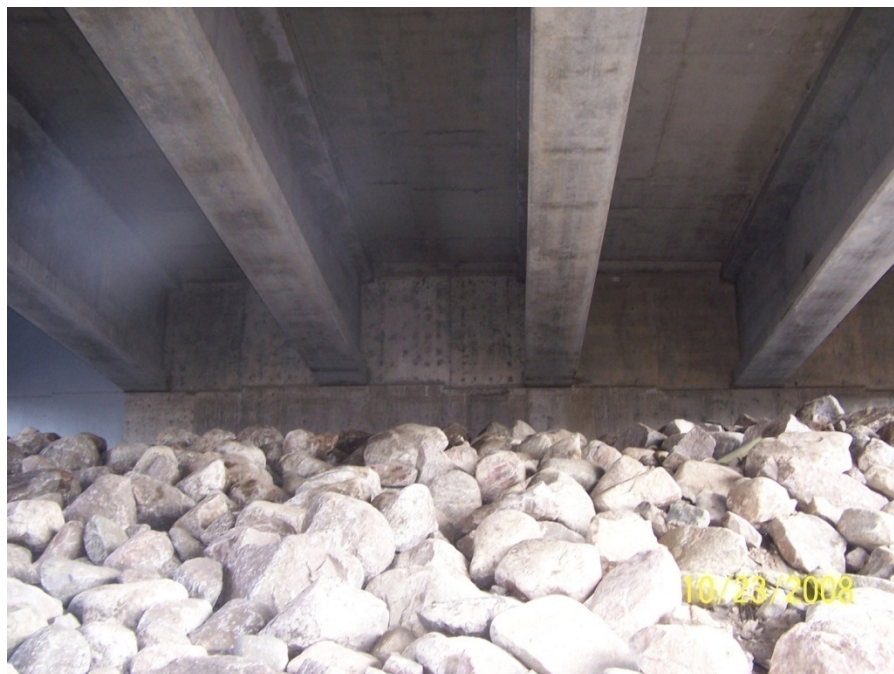
After the graffiti appeared to be fully lifted, Kent Leysring used the culvert washer to spray the wall with moderately pressurized water. The graffiti was completely removed. This process occurred on all 4 sections on the abutment, entirely removing the graffiti. See Photos 30-32.

Photo 30: Spraying *Erasol*®

Photo 31: Rinsing with moderately pressurized water

Photo 32: After graffiti removal

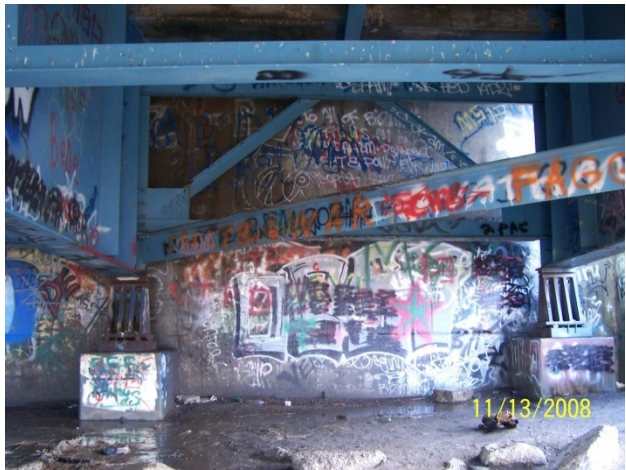
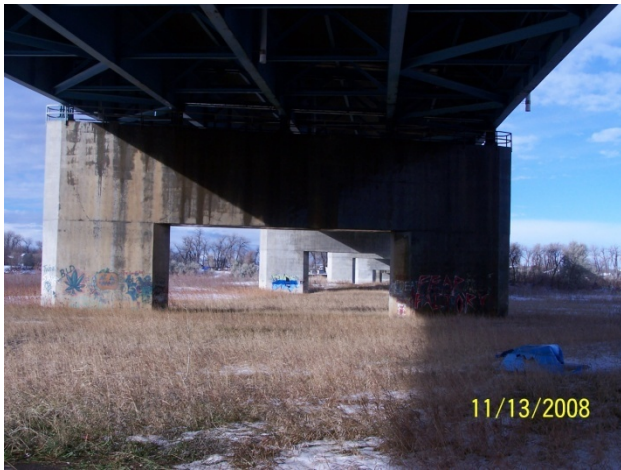
At the suggestion of Jim Colling, M & R personnel went down beneath the Expressway Bridge to observe the vandalism done there. The concrete abutments and piers, as well as parts of the steel substructure, were heavily covered with graffiti. See Photos 33 & 34.

Photo 33: Portion of Expressway Bridge abutment

Photo 34: Expressway Bridge piers

The *Erasol*® product was tested on some old graffiti and a small portion did come off, but it was obvious that a coating underneath the graffiti was needed for the *Erasol*® product to work. In the case of this bridge, a pigmented version of the *GSS*® coating could be used to cover the current graffiti, as well as to allow for easy future graffiti removals.
