Experimental Study ND 94-02

**Experimental Feature "PavePrep"
Pavement Interlayer To Halt or
Retard Reflective Cracking**

Final Report

Projects SS-6-017(015)112 and NH-3-002(040)212R

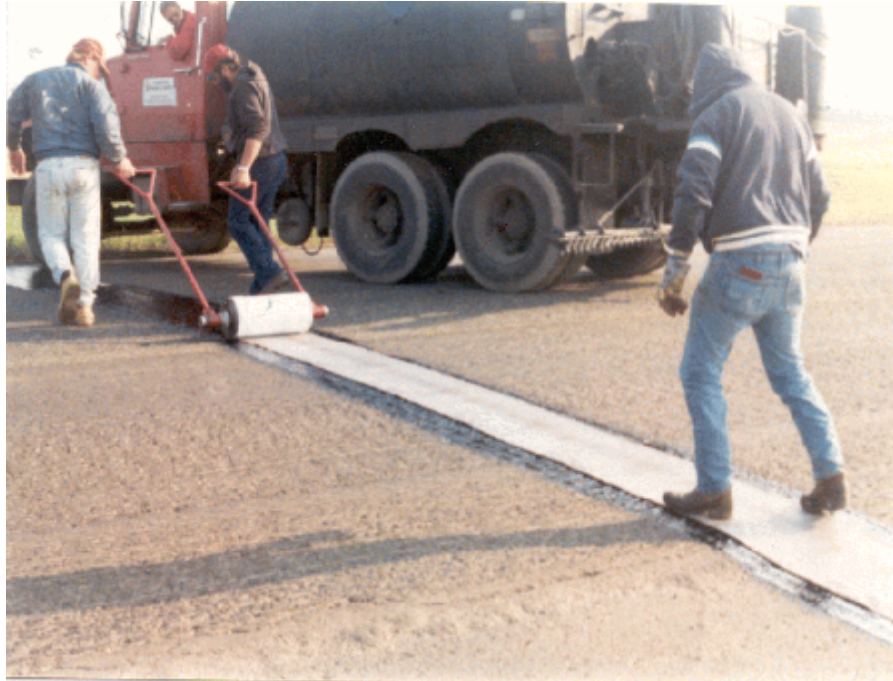
Photo 1--PavePrep installation

An AC 120-150 tack coat was applied at a rate of 0.25 gal/sy to each crack prior to installing the PavePrep. The installation method is shown in photo 1. The contractor placed the first asphalt overlay lift about an hour after the last PavePrep was laid. Problems developed soon after the paving began. The PavePrep material was being pulled up by the slow moving paver wheels. This is shown in photo 2. One reason this happened may be that the tack coat under the PavePrep did not cure enough to bond to the old roadway surface. Once the contractor got the feel of things the work progressed satisfactorily.

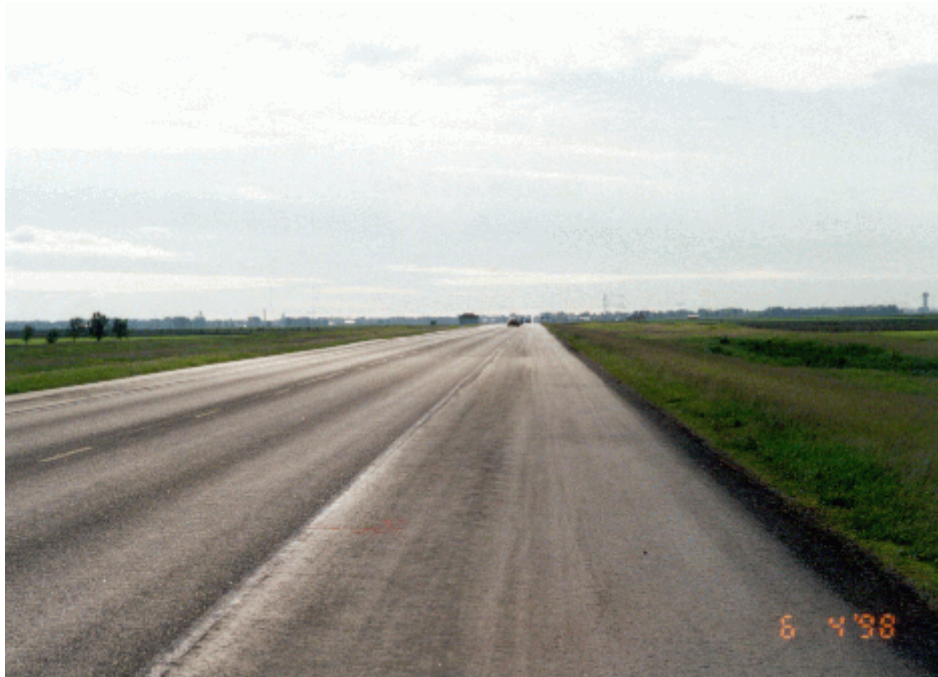
Photo 3--Control section--Highway 17

The experimental project was evaluated and cored on June 3, 1998. Photo 3 shows the beginning of the control section at station 592+00. The control section originally had about the same number of cracks as the PavePrep section.

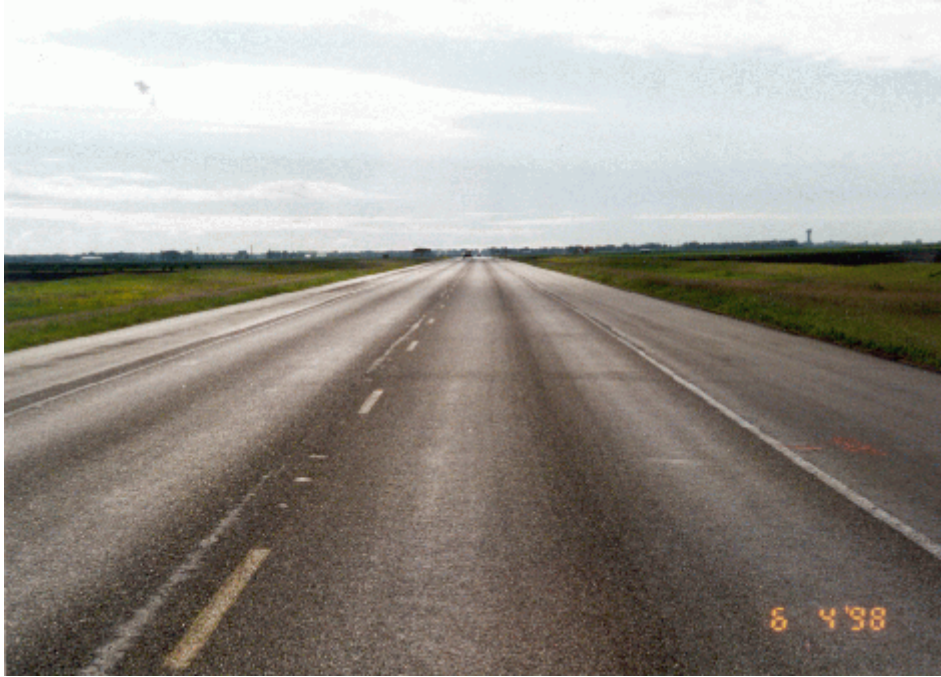
Photo 4--PavePrep section--Highway 17

Photo 4 shows the beginning of the PavePrep section. PavePrep had been placed on 2189.49 lineal feet of cracks. Of this, 417 feet was on longitudinal cracks. On June 3, 1998, the project looked good. It provided a good ride with no visible rutting. More cracks in the PavePrep section are reflecting through the shoulder and into the driving lane about three feet. This is also occurring in the control section. The project was contract chip sealed in June of 1996 shortly after the 1996 evaluation. This made the reflected cracks harder to see in 1997

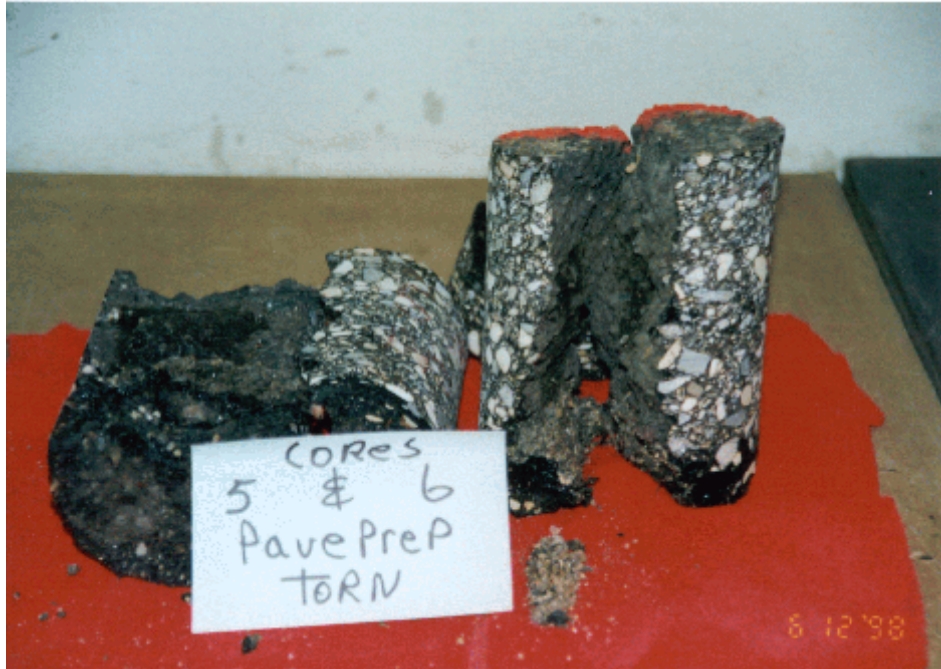
Photo 5--Cores 5&6 on Highway 17-----PavePrep torn

The 1996 cores revealed that the transverse cracks are reflecting through the PavePrep. One feature of the PavePrep was its ability to provide a moisture barrier even if a crack reflects up through it. The PavePrep served as a moisture barrier in only one-third of the cores evaluated. The PavePrep was completely torn in the other two-thirds of the cores. No cores were taken in 1997.

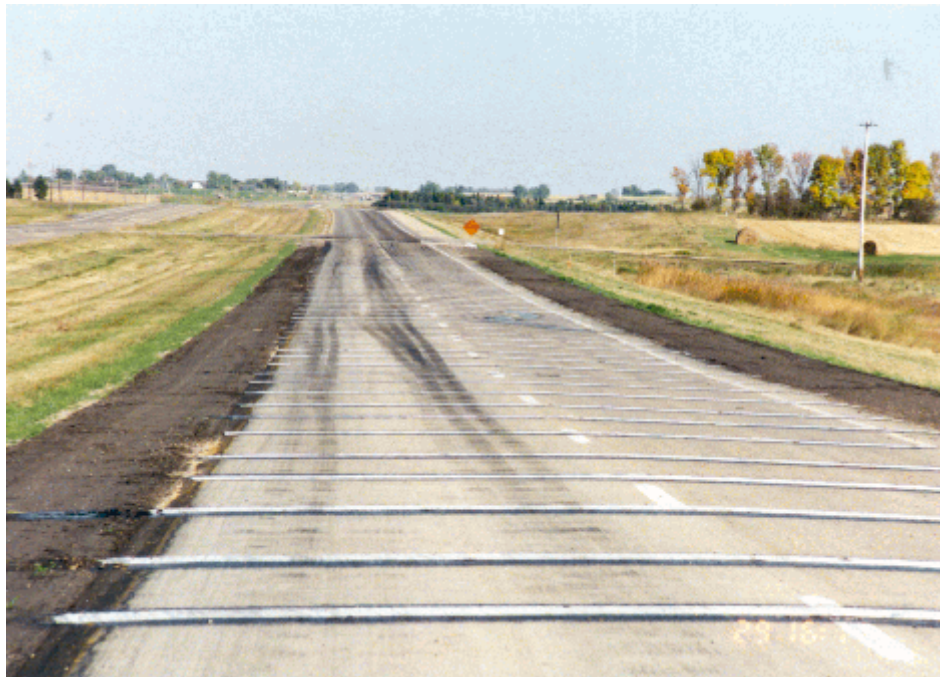
Photo 6 --East end overview of PavePrep section

The contractor, gaining experience from the Highway 17 project, was better prepared for this Highway 2 test section. Working on concrete with joints that are in a straight line also helps. The same basic procedure was used to install the PavePrep here as on Highway 17. The roadway was cleaned. A tack coat was applied over the joints at a rate of approximately 0.1 gal/sy. The PavePrep was placed over the joint and worked into the tack. Photo 6 shows a view of the PavePrep on the east end of the test section.

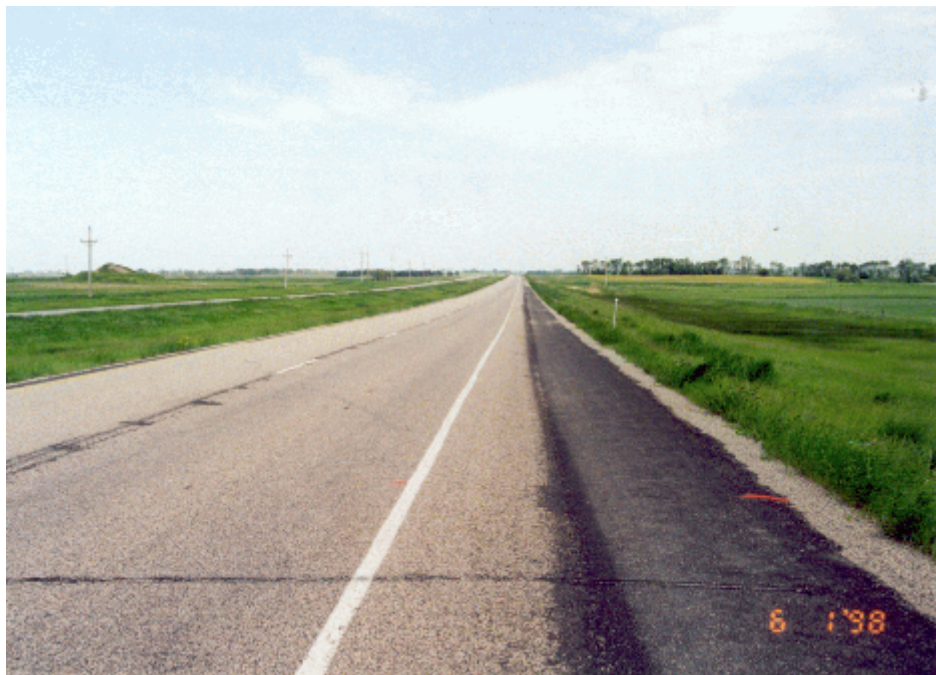
Photo 7 --PavePrep section overview--looking east

All of the joints in the PavePrep section were covered with the PavePrep material before the asphalt overlay. An overview of the PavePrep test section is shown in photo 7.

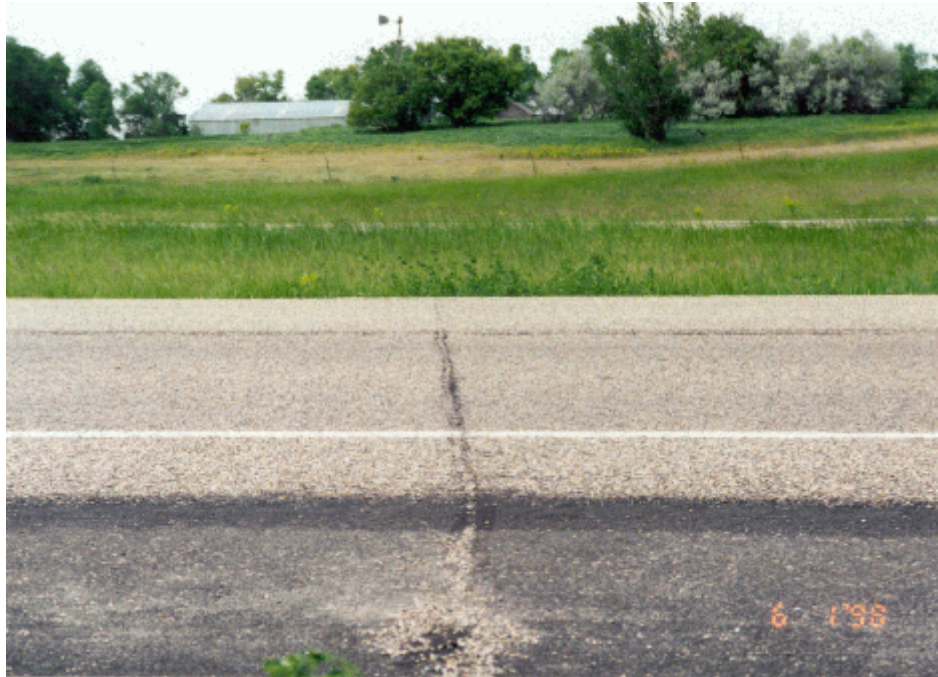
Photo 8 --Control section--reflected joint crack--sta.1213+23.9

The project was evaluated on June 1, 1998. The roadway appearance looked good. No rutting could be seen and the ride was smooth. The joints on this project are skewed and can be seen by the reflected crack in photo 8. Photo 8 is at station 1213+23.9 and shows that the crack reflects directly over the underlying joint. The crack is quite straight.

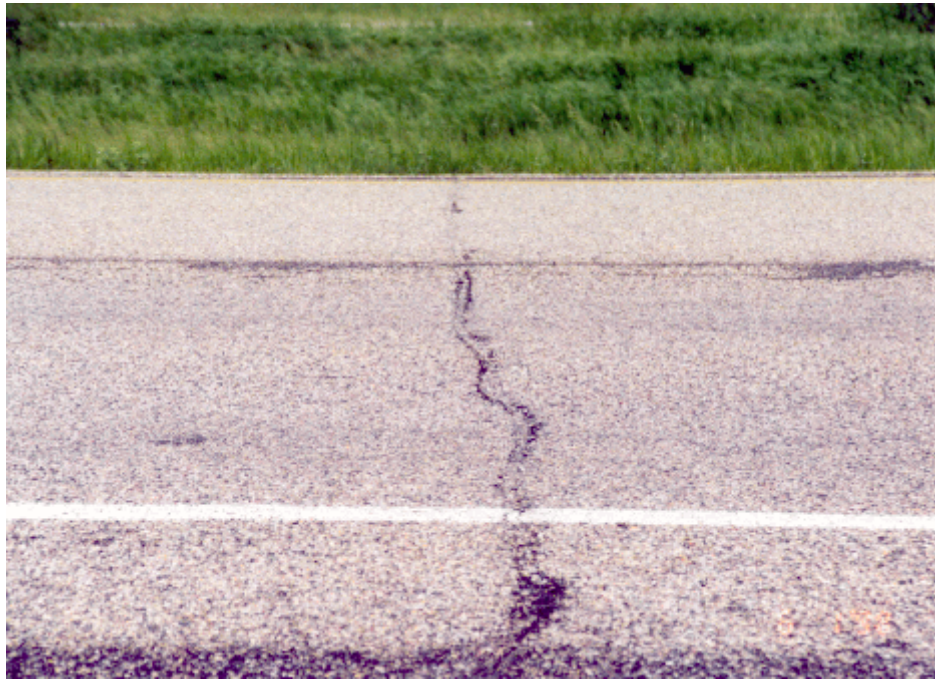
Photo 9 --PavePrep section--typical reflected joint crack--sta.1221+0.6

Photo 9 shows a reflected crack in the PavePrep section. The crack is fairly straight except for the shoulder.

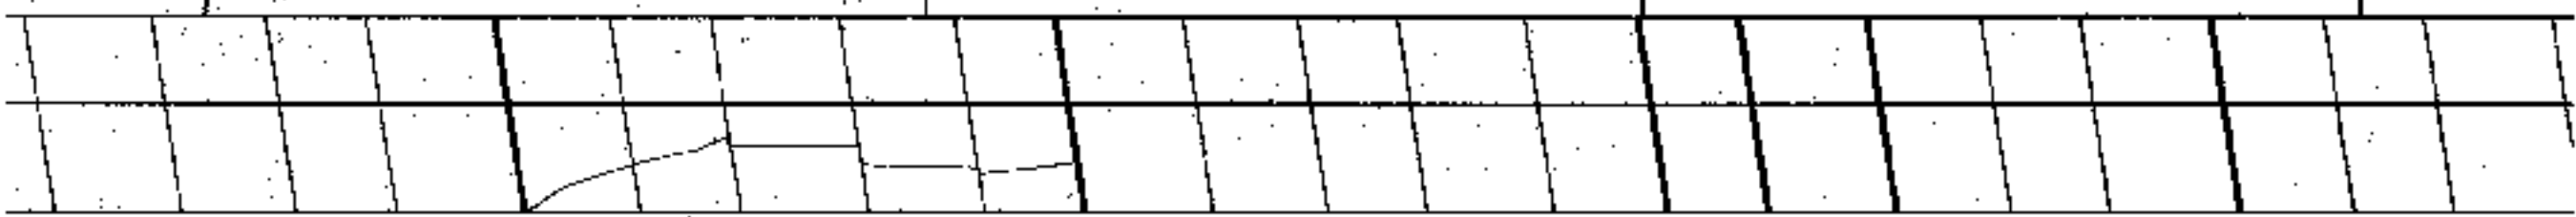
NH-3-002(040)212R - EAST BOUND LANES
CRACK SURVEY FOR PAVEPREP

- ORIGINAL JOINT CRACK
- REFLECTED CRACK 1998
