Experimental Study ND 95-02

Crushed PCC for Drainable Base Material

Final Report

Project IM-6-029(011)175

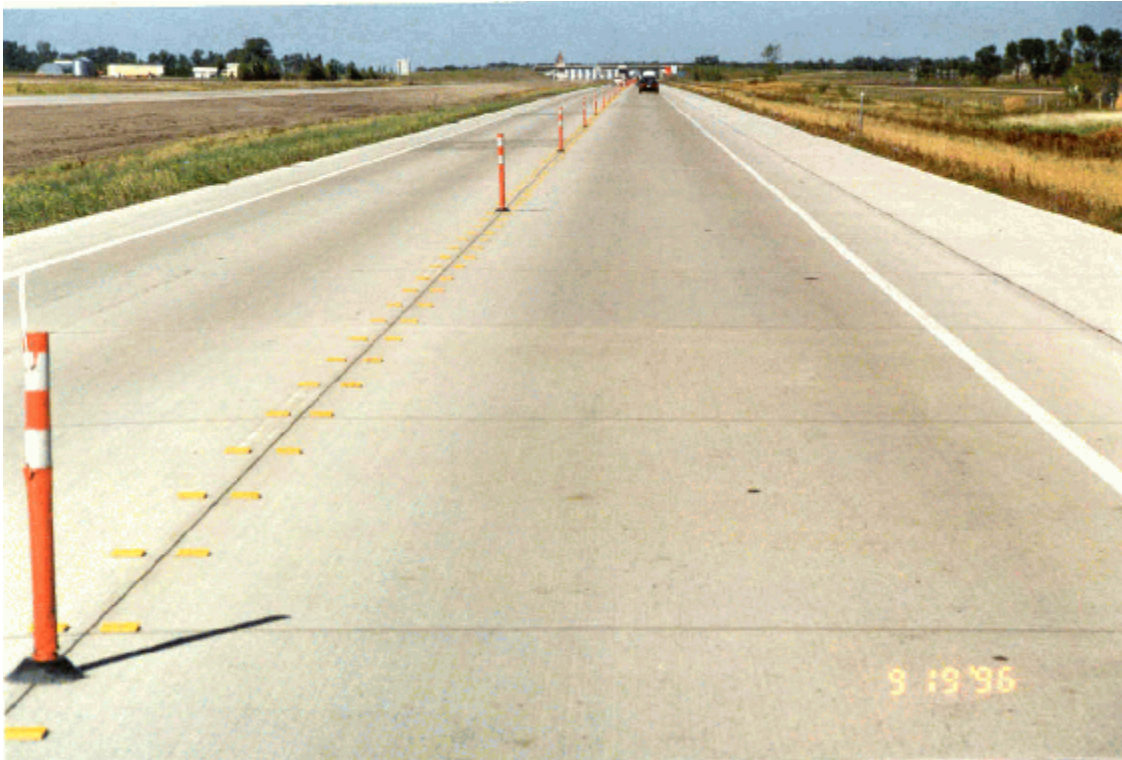
Photo 1. Overview of project location

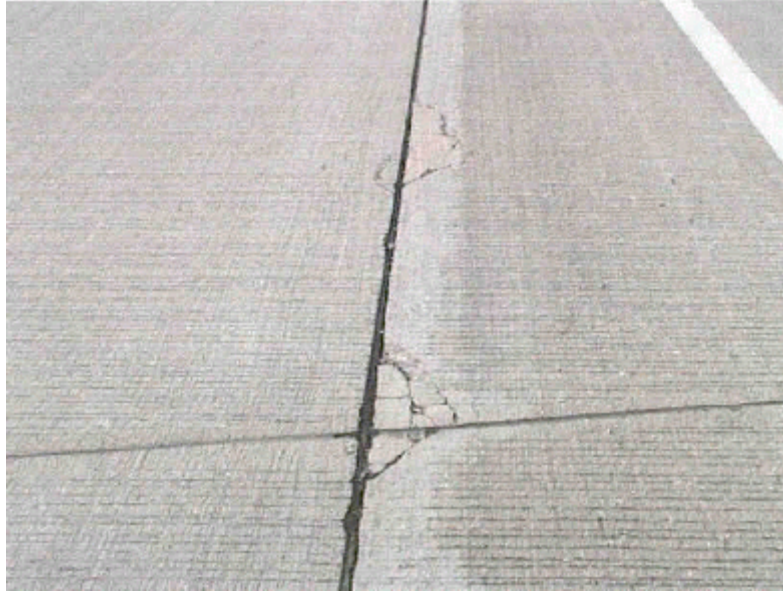
The final evaluation identified approximately 210' of longitudinal cracking and four (4) transverse cracks in this test section. Approximately ten (10) corner breaks were also noted.

During the final evaluation the roadway pavement (observed approximately $\pm 100'$ either side of headwall) was experiencing small corner cracking of pavement panels, and spalling of the edges at the connection of the driving lane and shoulder. Frequent corner cracking, spalling of cracks and breaking up of corners was observed. Photo 2 shows a typical pavement distress in this test section of the project. The longitudinal shoulder joint is separating at several locations. The separation is 3/8" to 1/2" in areas.

Photo 2. Typical Pavement Distress (Sta. 2160+60L) . Note the snowplow marks on the shoulders.

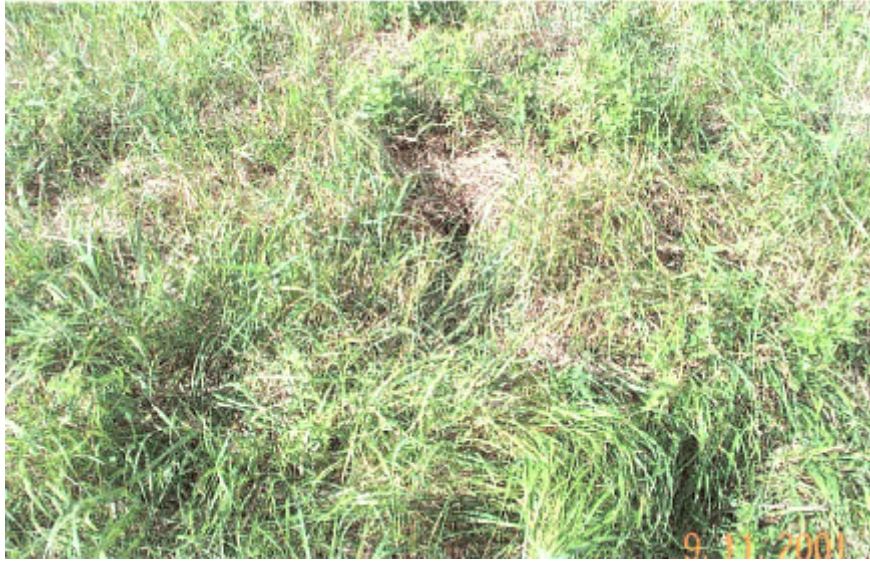
The drain pipe at Sta.2004+75L was observed to be dented approximately 90' from the headwall as observed in the fourth evaluation. The pipe is crushed approximately 164' from the headwall (observed in the fourth evaluation); however, a 3/4" gap for material passage remains and sediment build up was not noted at this location. It appeared that the structural damage is not affecting the performance of the system. The headwalls in this section were in excellent physical condition. Three (3) were covered, or contained a significant amount of grass clippings. Photo 3 illustrates the grass covering the headwall at Sta.2073+00.

Photo 3. Grass covering headwall (Sta. 2073+00L).

The edge drain systems continue to be in excellent condition, with the exception of grass clippings covering the head walls. The headwalls should be kept clean to prevent damming of draining water and material, which could result in flow restrictions in the edge drain system. Results obtained from experimental project ND 98-03, (*Vegetation Barriers Around Headwalls of Edge Drains*), indicate that the use of vegetation barriers can be effective in decreasing the accumulation of grass and grass clippings thereby reducing headwall maintenance.

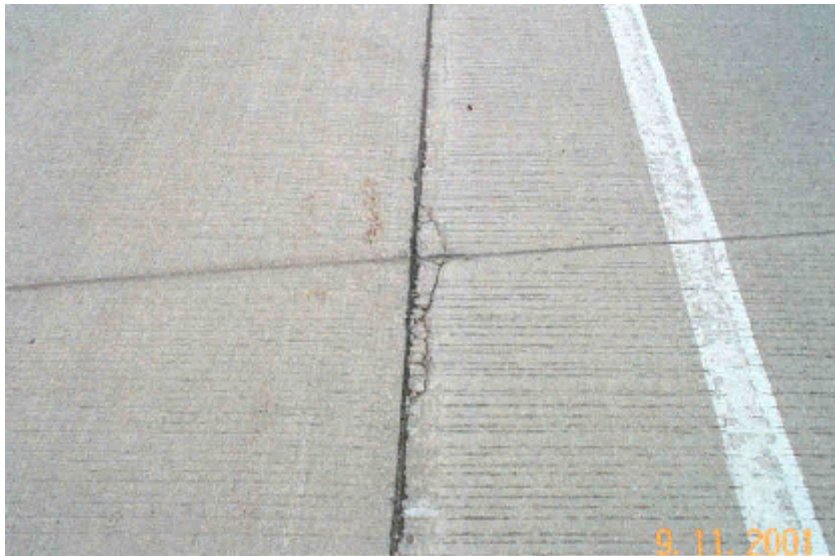
The roadway pavement, (observed approximately $\pm 100'$ either side of headwall), is experiencing spalling of the edges at the longitudinal shoulder joint. Fewer corner cracks were noted in the super elevation portion of this test section. Transverse cracking in the shoulder was also noted. Approximately 60' of longitudinal cracking was observed in this test section. The longitudinal shoulder joint is separating at several locations. The separation is 3/8" to 3/4" in some locations.

Photo 4. Typical Pavement distress (Sta. 2004+75L).

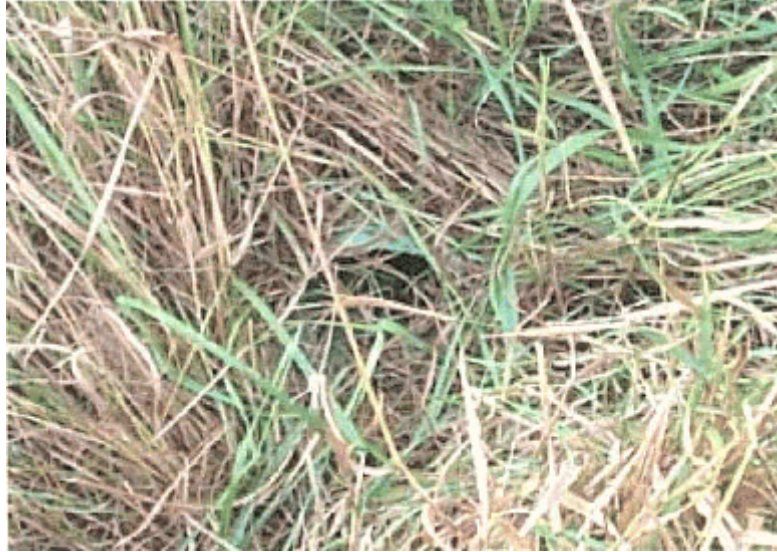
The headwalls in this section were in excellent physical condition; however, the headwall at Sta. 1875+35L was missing (Refer to Photo 5). Consequently, the drain pipe was open and there is a potential for damage by mowers but more importantly to become plugged and not allow water to drain from the pipe. Without a rodent screen, an open entrance for rodents exists. Sediment or grass clippings were observed in the other headwalls.

Photo 5. Headwall missing (Sta. 1875+35L).

The headwall at Sta. 1875+35L is missing and should be replaced as soon as

possible to prevent damage to the drain outlet pipe and keep rodents out of the edge drain system.

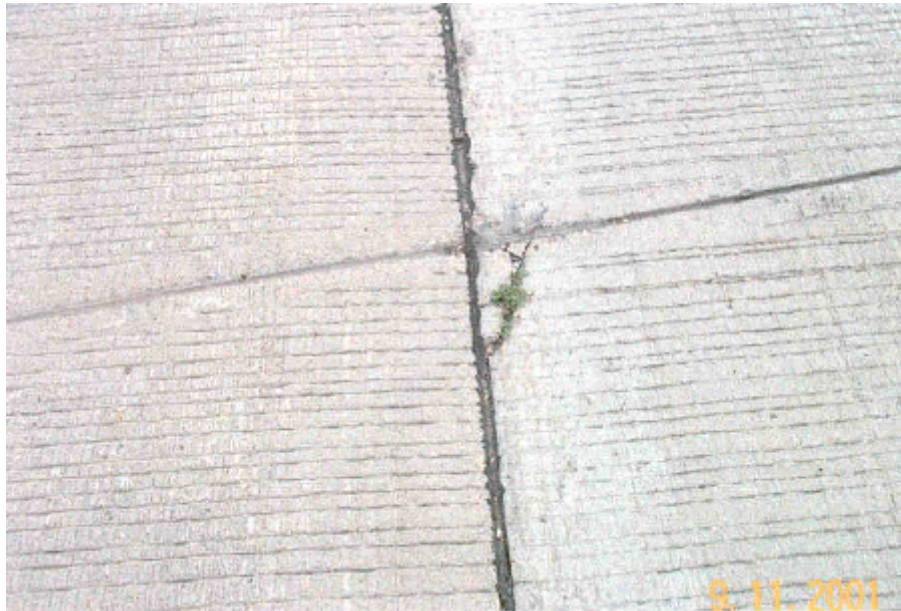
The roadway pavement, (observed approximately $\pm 100'$ either side of headwall), is experiencing corner cracking of pavement panels, and spalling of the edges at the connection of the driving lane and shoulder. Photo 6 illustrates the typical pavement distress in this test section of the project.

Photo 6. Typical Pavement Distress (Sta. 1875+35L).

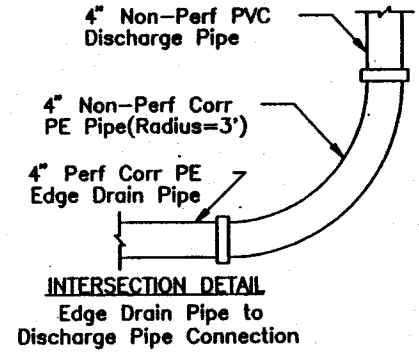
EDGE DRAIN, DISCHARGE PIPE, & SPLASH BLOCK DETAILS

RODENT SCREEN:
 Dimensions are approximate to allow for bend and a snug fit in slot in headwall

*NOTE: The rodent screen shall be fabricated from flattened expanded metal with screen openings of approximately 0.25 square inches. The screen shall be 16 ga. metal and be hot dip galvanized after fabrication.
