Experimental Study ND 96-04

**Evaluation of CRAFCO
Crack Sealant on
Asphalt Pavements**

Final Report

Project H-5-085(004)041

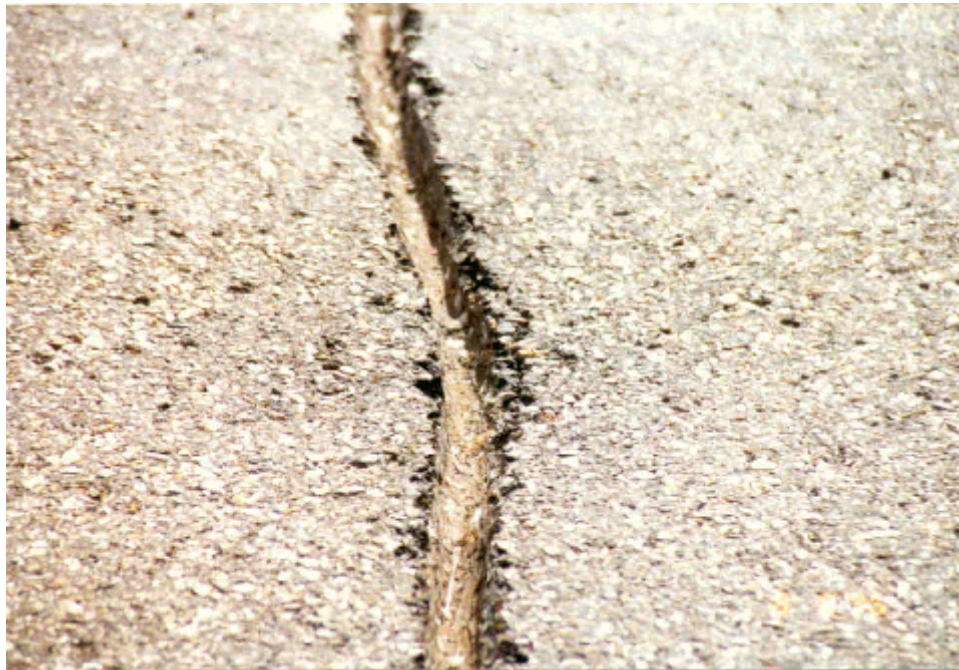
Problems can occur during the routing process. The cutting edges on the routers will wear down and become rounded. This is not acceptable as it will produce a reservoir that does not comply to construction requirements. A poor reservoir is shown in photo 1. Notice in photo 1 that the reservoir bottom is rounded. Also notice the surface edge is very irregular. Worn cutting wheels actually hammer their way through and can cause hairline cracks next to the

Photo 1
Poor reservoir---worn cutting wheels on router.

vesseledge. These hairline cracks later show up as spalls.

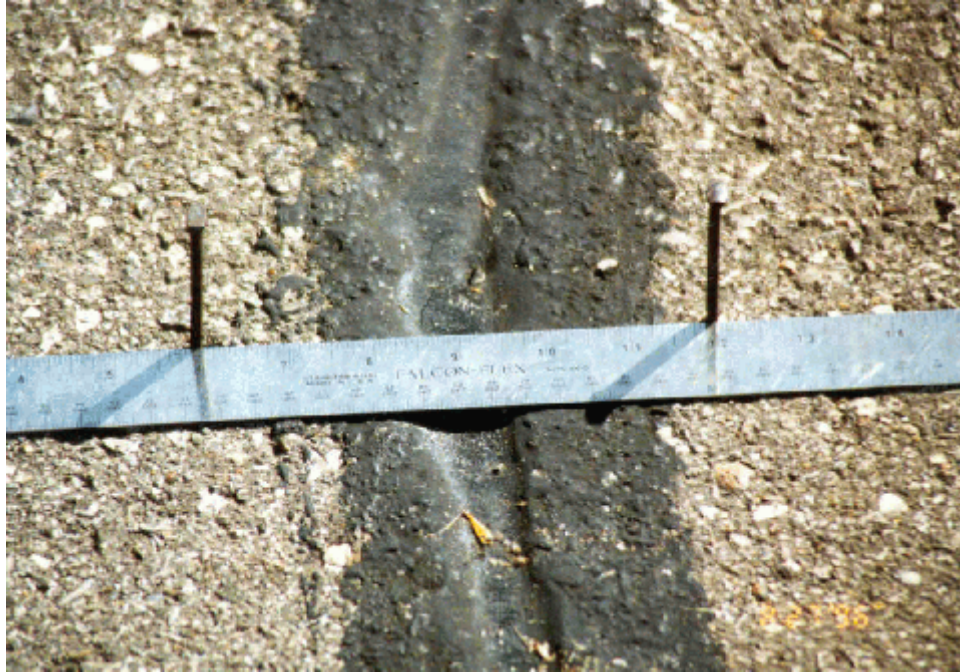
Photo 2
Method for nail installation.

Measurements between the nails are taken each winter. The ruler in photo 2 was used for demonstration only. Actual measurements are taken in millimeters. These measurements are to determine how much the transverse crack opens up under cold conditions. A comparison can be made to the bond extension percent for each tested material. Cracks are routed to obtain a $\frac{3}{4}$ " x $\frac{3}{4}$ " reservoir. A crack like this would have to expand $\frac{3}{4}$ " to receive a 100% extension.

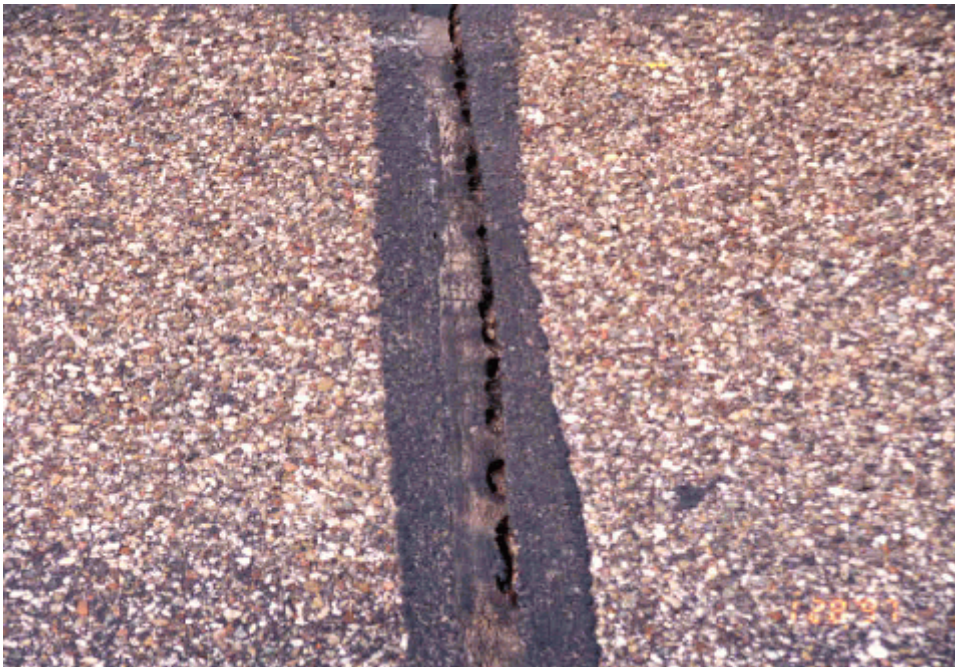
Crafco 221 sealant is the material that has the highest failure rating. The major cause for failure of this sealant is

adhesion. A typical adhesion failure

is seen in photo 6.

Photo 6
Crafco 221-adhesion failure

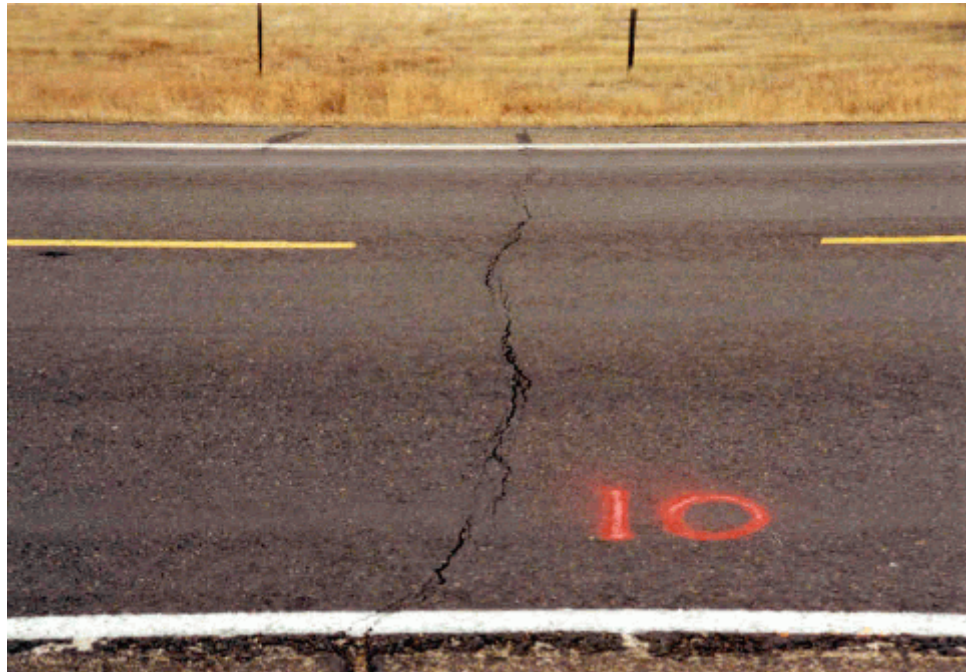
Severe rutting is taking place on many parts of the project. Some areas have been completely overlaid with asphalt mix to correct the rutting. A good stretch in the Crafco 231 control section was

overlaid due to rutting. This section was extended to include about the same number of cracks as in the other sections. In some areas the entire roadway was overlaid. Photo 7 shows a lane overlay at

Asphalt overlay to correct rutting---Crafco 231 section

The asphalt overlay has been in place for about a year and shows that the routed crack is reflected through the overlay.

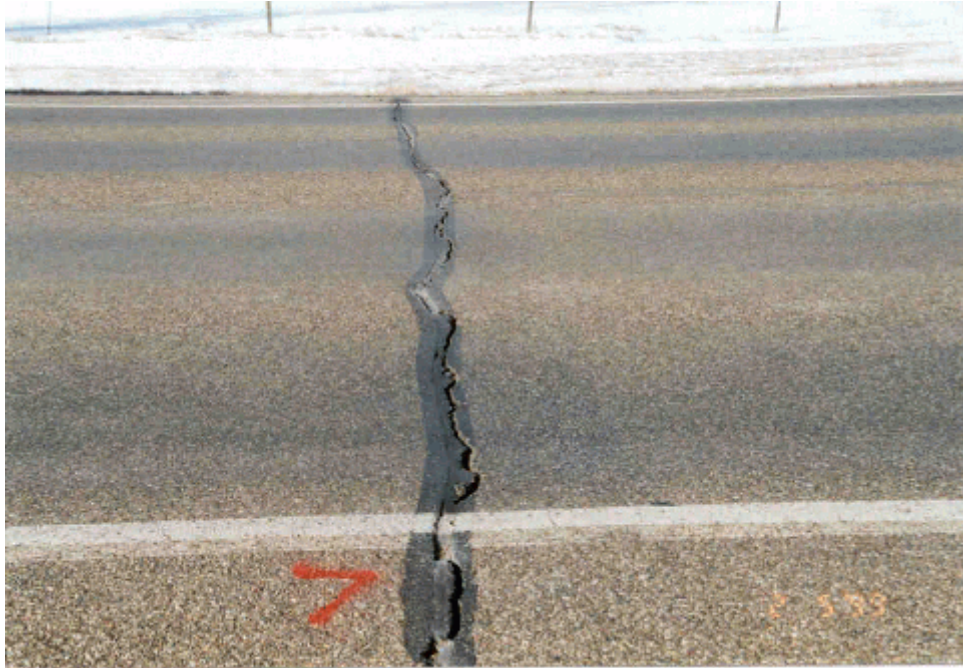
Two photos taken at the same crack location are shown on the next page. Photo 9 shows a typical bad crack during the early part of February 1999. This crack is located in the Crafc0 231 section. Photo 10 shows the same crack on May 5, 1999. This is not during the warmest part of the year, but already shows how the crack is closing up. This is why there can be such a difference between evaluators and also what time of year the evaluation occurs.

Photo 9
Crafcro 231 section – February 1999 crack severity level

The section ratings are up over last year as expected by a summer time evaluation. Photos 9 and 10 from the 1999 evaluation show this very well. These photos show the visual difference of a cracks sealant failure between a winter and spring environment. Both materials were given the thumb test for flexibility and were judged equal. After four years of service both Crafcoc Sealants 230 and 231 are performing satisfactorily.

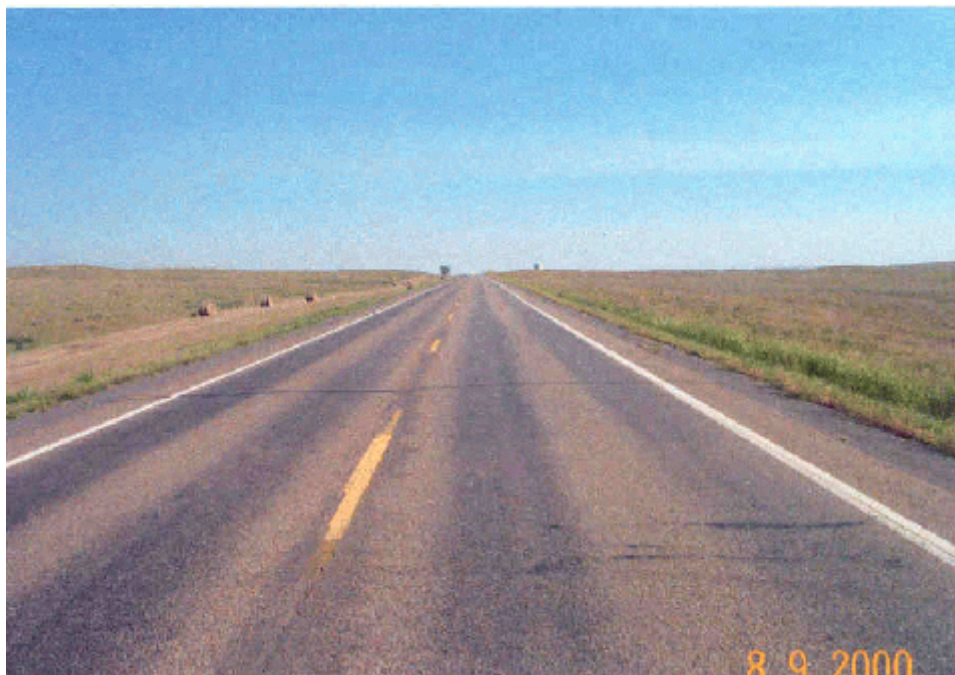
Photo 11
Bleeding in wheel paths

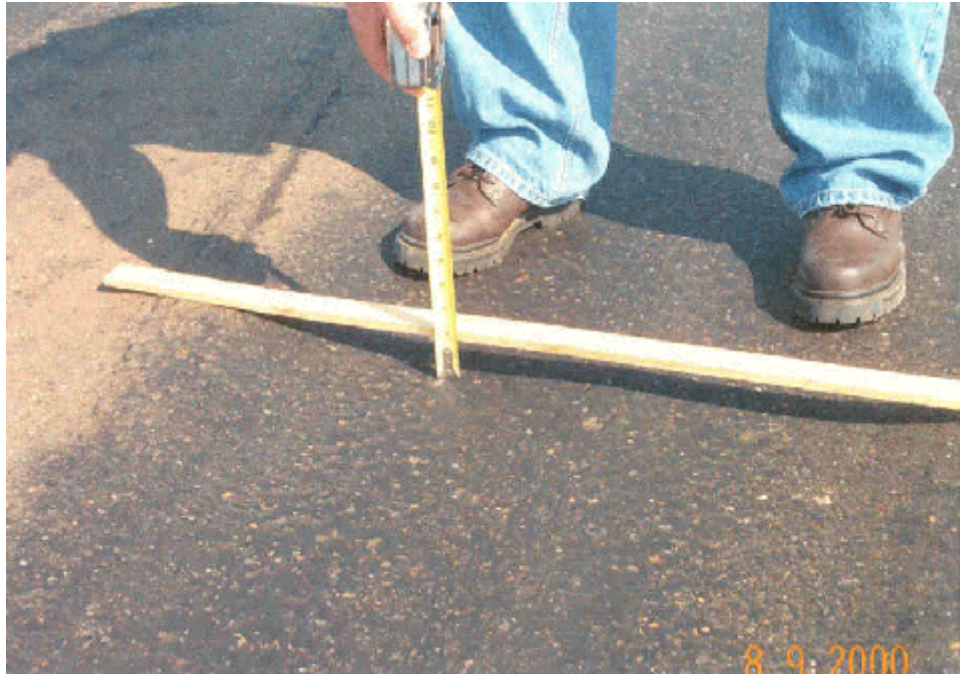
The Crafcoc 230 section has been patched in some areas leaving only 23 cracks to evaluate. The cracks look like they are in rather good shape in this section but, some places are rutted over an inch. Photo 11 shows a sand seal where the asphalt is bleeding through. Photo 12 shows the depth of rutting at places in the Crafcoc 230 section.

Photo 12
Rutting in inside wheel path – SB
