Experimental Study ND 98-03

**Evaluation of Vegetation Barriers Around
Headwalls of Edge Drains**

Final Report

AC-IM-8-029(025)053

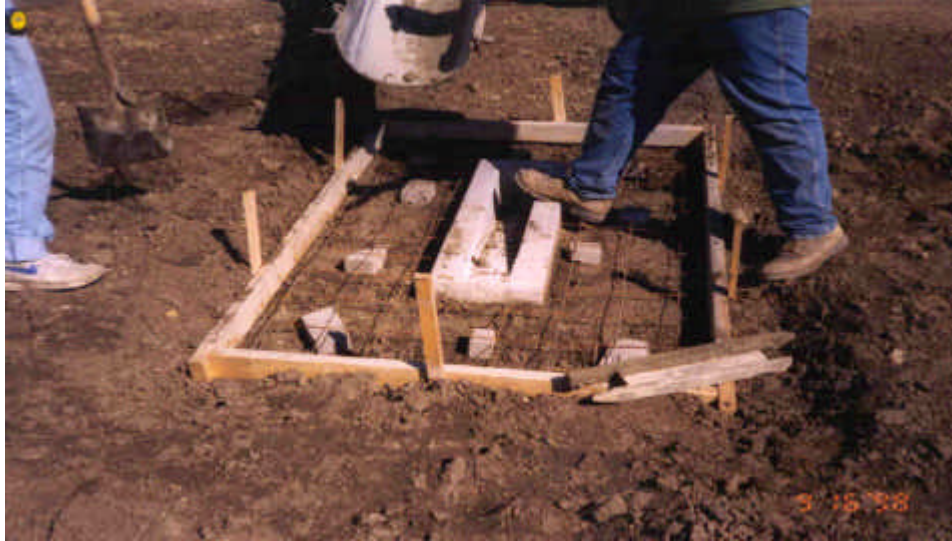
Photo 4 - Concrete Form.

The concrete barrier locations were shaped and formed. At a few places where the drainage was coming from both directions, a double headwall was used. The headwalls were constructed for a 4:1 slope and were difficult to fit to the 6:1 slope on this project.

The contractor adjusted the headwalls to a 5:1 and made a better match with the slope. This was also done in the aggregate section. Photos 4 and 5 show the construction of the concrete barriers.

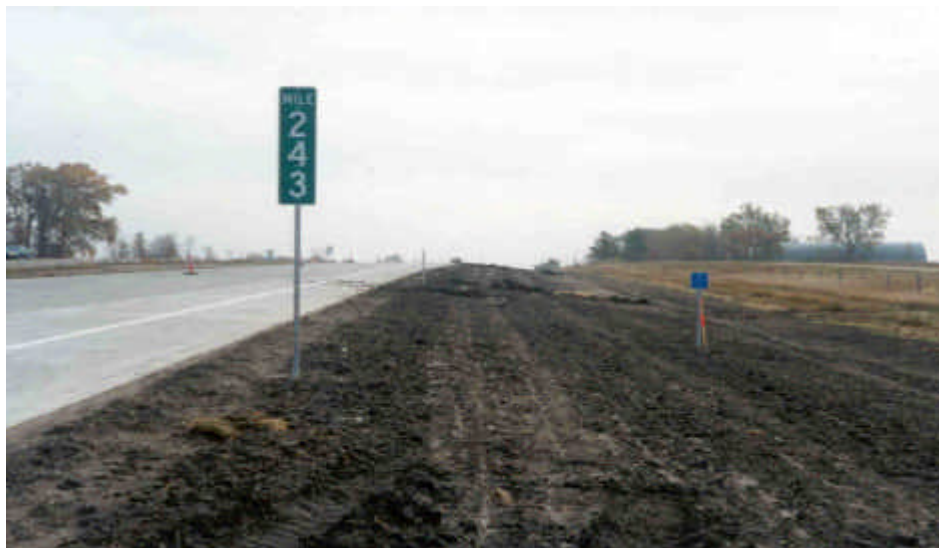
Photo 6 - Overview of project.

The vegetation barriers were built and installed according to the plans with a few variations. These variations are noted later in this report. Plans sheets showing details and location of the vegetation barriers are located in Appendix B. Also located in Appendix B is a concrete mix design for the concrete barriers, a gradation sheet for the aggregate used in the aggregate barriers, and a certification for the geotextile fabric used under the aggregate of the aggregate barriers. Photo 6 shows the beginning of the experimental section.

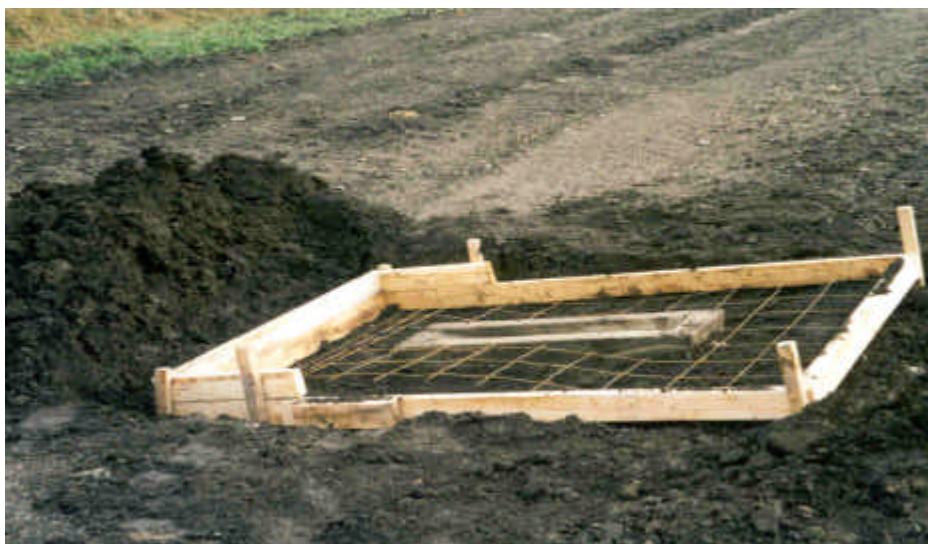
Photo 7 - Modified concrete barrier.

The prime contractor for this project was Progressive Contractors Inc. (PCI) and the subcontractor for the experimental vegetation barriers was Traxler Construction Inc. The drain headwall is designed for a 4:1 slope. The contractor had to adjust each headwall to best fit the slope it was placed on. Photo 7 shows a framed barrier ready for concrete.

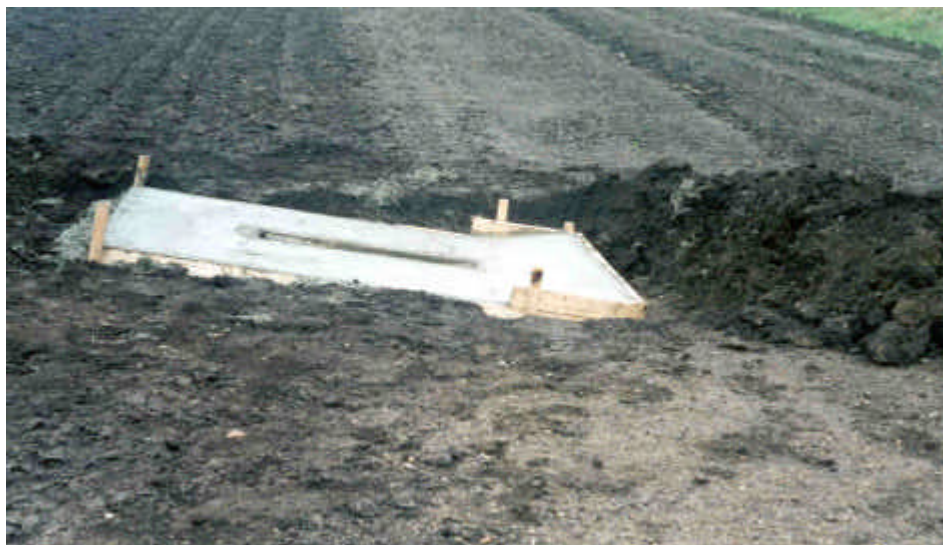
Photo 8 - Finished concrete barrier.

Photo 8 shows a finished concrete barrier and how it fits to the rest of the slope. Notice that the bottom of the barrier would be below the soil to the sides if the bottom had not been modified. This modification fits the existing grade better and shortens the contractor's time required to finish grading the soil to the barrier.

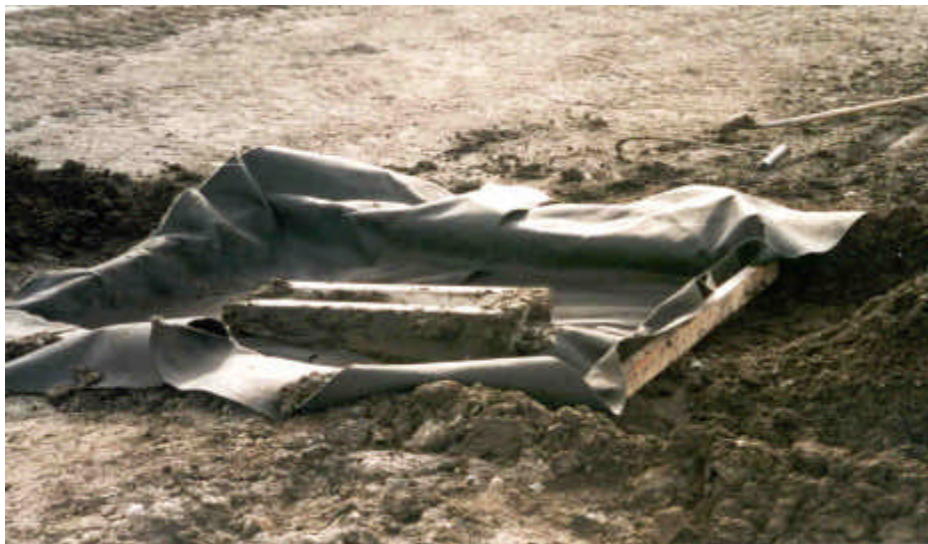
Photo 9 - Fabric in aggregate barrier.

An experimental aggregate barrier is shown in Photos 9 and 10. Photo 9 shows a form that is set to the desired grade with a S2 geotextile fabric in place. The fabric should keep the aggregate separated from the soil and help to prevent weeds from growing around the headwall. The vegetation barriers, aggregate or concrete, were bid at \$350.00 each, same as in the previous project.

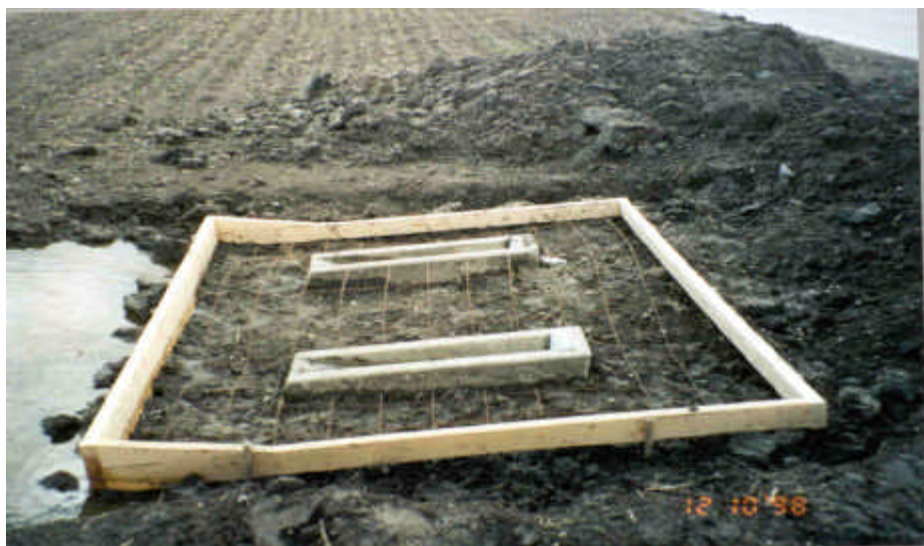
Photo 11 - Double concrete barrier.

The low maintenance edge drains were installed on the southbound lane on October 10, 1998. The headwalls are designed for a 4:1 slope and were adjusted to fit better with the 6:1 slope of the roadway. The concrete barrier bottom below the outlet trough was flattened to fit the grade and prevent a low spot where water can pool. The project area experienced heavy rains and the contractor had difficulty in completing this work. Photos 11, 12, and 13 show some completed barriers and site conditions.

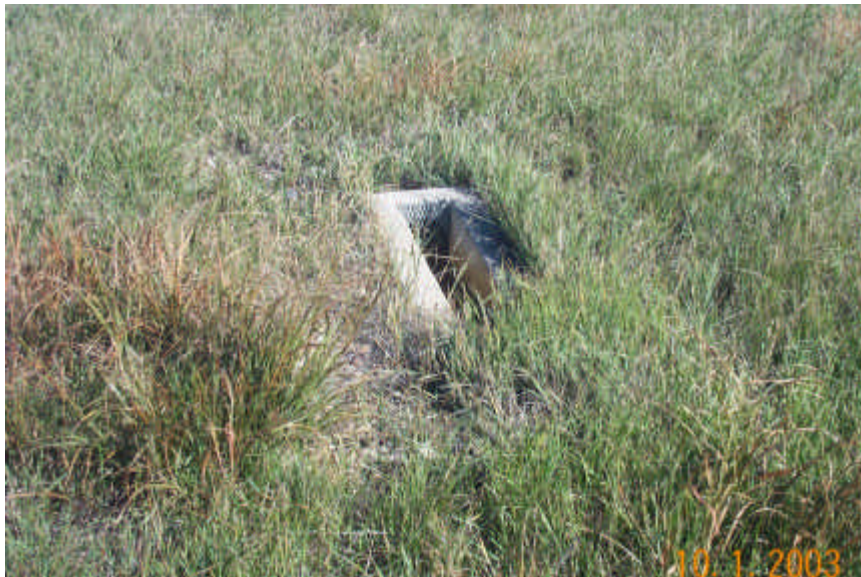
Photo 14 – Aggregate barrier – vegetation growth.

The majority of the aggregate barriers have grass and weeds growing out of the aggregate. Vegetation growth in the aggregate barriers has increased every year since construction. Vegetation coverage in these barriers ranges from 30 percent to 80 percent. Photo 14 is an example of one such barrier. Vegetation is expected to ultimately overgrow all of the aggregate barriers.

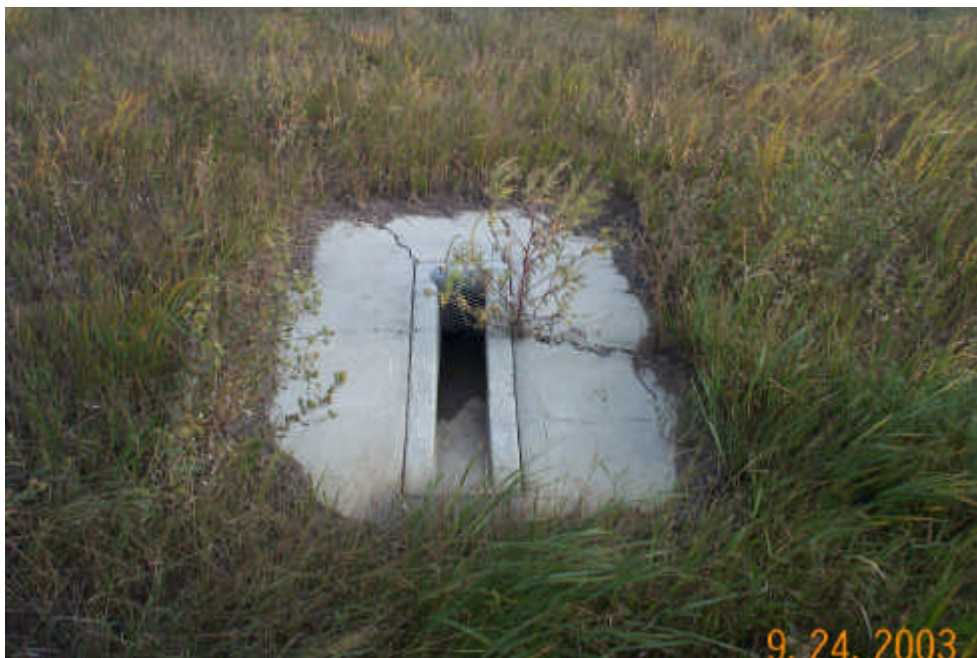
Photo 18 - Cracked concrete barrier.

The last evaluation for this project was completed on September 24, 2003. The vegetation growth in the aggregate barriers ranges from 15 percent to 80 percent of the area, with near 70 percent of the barriers over 50 percent coverage. All of the concrete barriers on this project are clean and in good shape except one. One concrete barrier is cracked but is still functioning satisfactorily. Photo 18 shows this cracked barrier.

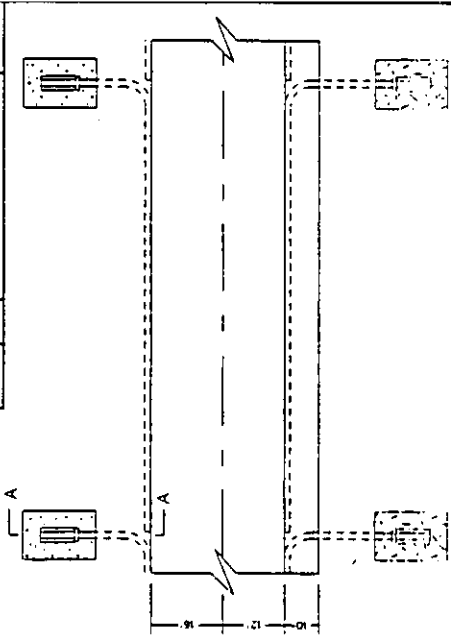
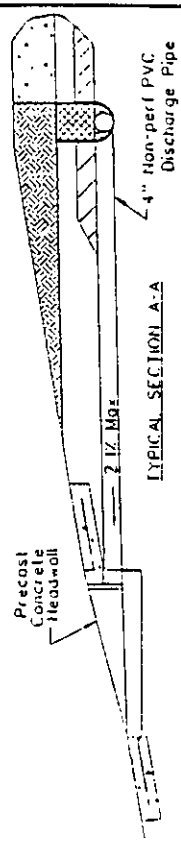
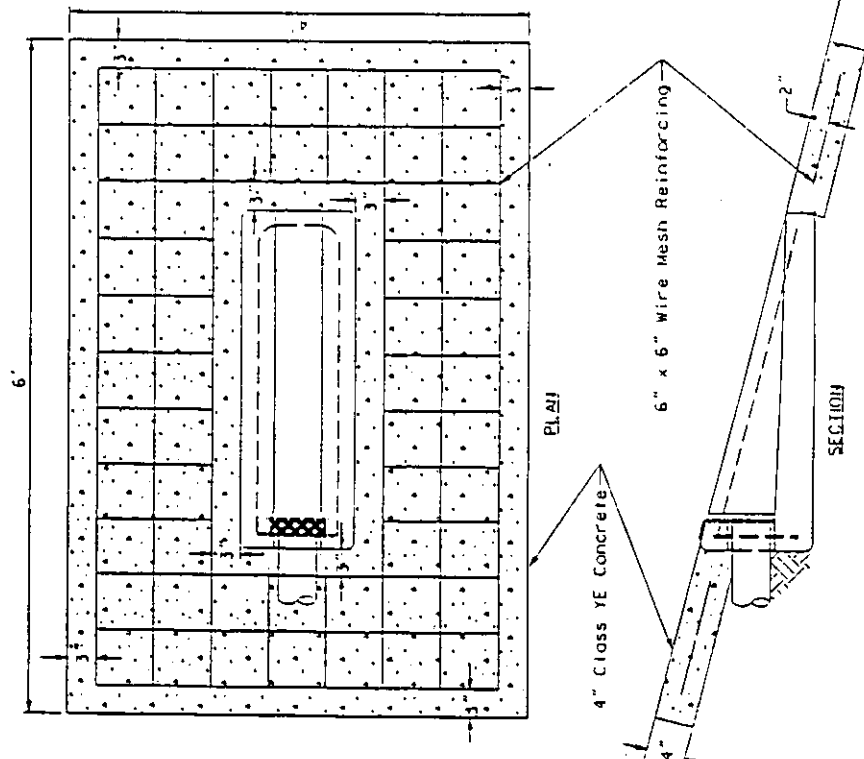
VEGETATION BARRIER AROUND HEADWALLS OF EDGE DRAINS
 CONCRETE
 MEDIAN DRAINS - TYPE C -
 GLADSTONE EAST TO TAYLOR INTERCHANGE - EAST BOUND
 RECYCLED P.C.C. PAVEMENT

NOTE 1: Concrete Vegetation Barriers shall be placed around the headwalls of the edge drains from sta 4013+12 to sta 4039+82.5 right and from sta 4039+82.5 to sta 4066+53 left.

NOTE 2: MEASUREMENT AND PAYMENT (MEDIAN DRAINS-TYPE C): The concrete shall be cast in place around the splashblock. The concrete and wire fabric shall not be measured for payment. The unit price bid for "Median Drains-Type C" shall include all costs to supply, prepare, form, and place the wire fabric and concrete.

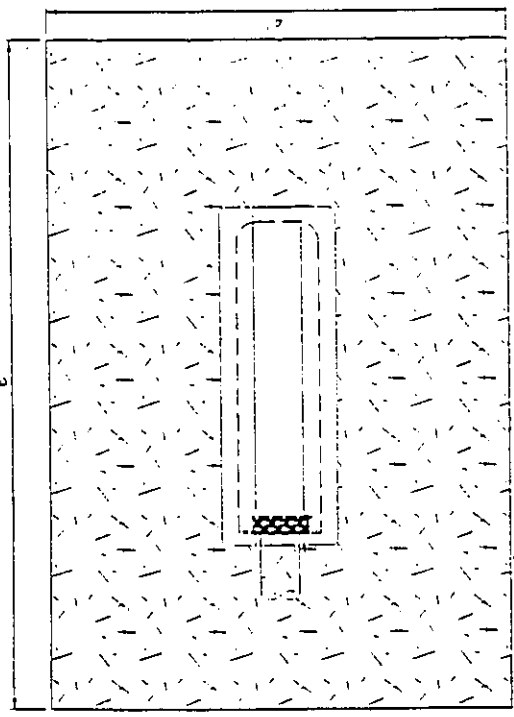
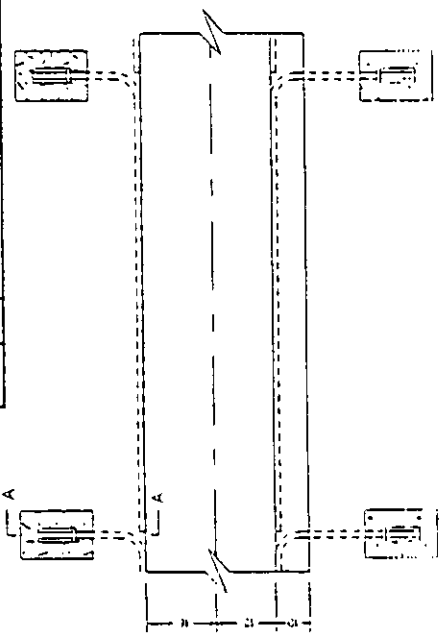
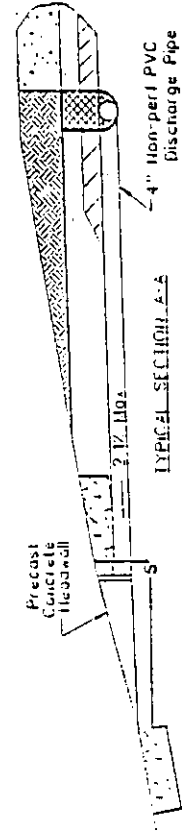
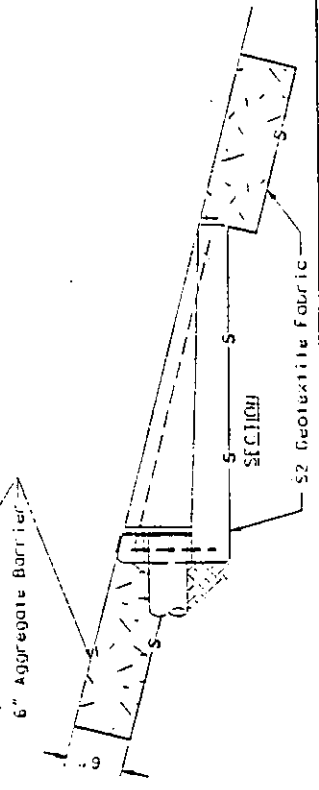
VEGETATION BARRIER AROUND HEADWALLS OF EDGE DRAINS
 AGGREGATE & SEPARATION FABRIC - MEDIAN DRAINS - TYPE A - GLADSTONE E TO TAYLOR INTERCHANGE - EAST BOUND
 RECYCLED P.C.C. PAVEMENT

NOTE 2: MEASUREMENT AND PAYMENT MEDIAN DRAINS-TYPE A1: The S2 Geotextile fabric shall be placed under the aggregate barrier and the splashblock. The fabric and the aggregate shall not be measured for payment. The unit price bid for "Median Drains-Type A" shall include all costs to supply and place the fabric and aggregate.

AGGREGATE BARRIER GRADATION

SIEVE SIZE	PERCENT PASSING
3"	100
2 1/2"	90-100
3/4"	0-5

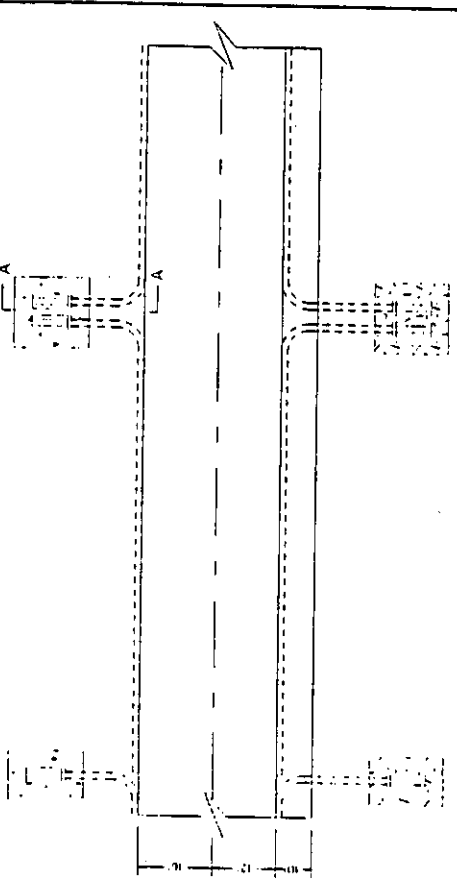
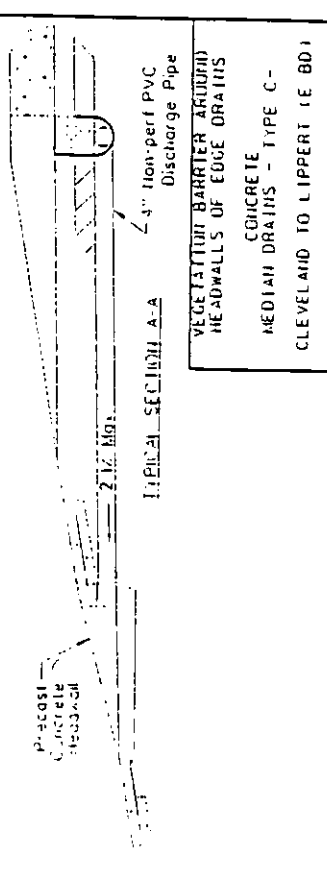
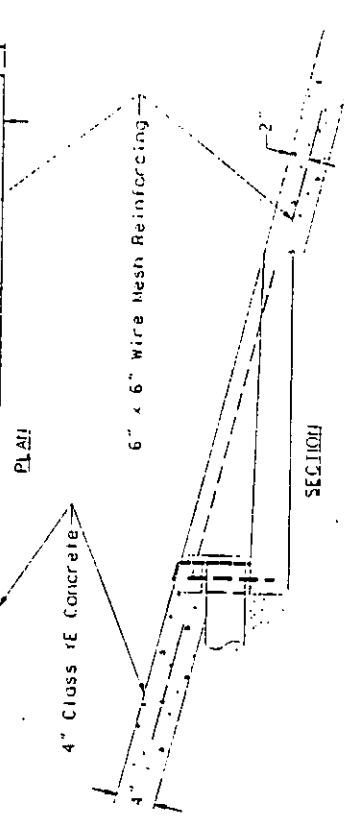
VEGETATION BARRIER ARMOR
HEADWALLS OF EDGE DRAINS
CONCRETE
MEDIAN DRAINS - TYPE C -
CLEVELAND TO LIPPERT (E BD)

NOTE 1: Concrete Vegetation Barriers shall be placed around the headwalls of the edge drains from sta 12829+89 to sta 12856+29.5 right and from sta 12856+29.5 to sta 12882+70 left.

NOTE 2: MEASUREMENT AND PAYMENT (MEDIAN DRAINS-TYPE C): The concrete shall be cast in place around the spiroblock the concrete and wire fabric shall not be required for payment. The unit price bid for "Median Drains-Type C" shall include all costs to supply, prepare, form, and place the wire fabric and concrete for each Concrete Headwall.

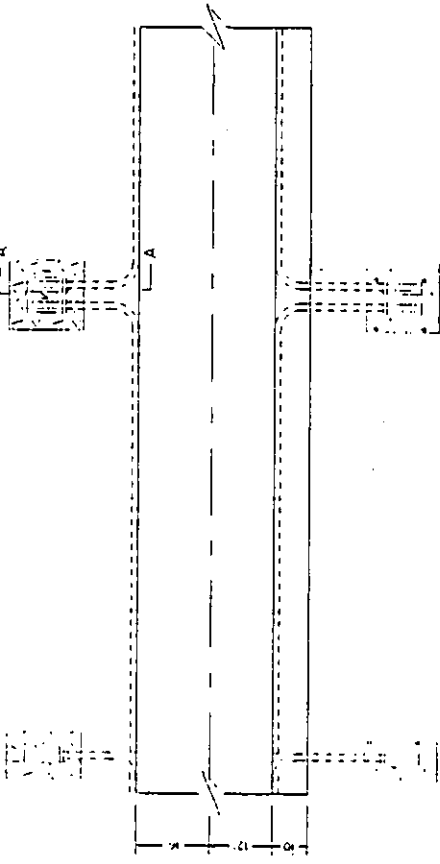
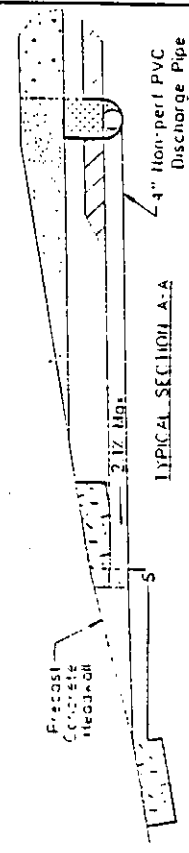
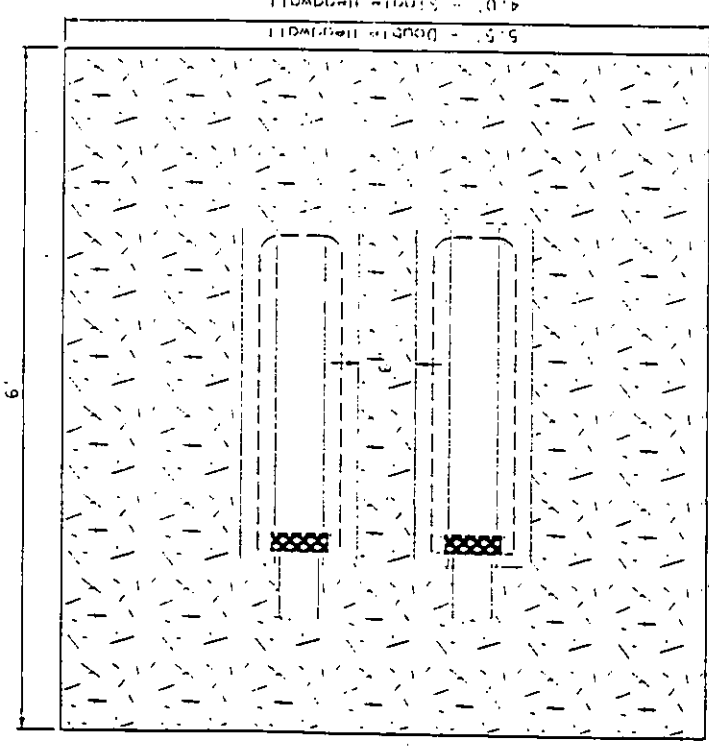
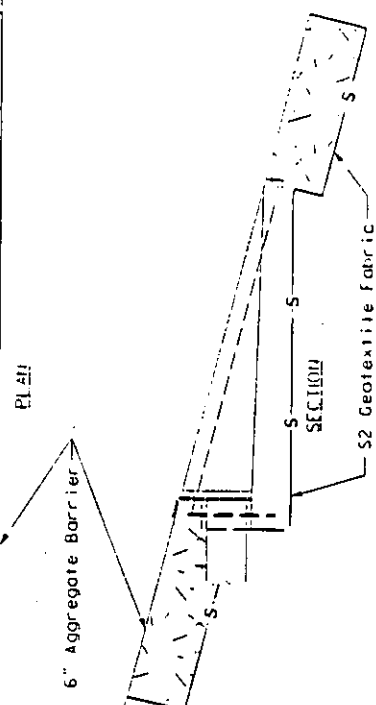
VEGETATION BARRIER AROUND HEADWALLS OF EDGE DRAINS
 AGGREGATE & SEPARATION FABRIC - MEDIAN DRAINS - TYPE A - CLEVELAND TO LIPPERT (E BD)
 RECYCLED PCC PAVEMENT

NOTE 1: Aggregate and Separation Fabric Vegetation Barrier shall be placed around the headwalls of edge drains from Sta 12823+89 to Sta 12856+29.5 left and from Sta 12856+29.5 to Sta 12882+10 right.

NOTE 2: MEASUREMENT AND PAYMENT MEDIAN DRAINS-TYPE A: The S2 Geotextile fabric shall be placed under the aggregate barrier and the splashblock. The fabric and the aggregate shall not be measured for payment. The unit price bid for "Median Drains-Type A" shall include all costs to supply and place the fabric and aggregate for each Concrete Headwall.

AGGREGATE BARRIER GRAVATION	PERCENT PASSING
3"	100
2 1/2"	90-100
3/4"	0-5
