Experimental Study ND 98-04

**Use of Snowplowable Reflective Pavement
Markers for Effective Delineation**

Final Report

H-8-999(003)
NH-4-052(030)167

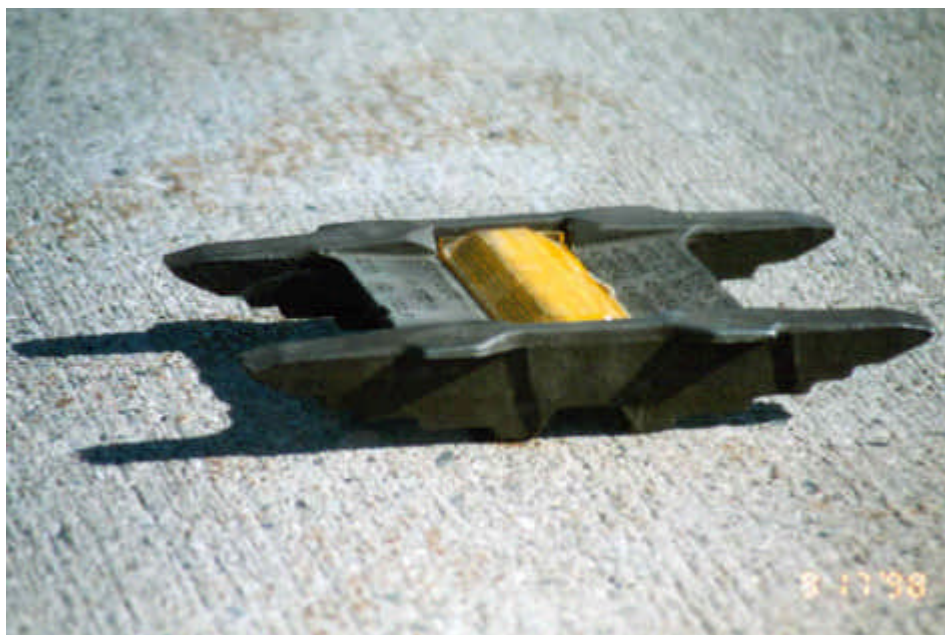
Photo 1- Stimsonite Lifelite 101 LP marker before installation.

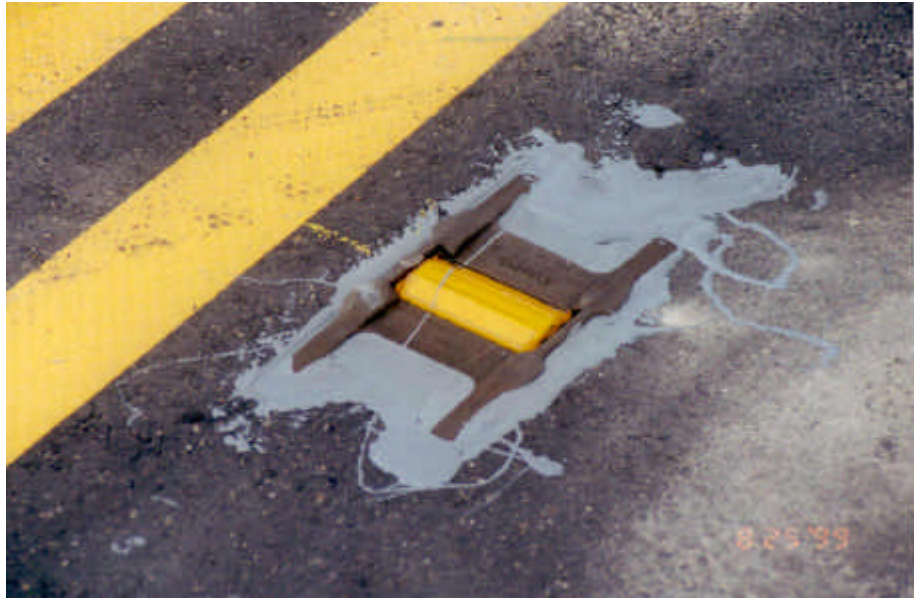
Photo 2 - A typical installation of a raised pavement marker.

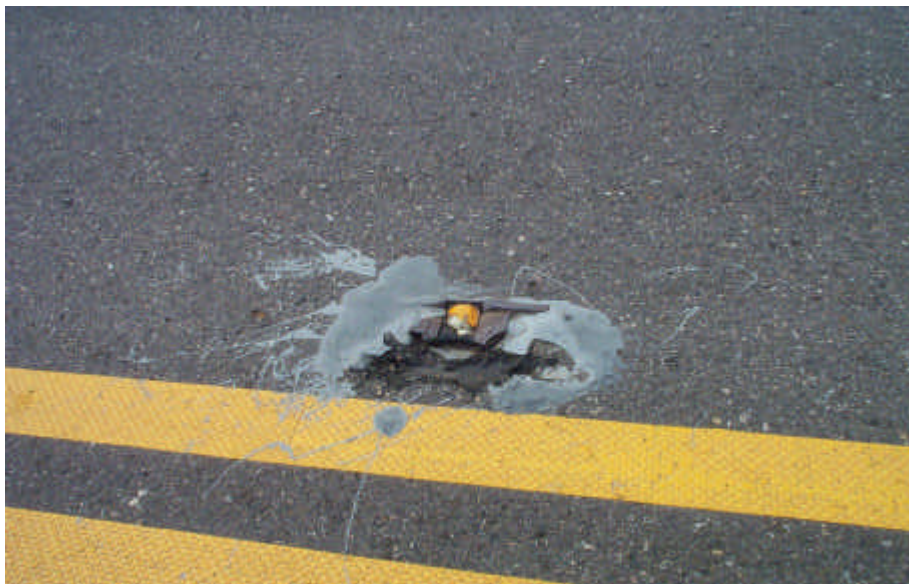
The first evaluation was completed in 2001. One marker on the US 52 installation was partially removed because it was too high and caused some damage to a district snowplow. District Section personnel subsequently removed the portion of the marker that was too high. The marker is shown in Photo 3.

Photo 3 - A marker that had been partially removed by Section personnel.

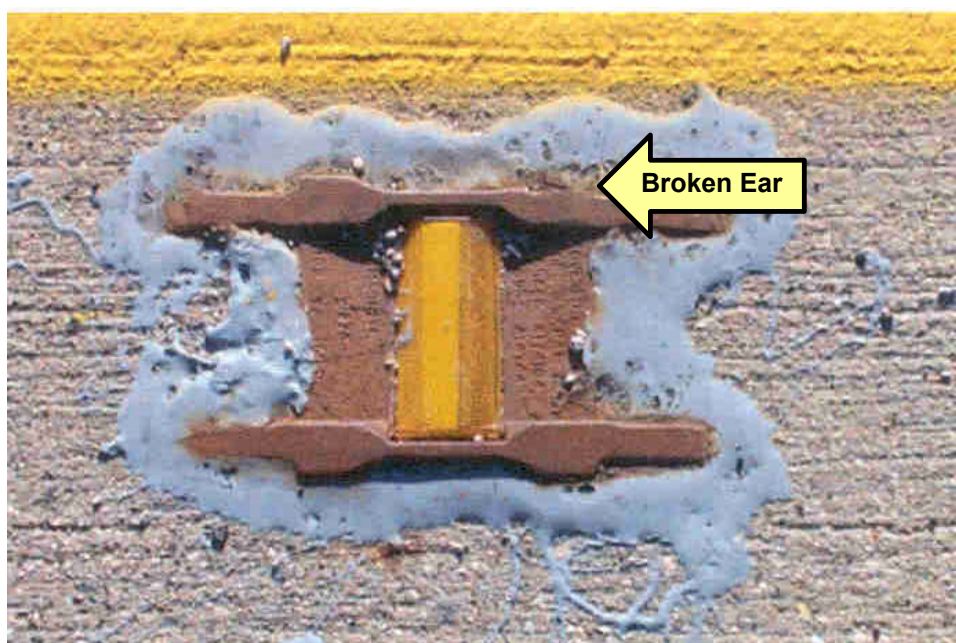
Some of the markers at the I-29 ramp had cracks or breaks at one of the ears that the marker rests on. No obvious reason for the damage was evident. The cracked and broken ears were all in the edge that the snowplow would hit first. Photo 4 shows a marker with a broken ear. There was no traffic or snowplow damage to any of the markers' reflectors. All of the markers on the I-29 installation were in place and serviceable. Some oxidation of the metal casting had occurred but not to the extent that it had become a problem.

Photo 4 – Marker with broken upper right ear.

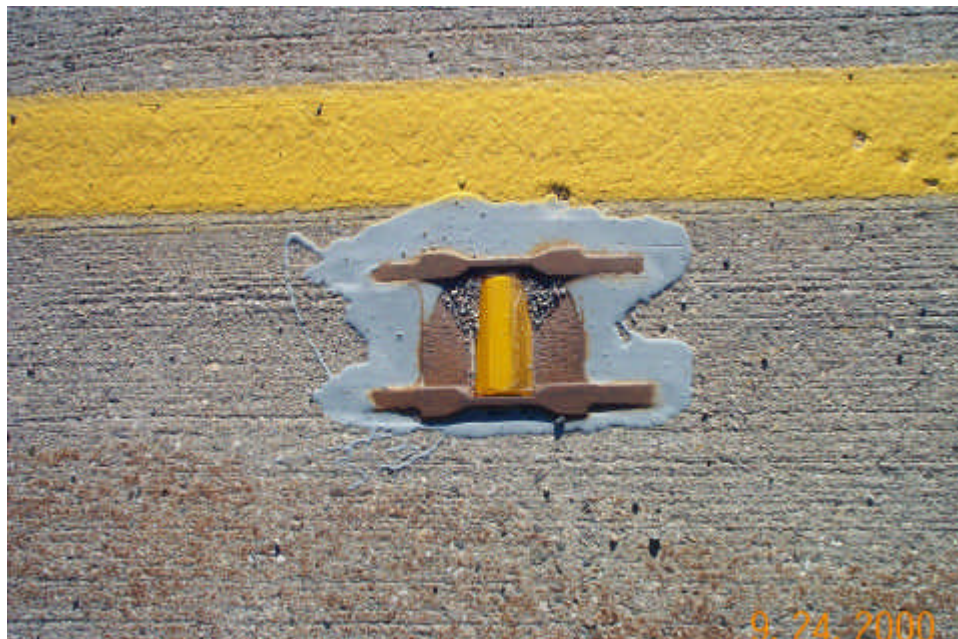
The installation at the I-29 ramp seemed to collect sand in the area adjacent to the reflectors and is shown in photo 5. This may be due to the fact that traffic tends to use the inside of the curve and does not drive next to the markers, which could blow the material out of the recesses. The location of the markers, outside the yellow striping on the outside of the curve, makes them nearly invisible. Because the traffic is only on one side of the markers, the slush seems to build up and cover the markers during thawing weather.

Photo 5 - Debris in recess of marker.

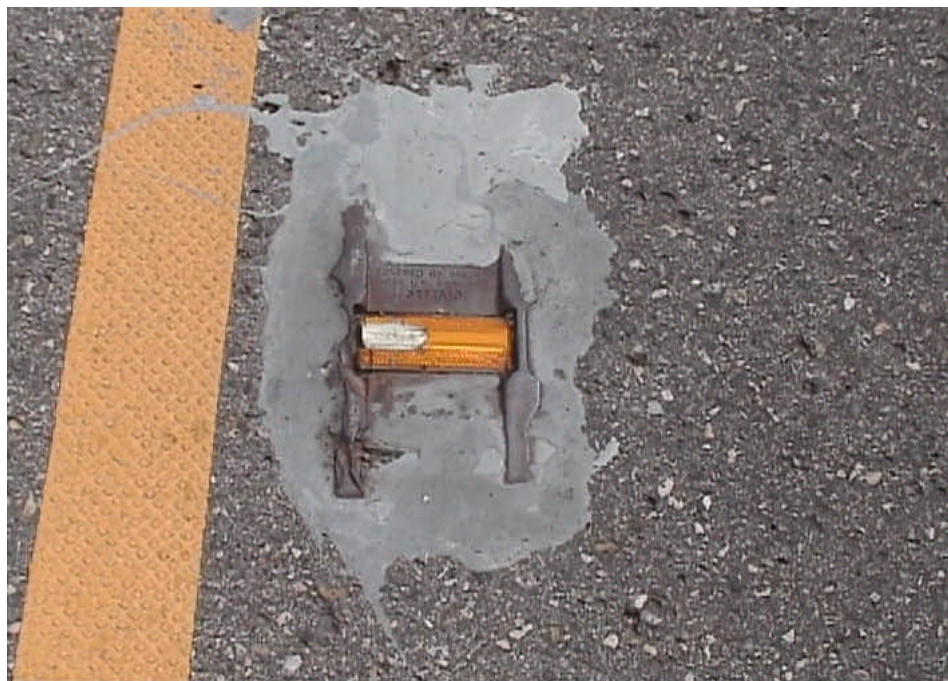
The second evaluation for the US 52 section was conducted on August 14, 2002 and the evaluation for the Interstate 29 ramp was conducted on September 9, 2002. Generally, the markers at both locations were in good condition and were serviceable. A marker, on US 52, had some damage to its top. This damaged marker is next to the marker that was removed by Minot District personnel the year before. Photo 6 shows the condition of this marker. Four other markers, on US 52, had cracked or damaged reflectors. Damage to the ears of the markers has continued. Five of the markers on the Interstate 29 ramp had damaged ears and 18 markers on US 52 had broken or cracked ears. The casings have continued to oxidize but are intact. Photo 7 shows an oxidized marker with a cracked ear. Some epoxy has chipped or cracked but this does not appear to be a problem.

Photo 6 – A damaged marker at the US 52 test section.

Damage to the markers may be due to the markers not being installed level and even with the pavement. It was noted, at the installation of markers at the Interstate 29 ramp that the markers were not even with the pavement. Uneven installation was probably responsible for a portion of one marker being removed because the marker was too high and also for damage to the top of an adjacent marker. A lack of contact with the pavement may be contributing to the damage to the ears. The ears are relatively thin tabs of metal and without pavement contact they are in an exposed and unsupported position.

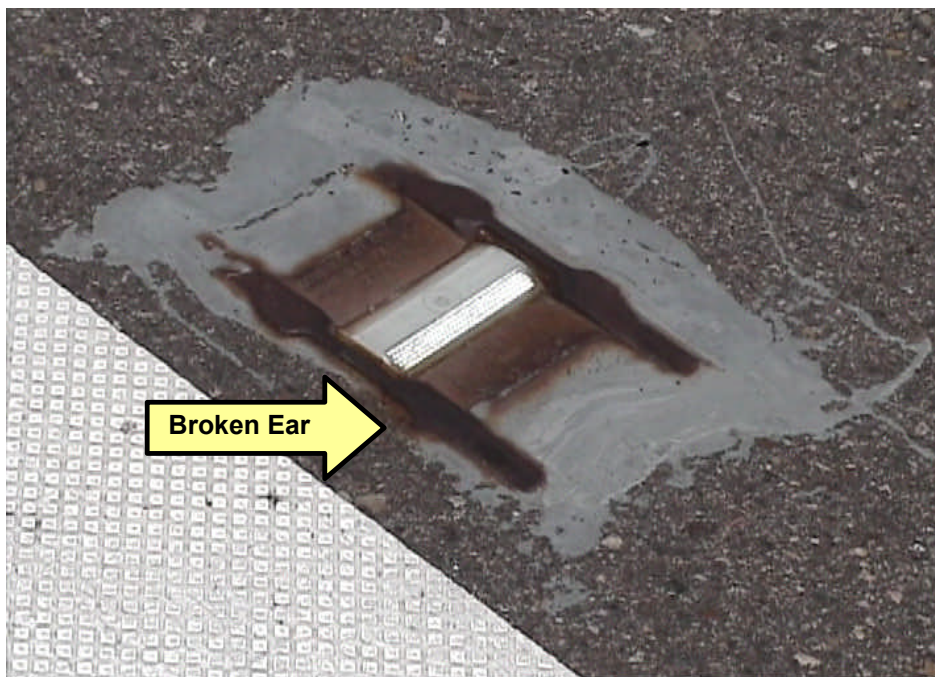
Photo 7 – Marker with oxidized casing and a broken lower right ear.

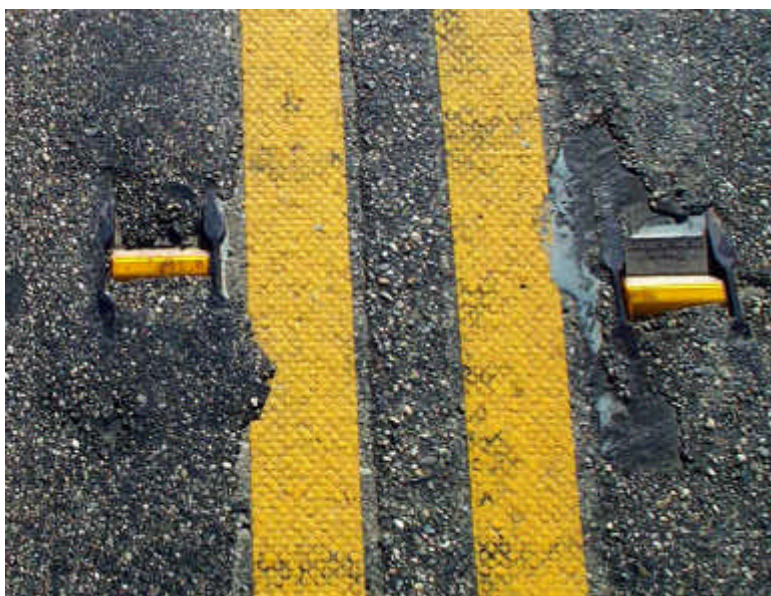
The third evaluation for the US 52 section was conducted on September 22, 2003 and the evaluation for the Interstate 29 ramp was conducted on August 13, 2003. The US 52 section had been chip sealed in the summer of 2002. The raised markers had been masked during the application of the chip seal but chip seal material partially obscured the reflectors of many of the raised markers and in some instances, the highest point of the raised marker was lower than the surrounding chip seal. Minot Section personnel stated that the raised markers were still visible at night but not as visible as before application of the chip seal. They also stated that the raised markers had much less effect on the snowplows. Photo 8 and Photo 9 show the condition of the raised markers after application of the chip seal. To have avoided reducing visibility of the raised markers, the chip seal material should have been kept several feet away from the reflector.

Photo 8 – Two raised markers that are partially obscured by chip seal material.

The application of a chip seal greatly reduced the visibility of the raised markers at the US 52 installation. Because the application of a chip seal can greatly affect the visibility of the raised markers, either the area around the raised marker should be masked or the area completely avoided.

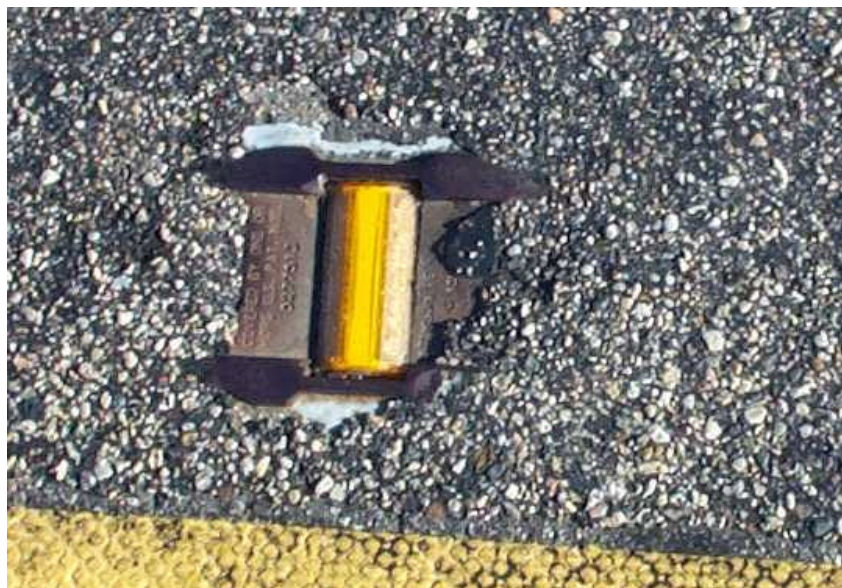
Photo 9 – A raised marker on the US 52 test section after application of a chip seal.

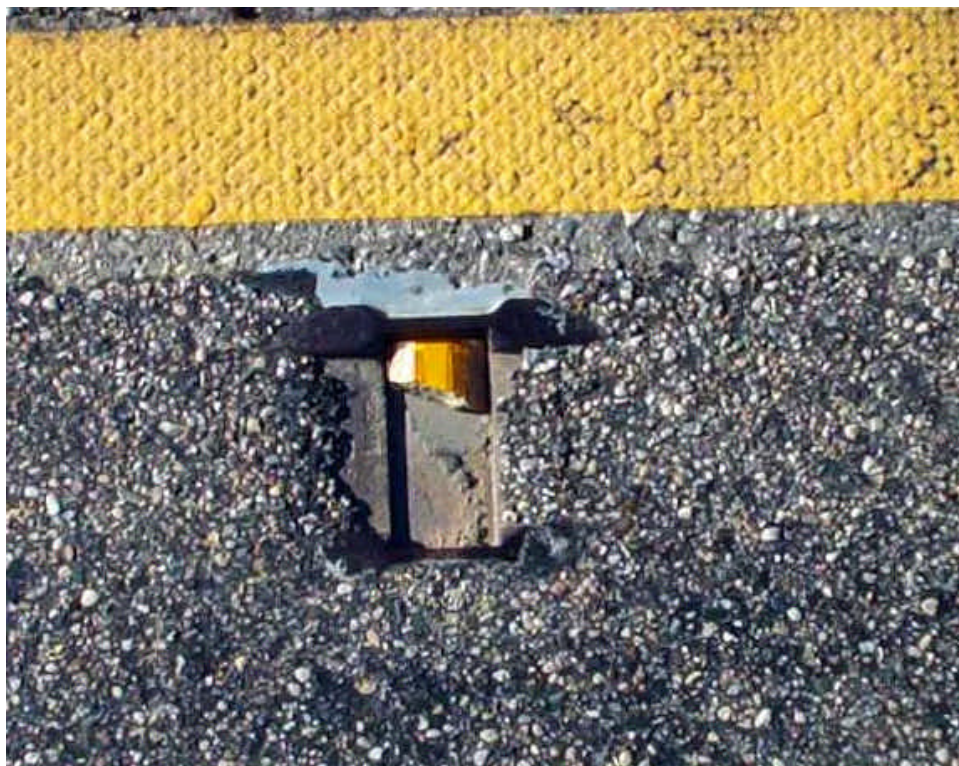
Damage to the raised markers has increased since the second evaluation. Nine raised markers had damaged ears at the Interstate 29 ramp and two markers had cracked lenses. It didn't appear that the damage was affecting the visibility of any of the raised markers at the interstate 29 ramp. The US 52 section had 38 raised markers with damaged ears and three with damaged lenses (including the marker that had been partially removed by maintenance forces in 2000). The lens of one other raised marker had been partially removed and is shown in Photo 10. Chip seal material covered many of the ears and their condition could not be assessed. The large increase in cracked ears at the US 52 section may be because snowplow speeds have increased since the chip seal was applied. The snowplows may now operate at higher speeds because very little of the cast iron housing is above the surface of the pavement. The ear of the cast iron housing is on the portion of the marker that typically remains above the pavement surface.

Photo 10 – A marker with a broken lens at US 52.

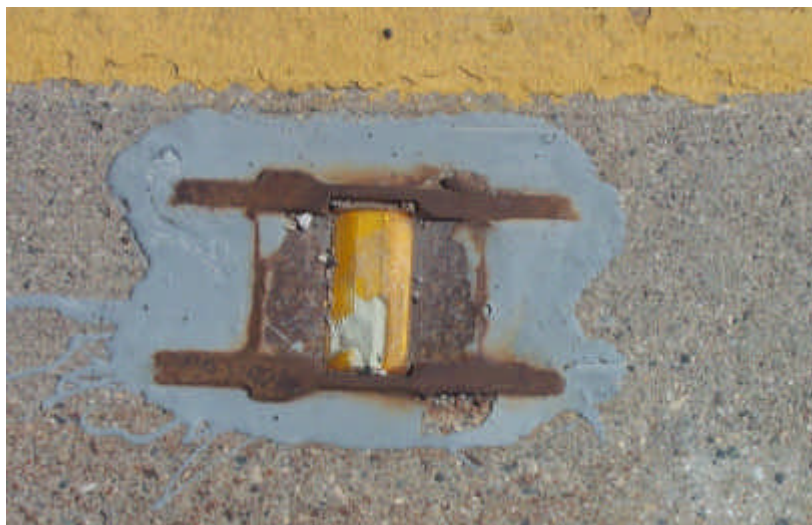
The fourth evaluation of the Interstate 29 ramp installation was completed on September 2, 2004 and the evaluation of the US 52 installation was completed on November 24, 2004. All of the raised markers had damaged ears at the Interstate 29 ramp and two markers had cracked lenses. One other marker had a heavily damaged lens and is shown in Photo 11. Damage to the US 52 section remained unchanged from the previous evaluation. Thirty-eight raised markers had damaged ears and there remained a total of four markers with damaged lenses (including the marker that had been partially removed by maintenance forces in 2000). It was difficult to assess the number of broken ears because many of them were covered by the chip seal material. At both sites, the lenses of some of the markers had become somewhat cloudy but the cloudiness didn't appear to greatly affect the performance of the lenses.

Photo 11 – A marker with a damaged lens at the Interstate 29 ramp installation.
