Experimental Study ND 2003-03

**Dowel Bar Retrofit Mix MR0301**

**FINAL REPORT**

Project AC-IM-8-094(041)342

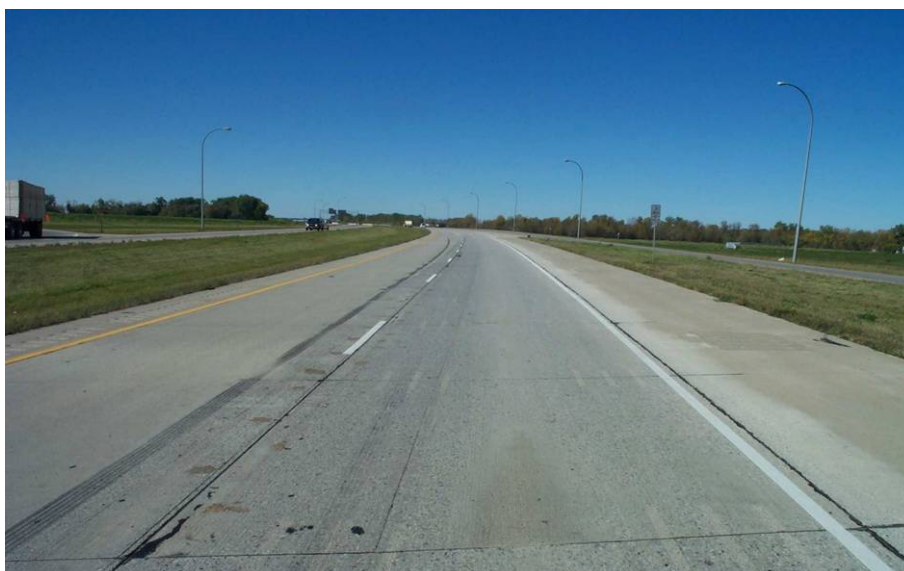
**Photo 1 - Overall view of control section 1.**

Overall, control section 1 looks good. The number of visible distresses identified has nearly doubled but the load transfer efficiency has remained the same. Control section #1 is outperforming the other sections with lower visible distresses and higher load transfer efficiency.

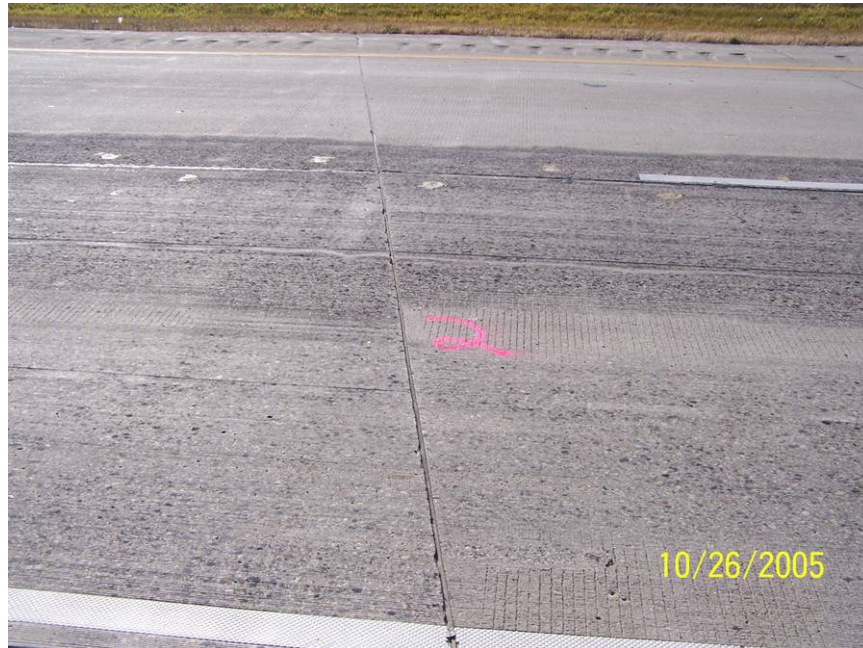
Photo 2 - Typical joint in control section 1.

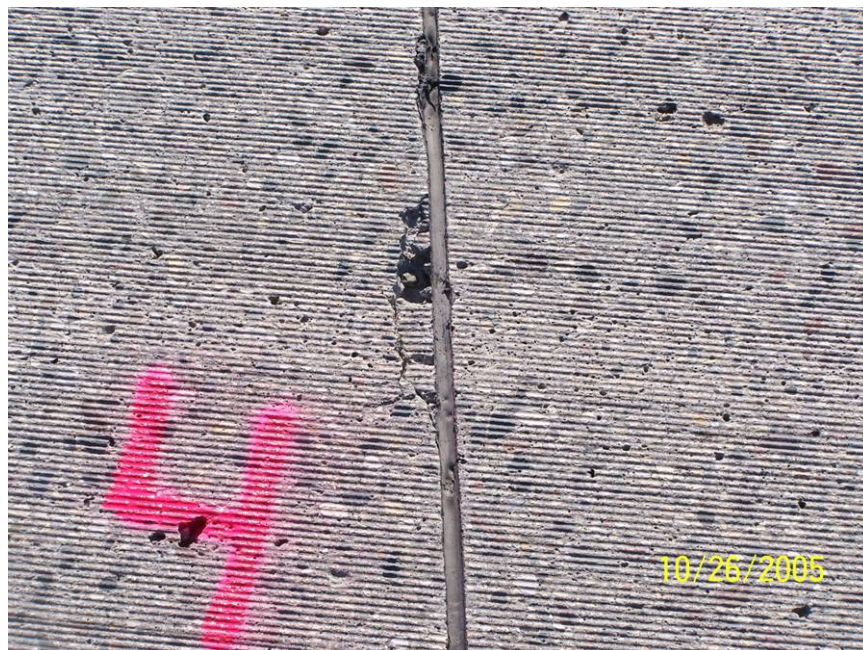
Photo 3 - Spalling at joint and dowel bar slot.

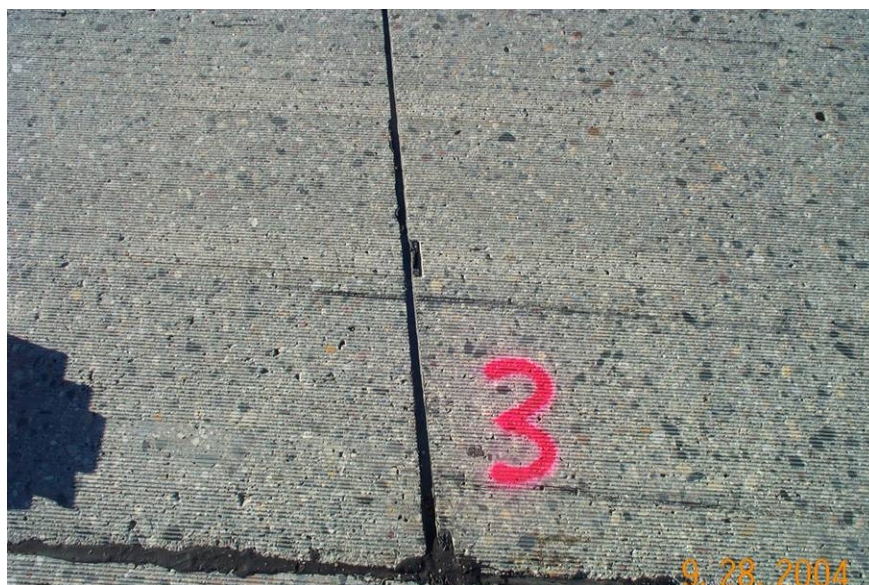
Provided in the following table is the percent of slots (there is a total of 432 slots) with distresses in control section 1 and average load transfer efficiency within this section. The percentage of transverse cracks is slightly lower than one year ago but the amount of coreboard failures are up. The location of some transverse cracks suggests that they may be the initial stages of coreboard failures. Coreboard failures are a result of misalignment of the coreboard within the slot (coreboard does not remain in the joint).

**Photo 4 - Coreboard failure in control section 1.**

It is recommended that special attention is given to the location of coreboards after the dowel bar mix is placed. Coreboard failures can be reduced or eliminated if the coreboard remains in the joint and not allowed to move into the dowel bar slot when placing the concrete patch mix.

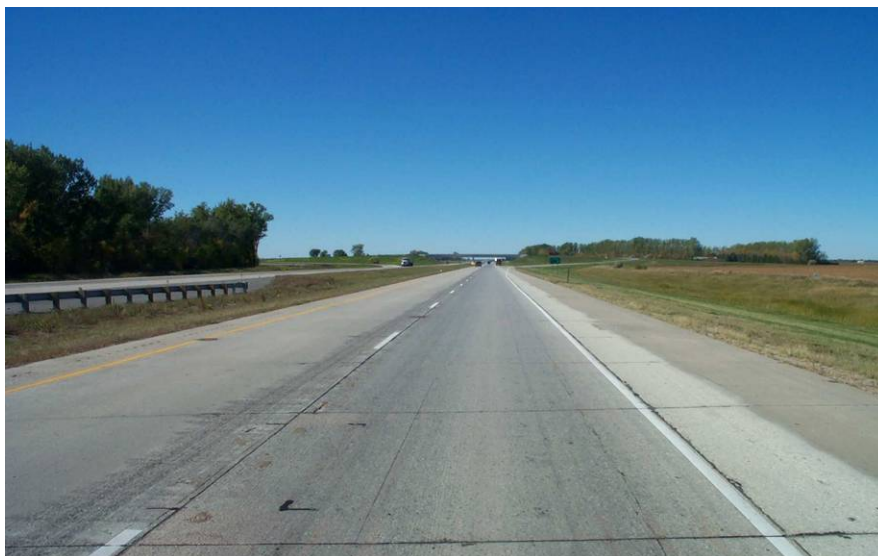
**Photo 5 - Overall view of control section 2.**

Overall, control section 2 looks OK. There has been a substantial increase in the number of visible distresses identified in the period of a year and load transfer efficiency has dropped. As the number and severity of the distresses increase, it is anticipated that the load transfer will continue to drop in this section.

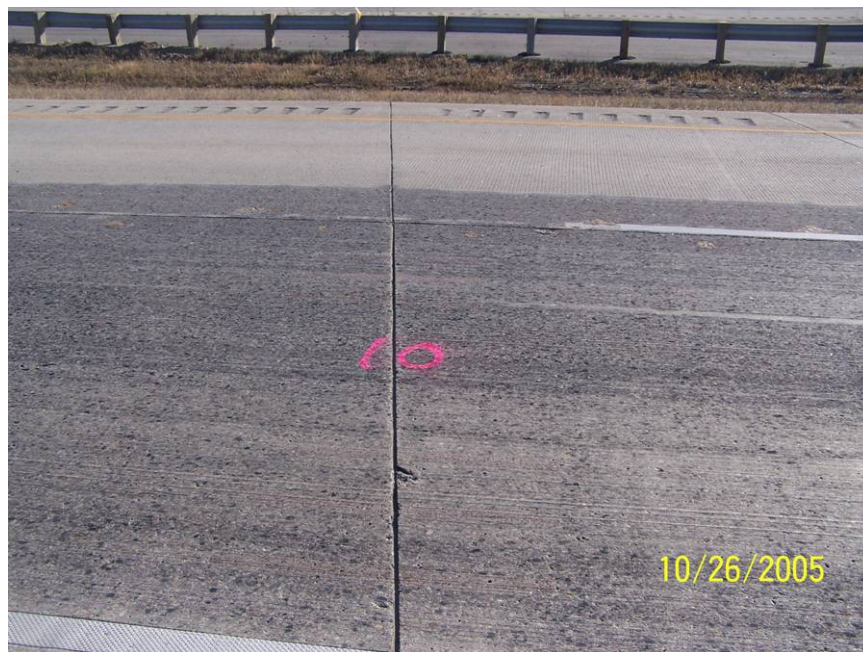
**Photo 6 - Typical joint in control section 2 - spall area is in the original PCC pavement.**

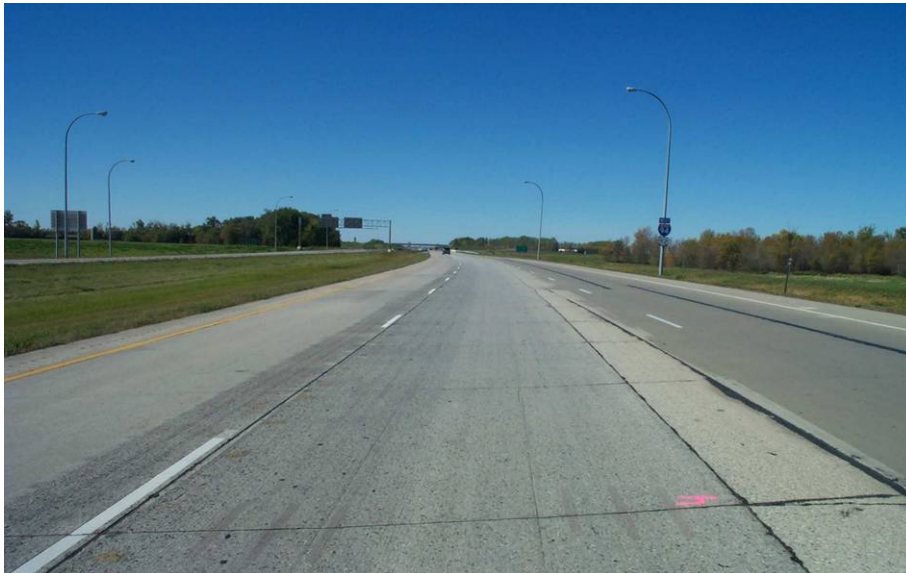
**Photo 7 - Overall view of the experimental section.**

Overall, the experimental section is experiencing the most visible distresses of the three sections evaluated. There has been an increase in the number of visible distresses identified with a decrease in load transfer efficiency. As the number and severity of the distresses increase, it is anticipated that the load transfer will continue to drop in this section.

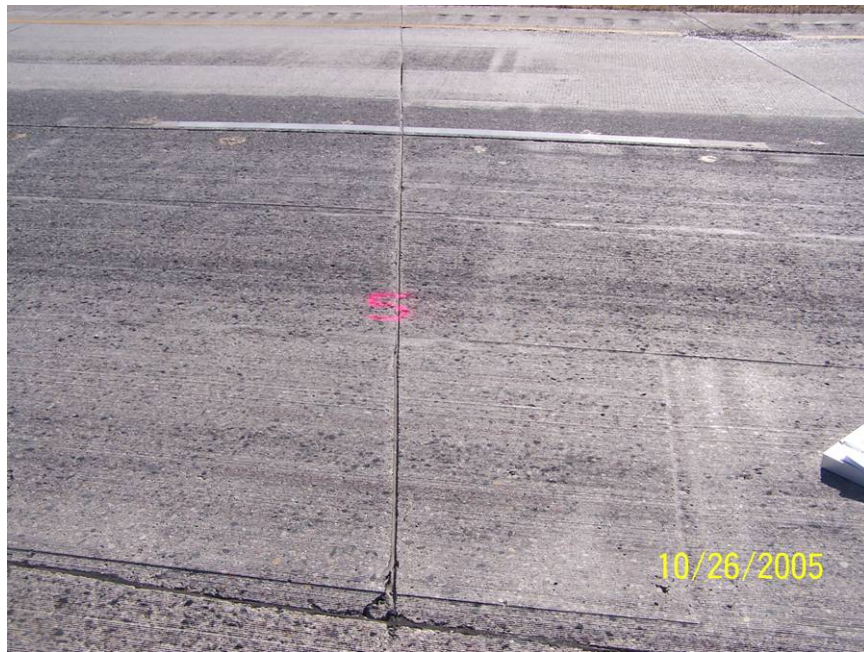
Photo 8 - Typical joint in experimental section.

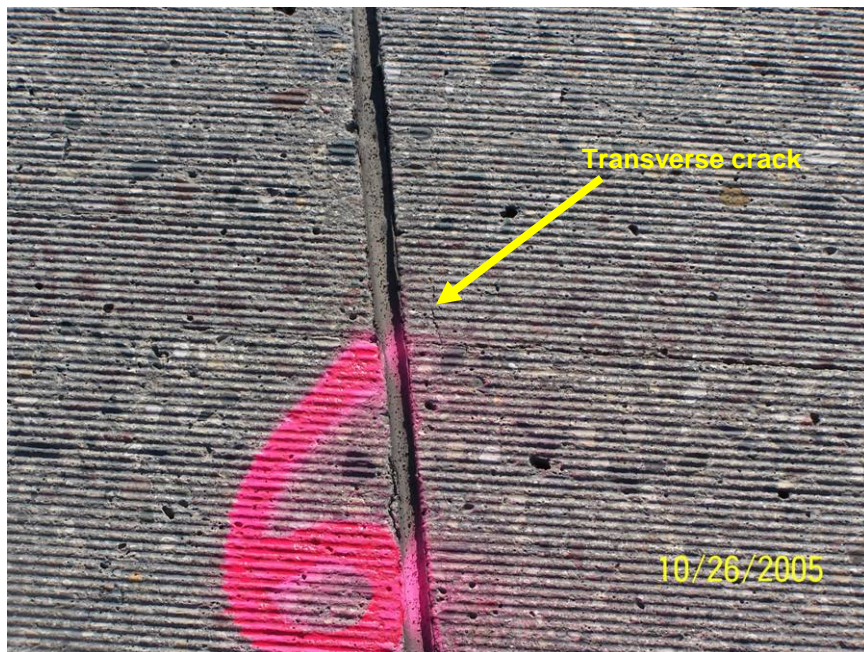
section. The location of some transverse cracks suggests that they may be the initial stages of coreboard failures. Coreboard failures are a result of misalignment of the coreboard within the slot (coreboard does not remain in the joint).

Photo 9 - Transverse crack location is likely the early signs of a coreboard failure.
