Experimental Study ND 2011-01

**Evaluation of Grooved Pavement Markings**

**Final Evaluation**

SIM-6-029(091)136

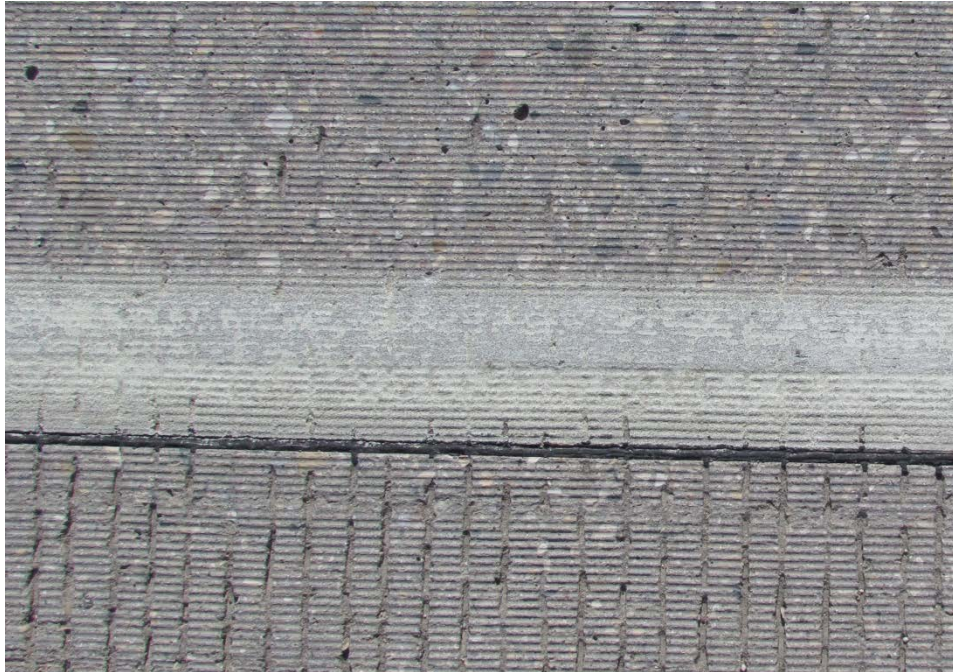
After 3 winters, the visual appearance of the surface applied epoxy has a few general characteristics. Marking that was protected by the aforementioned ridges is, as expected still intact. However, the areas in which the ridges did not protect the marking are also still intact, albeit with some distresses. The visible distresses are distinctly from the snowplows, evidenced by damage/removal of the reflective media (both glass beads and 3M elements) and scarifying of the top few mils of the epoxy. In isolated locations, a few square inches of material have lost adhesion and have been completely removed; but only three or four of these locations have been identified. Photo 3 shows the most common type of distress observed (loss of reflective media and scarification of upper mils of epoxy). In Photo 3, the ridge between grinding passes is in the center of the marking with most of the distress occurring on top of the ridge.

**Photo 3: Surface applied epoxy with standard glass beads after 3 winters.**

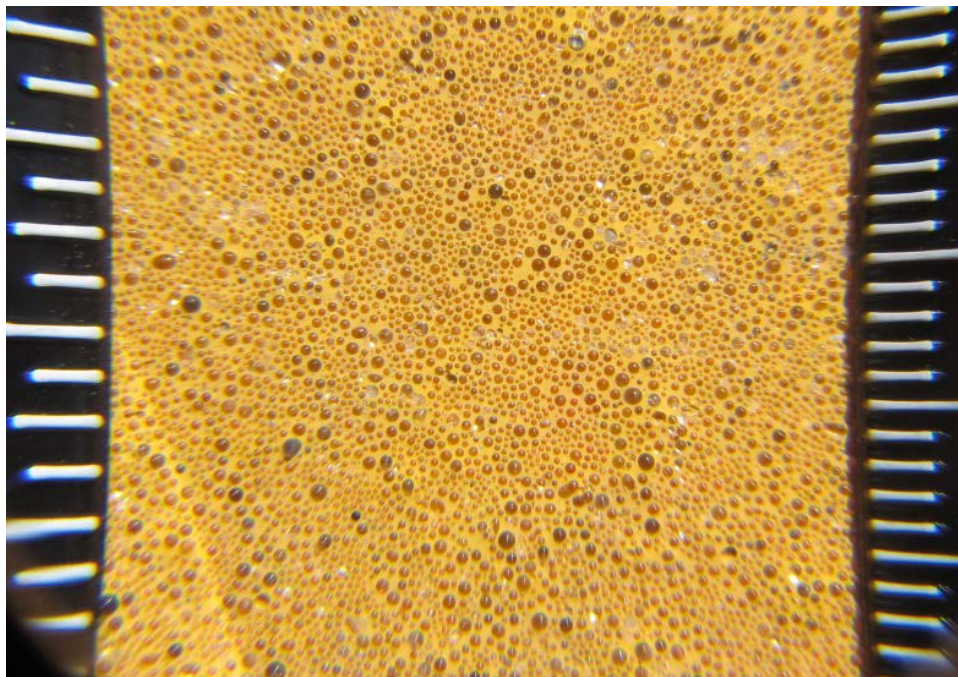
Photo 7 is a magnified view of the stripe in Photo 6. The epoxy and glass are in-place and undamaged.

**Photo 7: Magnified grooved epoxy with standard glass after 3 winters.**

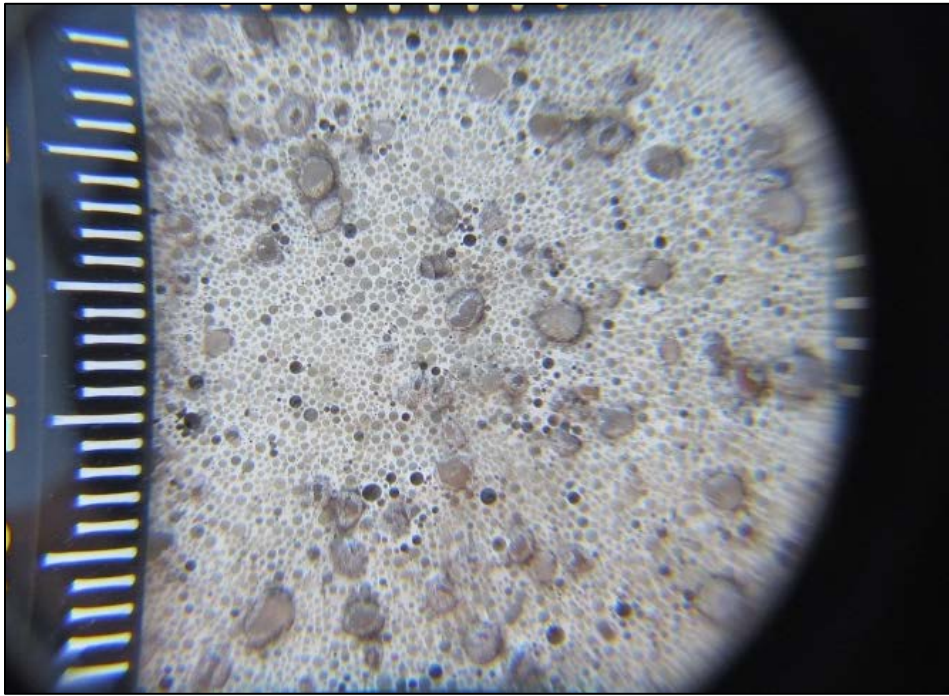
Photo 8 is a magnified photo of grooved epoxy with AW elements. The AW Elements are still all in place but the outer coating (which contains the AW Optics) is damaged and/or missing from some of the AW Elements.

**Photo 8: Magnified grooved epoxy with AW Elements after 3 winters.**

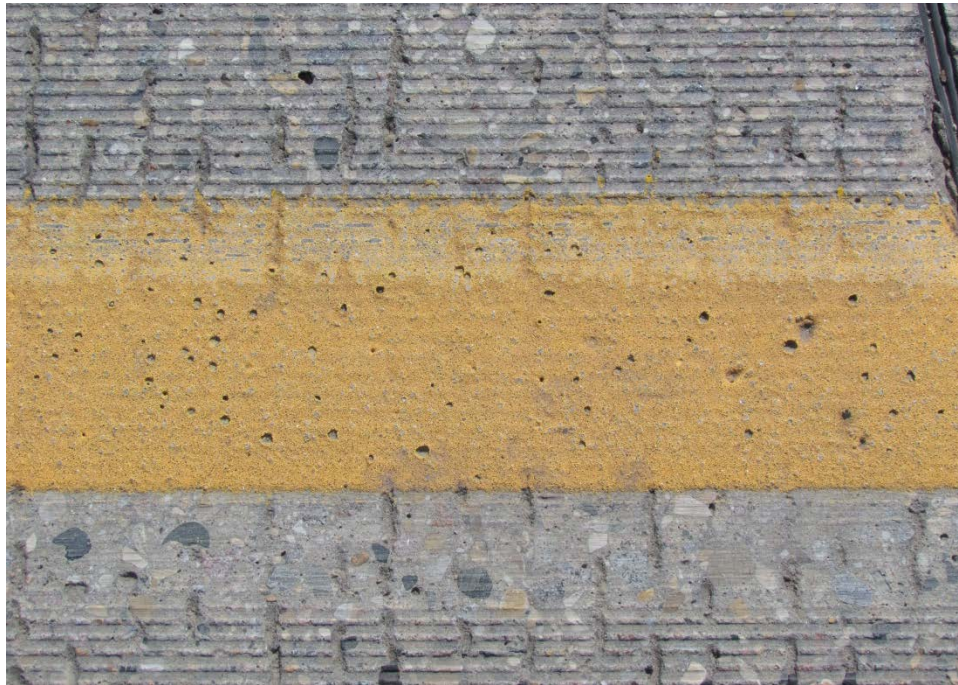
Photo 9 is an epoxy stripe that was improperly positioned. About 1 inch of the stripe was placed outside of the groove. This photo shows the additional damage that line has sustained when placed outside of the groove.

**Photo 9: Grooved epoxy with improper placement after 3 winters.**

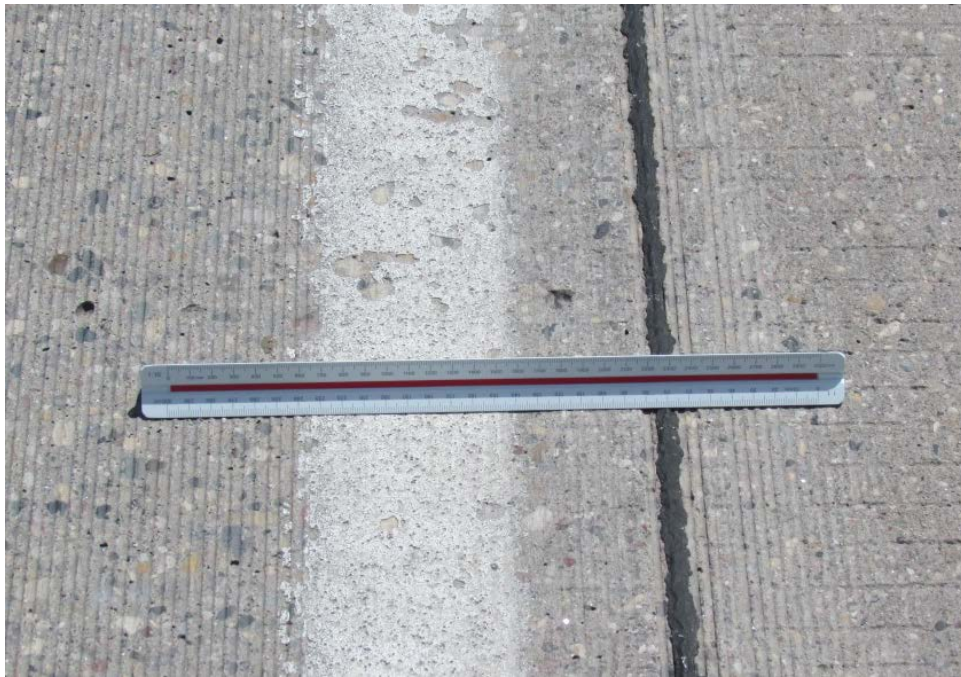
**Photo 11: Grooved AWP with AW Elements after 2 winters.**

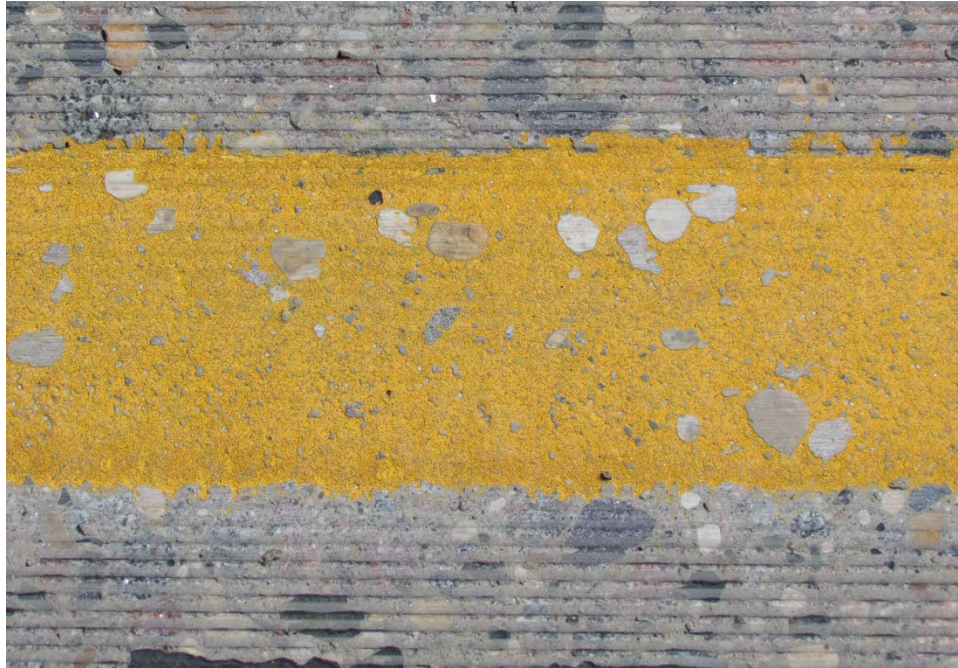
Photo 12 shows grooved AWP with AW Elements. The type of paint loss observed occurred on both standard water-based paint and AWP. The pavement marking has less adhesion to the exposed rock faces than to the concrete paste.

**Photo 12: Grooved AWP with AW Elements after 2 winters.**

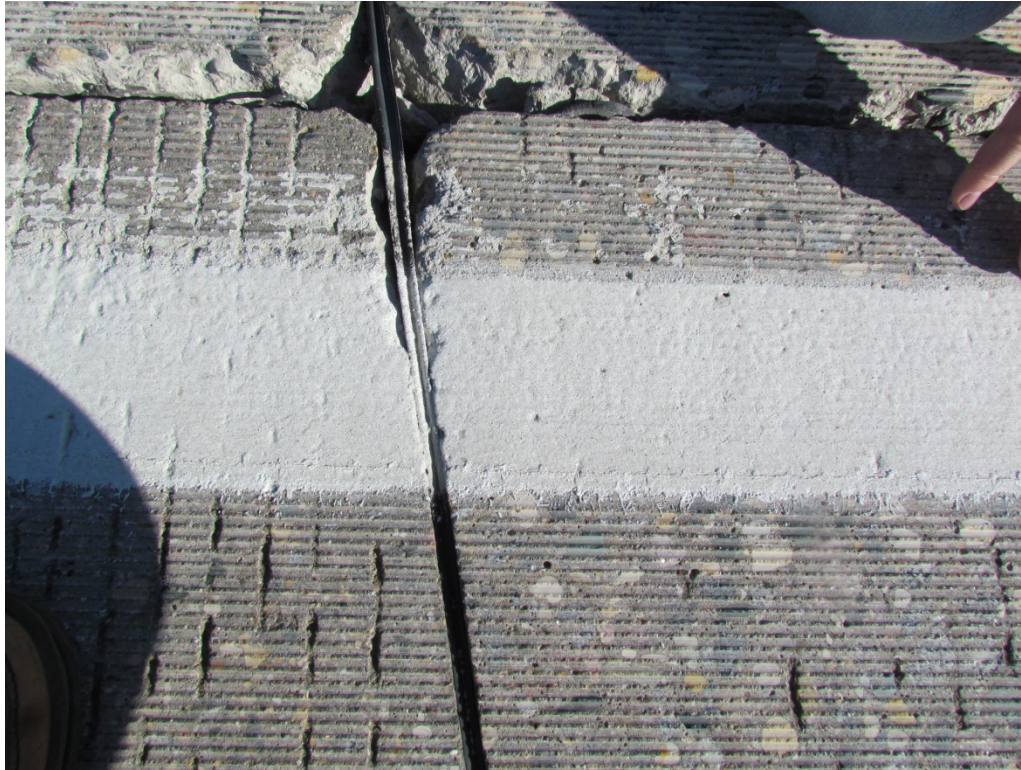
Segment 1A - Grooved Paint with Standard Glass Beads

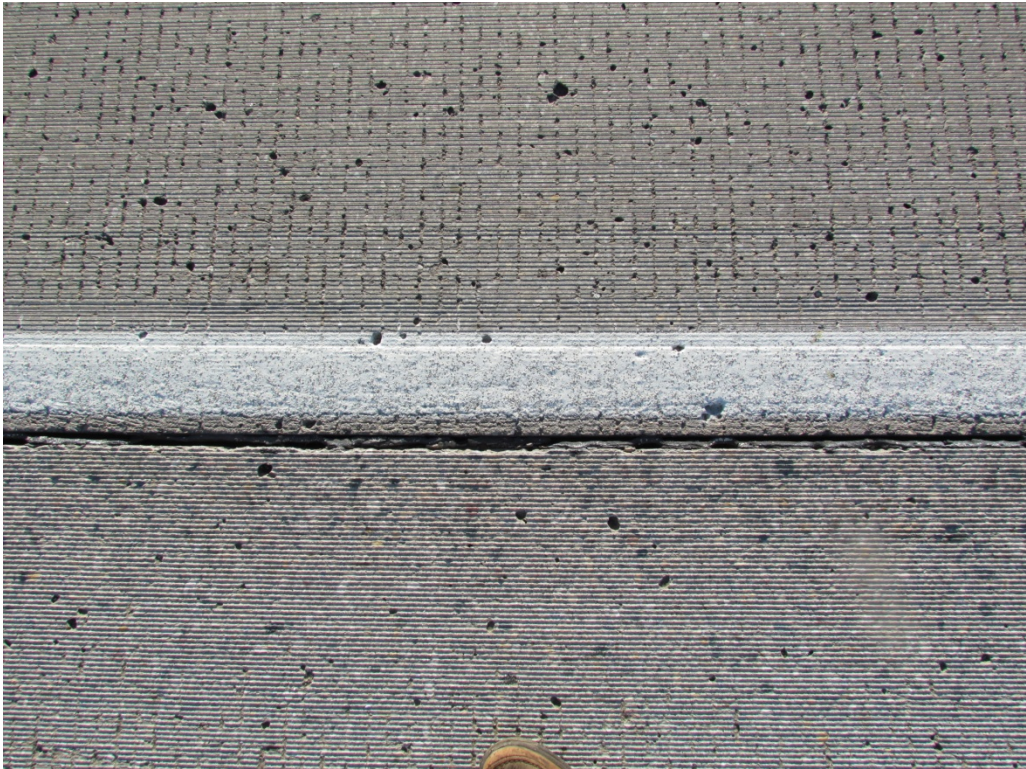
Segment 3B - Surface applied Epoxy with 3M AW Elements
