Experimental Study ND 2015-01

Evaluation of Conglomerate Optics

Final Evaluation

IM-1-094(181)162

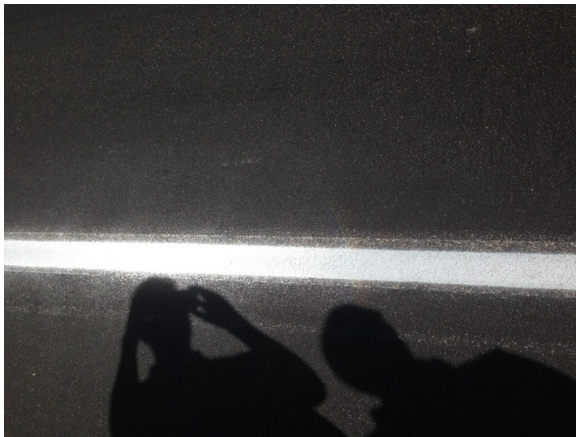
Photo 1 – Epoxy Centerline with 3M All-Weather Elements

The Potters Visibead Section was constructed on 7/28/2016, and the 3M Element Section was constructed on 8/2/2016. A representative from each manufacturer was onsite to ensure proper application of the experimental materials. Both manufacturers aided the contractor to make adjustments to installation equipment in the field. The adjustments included modifications amount of Type 1 glass, angle of drop, and application pressure in order to acquire proper embedment of the proprietary optics. Photos 1-4 below show the finished products after installation.

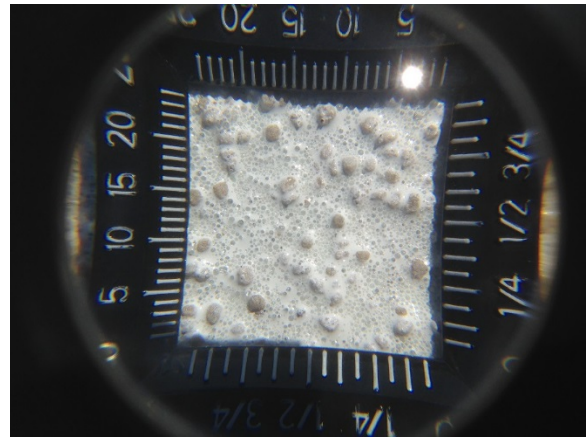
Photo 2 – Close-up of 3M All Weather Elements

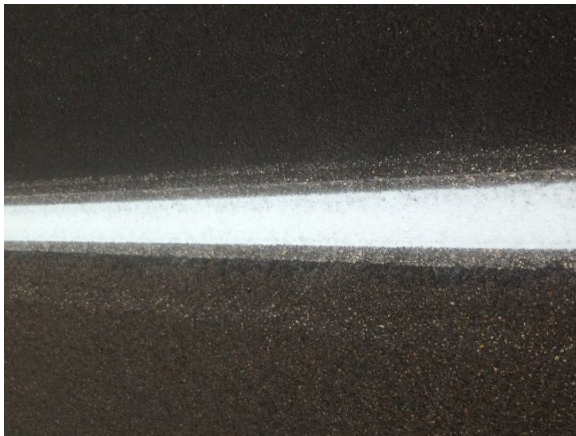
Photo 3 – Epoxy Centerline with Potters - Potters' Visibead

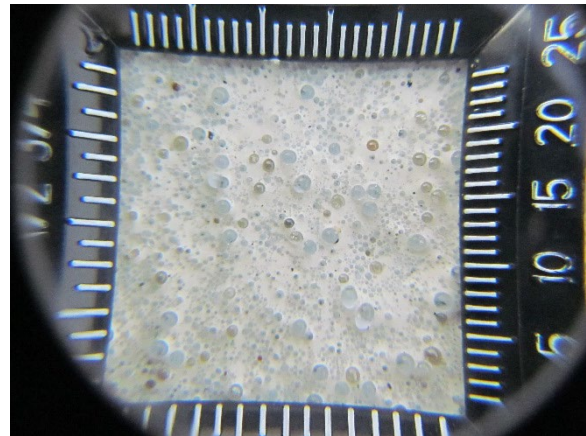
Photo 4 – Close-up of Potters' Visibead

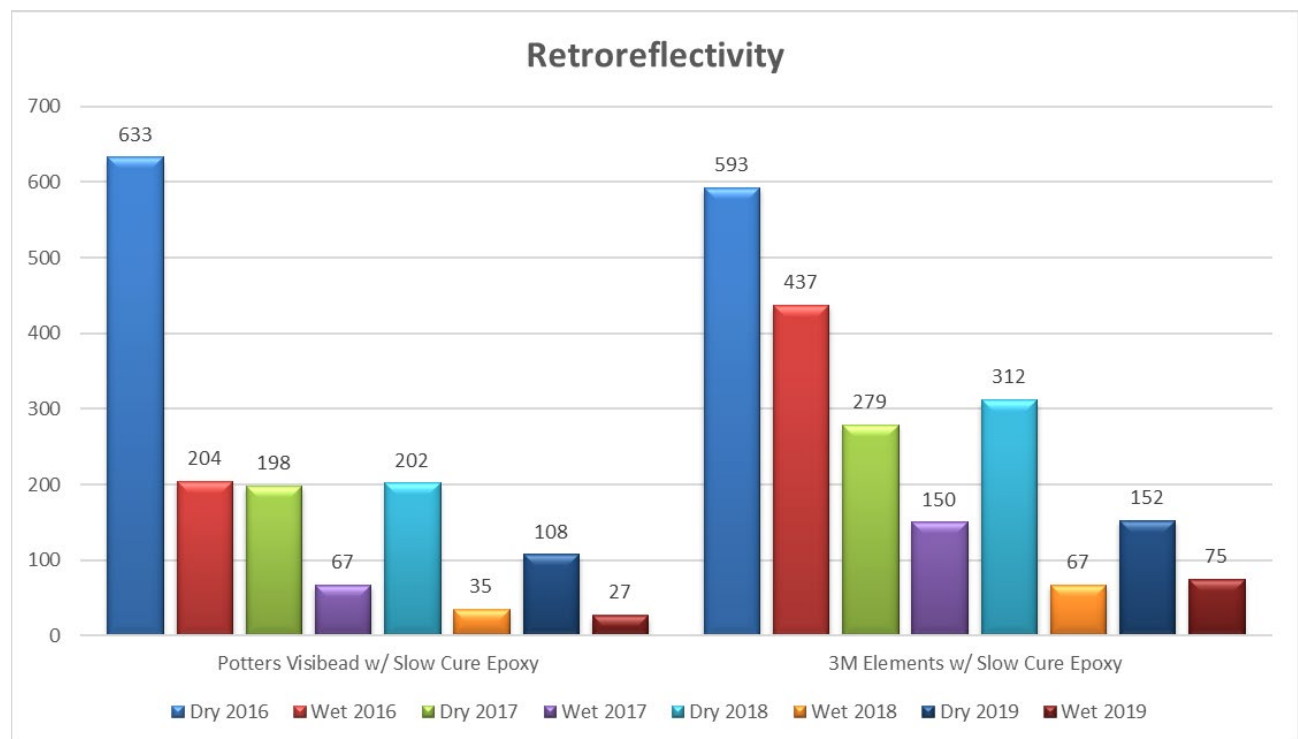
Figure 1 –Retroreflectivity Chart

Retroreflectivity data was collected after installation and in the springs of 2017, 2018 and 2019. The average dry and wet retroreflectivity at each test location is shown graphically in Figure 1. The data is presented in Table 1 below. The pavement markings were also evaluated visually for distresses and durability.

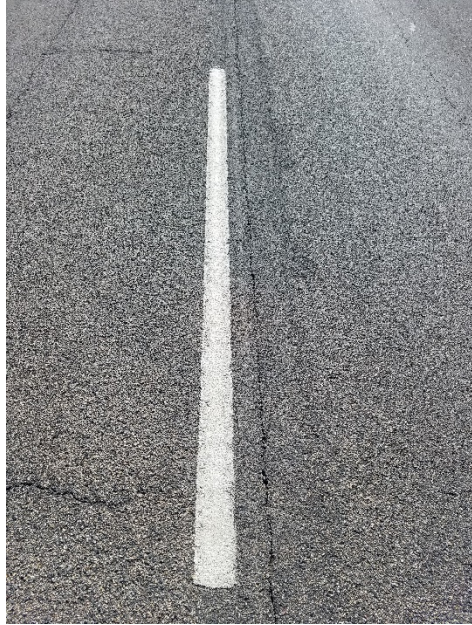
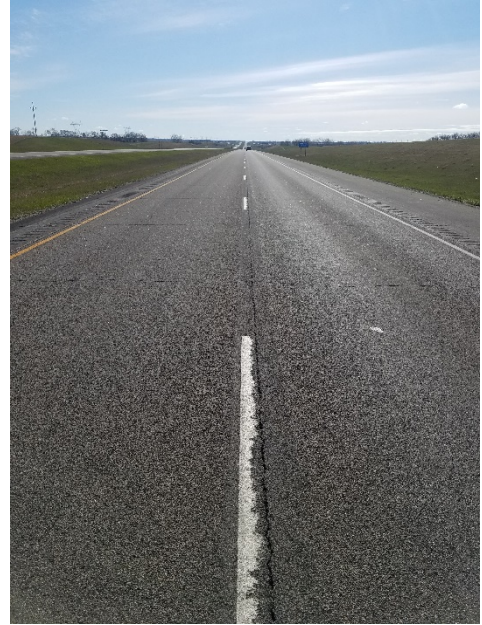
Photo 5 & 6 – Good condition markings at RP 169.0; Typical condition of pavement marking along project corridor (Potters Visibead)

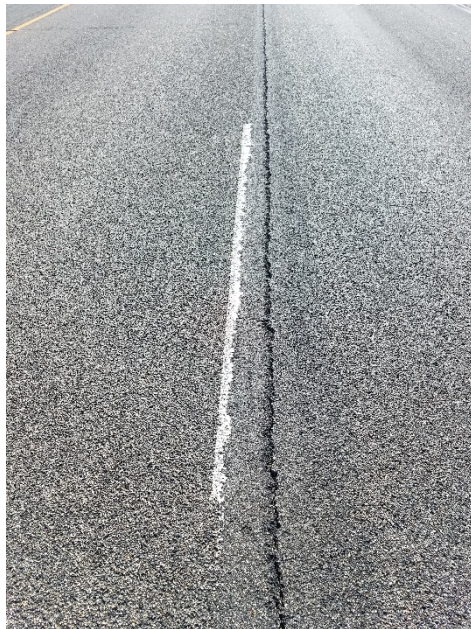
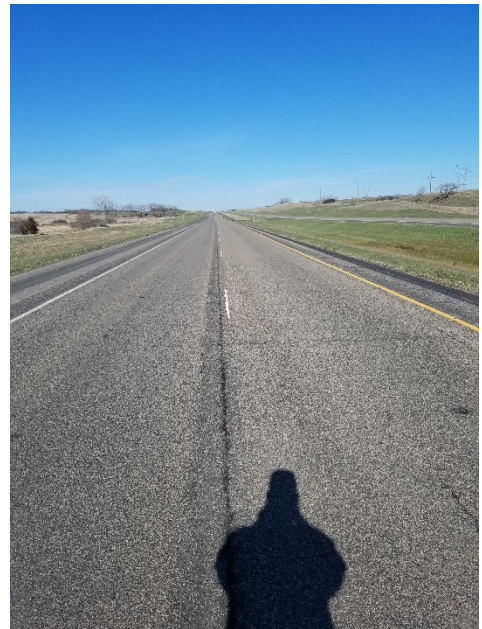
Photo 7 & 8 – Damaged markings at RP 168.0 (Potters Visibead)

The durability of the wet-reflective pavement markings is somewhat lacking due to conglomerate optic bead sizing. The loss attributed to the snowplows can be present as embedded bead loss, bead shearing at the top of groove, and total marking material loss. The bead loss / shearing is difficult to quantify due to traffic level safety concerns while the overall pavement marking condition is visually assessable. The 3M AW Elements markings performed better after several winters compared to Potters Visibead, but both pavement markings did not stand up as well as typical pavement marking sections. While visually inspecting the project corridor, there were sections which were lacking the pavement markings completely (though these sections did not fall on our RP test locations for retroreflectivity values). While the dry-reflective values were nearing the 100 mcd/m²/lux threshold value which MUTCD states as the minimum value of retroreflectivity for longitudinal markings on roads \geq 55mph, the current condition of total presence loss on certain segments along the project corridor warranted the replacement for safety reasons.

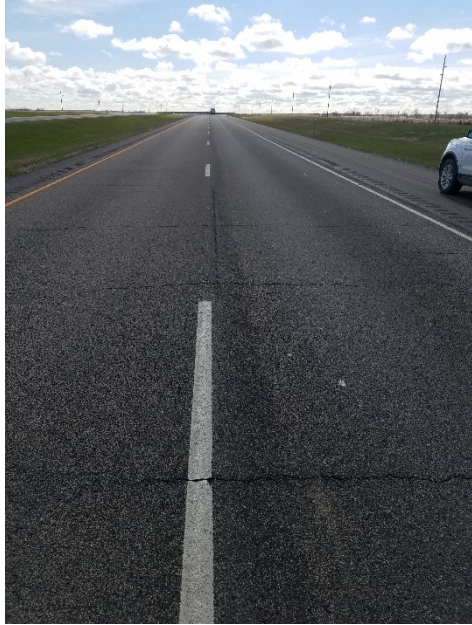
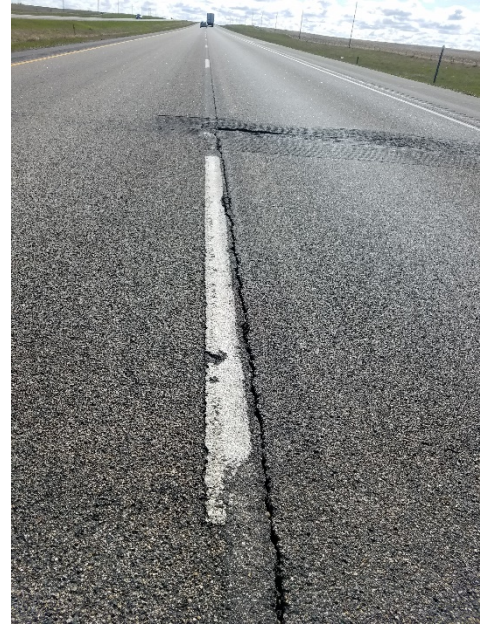
Photo 9 & 10 – Good condition markings at RP 179.0; Typical condition of pavement markings along project corridor (3M AW Elements)

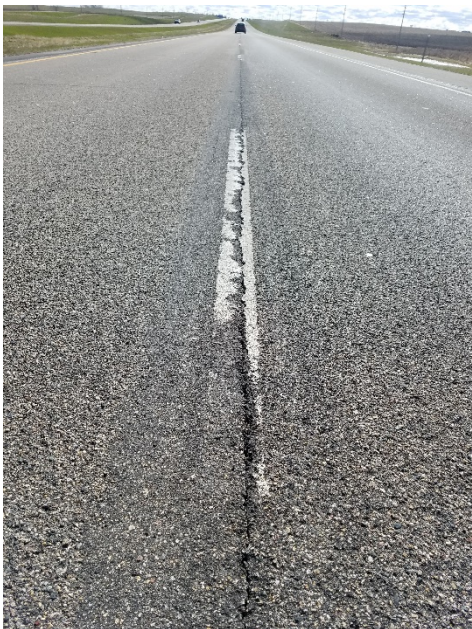
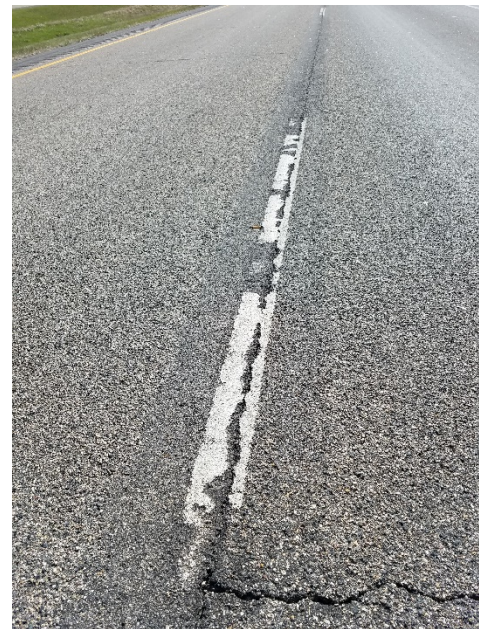
Photo 11 & 12 – Damaged markings at RP 180.0 (3M AW Elements)

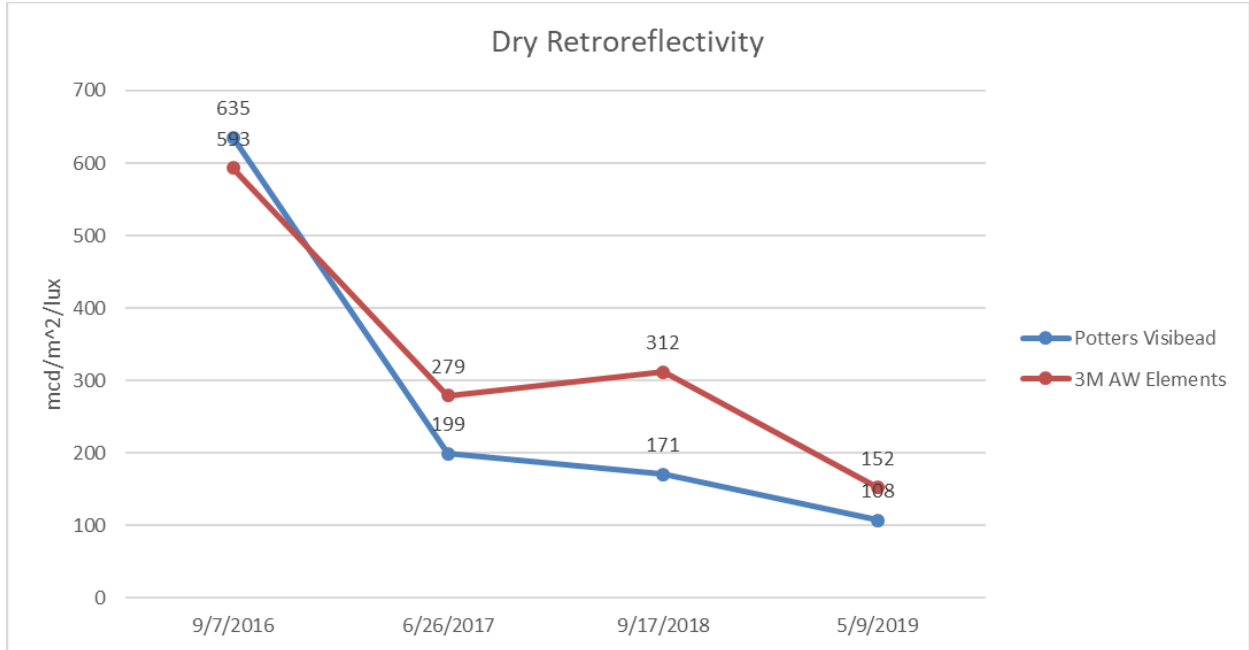
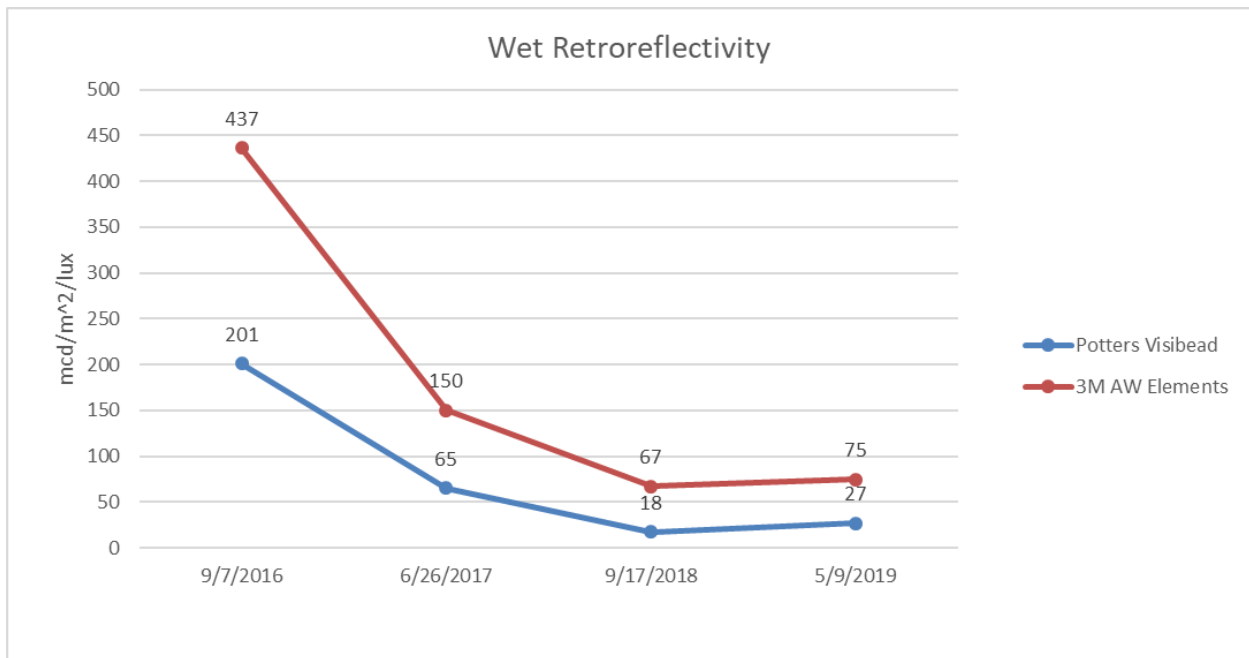
The initial data shows that the two wet-reflective pavement markings perform similarly. In the first year, the 3M AW markings have higher wet-reflective properties, but by year 2, both marking types have very little wet-reflective properties left. The dry-reflective properties in year 3 retained approximately 50% of the reflectivity values from year 2. While the dry-reflective values of the 3M AW Elements / Potters Visibead markings were comparable to that of the dry-reflective blends, the dry values for 3M AW Elements were approximately 1.4x that of Potters Visibead at the end of the annual evaluations. The wet-reflective values for 3M AW Elements were approximately 2.8x that of Potters Visibead at the end of the annual evaluations. The comparison values can be seen in the chart / graphs below:
