UNIVERSITY OF NORTH DAKOTA
Grand Forks, ND

Bridge Monitoring Project - Final Report

October 2008

EXPERIMENTAL PROJECT REPORT

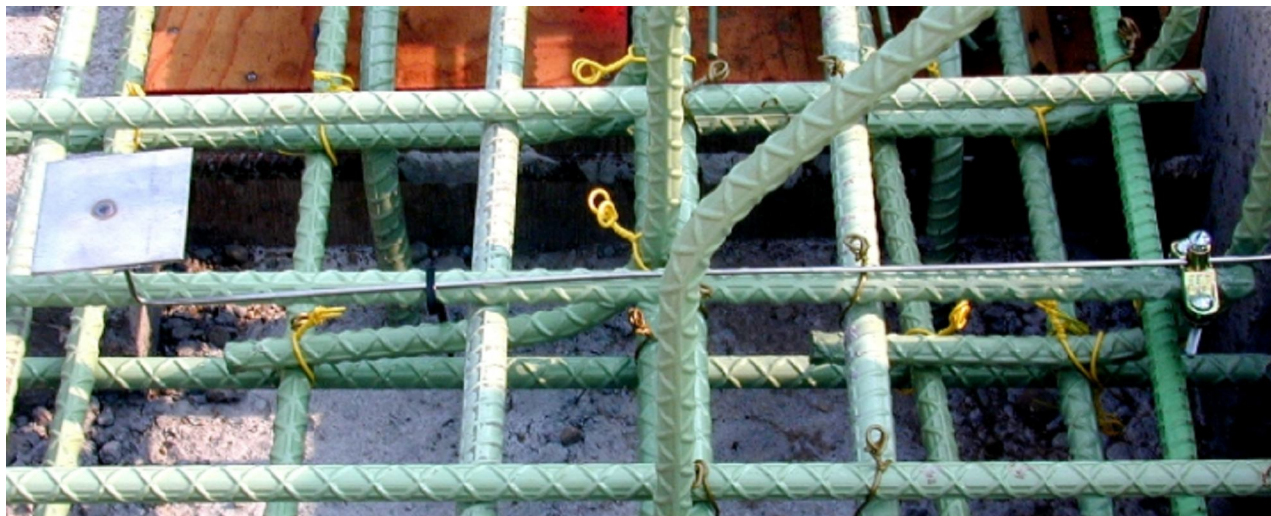
Figure 1: Stainless Steel Contact Attached to Bridge Deck Rebar

To allow the use of the Gecor 6 corrosion field test instrument, electrical contacts were attached directly to the rebar close to the points where the corrosion rate measurements were to be taken. To monitor the bridges, fifteen contacts were attached to each bridge at approximately equidistant intervals along the east edge of the deck. Each contact consisted of a stainless steel rod attached to a small square stainless steel plate. The rod was attached directly to the rebar and the plate was set level with the deck surface so that it could be accessed for the Gecor 6. When the contact was attached to the rebar, a clamp was used to penetrate the epoxy coating and make electrical contact with the steel reinforcing bar. A picture of a contact attached to the deck rebar is shown in Figure 1.

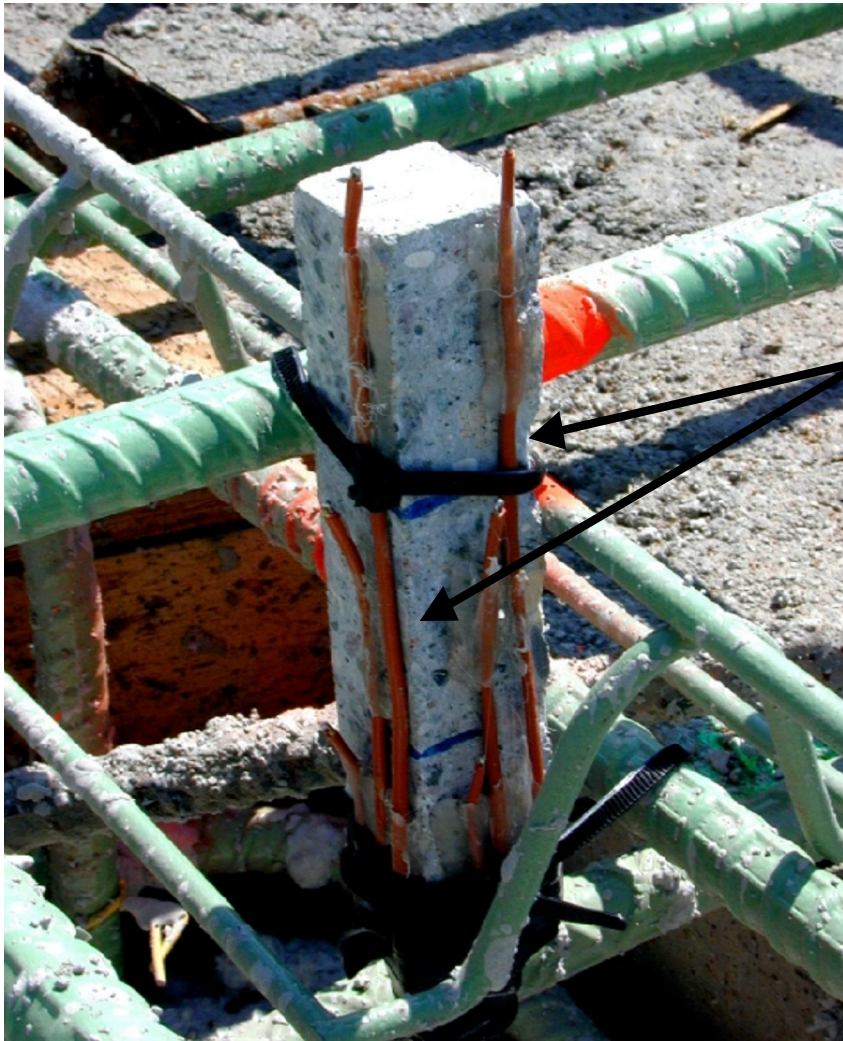
Figure 3: Arrangement of Redundant Thermocouples

Redundant
Thermocouples at
Depths
of 1/2 in., 3 in. and 5
in.

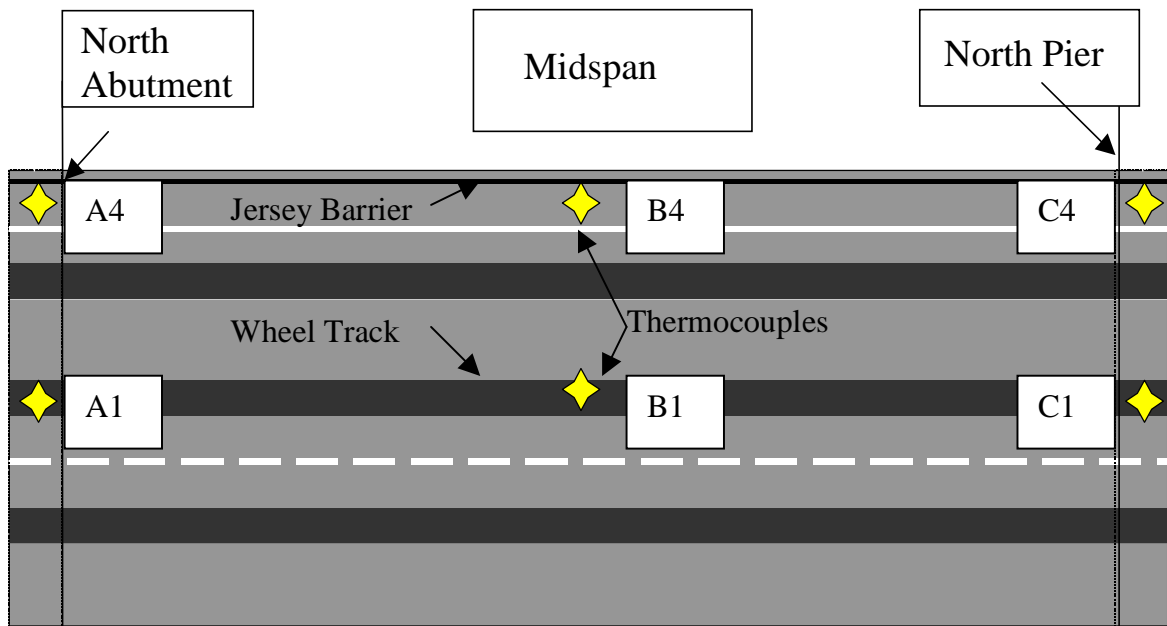
Figure 10: Thermocouple Designations on Bridge Deck

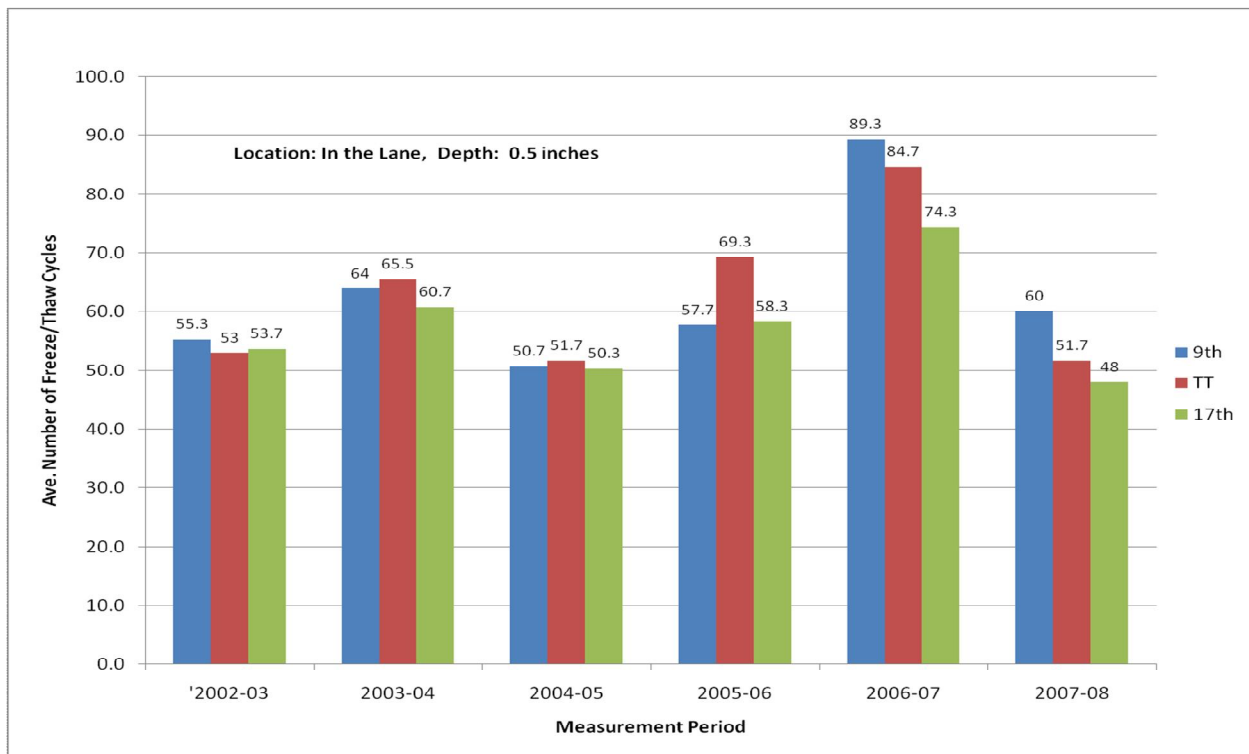
Figure 11: Average Number of Freeze/Thaw Cycles in the Bridge Decks (Samples Collected in the Wheel Track of the Far Left Lane at a Depth of 0.5 Inches)

The average numbers of freeze/thaw cycles that occurred at each bridge deck are plotted in Figures 11 through 16. The numbers are averaged separately for the probes located in the left-most traffic lane and the probes located close to the left jersey barrier. Each plot compares freeze/thaw numbers for the three decks at a specific depth and location. The figures show that the number of freeze/thaw cycles that occurred varied significantly from year to year. However looking at all of the figures, there does not appear to be a clear trend to suggest that any one bridge experienced significantly more cycles than the others.

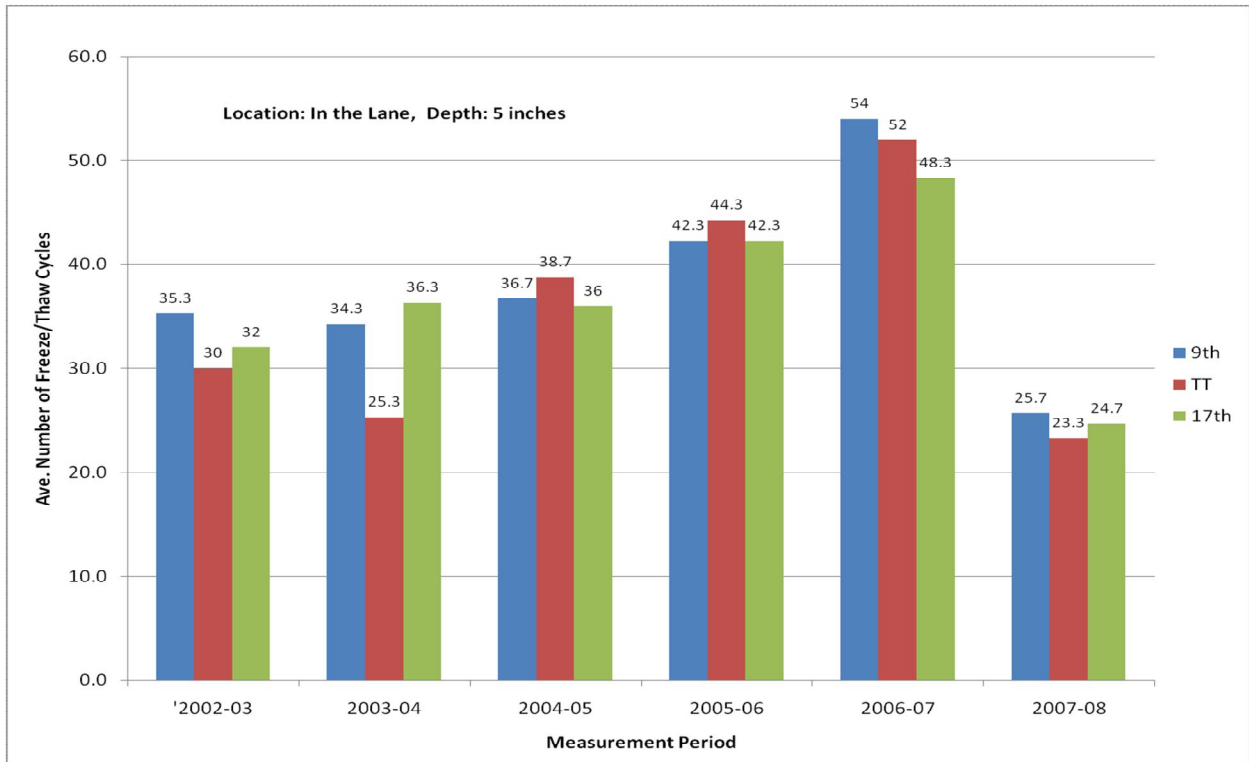
Figure 13: Average Number of Freeze/Thaw Cycles in the Bridge Decks (Samples Collected in the Wheel Track of the Far Left Lane at a Depth of 5 Inches)

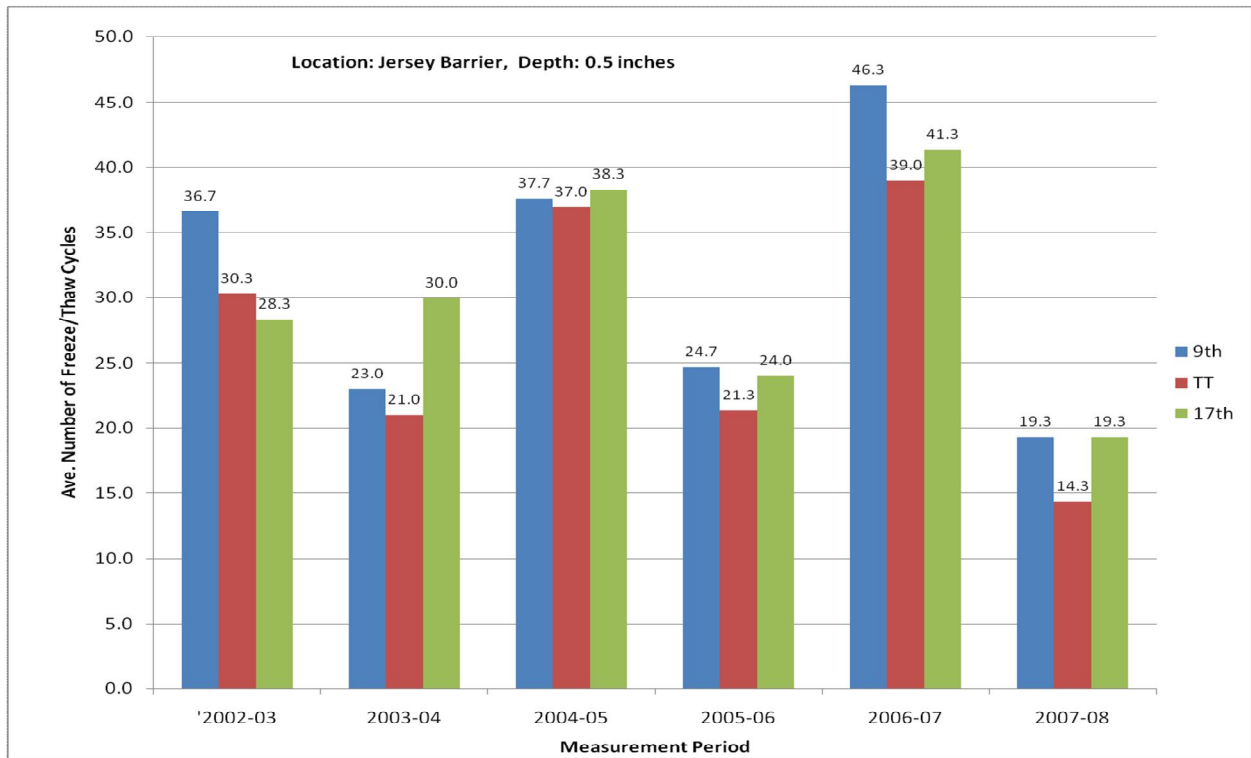
Figure 14: Average Number of Freeze/Thaw Cycles in the Bridge Decks (Samples Collected Close to the Left Jersey Barrier at a Depth of 0.5 Inches)

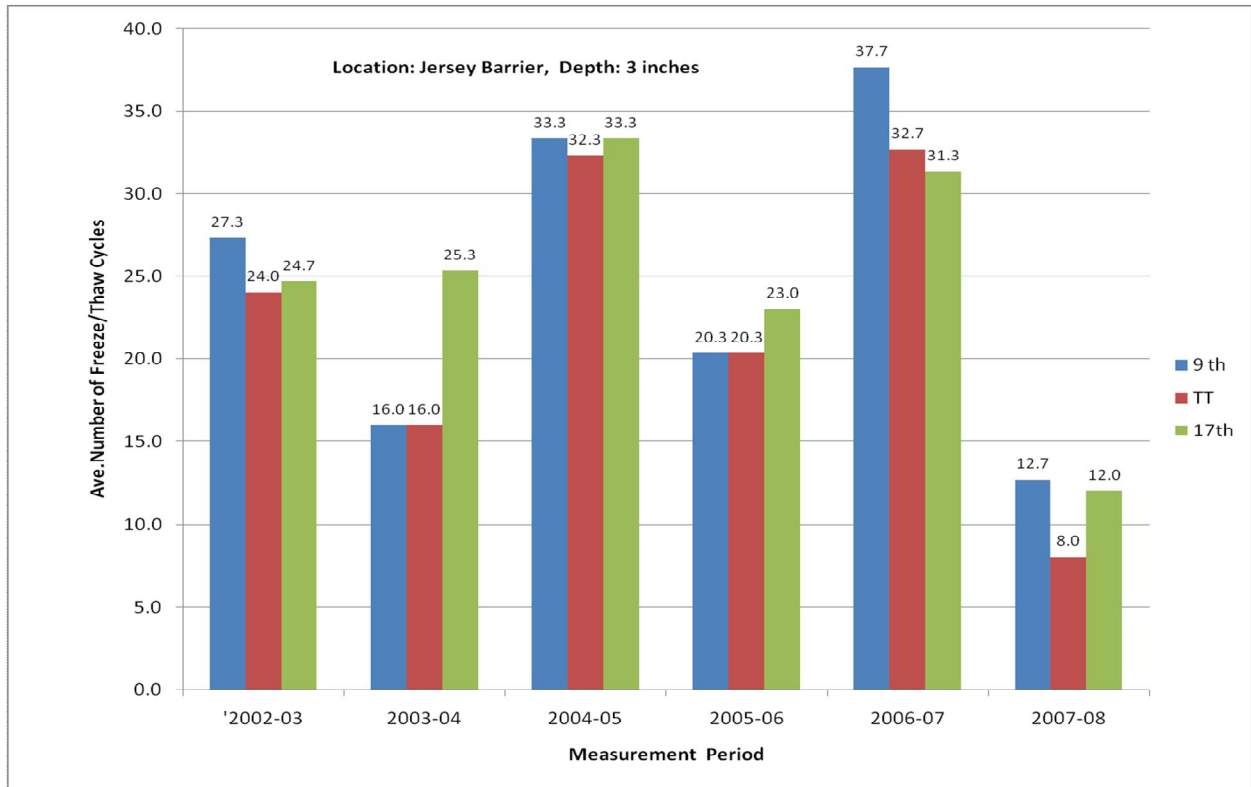
Figure 15: Average Number of Freeze/Thaw Cycles in the Bridge Decks (Samples Were Collected Close to the Left Jersey Barrier at a Depth of 3 Inches)

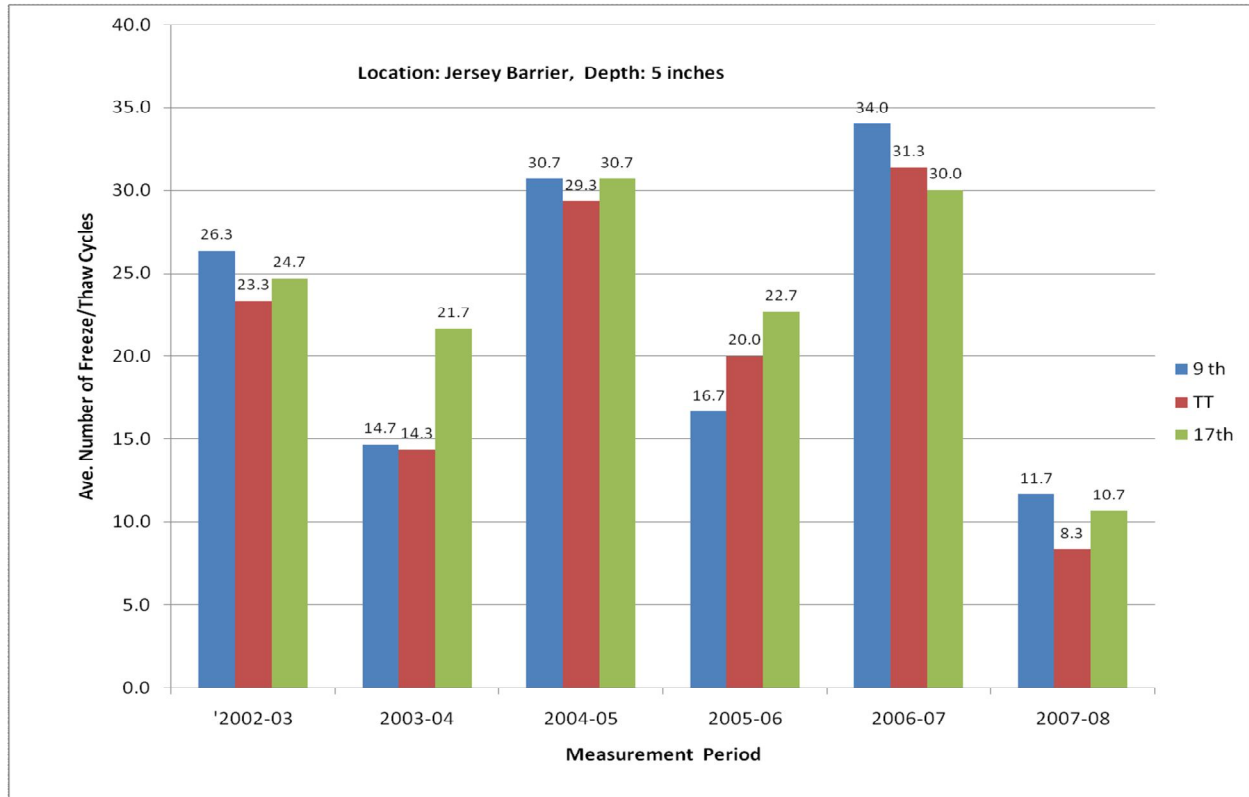
Figure 16: Average Number of Freeze/Thaw Cycles in the Bridge Decks (Samples Were Collected Close to the Left Jersey Barrier at a Depth of 5 Inches)
