**Use of HYCAT in Field Observations and Evaluations  
of Streambed Scours at North Dakota Bridges**

**Final Report**

**December 21<sup>st</sup>, 2023**

**NDDOT Research Report**

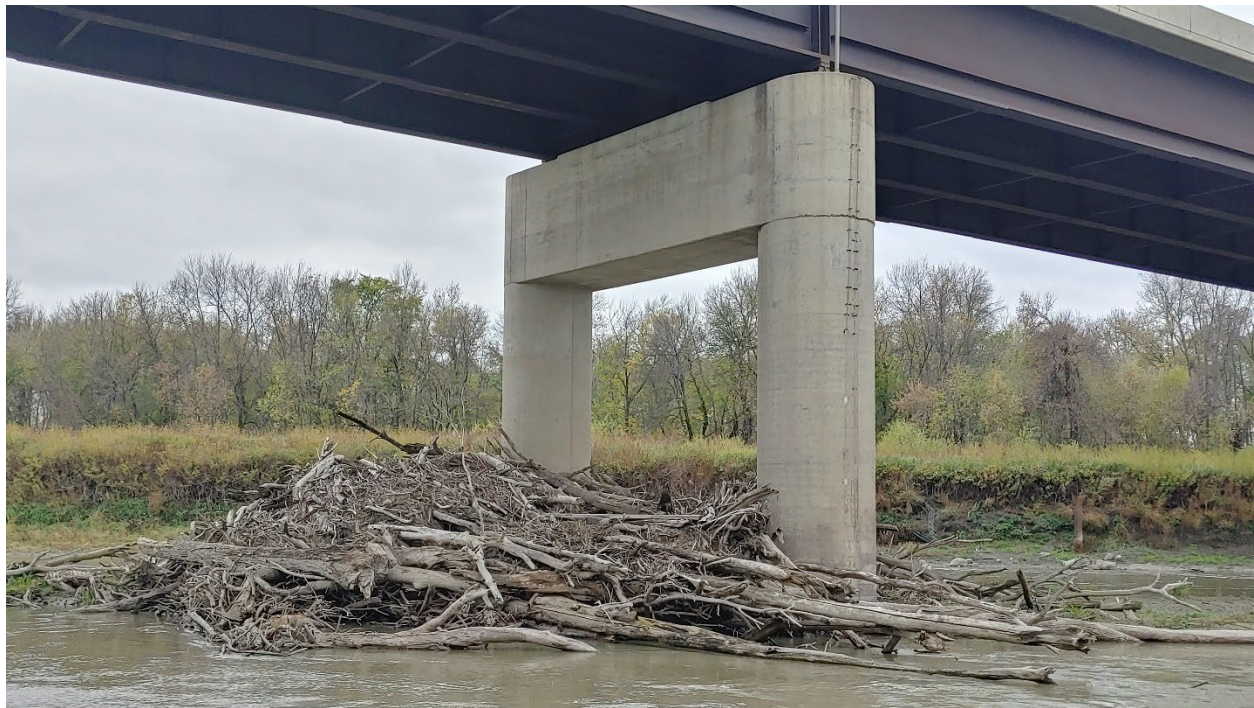
**Figure 3. A log-jam formed at the upstream side of the double column central bridge pier of Highway 200 Bridge near Halstad.**

In addition, there are also additional complexities such as the occurrence of tree trunks brought down by flood flow that got stuck at the upstream side of bridge piers. The reduction of effective flow area may increase the contraction scour potential. **Figure 3** shows the view of the central pier of Highway 200 Bridge near Halstad. Notice the high number of logs jammed at the bridge pier. This problem needs to be investigated on a case-by-case basis.

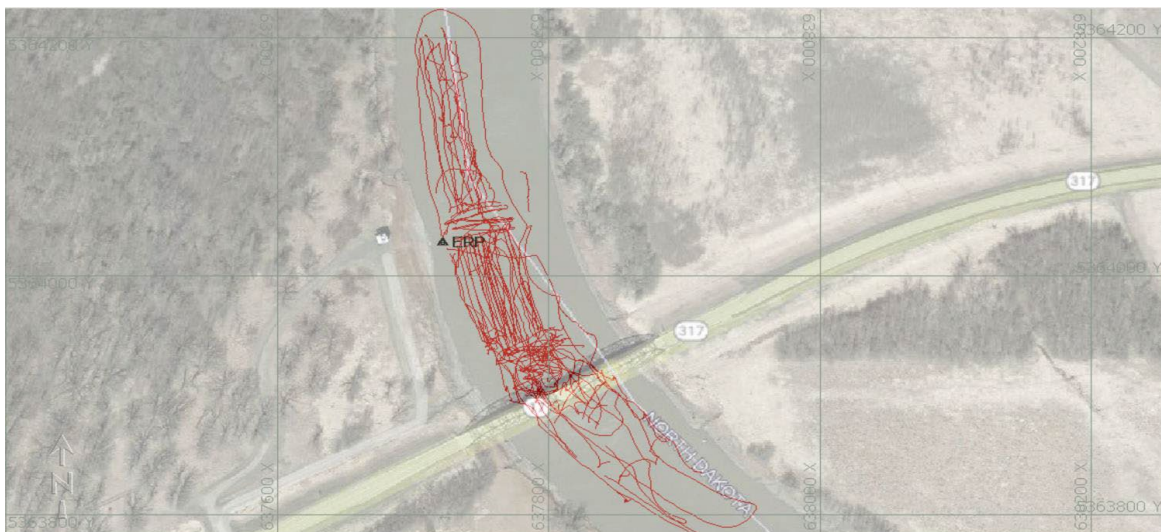
Figure 5. HYCAT's autonomous route at the site of Highway 17 Bridge near Grafton.

**Figure 4** illustrates the designed or intended navigation path for the HYCAT while **Figure 5** shows the path executed by HYCAT autonomously. Supplemental paths were added via remote joystick control. The watercraft under windy conditions and facing strong current may not be able to navigate exactly right on the planned pathway as defined by GPS waypoints. However, it is perfectly normal and fine because the purpose of defining the pathway is to provide a guide so that the bathymetric data can be collected with a good spread for the study area.

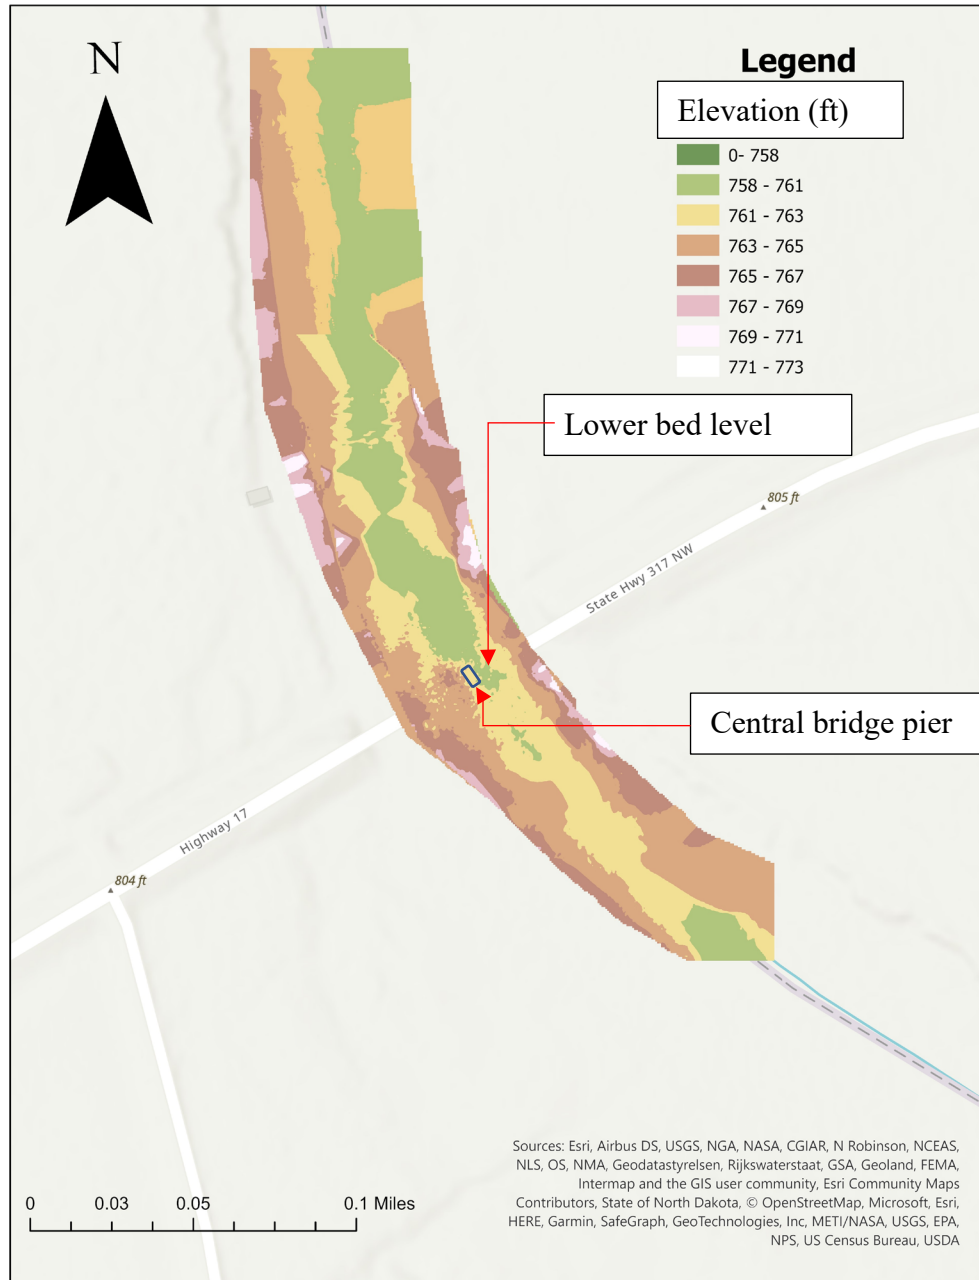
Figure 7. Bathymetry of the study site at Highway 17 Bridge near Grafton.

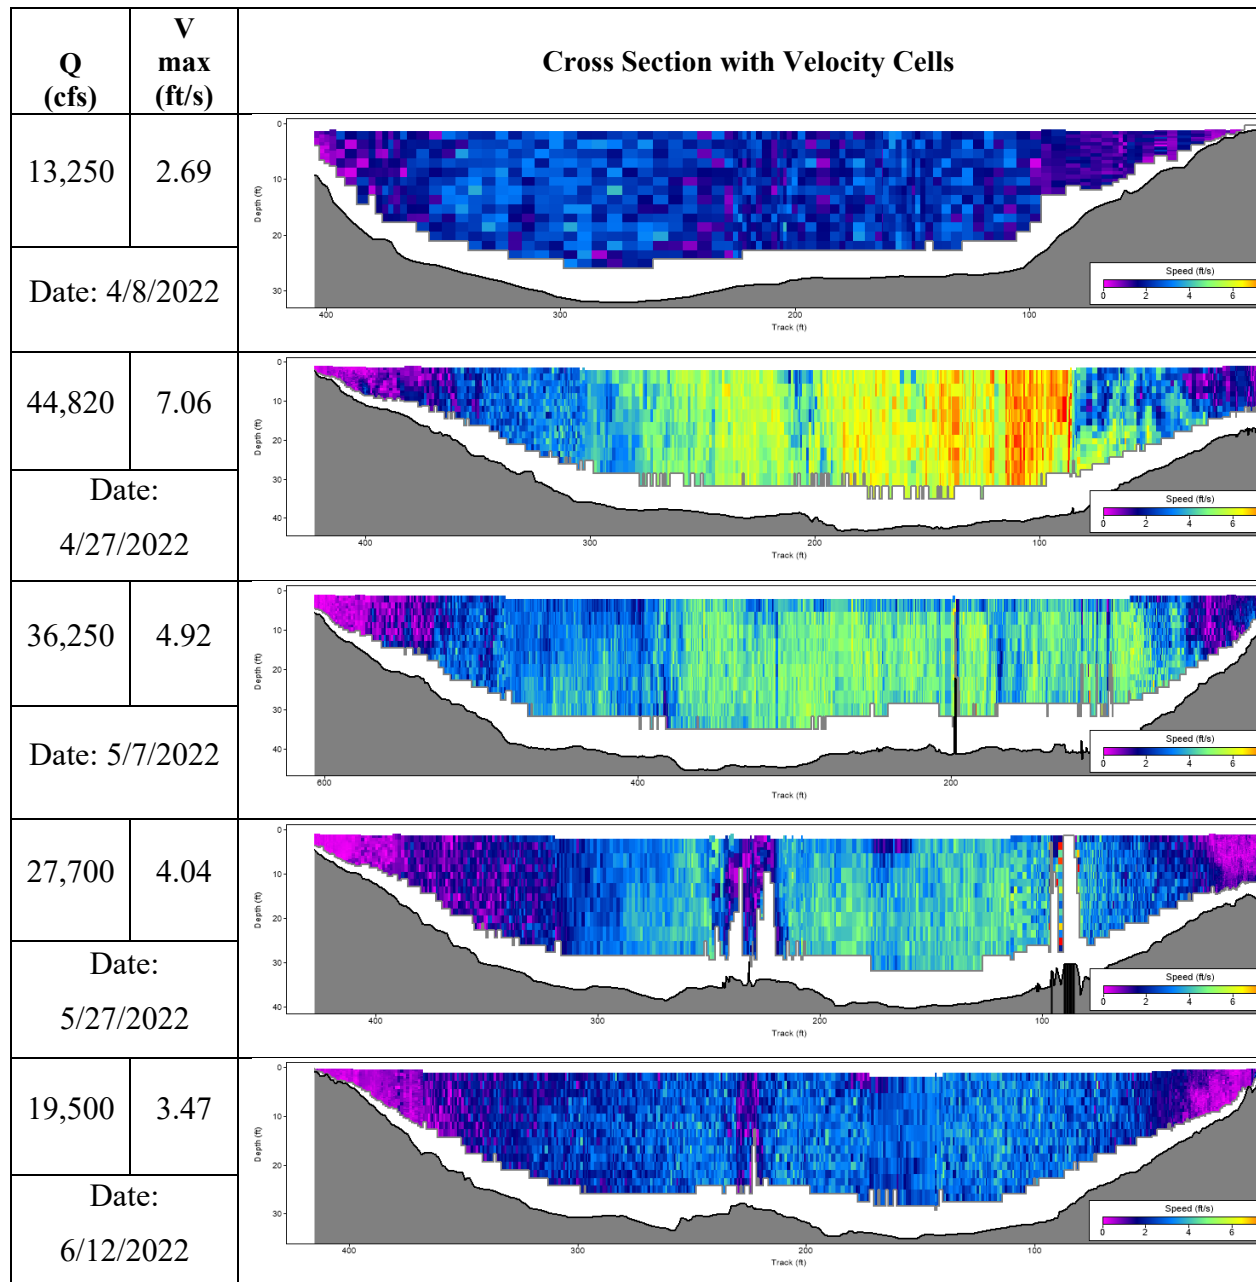
Figure 14. Discharge Measurement at Highway 17 Bridge Site Near Grafton

The consecutive measurements of discharge spread over many days are plotted in **Figure 13** to form a flood hydrograph. The measurement of flow velocities using M9 is shown in **Figure 14**. The maximum velocity recorded in the period of measurements was found to be 7.06 ft/s with a flow of 47,144 cfs through the river section on 4/27/2022. The limit of water velocity for safe

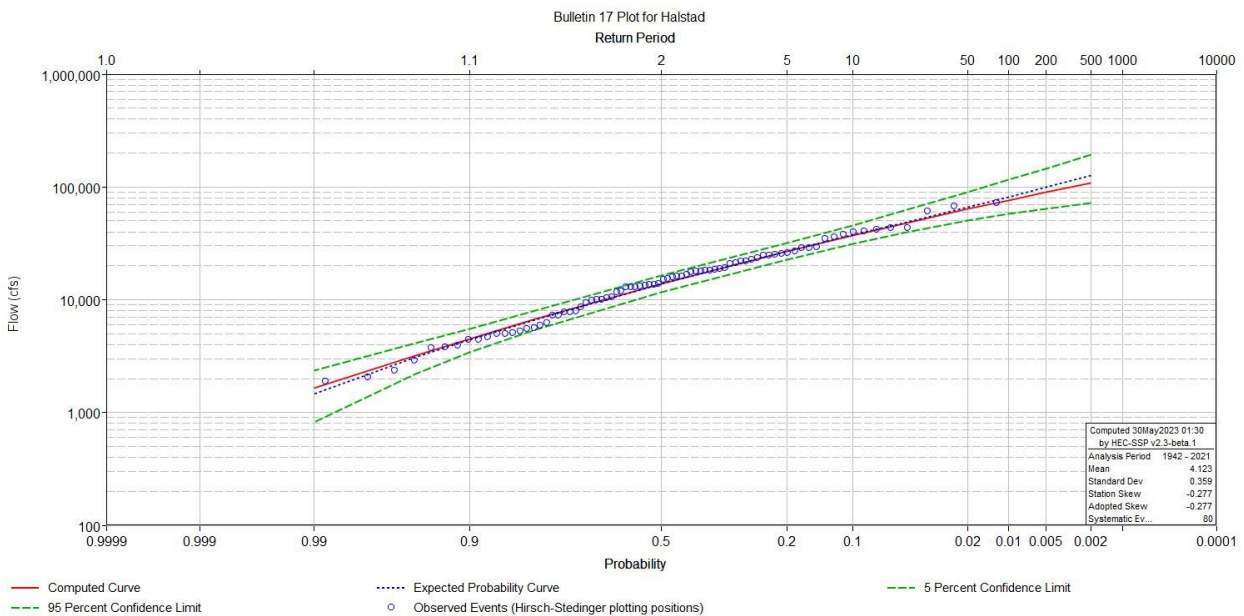
Figure 17. Flood Frequency Curve for Halstad, MN.

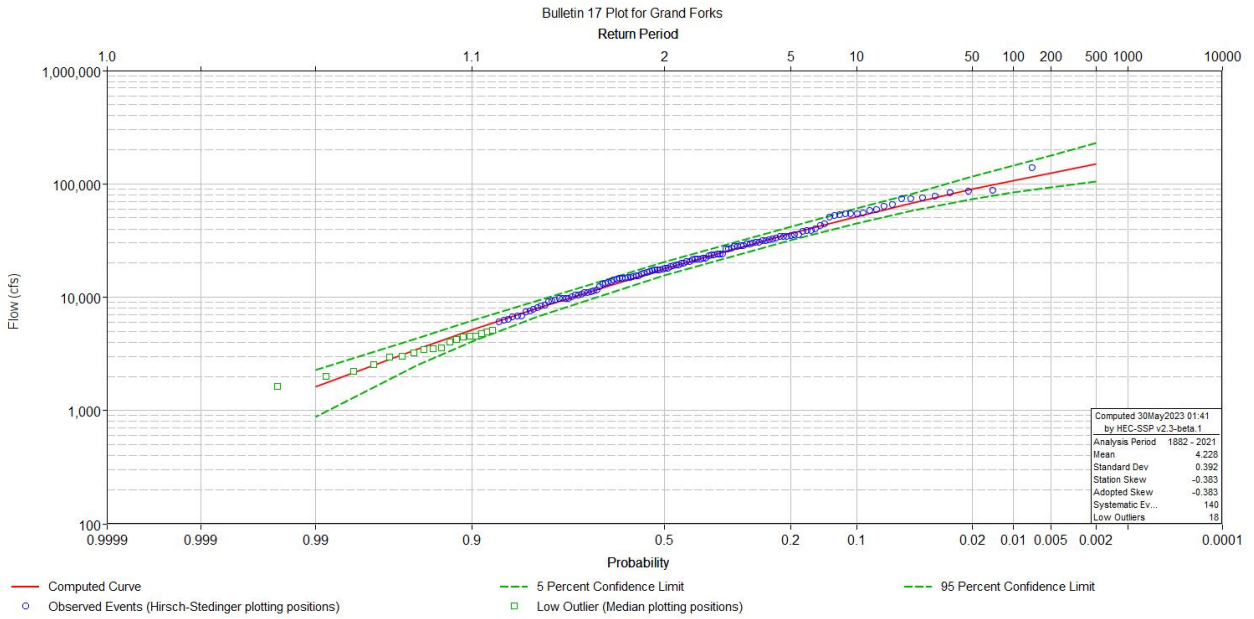
Figure 18. Flood Frequency Curve for Grand Forks, ND.

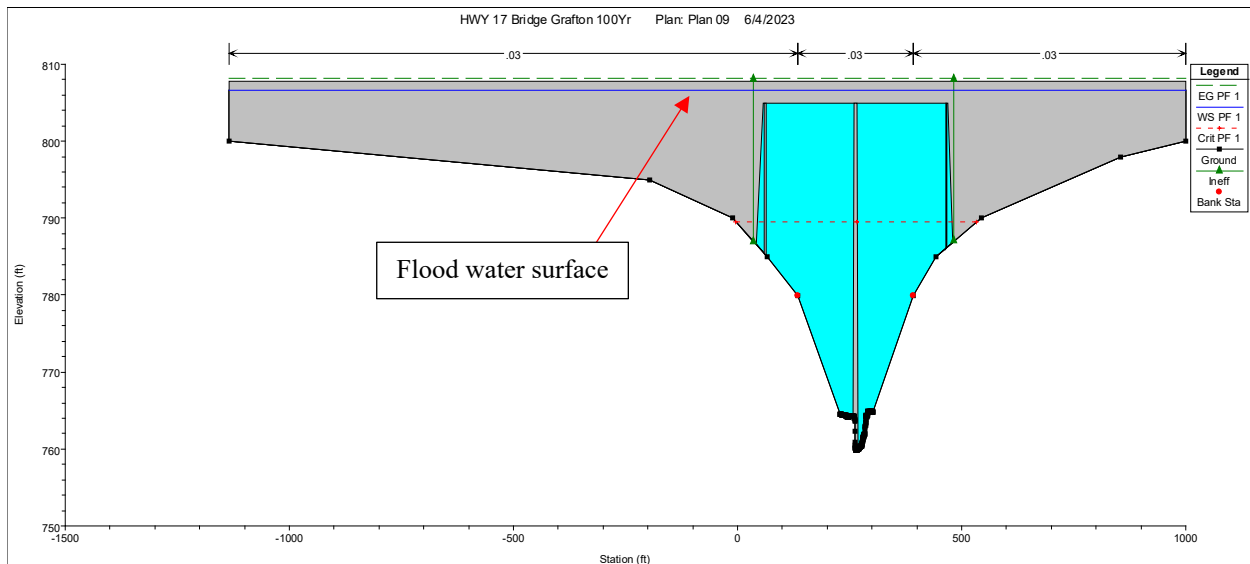
Figure 22. Cross-sectional view of Highway 17 Bridge near Grafton under 100-year flood.

It can be seen from **Figure 22** that the water surface (WS PF1-blue line) is at the bridge deck level under the 100-year flood flow condition. Another perspective is the streamwise flood profile plot shown in **Figure 22**. The bridge deck is half submerged.

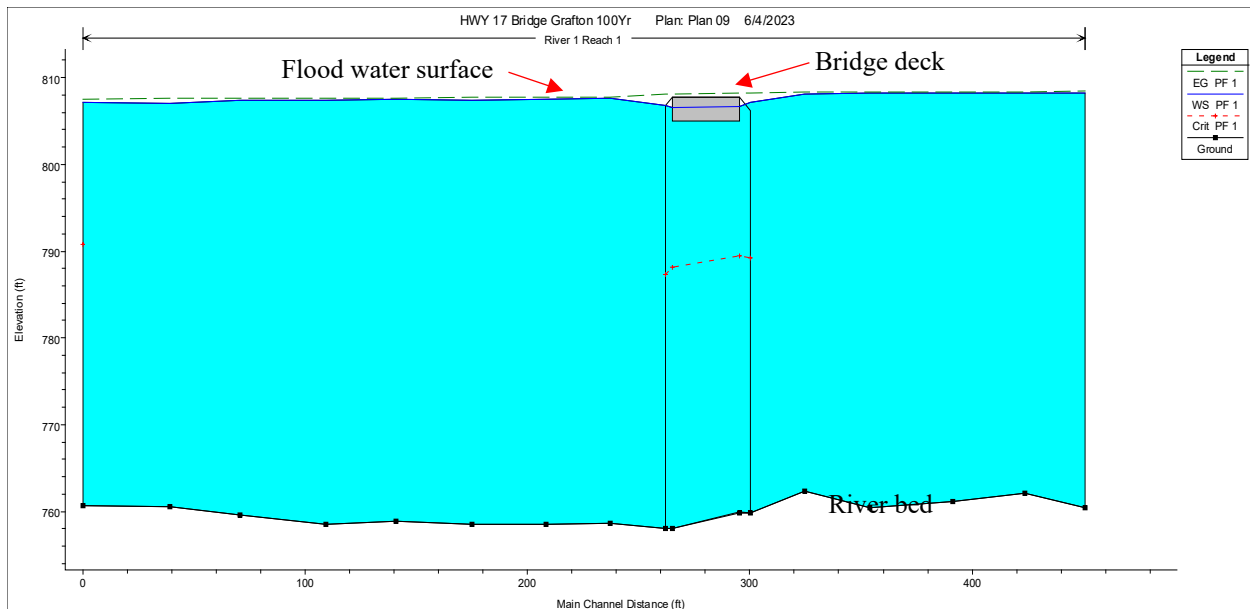
Figure 23. Streamwise flood profile plot of Highway 17 Bridge near Grafton under 100-year flood.

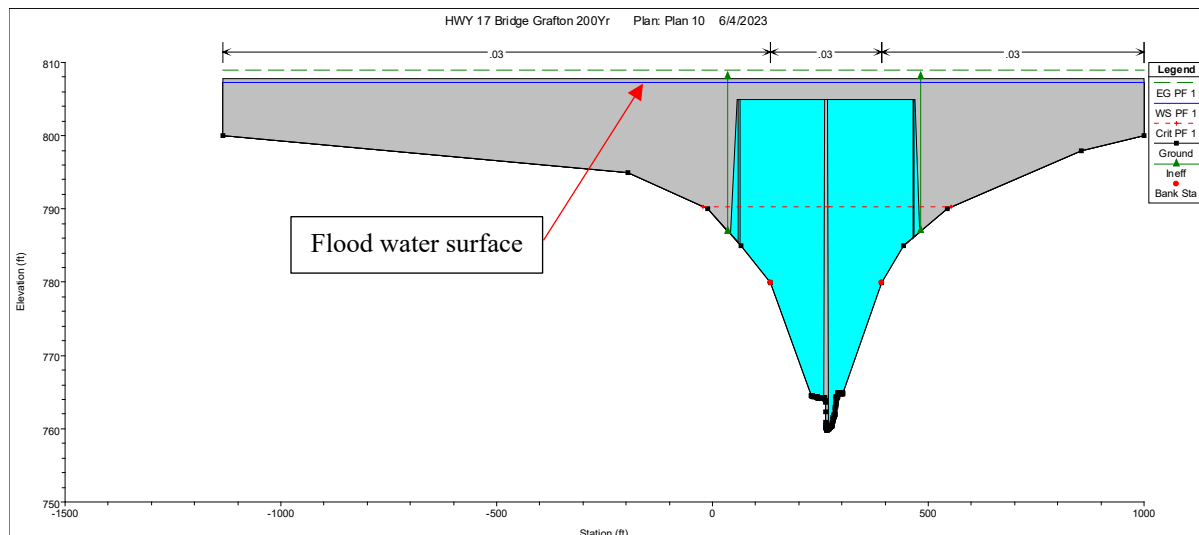
Figure 24. Cross-sectional view of Highway 17 Bridge near Grafton under 200-year flood.

**Figure 24** shows that the flood level (blue line) is still slightly below the top of the bridge deck. Another perspective view of the flood profile is shown in **Figure 25**.

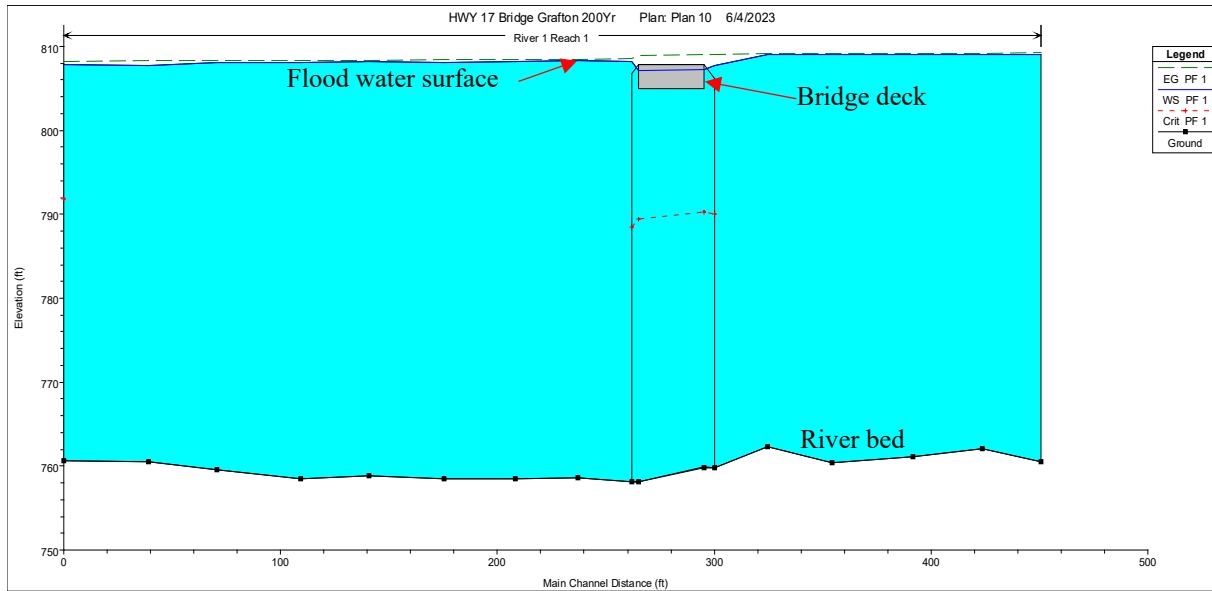
Figure 25. Streamwise flood profile plot of Highway 17 Bridge near Grafton under 100-year flood.

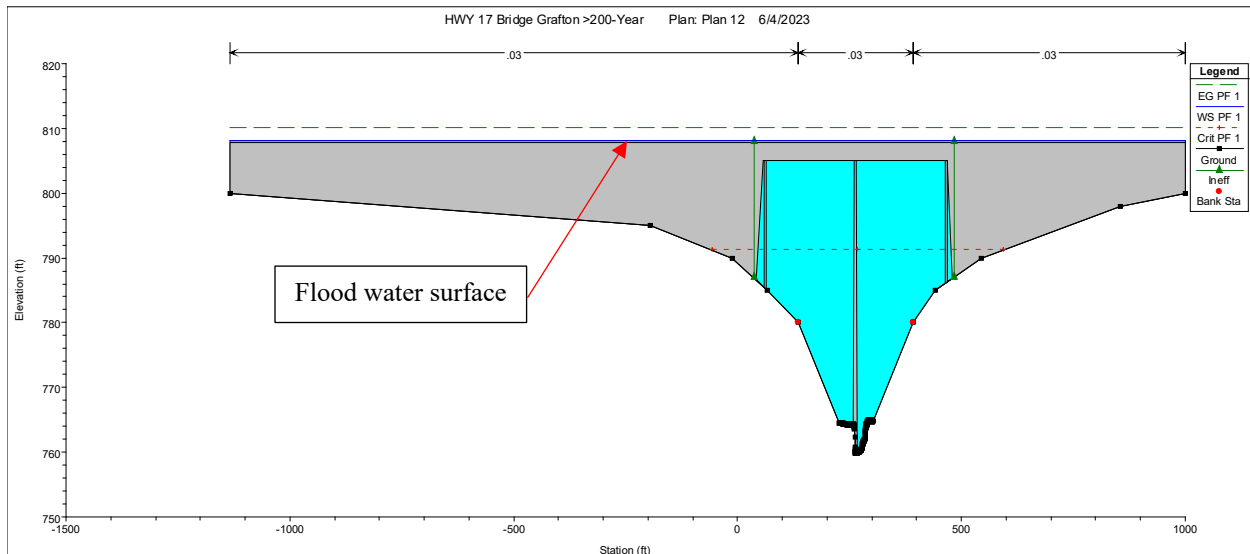
Figure 26. Cross-sectional view of Highway 17 Bridge near Grafton under extreme flood (140,000 cfs).

Since the 200-year flood at Highway 17 Bridge does not overtop the bridge deck, an extra exercise is conducted to see what is the flood discharge that will create an overtop flow condition. A discharge of 140,000 cfs is shown to create this condition as shown in the following **Figures 26** and **26**. A supercritical flow is formed on top of the deck, ie., with very high velocity.

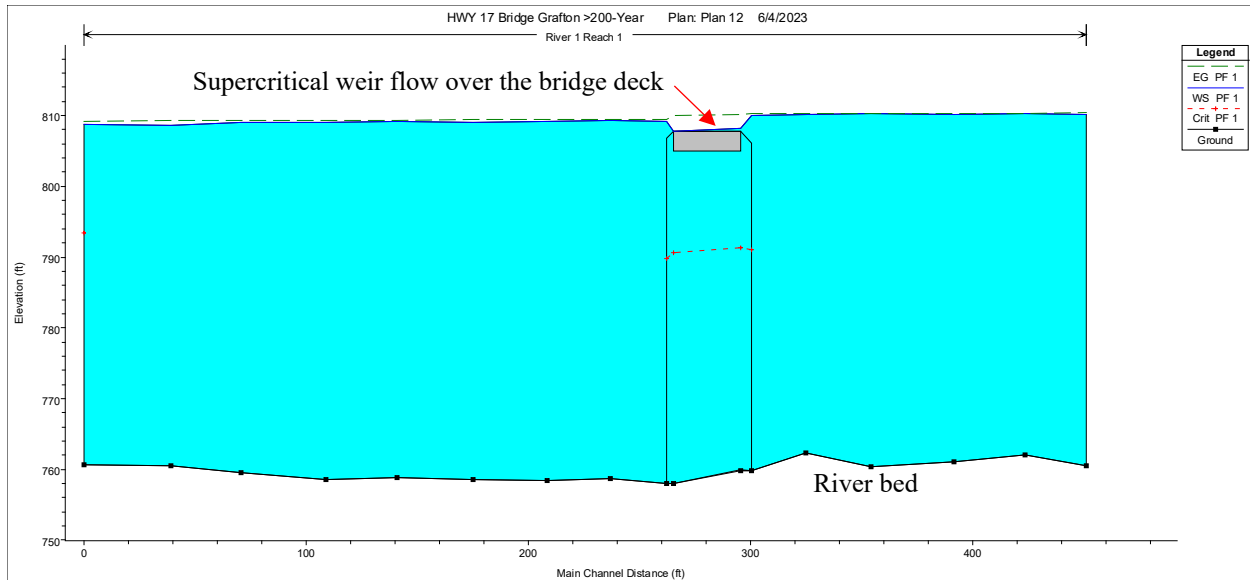
Figure 27. Streamwise flood profile plot of Highway 17 Bridge near Grafton under extreme flood (140,000 cfs).

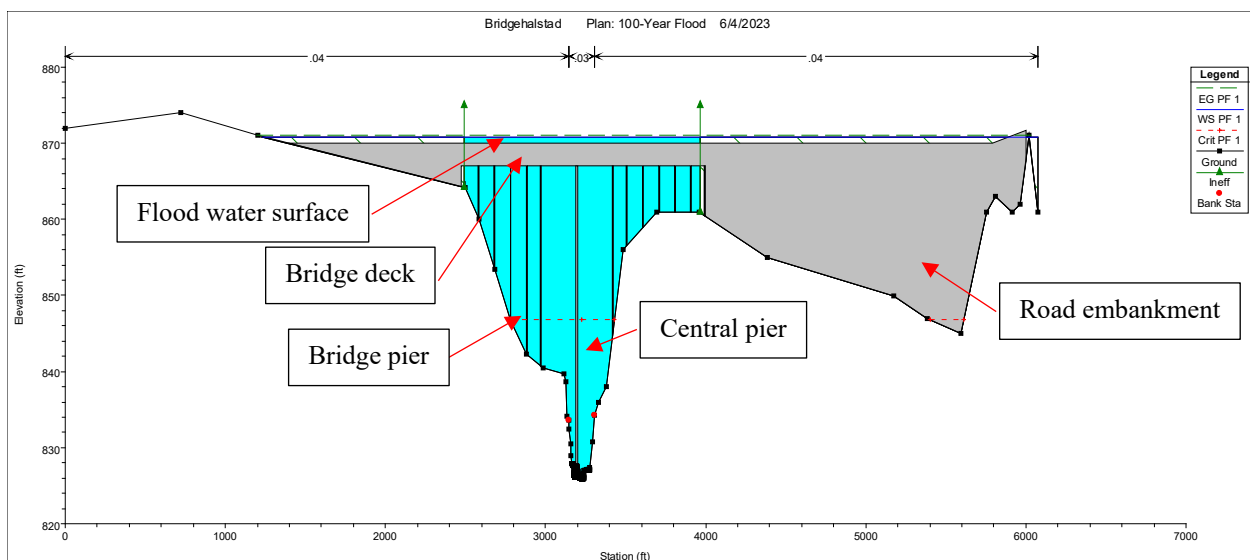
Figure 28. Highway 200 Bridge near Halstad under 100-year flood condition (81, 247cfs).

Flood flow at the Highway 200 Bridge near Halstad is placed under a 100-year flood flow condition. This is not good as compared with the Highway 17 Bridge near Grafton. The bridge here gets overtopped in this 1% chance scenario. **Figure 28** shows the flood level as above the deck, and **Figure 29** shows another perspective. The flood level is at 870.95ft as shown in **Tables 13 and 14**.

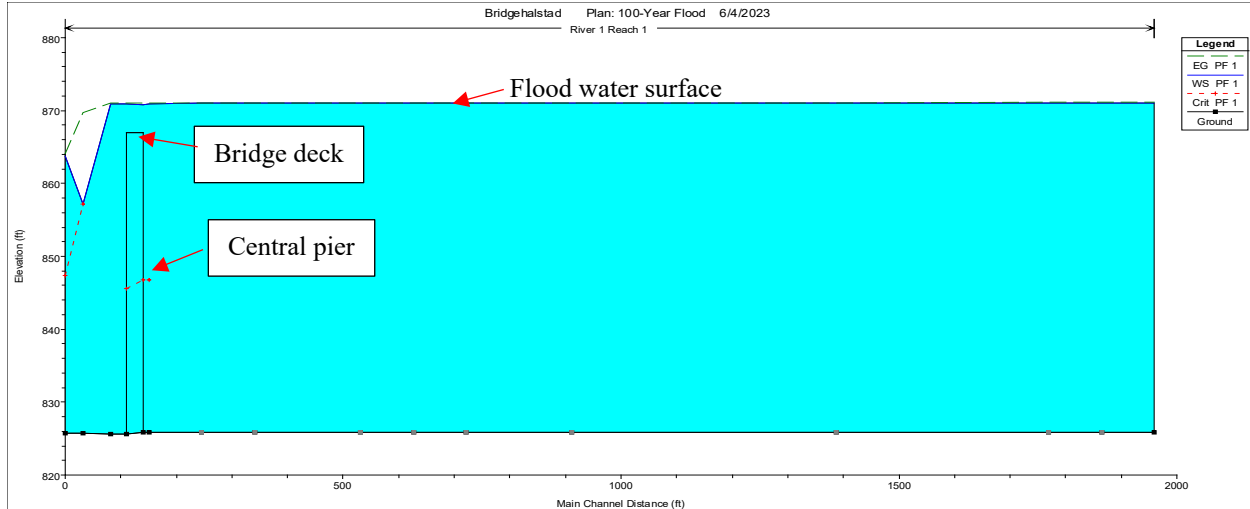
Figure 29. Streamwise flood profile plot of Highway 200 Bridge near Halstad under 100-year flood.

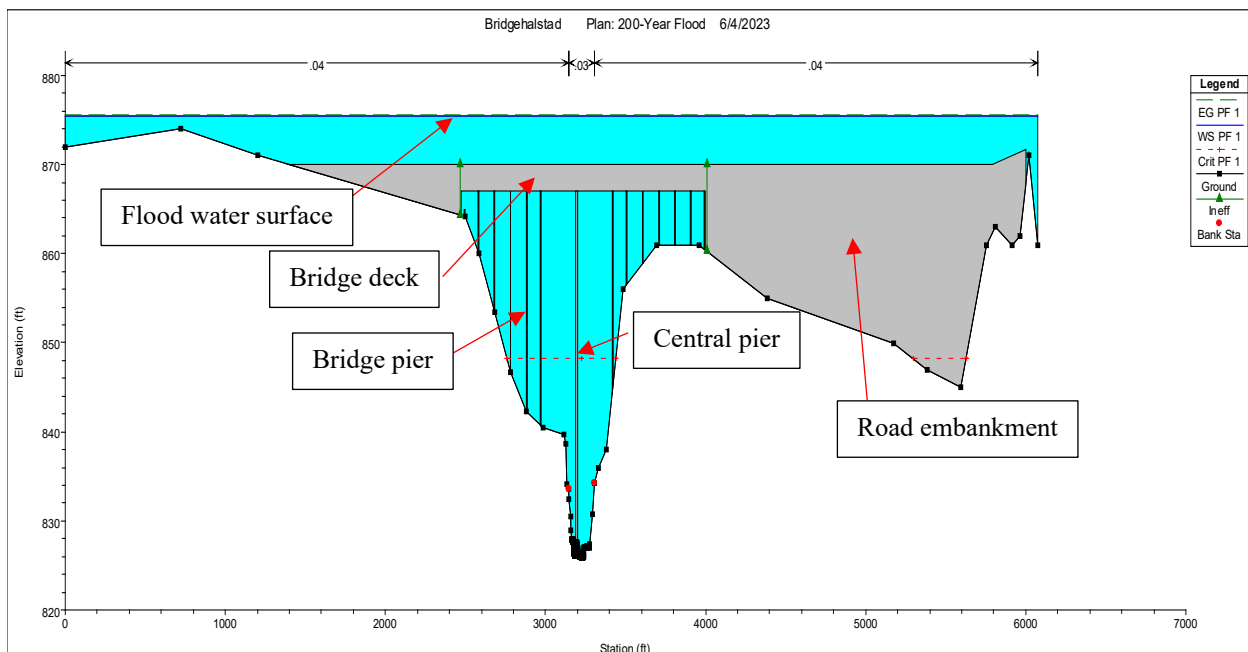
Figure 30. Highway 200 Bridge near Halstad under 200-year flood condition (98,778 cfs).

The bridge is now placed under a 200-year flood condition. An overtopping condition is expected since the 100-year flood has already overtopped the top of the deck. **Figures 30 and 31** show the massive overtopping flow over the deck and highway embankment by around 5.57 ft, as read from **Tables 15 and 16**.

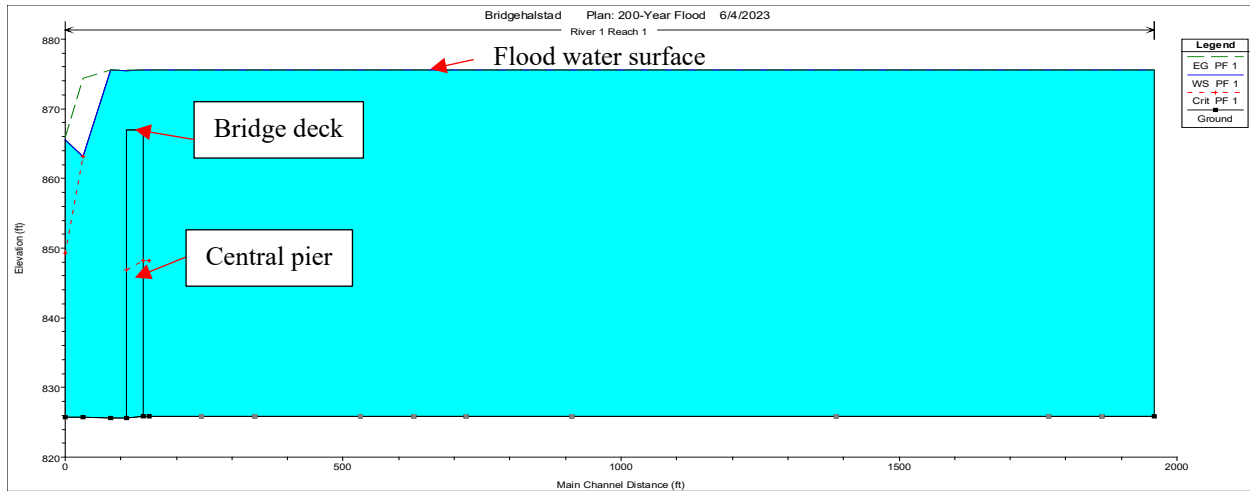
Figure 31. Streamwise flood profile plot of Highway 200 Bridge near Halstad under 200-year flood (98,778 cfs).

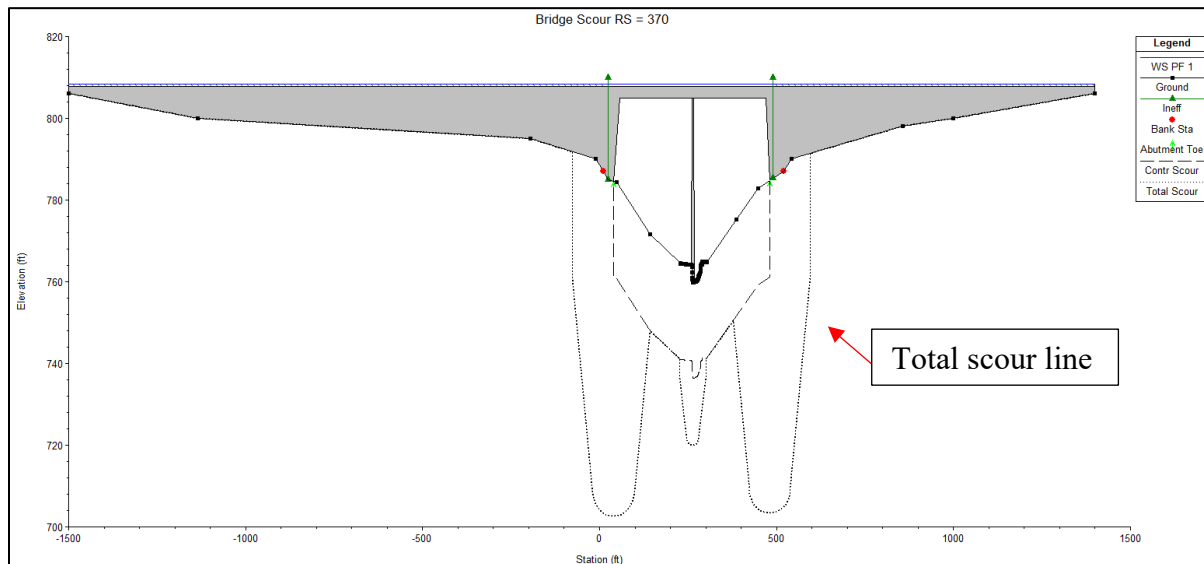
Figure 32. Predicted scour depth at Highway17 Bridge site near Grafton under 100-year flood.

The output of the scour analysis is summarized in a plot shown in **Figure 32**. The total scour line is the extent considering all the contributions from scour components.

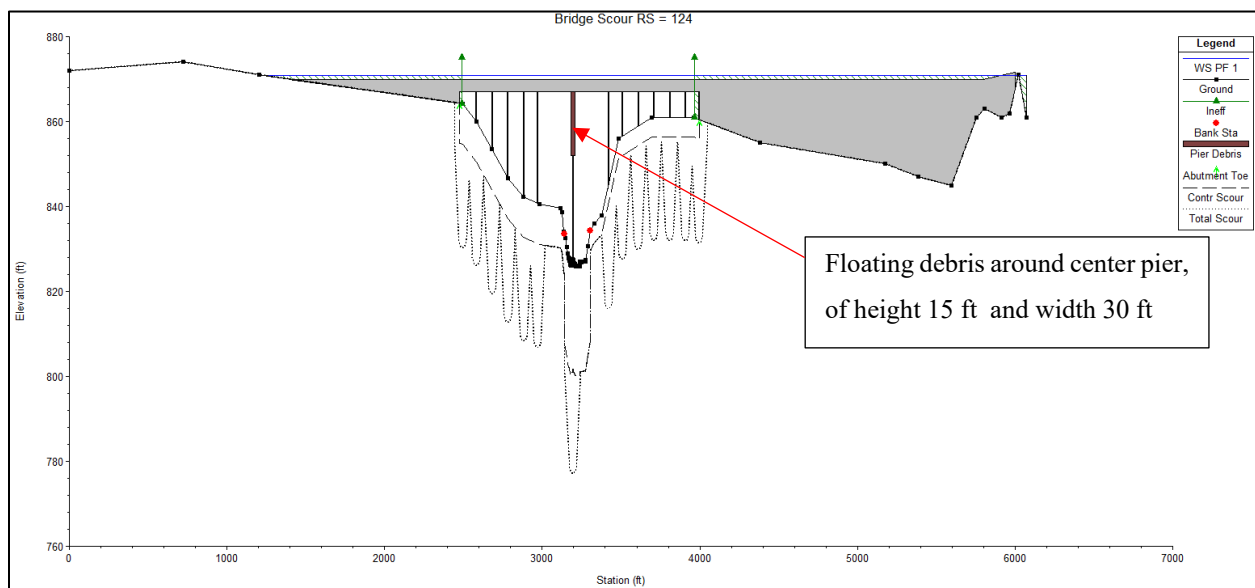
Figure 34. Predicted scour depth at Highway 200 Bridge site near Halstad under 100-year flood.

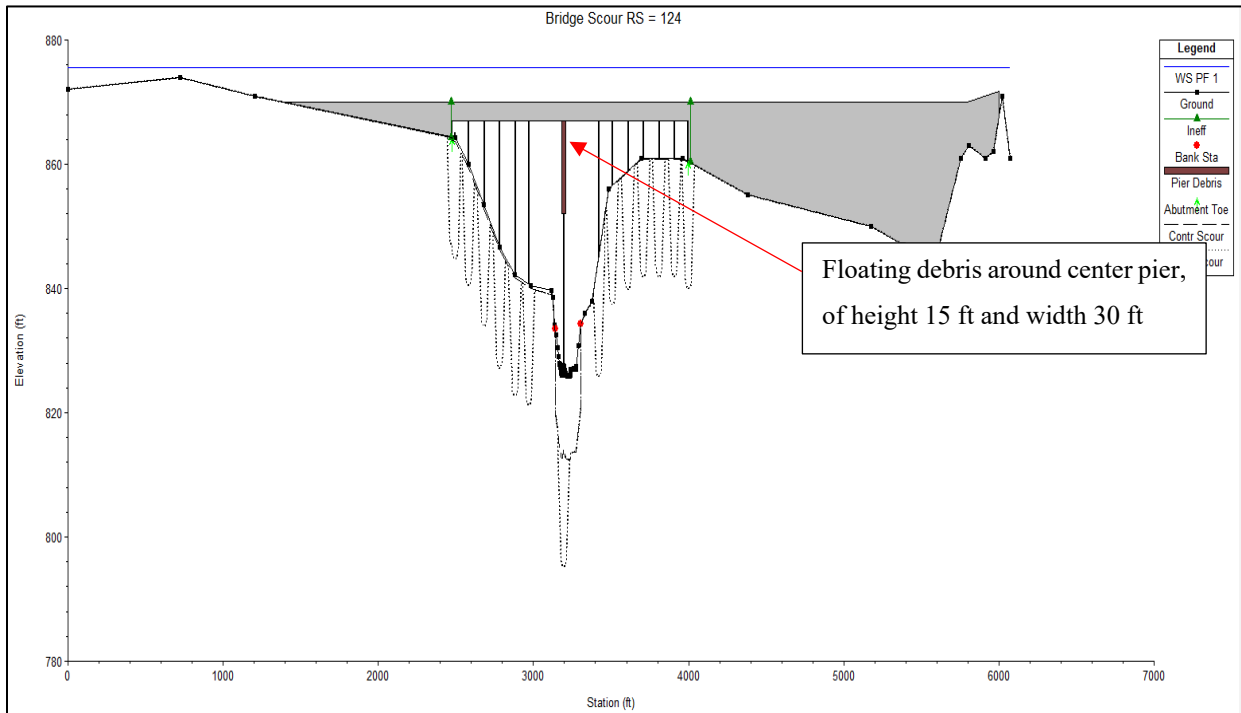
Figure 35. Predicted scour depth at Highway 200 Bridge site near Halstad under 200-year flood.

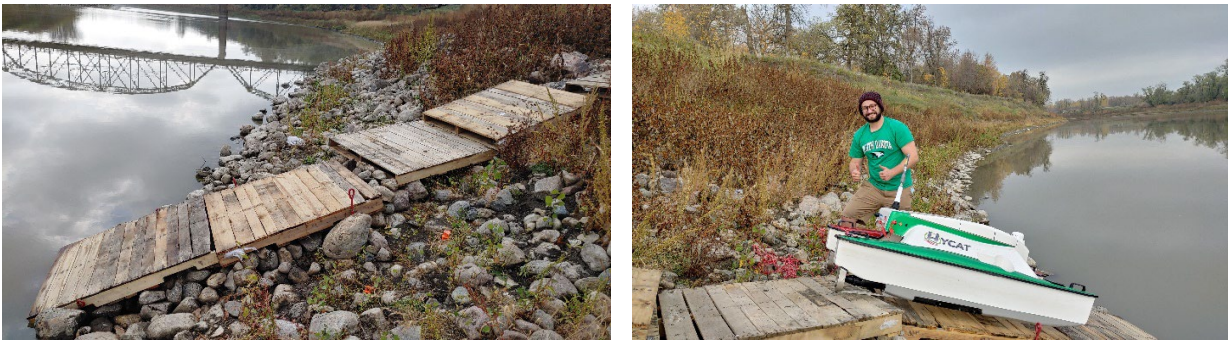
**Figure 36. Temporary walkway built for launching HYCAT on a rocky steep slope.**

It is essential to identify a gradual footpath that allows personnel to launch the HYCAT, which weighs 115.5 lbs, on the river. HYCAT can be carried by at least two persons. On a slope that is rough with loose rocks and generally steep, it is best to provide a temporary walkway for safety reasons and also to avoid scratching the sensitive M9 sensor surfaces. This was the situation the project team encountered at the Highway 17 Bridge site near Grafton. A temporary walkway was constructed using abandoned pallets found nearby. **Figure 36** shows the setup. The full specifications of HYCAT is: Length: 5.9 ft (1.8 m). Beam: 2.83 ft (.86 m). Draft (when the antenna is down): .5 ft (.15 m). Weight: 53 kg (115.5 lbs).

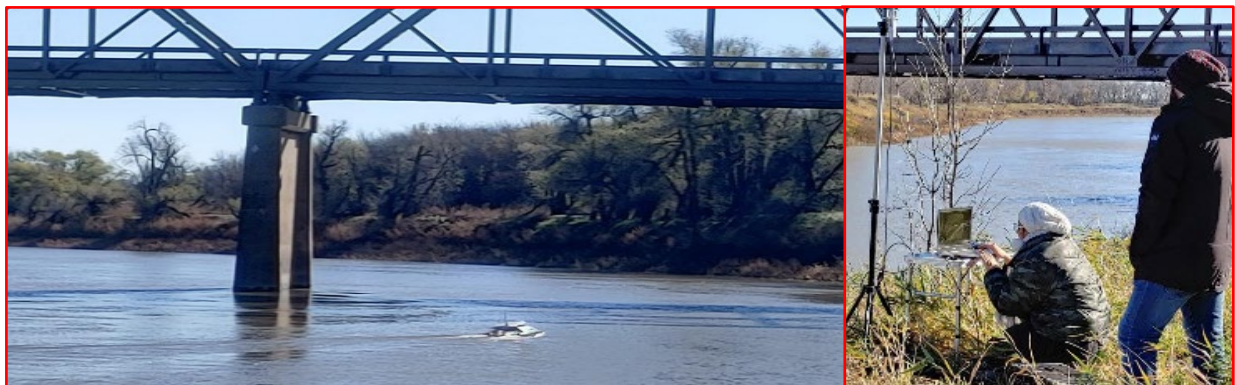
UND's HYCAT with SonTek M9 ADCP was deployed by a team of UND students on the Red River to measure discharge and bathymetric data. (a) the HYCAT navigated near Highway 17 Bridge near Grafton, (b) students checked the status of the HYCAT via a remote-control system.

Figures shown below the deployment of UND's HYCAT for discharge measurement. HYCAT can navigate on any open water with a GPS positioning system and is controlled by a remote-control system via radio communication.
