Experimental Study MR 2004-02

**Use of Texcote XL-70C Bridge Cote as  
a Concrete Surface Finish and Curing Compound**

**Final Report**

IM-8-029(052)065

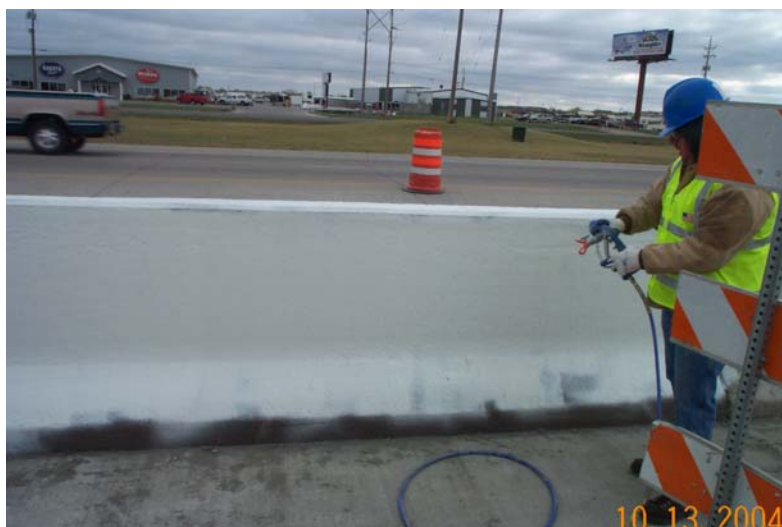
**Photo 1 - Texcote Representative demonstrating the application of XL-70C material.**

The Texcote representative initially had problems achieving an even coat because the material clogged the paint sprayer. After changing to a new nozzle, the XL-70C was applied more evenly. Personnel from Prairie Supply, the contractor awarded the project, continued to apply the product to the remainder of the barriers. Photo 1 shows the Texcote representative applying the product and Photo 2 shows the contractor applying the product.

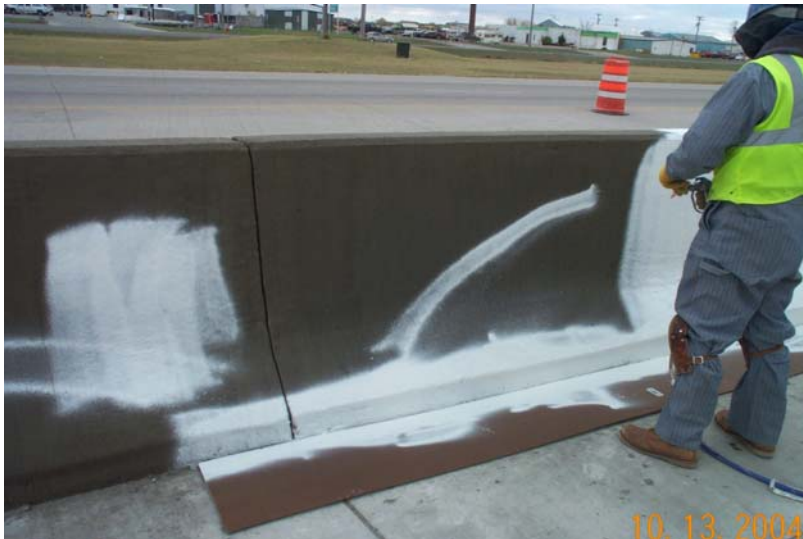
**Photo 2 – Contractor’s personnel applying the product.**

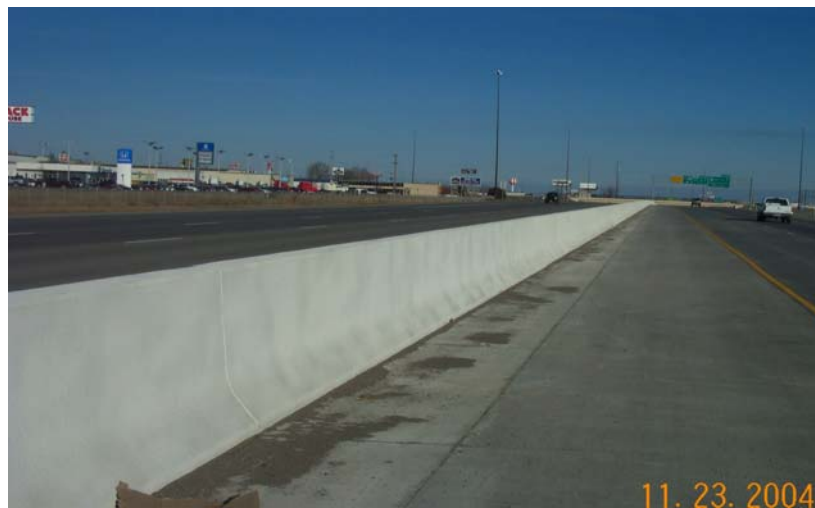
The fully cured material and the control section were observed on November 23, 2004. The color of the XL-70C appeared uneven and it appeared that the applicator’s up and down spray pattern could be seen. An improved spray pattern, or a second application, could provide a more even appearance. Photo 3 shows the cured XL-70C on a Jersey barrier in the test section.

**Photo 3 – Cured XL-70C on Jersey barrier.**

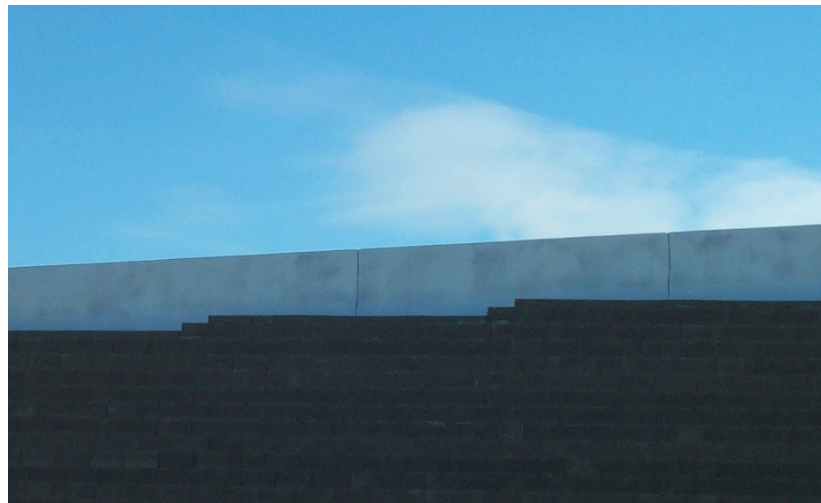
The color of the cement-based material in the control section also appeared uneven and blotchy. Photo 4 shows a Jersey barrier in the control section.

**Photo 4 – Cement-based material on Jersey barrier in the control section.**

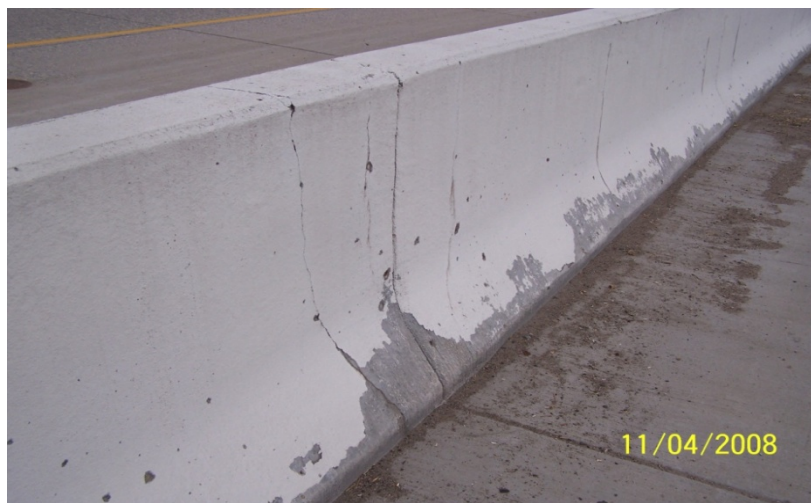
Materials and Research personnel conducted a final evaluation of the product on November 4, 2008. The Texcote XL-70C was showing signs of adhesion problems. The coating was either flaking off or missing at the bottom of the jersey barriers. There was also evidence of the coating eroding from surface voids. Both distresses are shown in Photo 5. Possible explanations for the accelerated deterioration at the bottom of the barriers are from de-icing salts and snow plow damage. The coating surface appeared blotchy in one location approximately 100' long. See Photo 6.

**Photo 5 – Texcote severe distress at bottom of Jersey barrier and eroding from surface voids.**

particularly in the bottom 3 to 6 inches, most likely because of salt/snow plow damage. The uneven color on the Jersey barriers is still evident in both the test section and the control section. Because the XL-70C did not meet the requirements of AASHTO T-155 it is not recommended that this product be used as a curing compound. As a surface finish, the XL-70C did not perform as well as the control section. However, the control section was located along a ramp while the test section was located along mainline interstate. As a result, there were differences in traffic loading and the amount of salt and snow plow activity. Also, a segment of the control section was protected by a guardrail. These issues may have improved the life of the control section. Therefore, while XL-70C is not recommended as a curing compound, further research would be beneficial to determine if XL-70C performs as well as Surface Finish "D" under identical conditions.

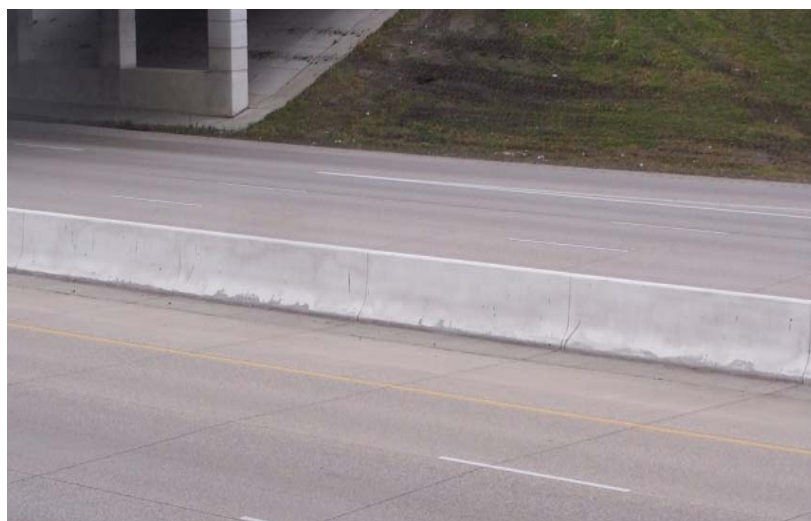
**Photo 6 – Texcote appears blotchy.**

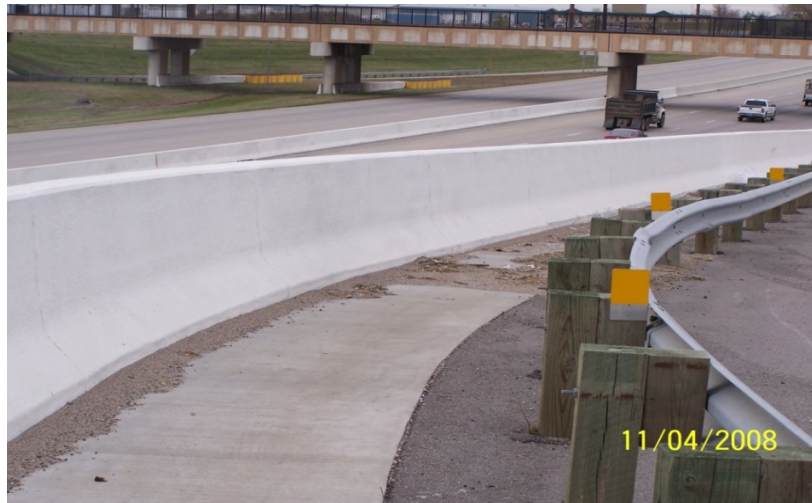
The control section was performing much better. However, the control section is protected from nearby traffic by a guardrail. The presence of the guardrail reduces the amount of salt contact, and eliminates snow plow damage. As the guardrail tapers closer to the Jersey barrier and eventually ends, the severity of the distress increases. See photos 7 and 8. The control section also experiences less traffic because it follows an on-ramp, while the test section follows mainline traffic.

**Photo 7 – Control section performing well behind guardrail.**

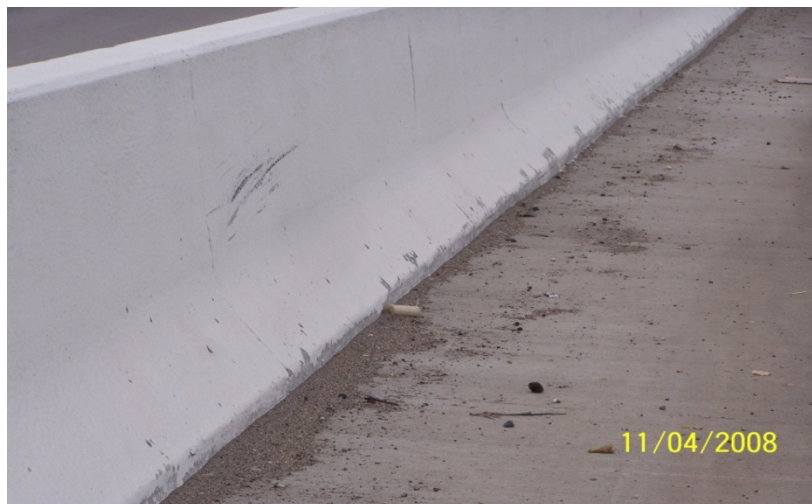
**Photo 8 – Control section, without guardrail, exhibiting similar distress as XL-70C**
