Experimental Study MR 2004-03

Evaluation of Rumble Stripes

Final Report

AC-NH-2-281(025)049

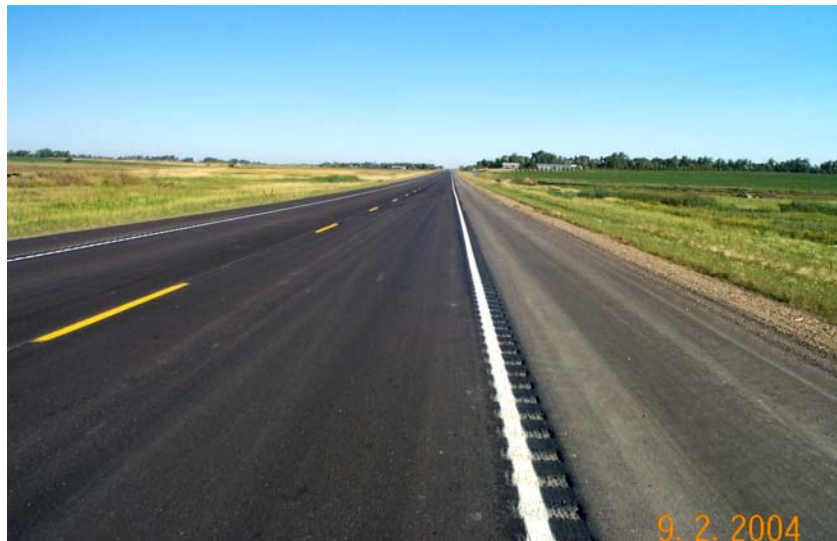
Photo 1 – Completed test section.

On August 23, 2004 a second layer of fog seal was observed being placed on the rumble strips in the experimental section. Later that day, water-based pavement markings, with glass beads for retroreflectivity, were applied. Photo 1 shows the completed test section.

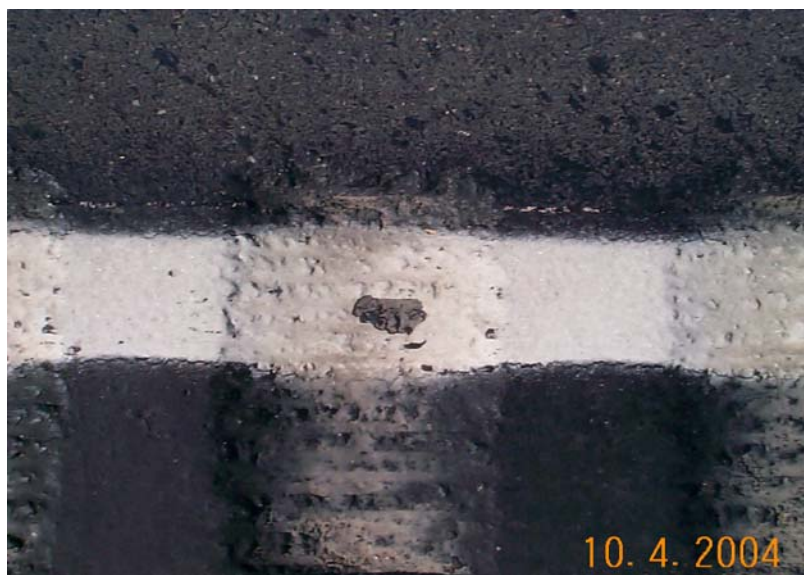
Photo 3 – Area of thick fog seal with paint flaking-off.

Materials and Research personnel evaluated the completed test section in the daylight on September 2, 2004. The change in location of the edge line did not appear to be a distraction. The edge line showed up well and its appearance wasn't much different from any other edge line. On closer inspection, some isolated spots of thick fog seal had bled through to the surface of the water-based paint, see Photo 2. On later inspections, these areas appeared to be cracking and some pieces of paint had flaked-off, indicating a failure of the pavement marking to bond to the pavement surface. This appeared to occur only in the areas with unusually thick fog seal material, see Photo 3.

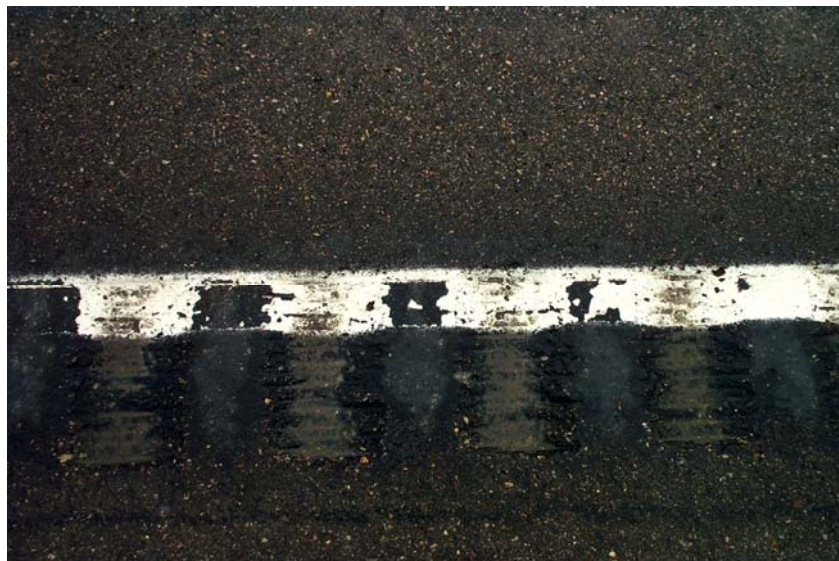
Photo 4 – A “rumble stripe” with peeling pavement marking.

The test section was observed again on April 13, 2005. The marking paint was peeling away from the rumble stripes in both the grind and non-grind areas. It is a possibility that the fog seal was not fully cured when the pavement marking was placed. As noted in the first evaluation, the bond of the pavement marking immediately failed in areas of thick fog seal. Photos 4 and 5 show that the most extensive failure, to date, is located in the non-grind areas. The most likely explanation is that the entire marking is suffering from an unsatisfactory bond; and when combined with the abrasiveness of

snow plow activity, the pavement marking is detaching from the surface. The markings in the control section and the centerline skips, both of which did not receive a second fog seal, were much more intact.

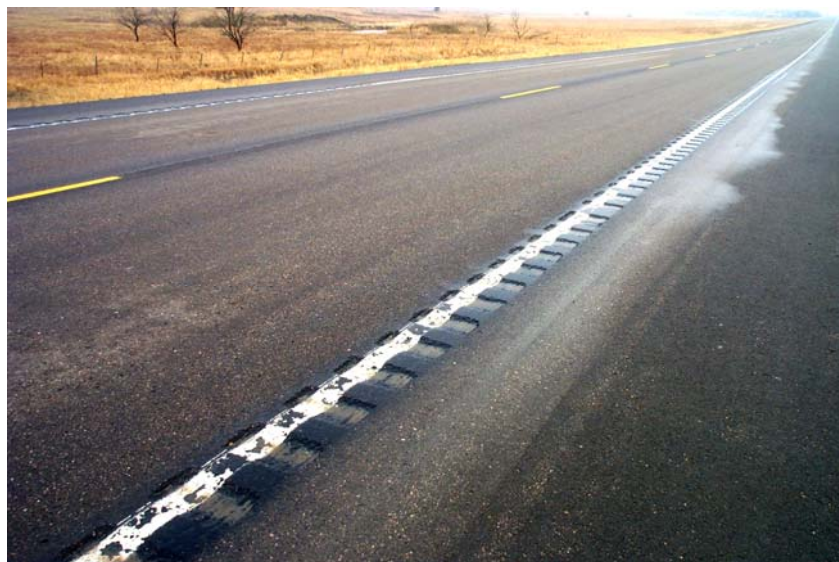
Photo 5 - -An overview of the “rumble stripes”.
