Experimental Study ND 2004-01

**Maximum Percentage of Asphalt Material  
in a Blended Base**

**Evaluation Report 2**

Project NH-5-012(027)034

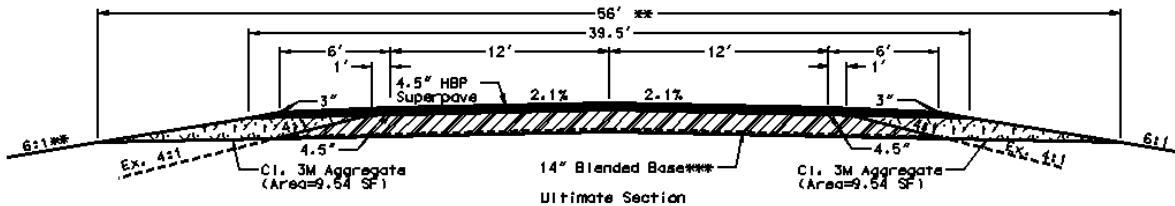
As part of the rehabilitation, the roadway was widened. Figure 2 shows the typical ultimate pavement section through the control and test segments. The test segments' blend depths and aggregate depths were modified by a plan note.

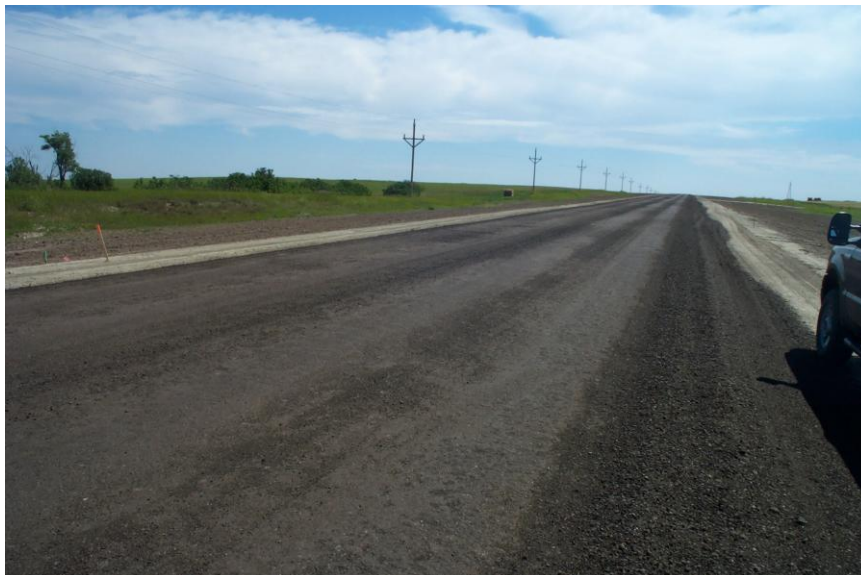
Construction of the control and test segments began with widening the graded shoulder. Virgin Class 3M aggregate was placed on the shoulders to provide the base for the widened pavement and onto the pavement surface of the control section. When salvaged HBP was available from the construction of the regraded segment, it was placed onto the surface of the pavement in the test segments. Traffic was allowed to travel over the surface of the added aggregate and salvaged HBP during construction. Photo 1 shows the test segment with the salvaged HBP on top of the pavement and Class 3M aggregate on the shoulders.

**Photo 1 – Test segment with salvaged HBP on top of the pavement.**

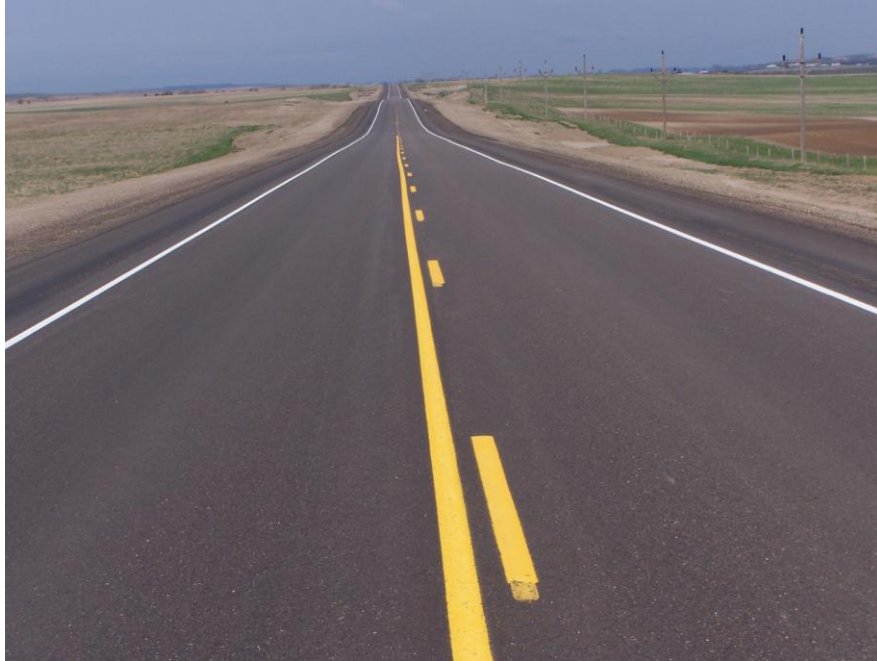
After the blended base was primed, 2 lifts of superpave HBP were paved for a total thickness of 4.5". The first lift was paved with a PG 58-28 binder and the top lift was paved with a PG 58-34 binder. The paving was completed October 15, 2005. Photo 2 shows the completed pavement surface after application of pavement markings and shoulder rumble strips.

**Photo 2 – US 12 after placement of pavement markings and shoulder rumble strips.**

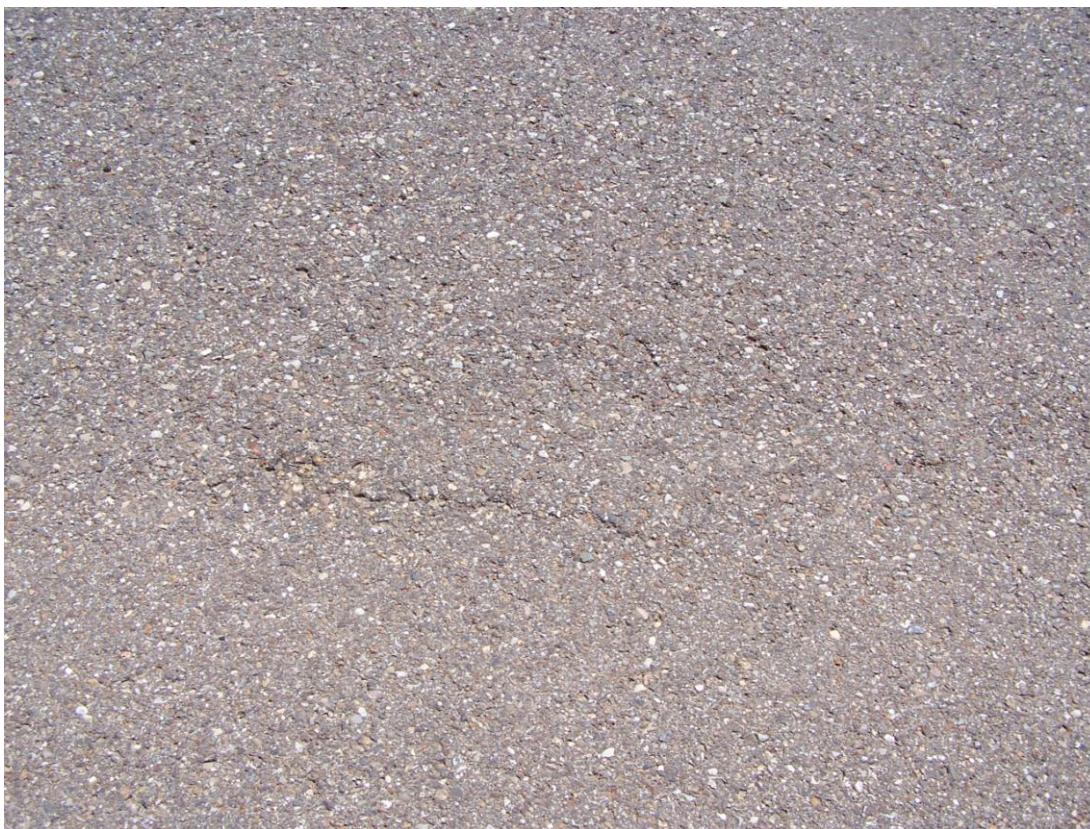
The test segments were evaluated on June 16, 2008. Visual inspection of the roadway revealed minimal transverse cracking and minimal rutting on all segments. The only notable distress observed was intermittent longitudinal cracking. These cracks appeared at random intervals and were not specific to any one test segment. Most of these cracks occurred in the outside wheel path in both east bound and west bound directions. The cracks were hairline cracks and varied in length from 1ft to 5 ft in length. The surrounding areas of these cracks had a slightly raveled look to it, with some of the surface rocks removed (See Photo 3). This condition is possibly the result of a dry mix or a defect of the paving process. Cores would need to be taken to investigate the depth of the cracks.

**Photo 3 –Longitudinal Crack in Wheel Path with Slightly Raveled Surface.**

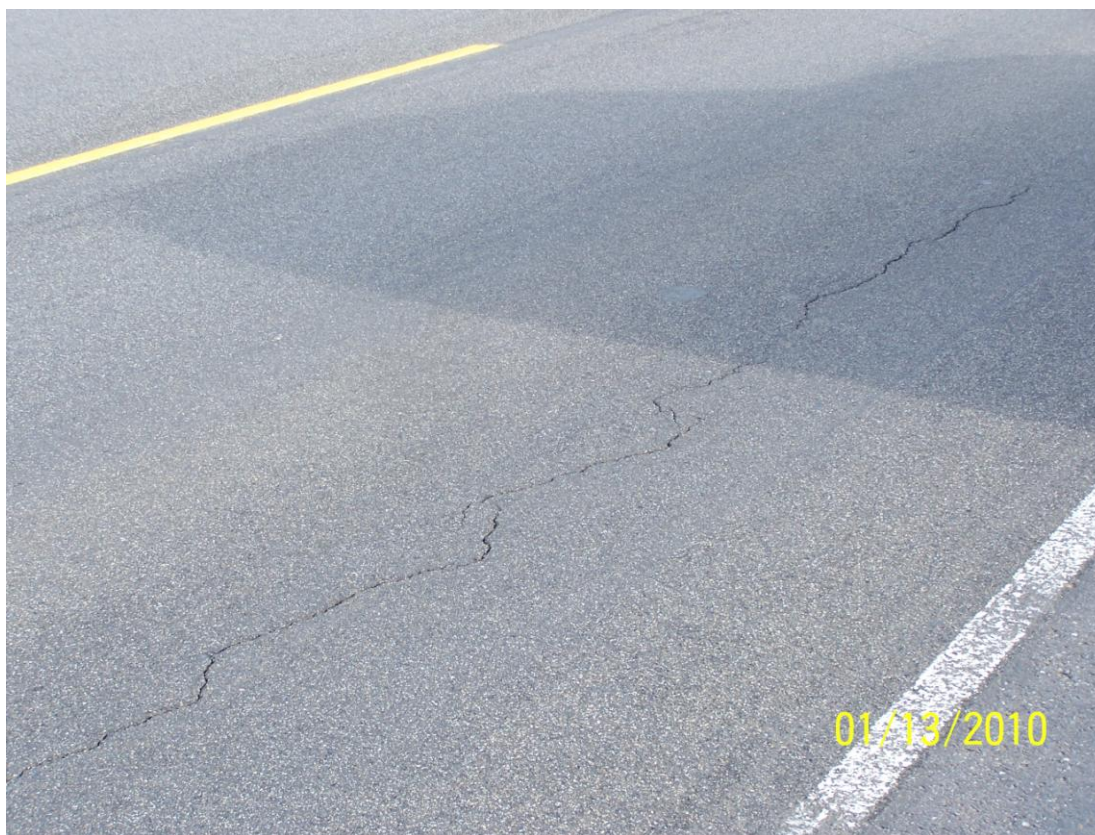
The test segments were evaluated again on January 13, 2010. Maintenance activities between the evaluations consisted of a slurry seal during the 2009 construction season. Visual inspection of the roadway revealed minimal transverse cracking and minimal rutting on all segments. The primary distress observed was longitudinal cracks that had reflected through the slurry seal (See Photo 4). The length of the longitudinal cracks now ranged from 5 ft to 20 ft in length. Table 7 quantifies the distresses that were observed.

**Photo 4 –Longitudinal Crack in Wheel Path Reflected Through Slurry Seal.**

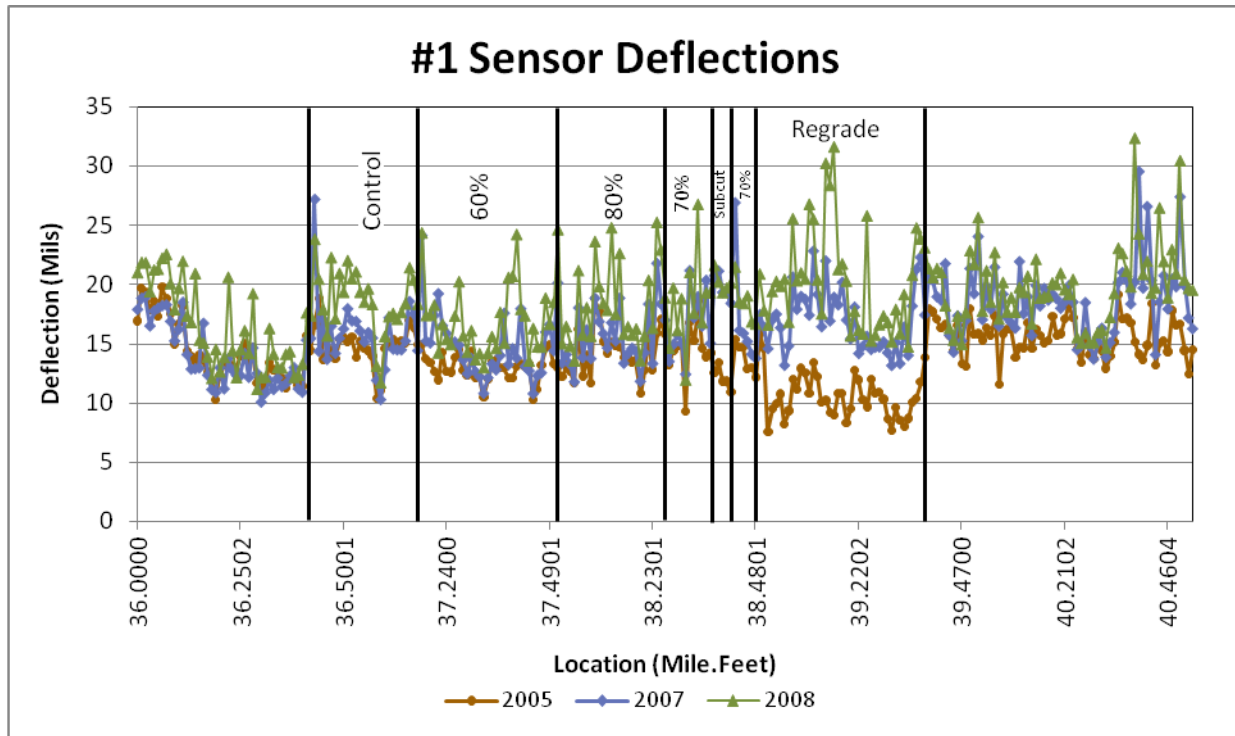
The roadway was tested with a Falling Weight Deflectometer (FWD) from RP 36.00 to RP 41.00. The FWD tested at 100 foot intervals. Figure 3 shows the #1 sensor deflections of the FWD. This sensor is located at the center of the load plate of the FWD and it is the maximum deflection of the pavement. Generally, lower deflections are associated with a stiffer pavement structure. Figures 4, 5, and 6 are the back-calculated moduli of the HBP pavement, base, and subgrade. Table 9 shows the averages for each segment.

The FWD data shows that the regrade section has the strongest overall pavement section. This section has the lowest sensor deflections and the highest back-calculated base and subgrade modulus. These results are likely because this section was reconstructed instead of mine and blend. As part of reconstruction, the subgrade was compacted and the base was compacted in lifts. Also, some of the base material in this section is virgin Class 5 aggregate.

The FWD data shows the subcut section as having unusually strong subgrade modulus and low pavement modulus. This is likely an error of the back-calculation software caused by the unusually thick base section in the subcut section.

Table 9 shows that the control and the various test segments do have different average moduli and deflections. However, from the charts there doesn't appear to be any significant changes at the boundaries of the segments and the variations in the segment averages is likely due to random variations in the materials.

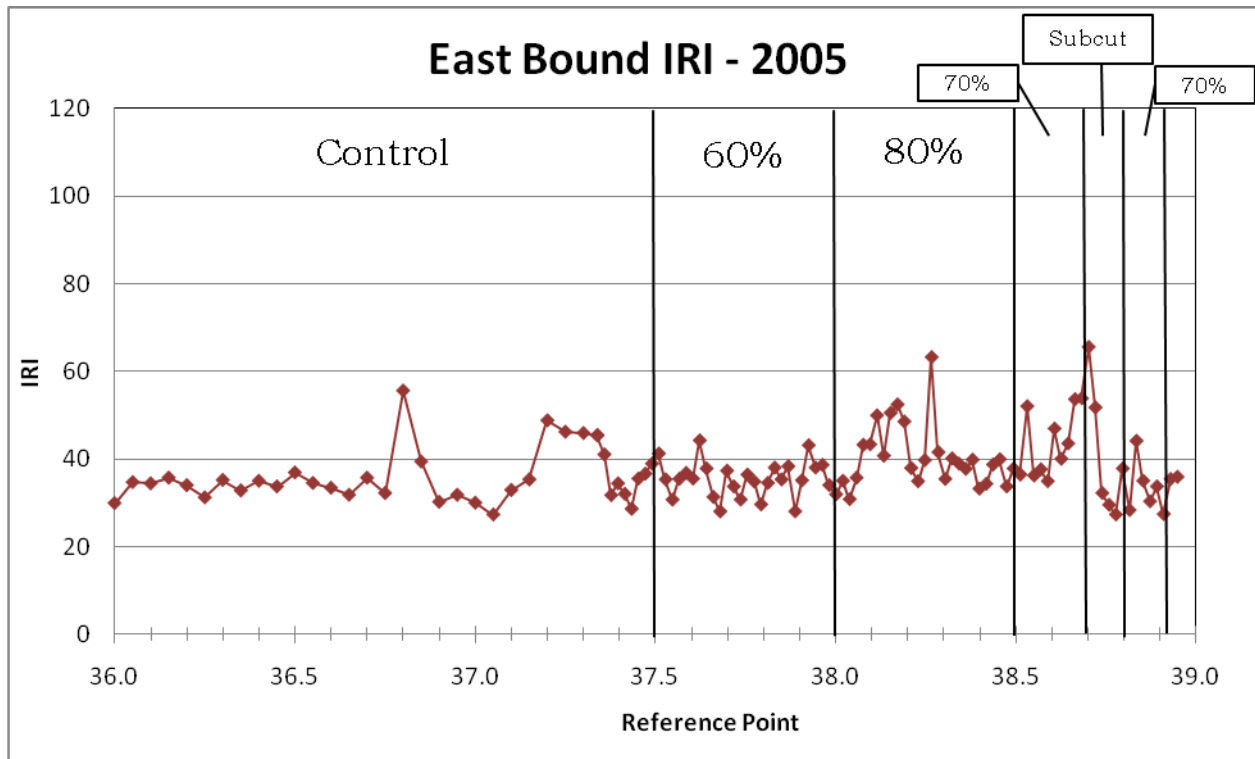
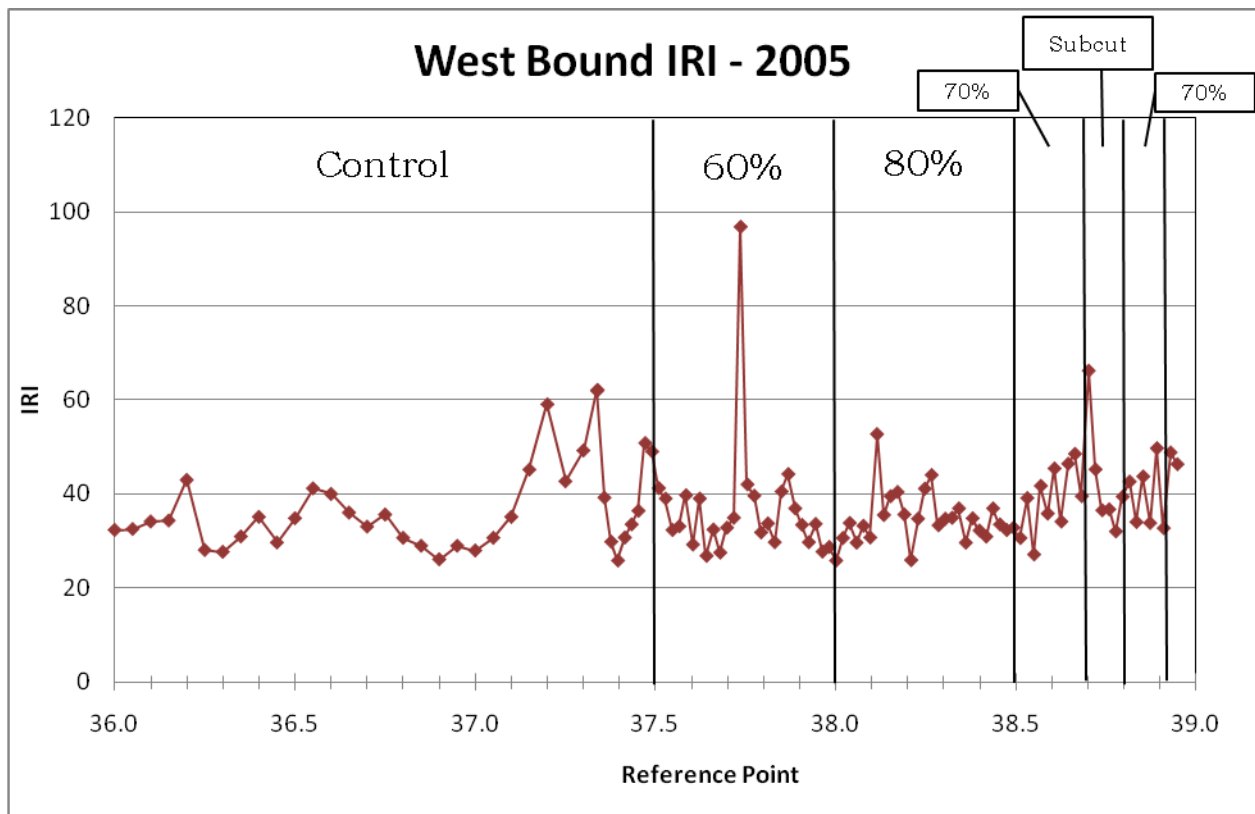
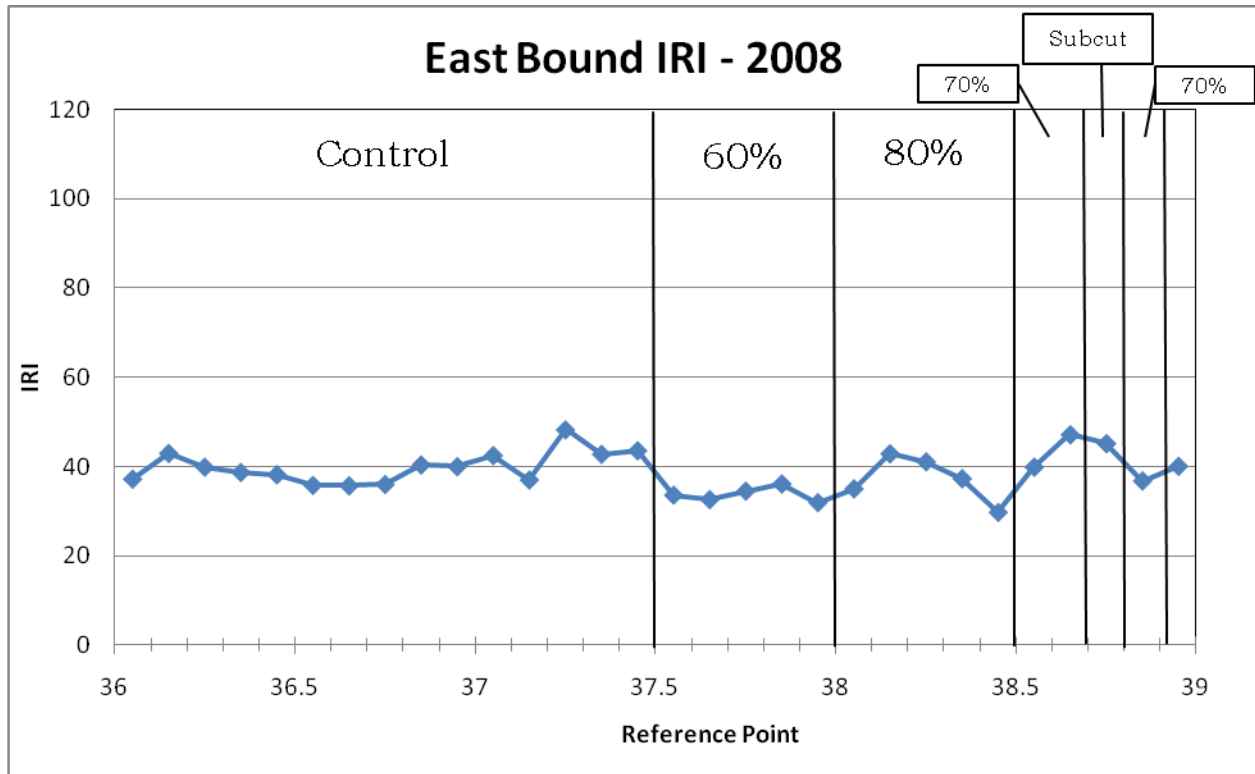
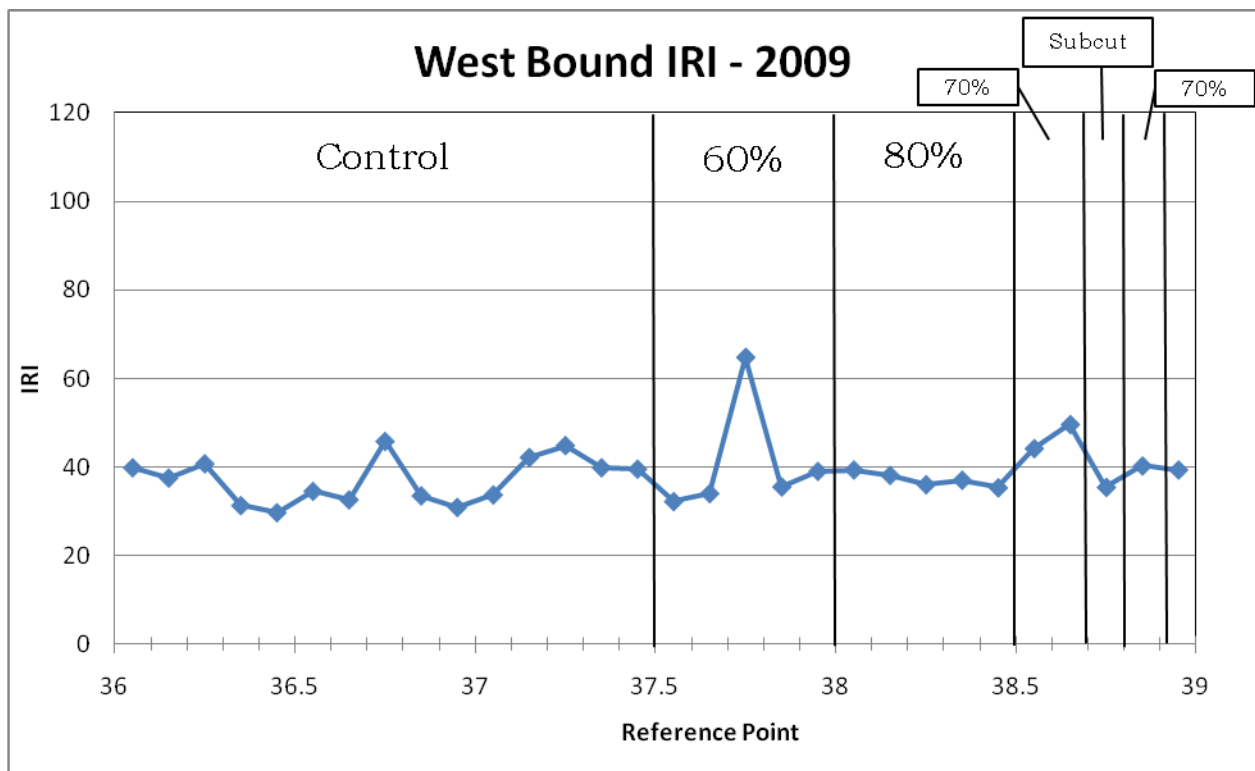
Figures 7, 8, 9, and 10 are a graphical representation of the IRI data that has been collected thus far. There doesn't appear to be a significant difference in the IRI between the test segments and control segments. There does appear to be a significant bump in the 60% salvaged HBP section in the west bound direction. It also appears that there may be a rough transition across both lanes at the boundary of the 70% salvage HBP segment and the Subcut segment.
