FINAL REPORT

Field Investigation of Warm Mix Asphalt Temperatures

Department of Construction Management and Engineering

NDDOT Research Project NDSU 11-02 SPR-R033(005)

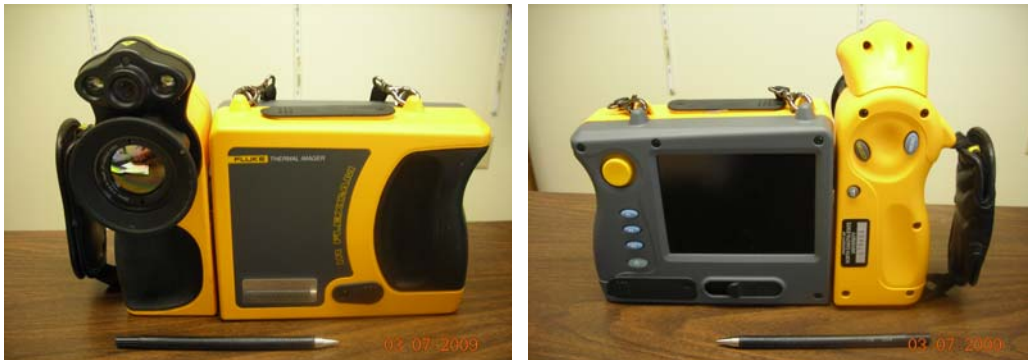
Figure 1. The infrared camera used (front and rear)

An infrared camera shown in Figure 1 was used to obtain thermal pictures of asphalt mat being paved. Starting at unloading of asphalt mix and ending at finish rolling, thermal pictures were taken at one fixed location each time, at the regular intervals in between start and finish of paving, corresponding to laydown and to the times immediately before and after each roller. The camera was mounted on a tripod, approximately five to ten feet from the edge of the pavement, and it was pointed at the right angle to the centerline of the road. The camera was often set up at locations where some physical marker, such as a survey station stake or milepost was present in the proximity. The camera location was also marked using on a handheld GPS receiver.

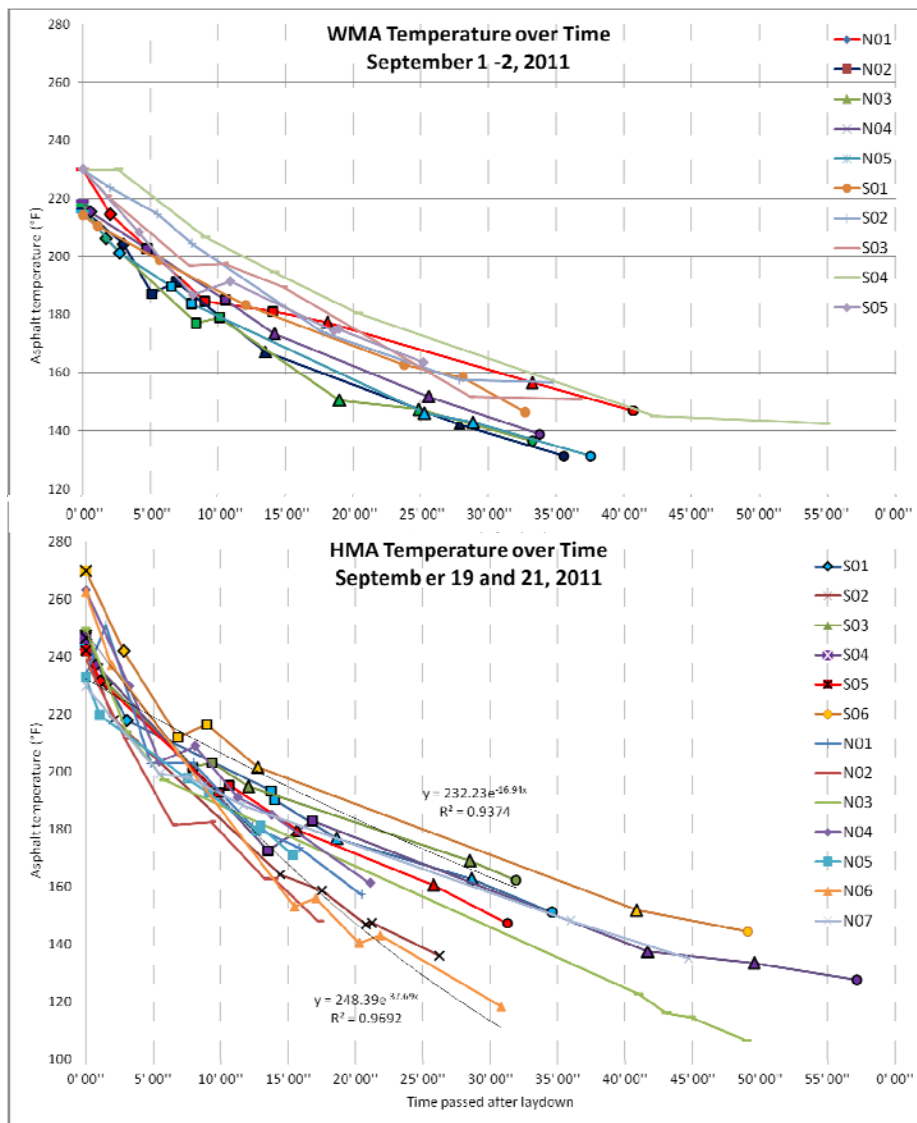
Figure 3. ND 3 WMA and HMA temperature change over time

Comparing WMA and HMA temperatures during ND 3 paving, shown in Figure 3, the following general observations are made:

- At laydown (behind the paver), WMA temperatures were lower: 223.2 °F for WMA; and 249.5 °F for HMA.
- At the end of breakdown rolling, WMA temperatures were higher than HMA: 194.5 °F for WMA; and 189.3 °F for HMA. This may be that WMA breakdown rolling lasted over 2 minutes shorter than HMA.
- WMA temperatures at each given step, e.g., laydown, were less variable than HMA temperatures at that step.

- WMA temperatures dropped by lesser degrees overall (from laydown till finish rolling): 78.8 °F drop for WMA; 99.3 °F drop for HMA. However, WMA took longer to be paved: 36.5 minutes for WMA; and 31.5 minutes for HMA. This means that WMA cooled more slowly than HMA.
- Temperature drops were more consistent with WMA (standard deviation 7.22 °F) than for HMA (st. dev. 22.2 °F). Also the overall time from laydown till finish was more consistent with WMA (st. dev. 7.5 min.) than for HMA (13.0 min.).

The change of WMA and HMA temperatures over time during ND 3 and ND 15 paving is shown in Figures 3 through 5. Temperatures in Figures 3 through 5 are average temperatures of freshly laid asphalts within the region of interest. As explained before, the region of interest is the asphalt mat area over the 12 feet lane width excluding the tapered edge. Each plotted line in Figures 3 through 5 corresponds to one fixed location at which temperature recording was performed, and marked points on the line represent the intervals at which thermal pictures were taken, e.g., behind the paver, immediately before breakdown rolling, etc. Note that average asphalt temperatures are plotted against time elapsed after laydown by the paver, rather than time elapsed after unloading – all thermal pictures of asphalts taken at the time of unloading can be found in Appendix. The reason for basing the elapsed time not off unloading is that average temperatures of unloaded asphalts tended to be lower than when the asphalts came out of the paver, which should not often be the case. Perhaps it is that a windrow of loose asphalts, formed during unloading, would not have a smooth surface. The surface texture of an object can significantly influence temperature calculation done by an infrared camera, which will “see” an object with the dull surface cooler than actually it is. The inaccuracy can be addressed by adjusting the emissivity value of an object to reflect its surface conditions, but this is not trivial for granular materials like loose asphalts not yet laid down.

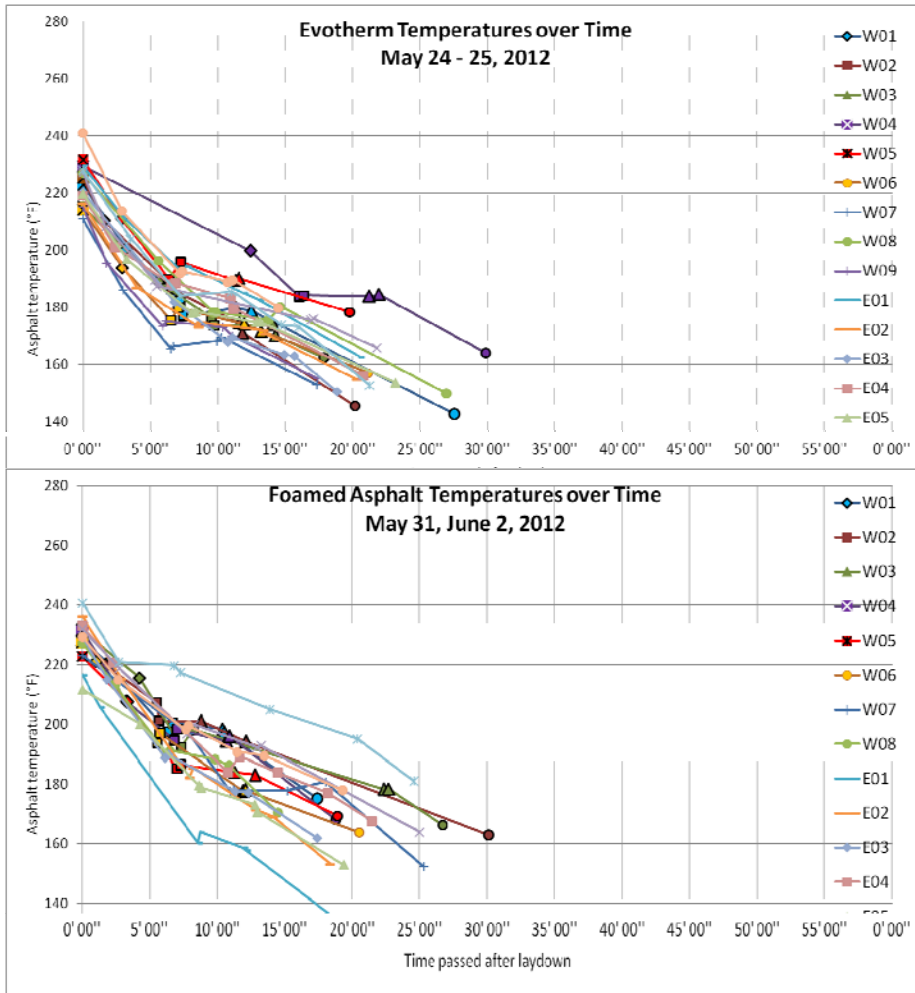
Figure 4. ND 15 WMA temperature change over time

Comparing WMA and HMA temperatures during ND 15 paving, shown in Figures 4 and 5, the following general observations are made:

- At laydown, WMA temperatures were lower: 223.1 °F for Evotherm; 228.0 °F for foamed asphalt; and 253.5 °F for HMA.
- WMA-Evotherm or foamed asphalt temperatures at each given step, e.g., laydown, were less variable than HMA temperatures at that step.

- WMA temperatures dropped by lesser degrees overall (from laydown till finish rolling): 65.3 °F for Evotherm; 64.5 °F for foamed asphalt; and 76.2 °F for HMA. WMA took just as long to be paved as HMA: 21.0 minutes for WMA, and 21.5 minutes for HMA. Since WMA temperatures dropped by smaller amounts over the time period just as long, it may be said that WMA cooled more slowly.

- WMA temperature drops were slightly more variable compared to HMA: standard deviation 8.64 °F for Evotherm, 9.64 °F for foamed asphalt, and 8.40 °F for HMA. Also the overall time WMA took from laydown till finish was slightly more variable, standard deviation 4.0 minutes for WMA and 3.5 minutes for HMA.

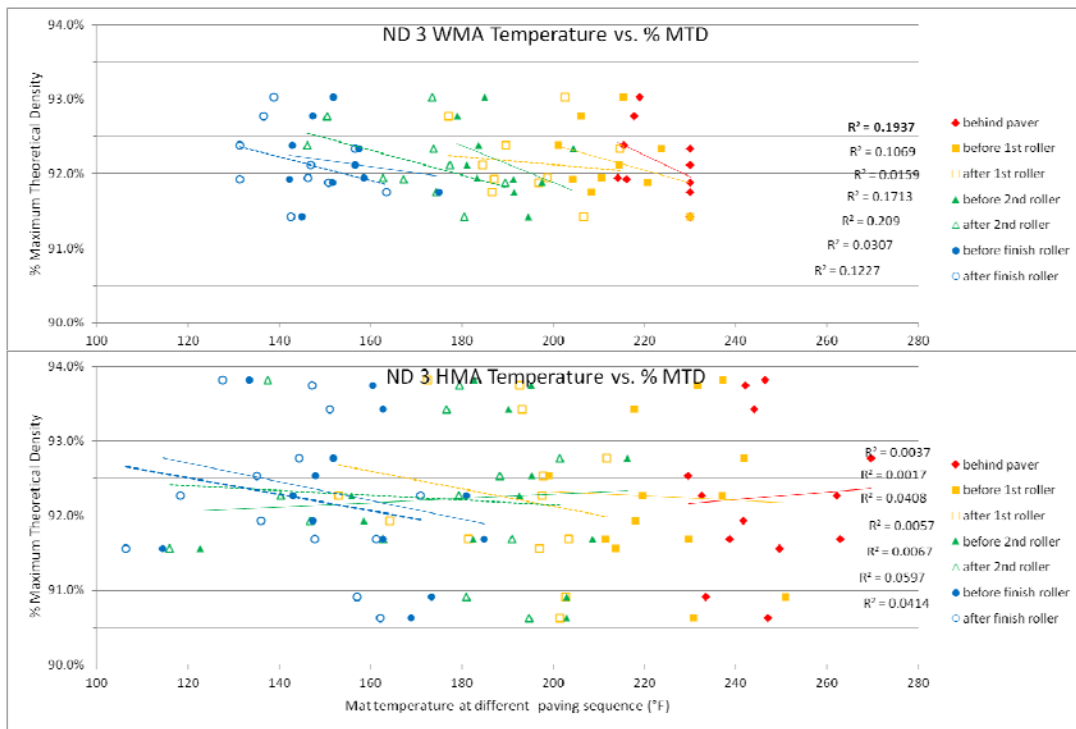
Figure 10. ND 3 asphalt temperature correlated to core density

Figure 10 shows that the correlation between core density and asphalt temperature recorded on ND 3 paving is very weak. This is also the case with ND 15 paving (see Figure 11). As such, field temperatures of asphalt mix, either WMA or HMA, are not a good indicator of the outcome of compaction – asphalt temperature alone cannot explain the resulting density. This conclusion is drawn based on density and temperature data from ten days of paving out of a total of twenty days of the entire paving. Also the density data used here for correlation analysis should be treated as an unbiased sample because core densities did not vary significantly from days of temperature recording to days with no temperature recording, as shown in Table 4 earlier. This means, for example, if asphalt temperature had been recorded on different dates and related to core densities from other days of paving than the present, any correlation may still be weak.

However, the conclusion should be considered only interim that there is no correlation between field asphalt temperature and density. One reason for qualifying the conclusion is that the density and temperature data analyzed here originated not from identical locations, but from locations in the proximity ranging from tens of feet to hundreds of feet. From the investigator's experience in the previous research, it is conceivable that there does exist some correlation between asphalt temperature and density but it requires the "right" field data to substantiate that relationship. The investigator had previously found a strong correlation (R^2 of over 0.9) between asphalt temperature and core density sampled at eight identical locations. Thus, the possibility of asphalt temperature influencing the ability to attain desirable density should not completely be disregarded despite the conclusion from this research leaning in the other direction.
