**ONSITE PCN 19207
WETLAND MITIGATION SITE
1st ANNUAL REPORT**

Project No.
AC-SOI-SCB-7-008(026)174

ND 50 to US 52
Burke County

NORTH DAKOTA DEPARTMENT OF TRANSPORTATION
BISMARCK, NORTH DAKOTA

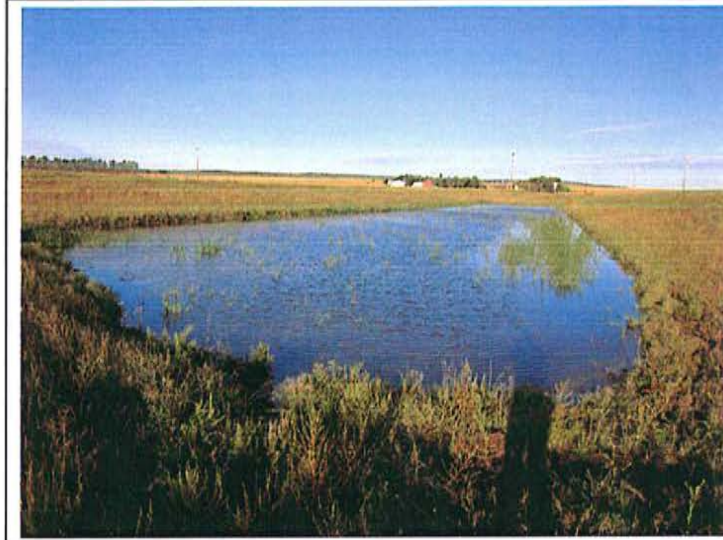
Adjacent Wetland #: Site 1
 Photo #: 1
 Observer: [REDACTED]

Location: Photo Point 1. View of Site 1 from NE corner.

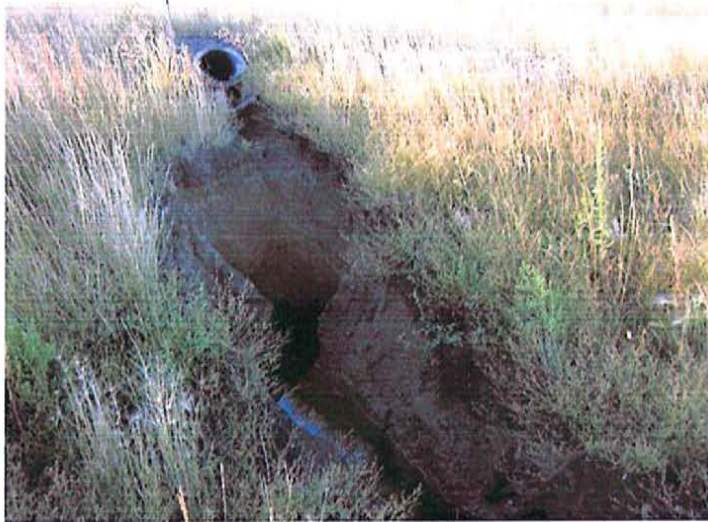
Adjacent Wetland #: Site 1
 Photo #: 2
 Observer: [REDACTED]

Erosion from the culvert (under ND 8) end sloping towards the Site is prominent as eroding back towards the culvert in the ND Highway 8 embankment. The erosional feature is 1.5-4 feet wide and 2-6 feet deep. Refer to Photo #2 taken at Photo Point 2. A second erosional feature is occurring on the west edge of the Site. This feature is 1-2.5 feet wide and 6 inches to 1.5 feet deep. Refer to Photo #12 and #13 taken at Photo Point 8.

Location: Photo Point 2. View of erosion below culvert flowing into Site 1 from the east under ND Highway 8.

NDDOT staff conducted a field review on 10/13/2015 and determined that the erosional features will not impede development of this site. NDDOT does not recommend remedial action at this time. However, NDDOT will review the site to determine best course of action moving forward.

NDDOT conducted a field review on 10/13/2015 and determined that the erosional features will not impede development of this site. NDDOT recommends no remedial action is required at this time. However, NDDOT will review the site to determine the best course of action moving forward.

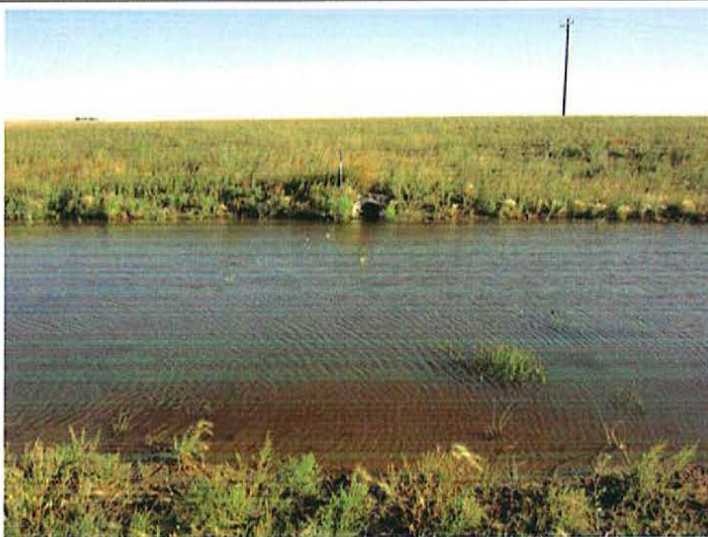
Adjacent Wetland #: Site 1
 Photo #: 3
 Observer: [REDACTED]

Location: Photo Point 3. View from NW end of peninsula in Site 1.

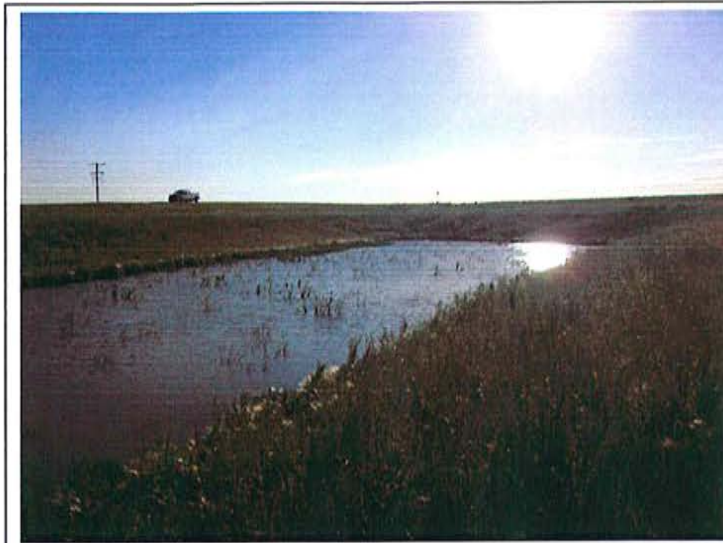
Adjacent Wetland #: Site 1
 Photo #: 4
 Observer: [REDACTED]

Location: Photo Point 3. View from NW end of peninsula in Site 1.

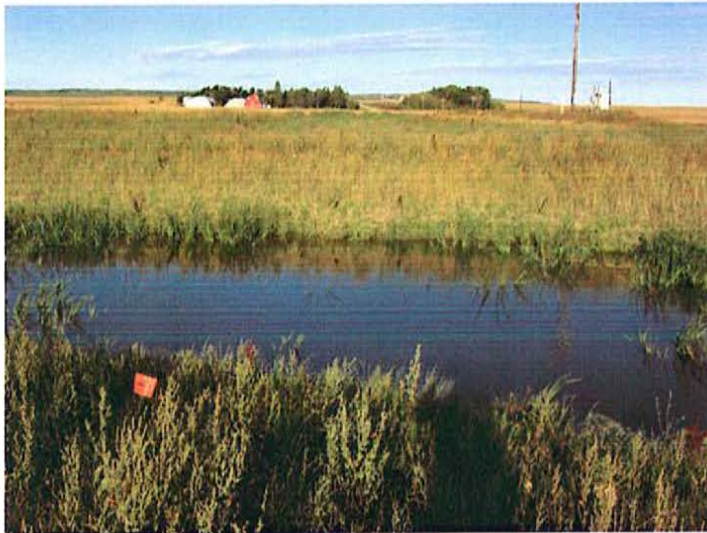
Adjacent Wetland #: Site 1
 Photo #: 5
 Observer: [REDACTED]

Location: Photo Point 3. View from NW end of peninsula in Site 1.

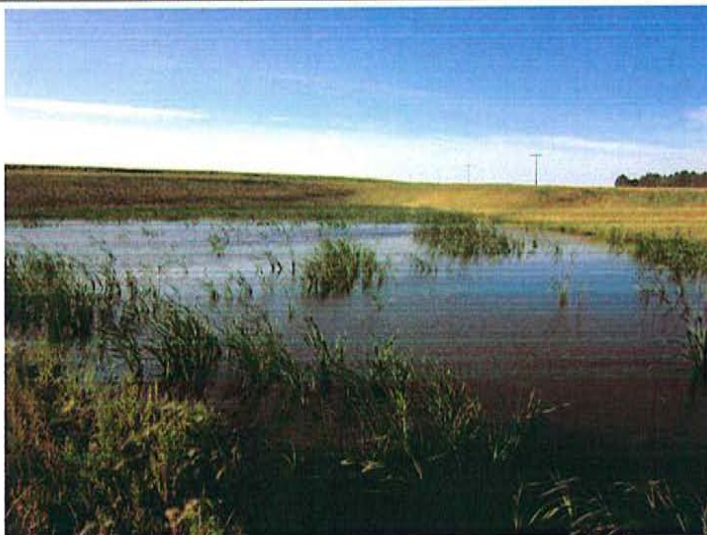
Adjacent Wetland #: Site 1
 Photo #: 6
 Observer: [REDACTED]

Location: Photo Point 4. View from SW end of peninsula in Site 1.

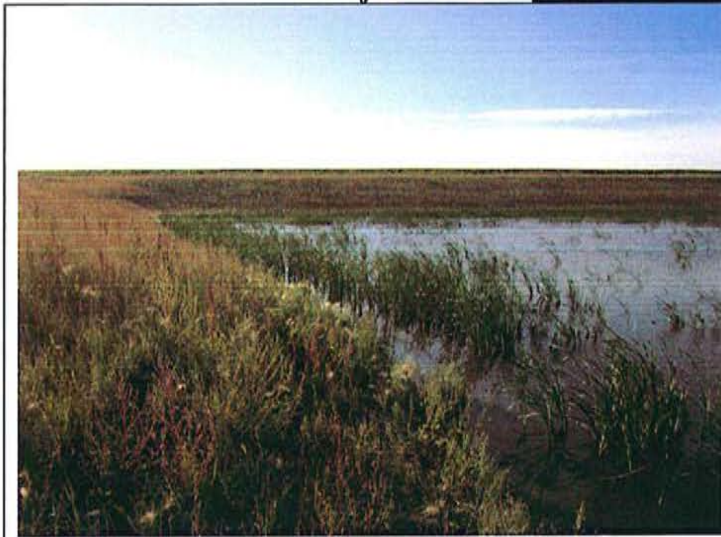
Adjacent Wetland #: Site 1
 Photo #: 7
 Observer: [REDACTED]

Location: Photo Point 4. View from SW end of peninsula in Site 1.

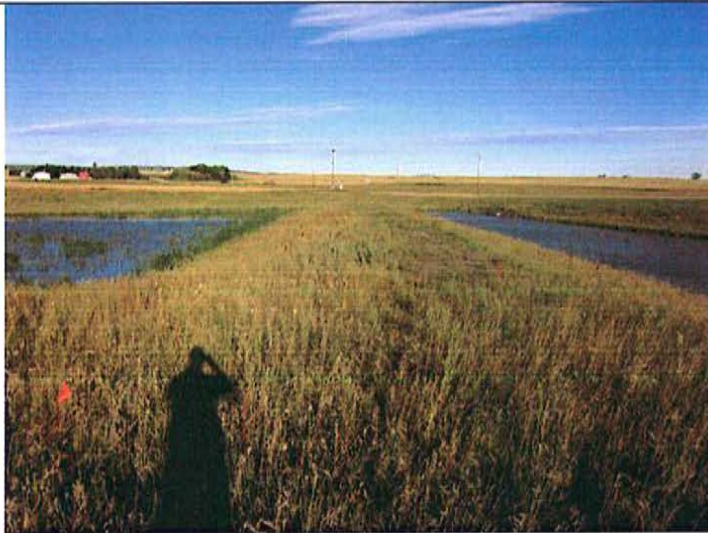
Adjacent Wetland #: Site 1
 Photo #: 8
 Observer: [REDACTED]

Location: Photo Point 5. View from east end peninsula of Site 1.

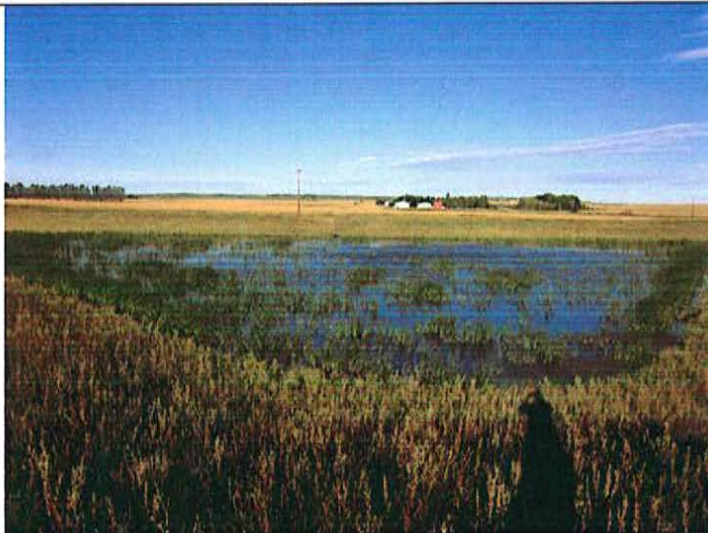
Adjacent Wetland #: Site 1
 Photo #: 9
 Observer: [REDACTED]

Location: Photo Point 6. View of south bay of Site 1 from NE edge of south bay.

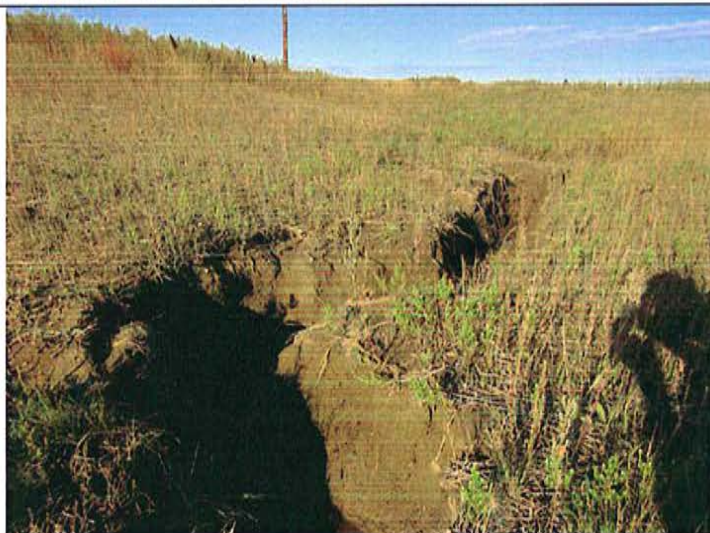
Photo #: 12

Location: Photo Point 8. Erosional feature forming on west edge of Site 1.

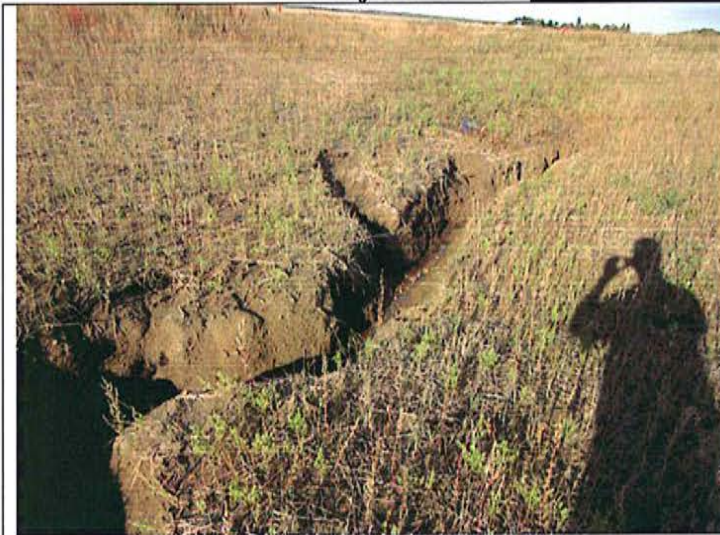
Adjacent Wetland #: Site 1
 Photo #: 13
 Observer: [REDACTED]

Location: Photo Point 8. Erosional feature forming on west edge of Site 1.

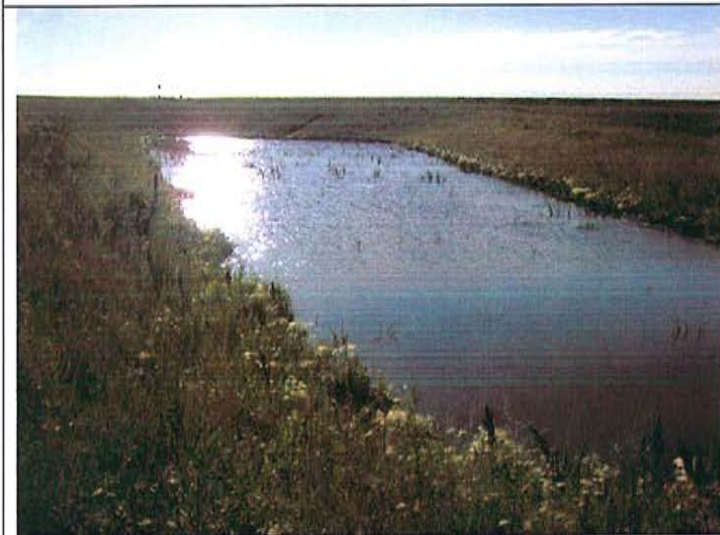
Adjacent Wetland #: Site 1
 Photo #: 14
 Observer: [REDACTED]

Location: Photo Point 9. View from NW corner of Site 1.

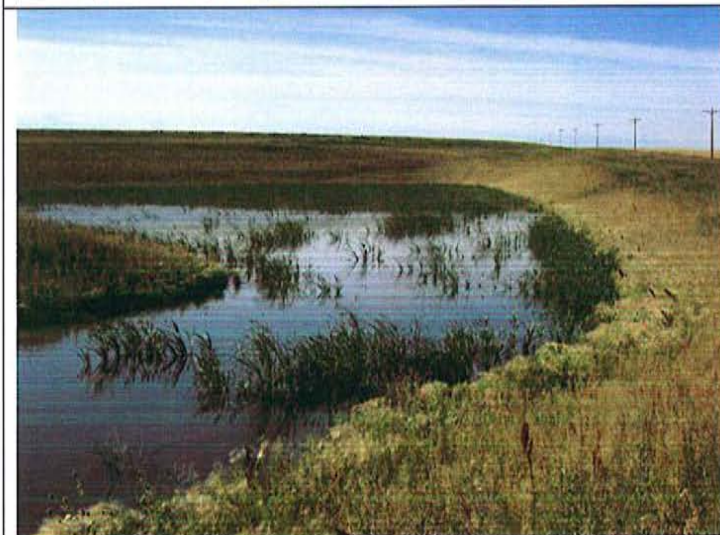
Adjacent Wetland #: Site 1
 Photo #: 15
 Observer: [REDACTED]

Location: Photo Point 9. View from NW corner of Site 1.
