NORTH DAKOTA
DEPARTMENT OF TRANSPORTATION

Experimental Study MR 2004-03

Evaluation of Rumble Stripes

AC-NH-2-281(025)049

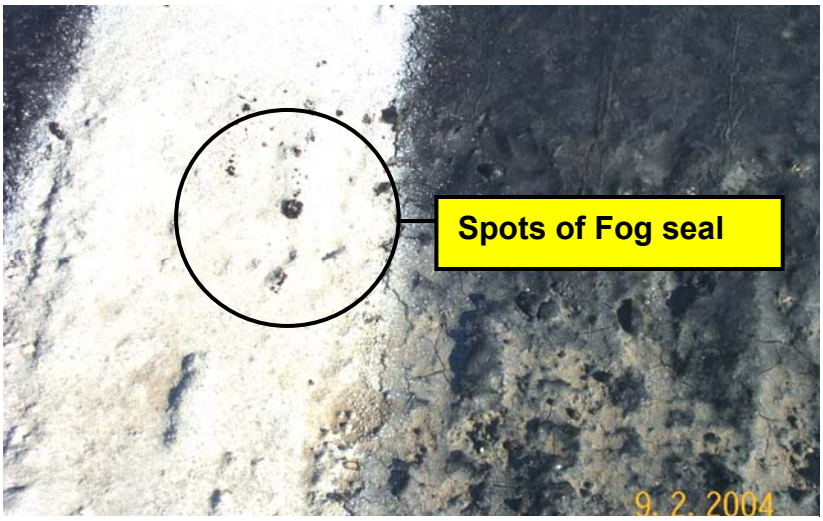
Materials and Research personnel evaluated the completed test section in the daylight on September 2, 2004. The change in location of the edge line did not appear to be a distraction. The edge line showed up well and its appearance wasn't much different from any other edge line. On closer inspection, some isolated spots of thick fog seal had bled through to the surface of the water-based paint, see Photo 2. On later inspections, these areas appeared to be cracking and some pieces of paint had flaked-off, indicating a failure of the pavement marking to bond to the pavement surface. This appeared to occur only in the areas with unusually thick fog seal material, see Photo 3.

Photo 2 – Spot of fog seal that bled through to the surface of the marking.
