# ***Asbestos Survey Report***

Edgewater Country Club  
Asbestos Inspection  
New Town, North Dakota

Prepared for:  
North Dakota Department of Transportation  
608 East Boulevard Avenue  
Bismarck, North Dakota 58505-0700

Prepared by:  
KLJ  
4585 Coleman Street  
Bismarck, North Dakota 58503

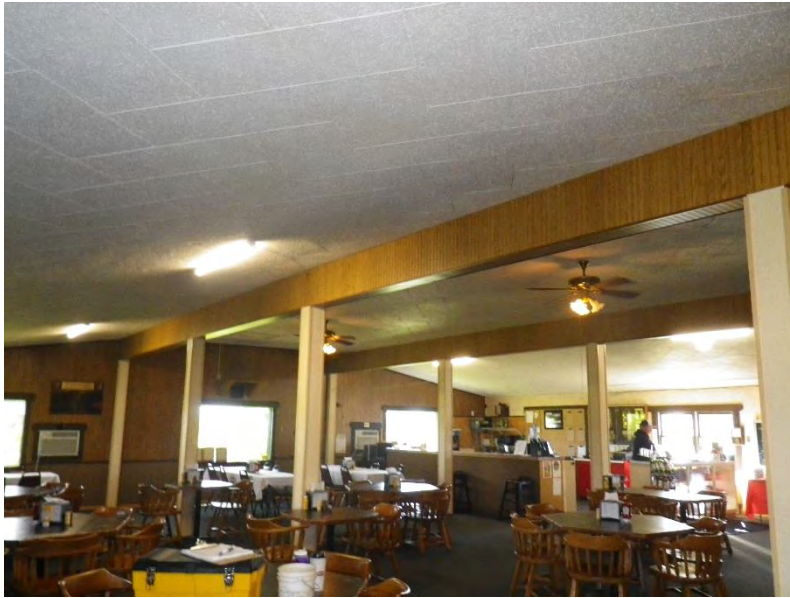
**Photograph #816**

<b>Building:</b>	Edgewater Country Club	 
<b>Date Taken:</b>	May 18, 2017	
<b>Description:</b>	Main Dining – General Overview

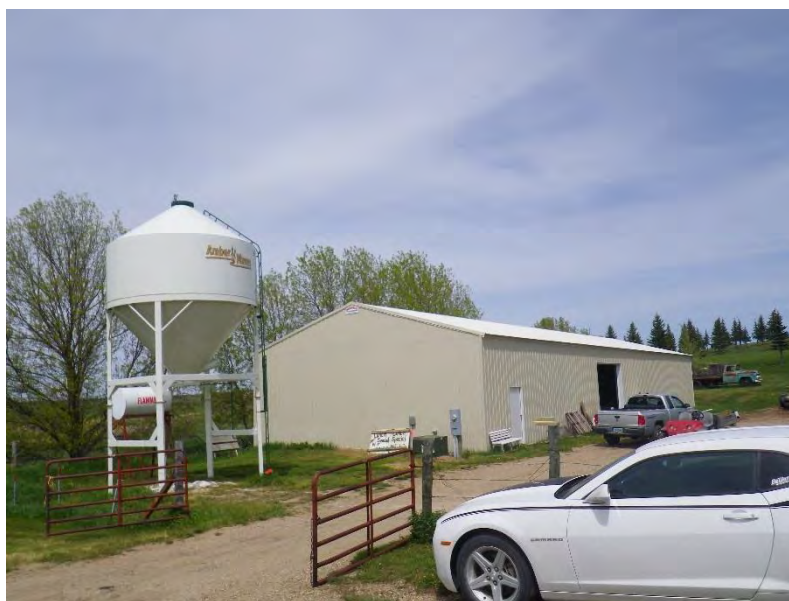
**Photograph #851**

<b>Building:</b>	Edgewater Country Club	No samples taken
<b>Date Taken:</b>	May 18, 2017

<b>Description:</b>	Pole barn

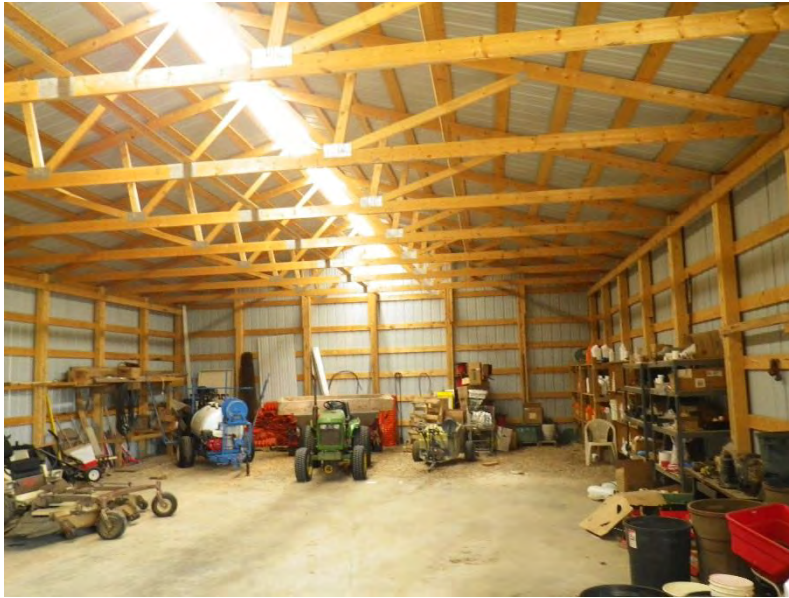
Photograph #849

Building:	Edgewater Country Club	No samples taken
Date Taken:	May 18, 2017

Description:	Pole barn interior

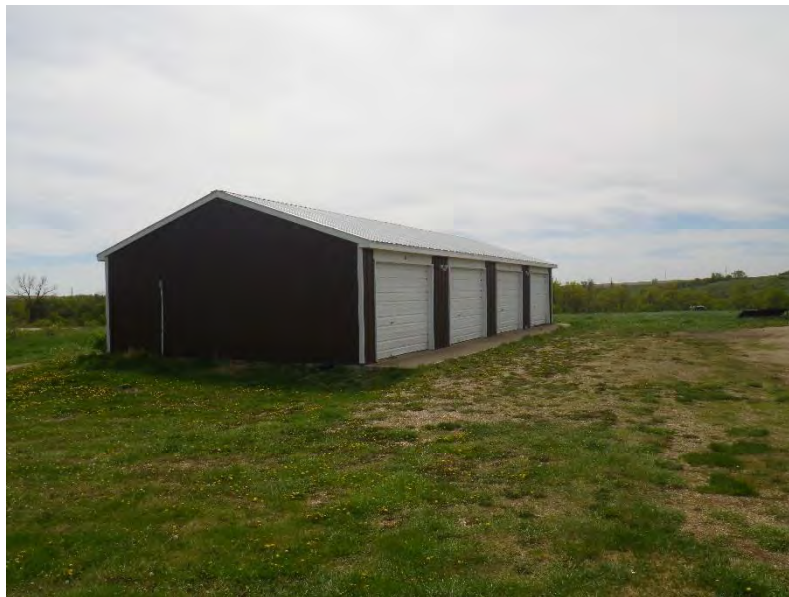
Photograph #856

Building:	Edgewater Country Club	No samples taken
Date Taken:	May 18, 2017
