NORTH DAKOTA  
DEPARTMENT OF TRANSPORTATION

Experimental Study ND 2013-03

*Spraywall Pipe Liner*  
**Evaluation**

SOIA-5-094(084)023

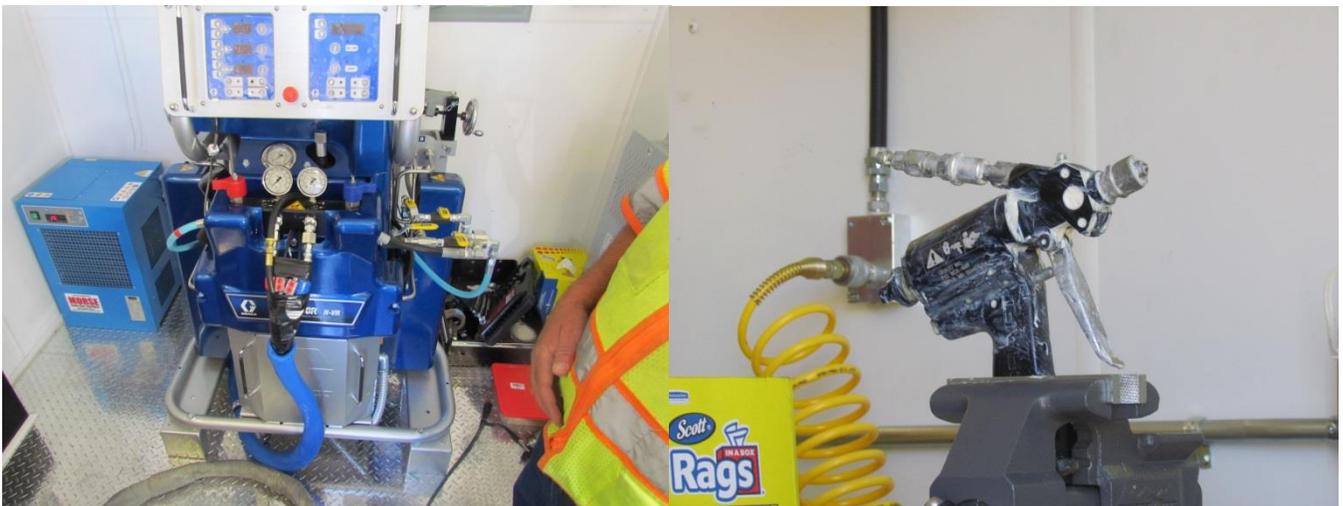
Spraywall is a two-part polyurethane, components A and B. Components A and B are located in an enclosed trailer with a specialized pump for pumping and metering the components to a spray gun/nozzle. The hose used to transfer the components from the pump to the spray nozzle is heated to control the temperature of the components as

Photo 6 – Pump and spray nozzle used for Spraywall application.

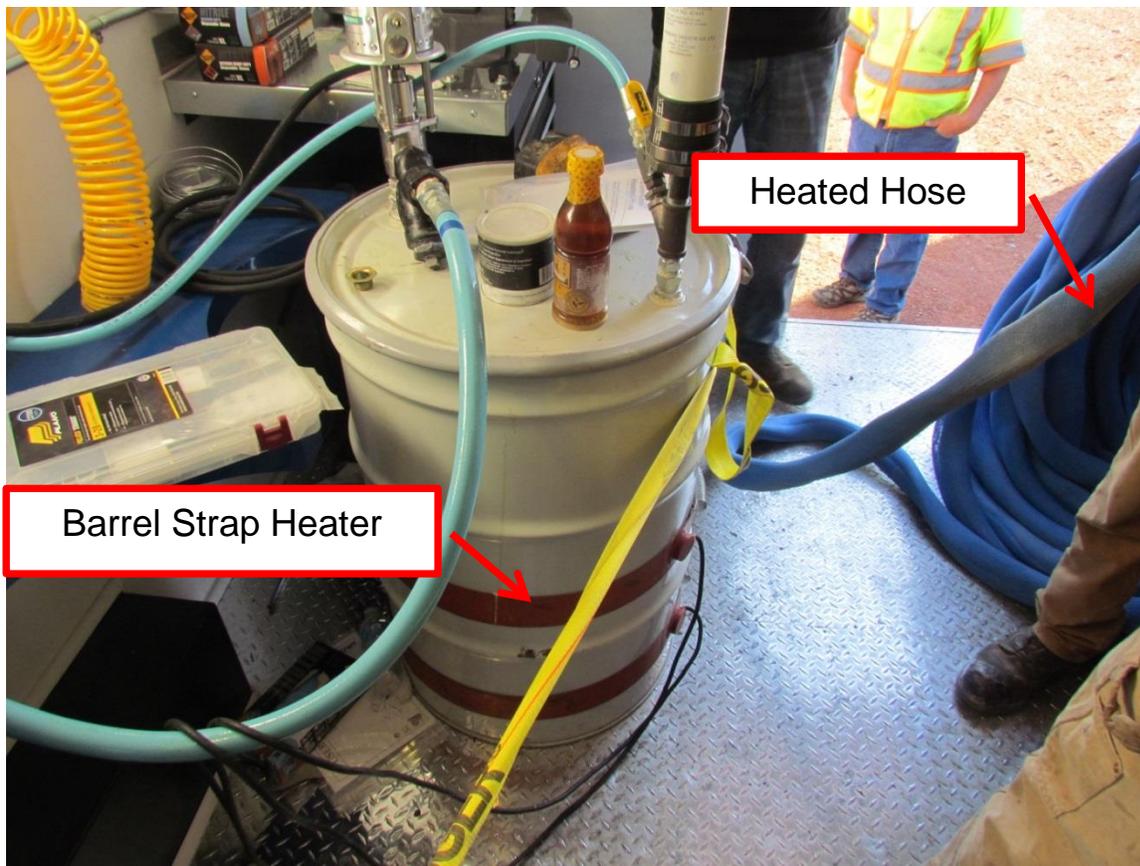
they travel to the nozzle. The components are delivered and stored in steel barrels. The barrels can be heated to ease the flow of the components through the pump. The components are sensitive to temperature and pressure. These specialized instruments help control the pressure and temperature for a smooth application of the product.

Photo 7 – Temperature controls used with the Spraywall application.

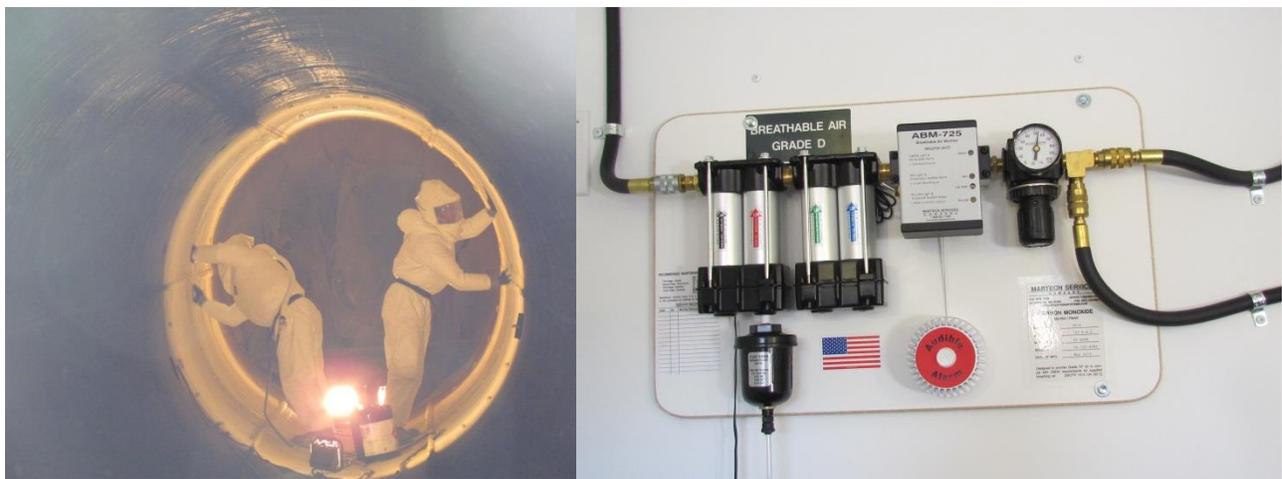
Contactors wishing to use Spayroq products must become Sprayroq Certified Partners (SCP). To achieve SCP, personal must complete training how to use Sprayroq products. The heat and the fumes produced from the application of the Spraywall required full body suits. Within the suit, breathable air is provided to the applicator from the enclosed trailer.

Photo 8 – Full body suit and breathable air regulator.

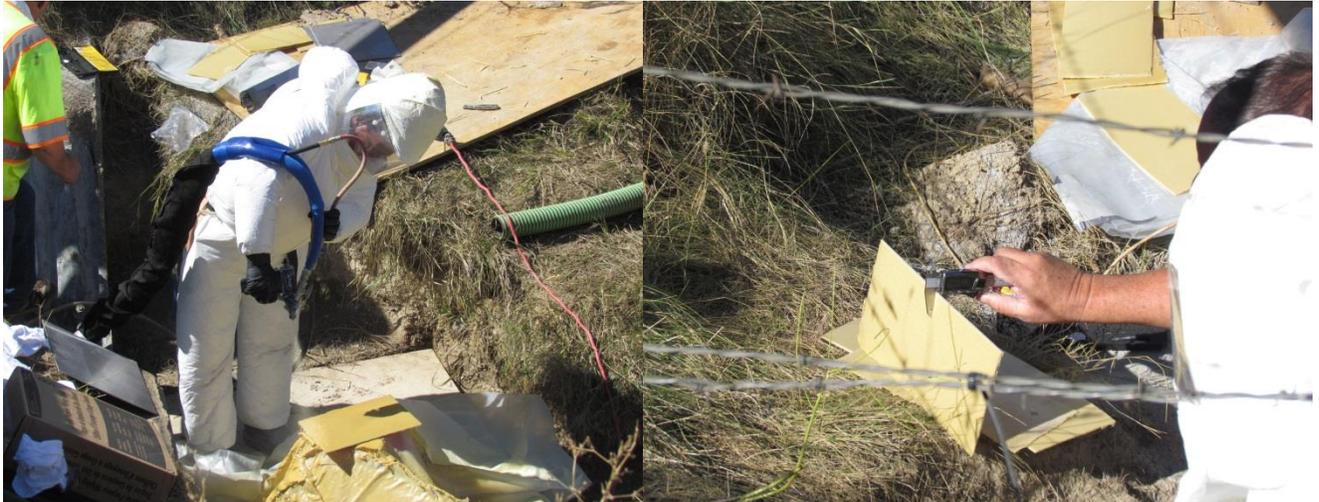
The Spraywall application began on September 11, 2013. Prior to any application of Spraywall to the pipe a test panel was applied with Spraywall to adjust the equipment and spray passes to achieve the correct thickness. The test panels have a wax release agent to allow the Spraywall material to be removed.

**Photo 9 – Spraywall test panel and thickness measurement.**

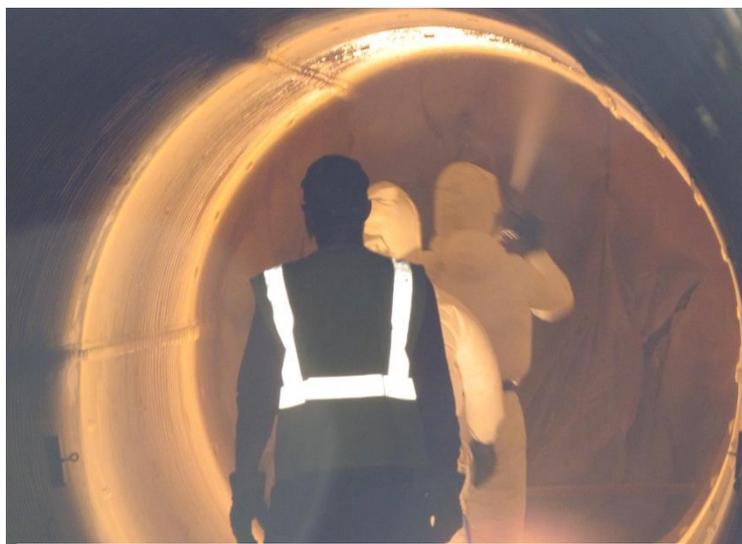
After the test panels have been completed the contractor began application of Spraywall to the pipe. The contractor would mark the pipe every 12.5' with a marker. This was used to aid the contractor in knowing how much material was being used, with the amount of passes used to cover the area. Photo 10 displays the contractor applying the Spraywall liner onto the pipe.

**Photo 10 – Application of Spraywall.**

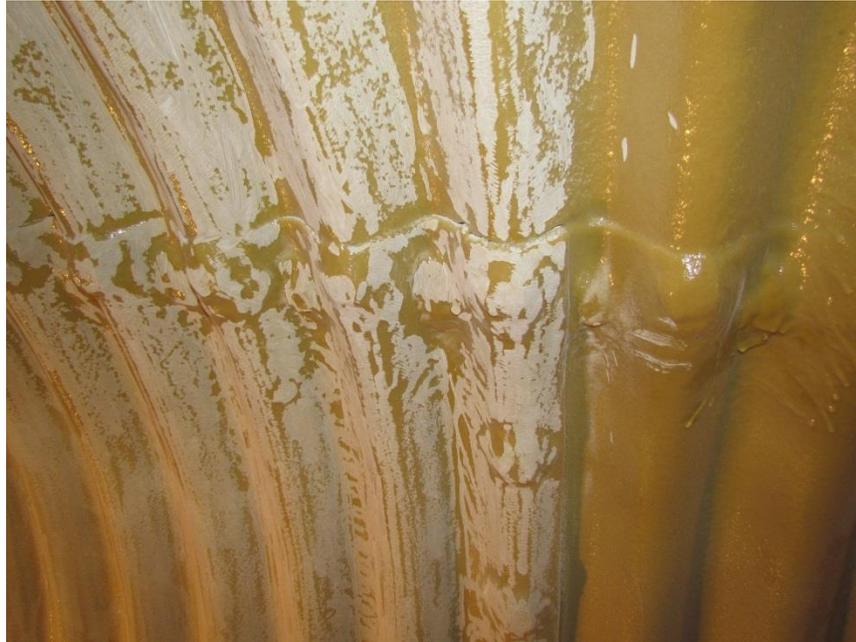
The contractor was unable to complete the installation within one day. This required the contractor to quit and begin the process the following day after the Spraywall liner has cured. To begin the installation the following day the Spraywall liner is overlapped over the existing Spraywall liner. The Spraywall liner being overlapped is scuffed for proper adhesion with wire brush attached to a grinder as shown in Photo 11.

**Photo 11 – Spraywall Liner scuffed for overlap preparation.**
