Experimental Study ND 92-02

**Evaluation of Stratagrid's A-100
Ability to Strengthen an Asphalt Overlay**

Final Report

Projects
ST-6-032(017)191 & NH-4-002(046)130

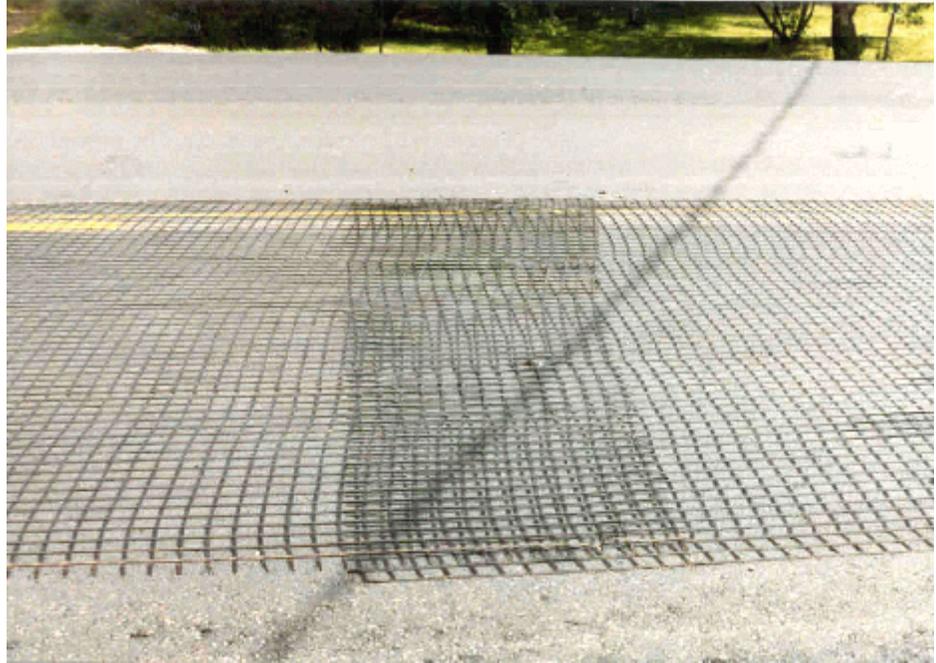
started it became necessary to overlap the geogrid ends. In this case a minimum of 20" was used as shown in photo 3.

Photo 3. View of the geogrid overlap.

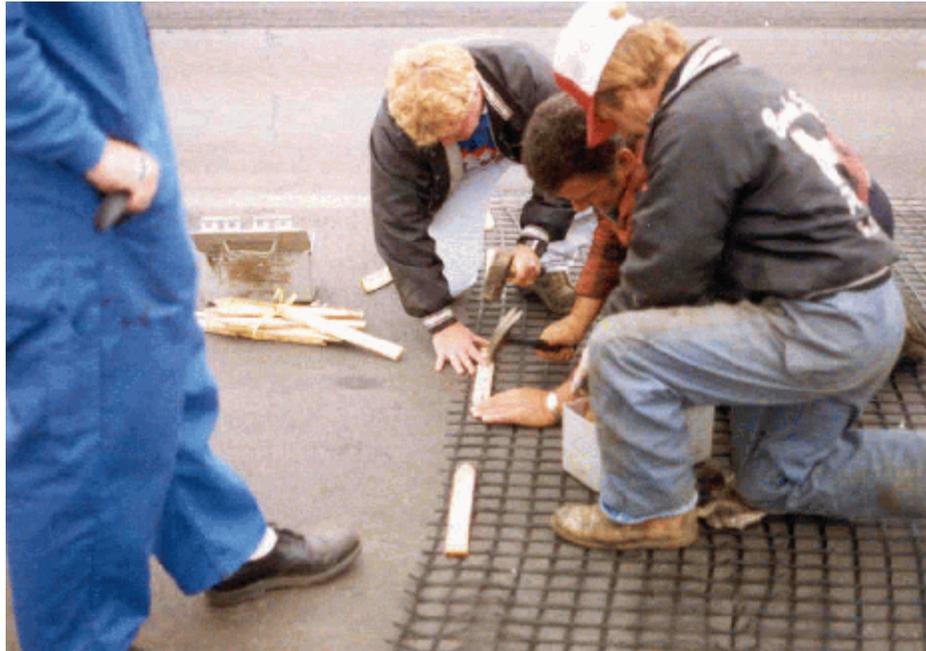
Photo 7. View of the lathe-nail system.

Highway 2 from station 150+00 to 156+00. Many of the construction practices that were applied to project ST-6-032(017)191 were applied on this project also. One exception to the Edinburg project was in the fastening of the geogrid to the leveling course prior to the laying of the final lift. A lathe-nail system was used for this purpose as opposed to u-shaped nails. The lathe-nail system is shown in photo 7. There were also similar problems encountered with the geogrid sticking to the wheel of the paver. The tack coat material when applied, formed a sticky surface on the fabric which in turn adhered to the paver wheels. As a result the fabric would lift up allowing the asphalt to work its way under the fabric. There was one incident where the fabric actually lifted high enough that the fabric climbed up onto the wheel of the paver.

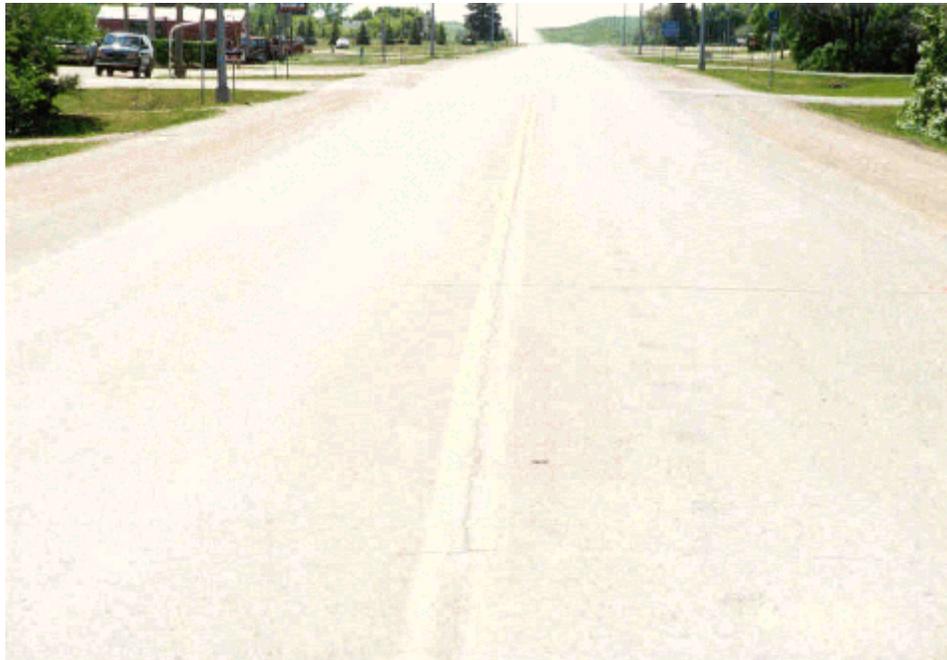
In general the distresses do not appear to be getting worse in the test section. Materials and Research registered approximately 9 full length transverse cracks, 3 half-length transverse cracks, and 1 longitudinal crack in the test section. Photo 8 is an overview of the test

Photo 8. Overview of the test section looking north.

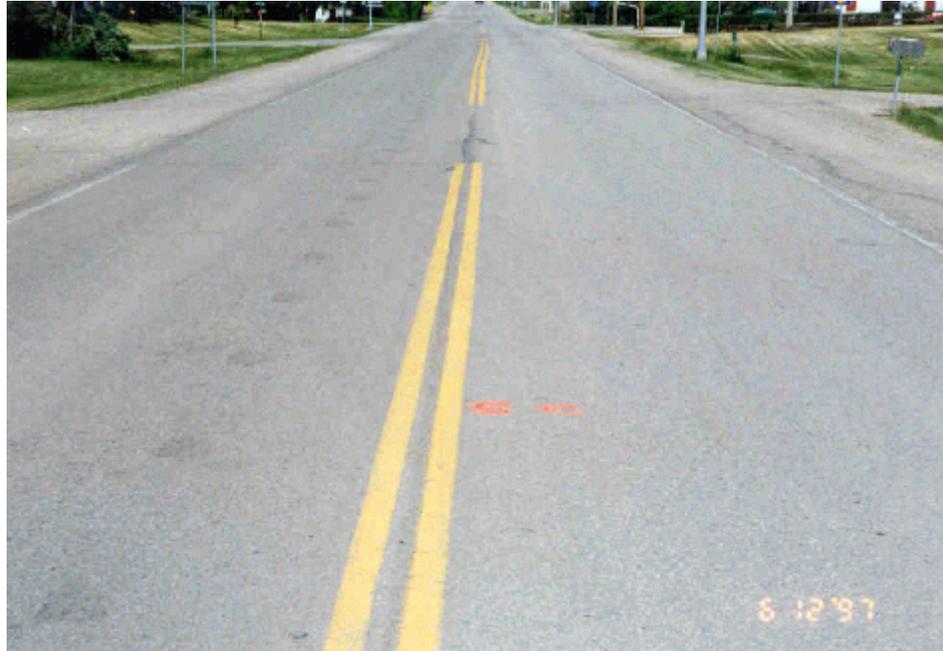
The control section registered approximately 32 transverse cracks, 16 of which were characterized as full length. There were also 7 longitudinal cracks of various lengths.

Photo 12. View of the control section looking north.

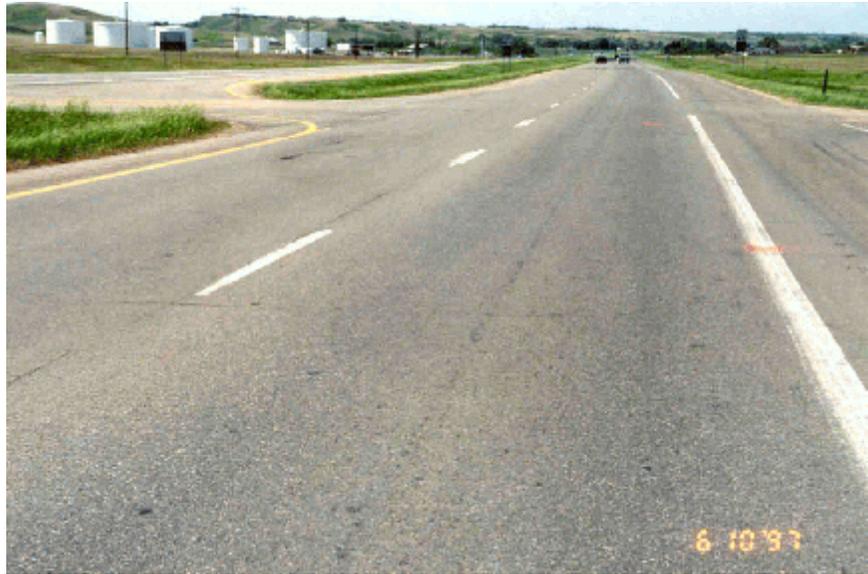
The test section registered nine full length transverse cracks and one longitudinal crack approximately 30' in length located along one of the shoulders. Photo 17 shows a view of the Stratagrid test section. Photo 18 shows a view of a typical crack in the test section.

Photo 17. An overview of the stratagrid test section

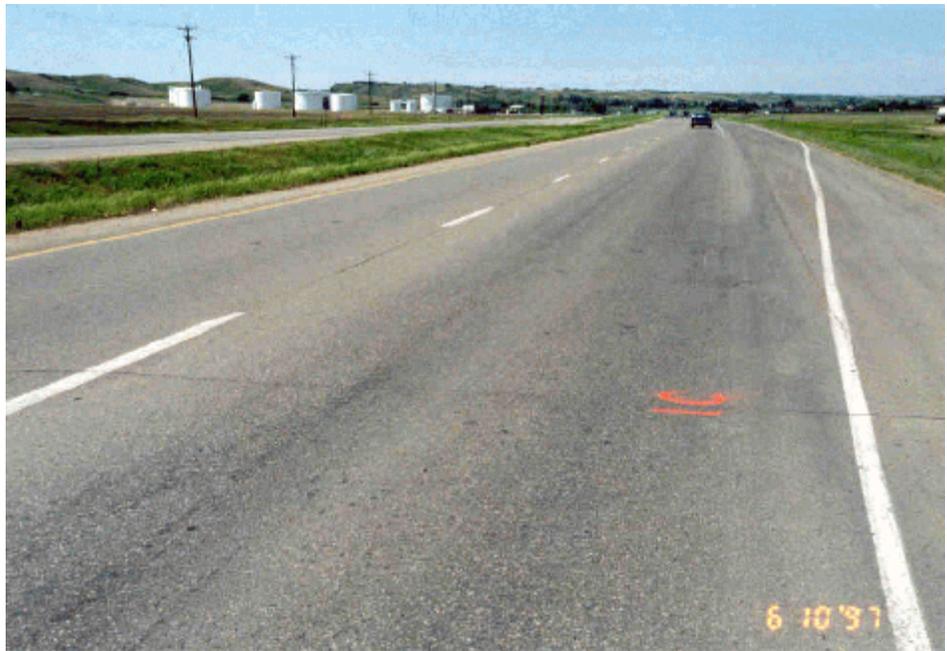
Photo 21 shows an overview of the east control section. The east control section registered 12 full transverse cracks and a 30' longitudinal crack in the shoulder. Photo 22 shows a typical crack located in the east control section.

Photo 21. An overview of the east control section.

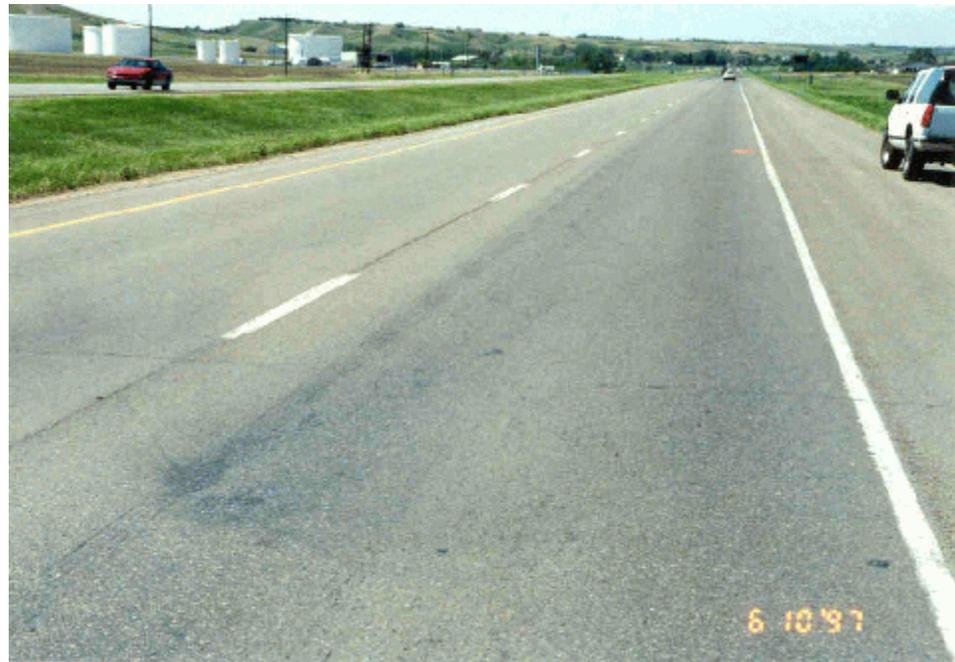
Photo 23 shows an overview of the west control section. The west control section registered eight full transverse cracks and a 30' longitudinal crack in the passing lane. Photo 24 shows a typical crack located in the west control section.

Photo 23. An overview of the west control section.
