**NORTH DAKOTA
DEPARTMENT OF TRANSPORTATION**

Experimental Study ND 95-03

Dowel Bar Retrofit for Load Transfer

Final Report

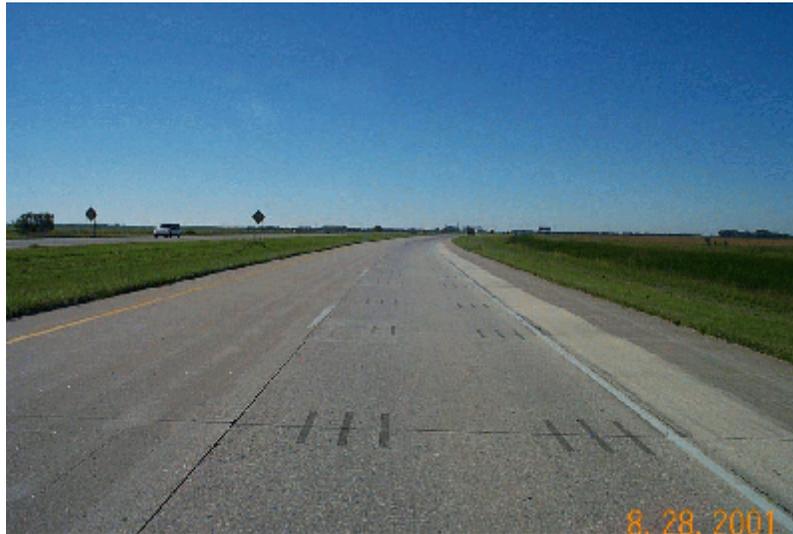
Photo 2 depicts an overall view of the dowel bar retrofit test section. This photo indicates a segment of the test section where Patchroc 10-60 had been installed as the patch mix.

Photo 2. An overall view of the dowel bar retrofit section.
