**NORTH DAKOTA
DEPARTMENT OF TRANSPORTATION**

Experimental Study ND 96-01

**Evaluation of "Wasser" Single Component
Moisture Cured Polyurethane Paint
for Bridge Maintenance Overcoating**

Project IM-1-094(017)156

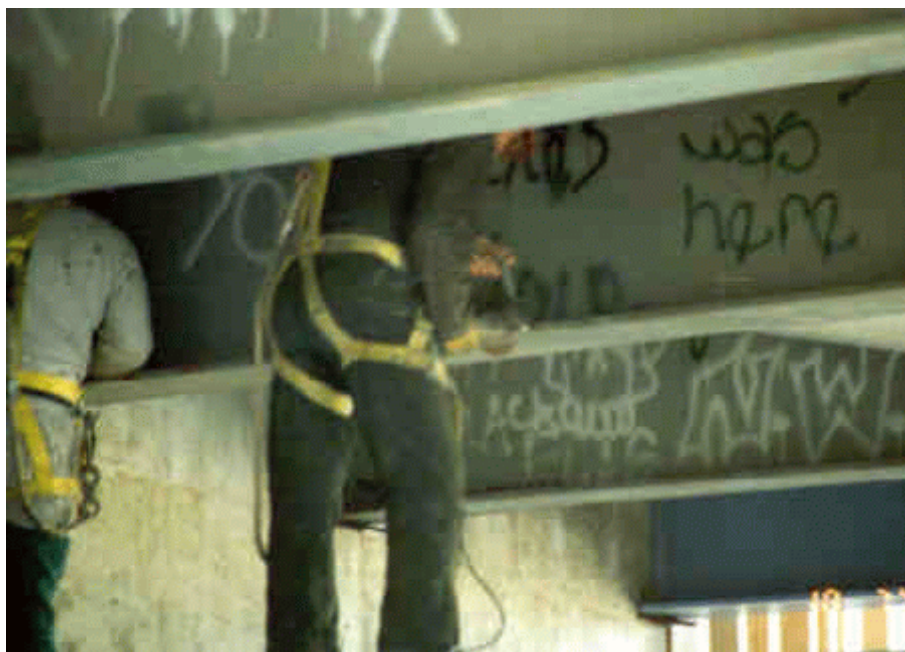
very well. Photo 6 exhibits one of the exterior beams after it has been washed with the high pressure washer. This is an area that requires spot grinding with a power hand grinder. This operation is depicted in photo 7.

Photo 7: View of worker spot grinding.

This operation also proceeded very well with no complications. The spot priming operation was able to begin October 5 and no problems were encountered. The spot primer was applied with brushes. Photo 8 shows an area after the spot primer had been applied.
