**Evaluation of Portland Cement Concrete
as a Rehabilitation Option for
Overlaying an Existing Asphalt Roadway**

Final Evaluation Report

Project NH-2-052(012)244

April 2009

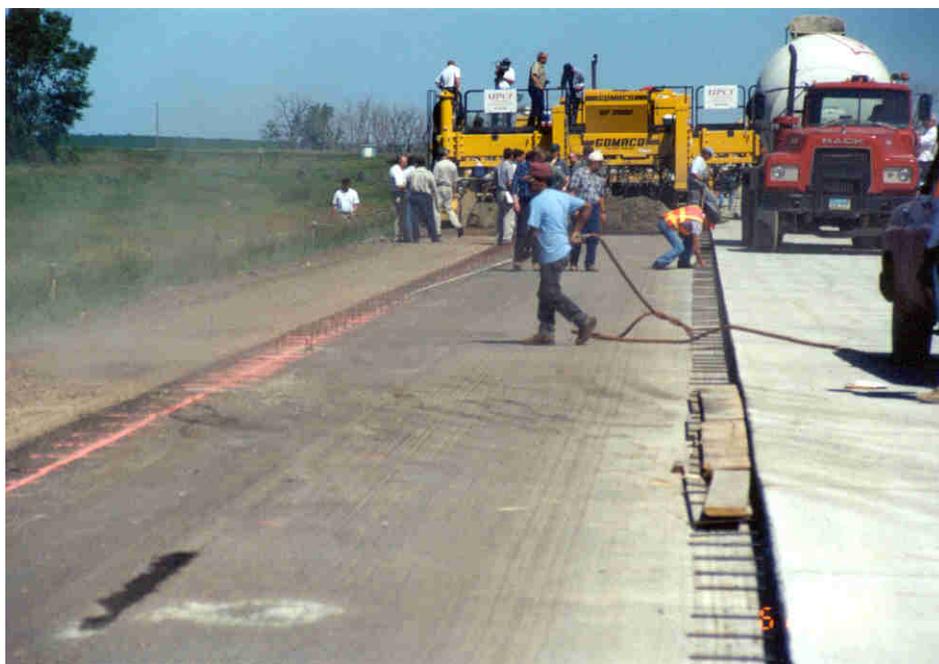
On June 25, 1998 the contractor began paving the southbound lane. A research team from the NDDOT again visited the site to monitor and evaluate the construction of the other half of the whitetopping test sections. Photo 5 is an overall view of the paving operation in the southbound lane.

Photo 5 - Paving operation in southbound lane.
