Experimental Study ND 07-01

**High Density Polyethylene Pipe**

**4th Evaluation**

Project AC-HPP-NH-5-012(031)054

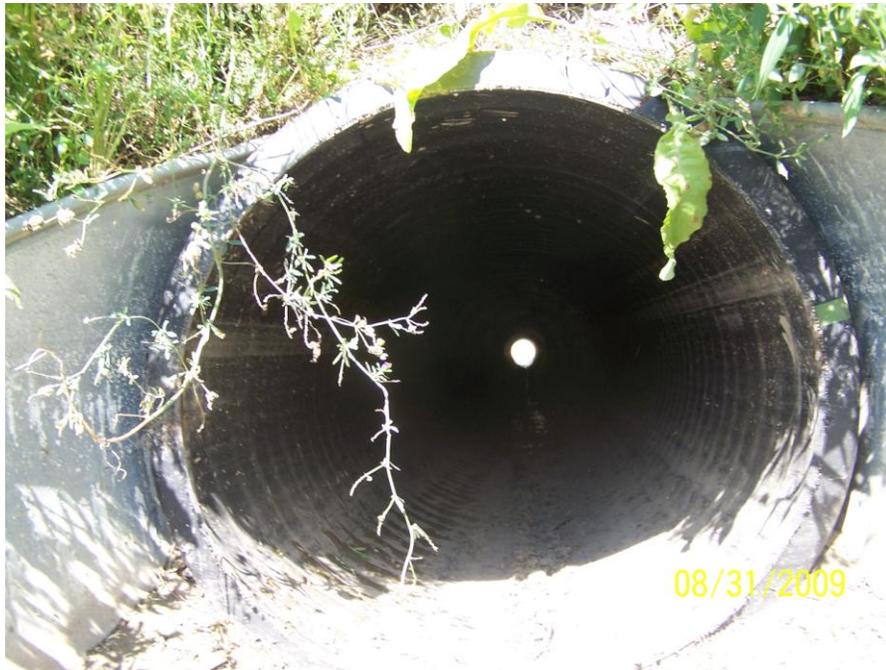
Materials and Research personnel, along with the pipe manufacturer's representative, mandrel tested the HDPE pipes on 08/31/2009. The representative provided three mandrels sized 5% less than the nominal diameter of the 18", 24", and 30" pipes. A lath (cut to 5% less than nominal diameter) was used to evaluate the 30" HDPE pipes because the 30" mandrel measured 27.11" which was less than the required 28.5 in. Included is the mandrel testing field notes from 2009. Table 4 has the summarized results of all of the mandrel testing.

The areas where the mandrel did not pass through were usually near a pipe joint.
