Geotechnical Evaluation Report

CERP-0221(085) PCN 24082
CR 21, North of Bayshore Resort
Barnes County, North Dakota

Re: Geotechnical Evaluation
CERP-0221(085) PCN 24082
CR 21, North of Bayshore Resort
Barnes County, North Dakota

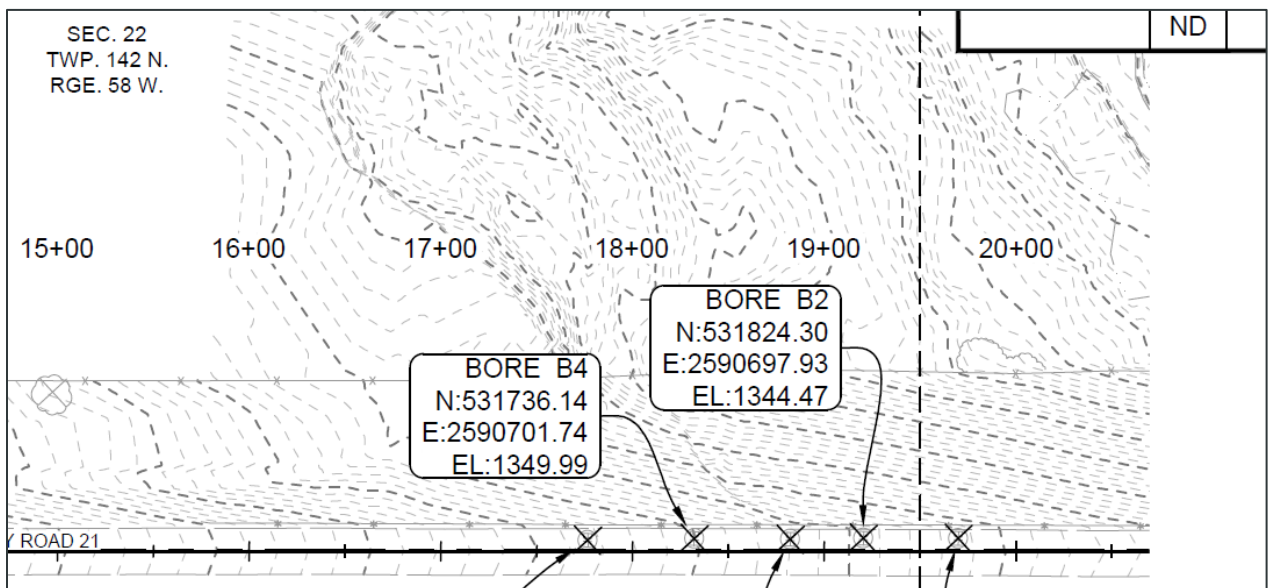
Figure 1. Topographic Map Excerpt

The embankment has a culvert which allows water from an intermittent stream to pass below the road. There is up to 35 feet of relief between the roadway and the intermittent stream. The instability that is impacting the west embankment is part of a larger landslide to the southwest of the embankment. KLJ surveyed the area and measured the inclination of the slope to the west that was about 3-horizontal to 1-vertical. As seen in this excerpt from the topographic survey, the transition area becomes hummocky and less uniform past the right of way to the north.
