SPRAYWALL PIPE LINER

Office of Project Development (OPD)
Conference

Kyle Evert
NDDOT - Materials & Research
Division

PROBLEM – DETERIORATED PIPE WEST RIVER ROAD INTERCHANGE

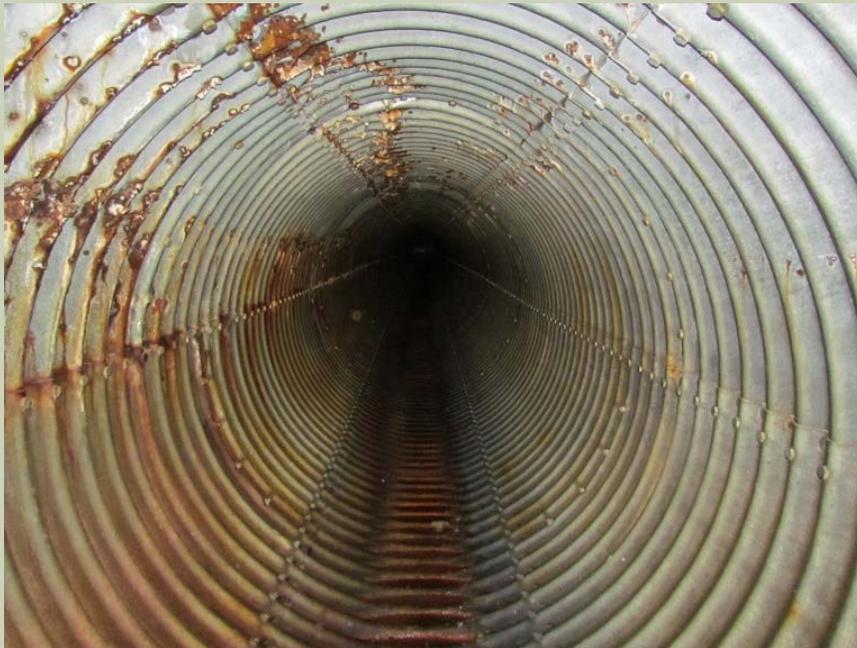
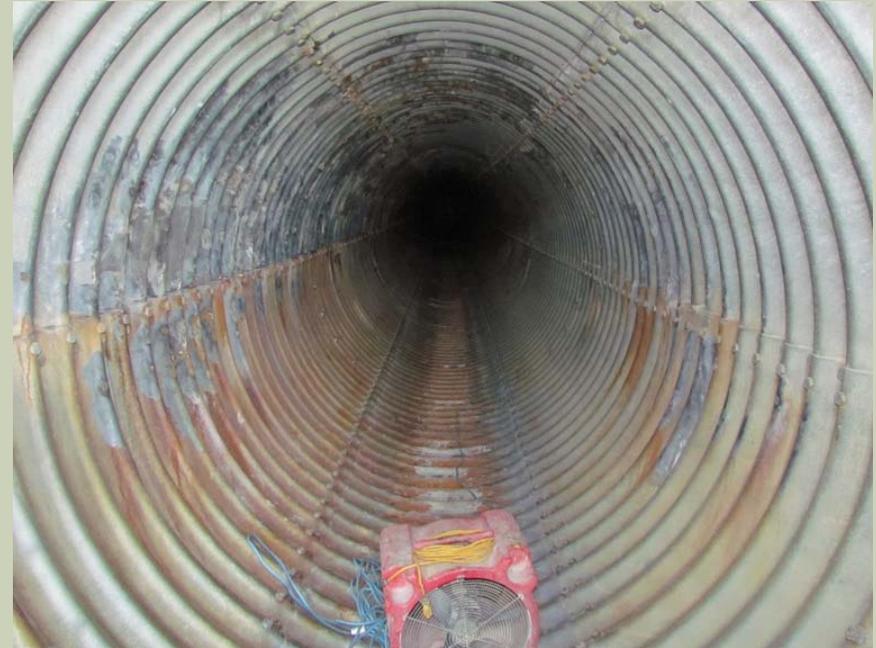
BEFORE AND AFTER PIPE PREPARATION

- Dewatered the pipe
- Removed the corrosion
- Sealed deteriorated holes caused by corrosion
- Heated the pipe to optimal temperature for SprayWall installation

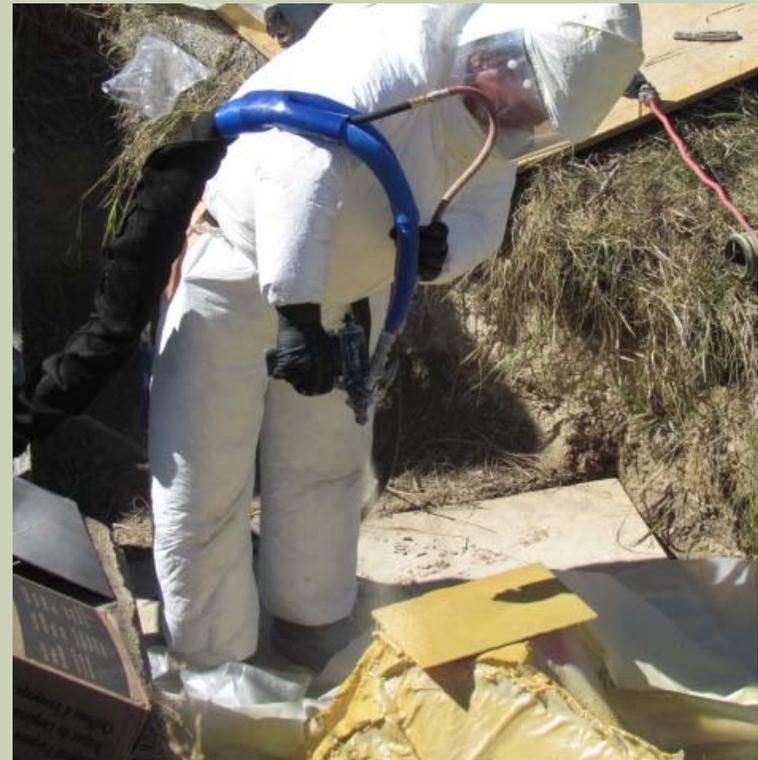
SPRAYWALL INSTALLATION

- Technician wore a Tyvek suit and mask
 - Fresh Air
 - Cooler temperature
- Test Panel
 - Used to find correct application rate.
 - Performed Daily
 - If weather conditions change multiple test panels may be performed

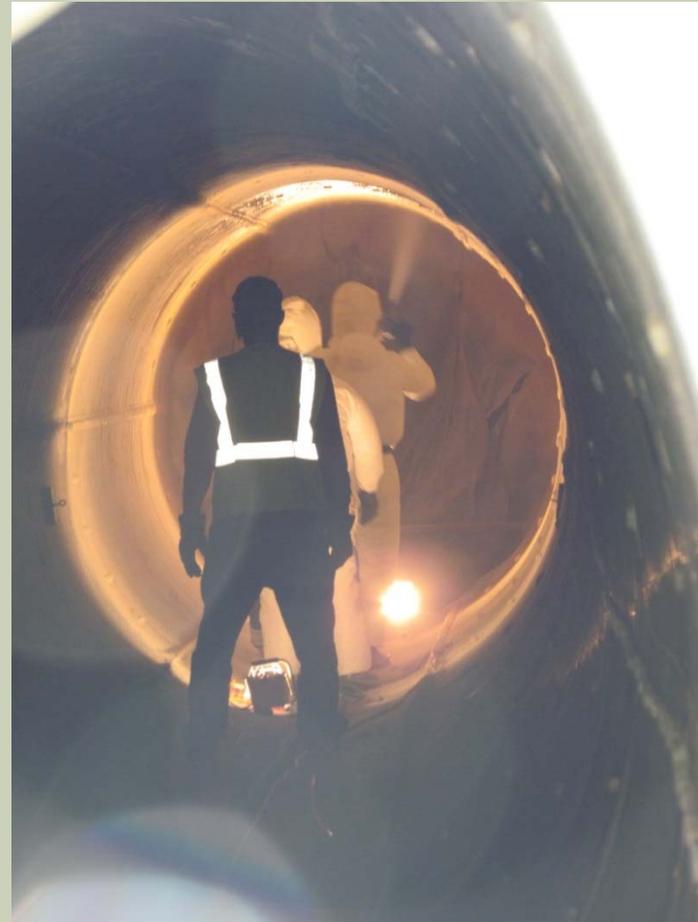
SPRAYWALL INSTALLATION

- Pipe must be completely dry
- Can be applied during winter months
 - Hose transferring 2-part polyurethane is heated
 - Inside of pipe is also heated
 - Water near entrance is frozen
