| IDENTIFICATION | |
|---|---|
| (8) Structure Number | 0022-081.376 |

| CLASSIFICATION | |
|---|--|
| (90) Inspection Date | 09/2020 |

**Bridge #0022-081.376(Routine)
ND HIGHWAY 22 over RUSSIAN SPRING CREEK
Location: 9 NORTH OF I-94**

Team Lead: Jake Mertz, **Inspection Date:** September 01, 2020

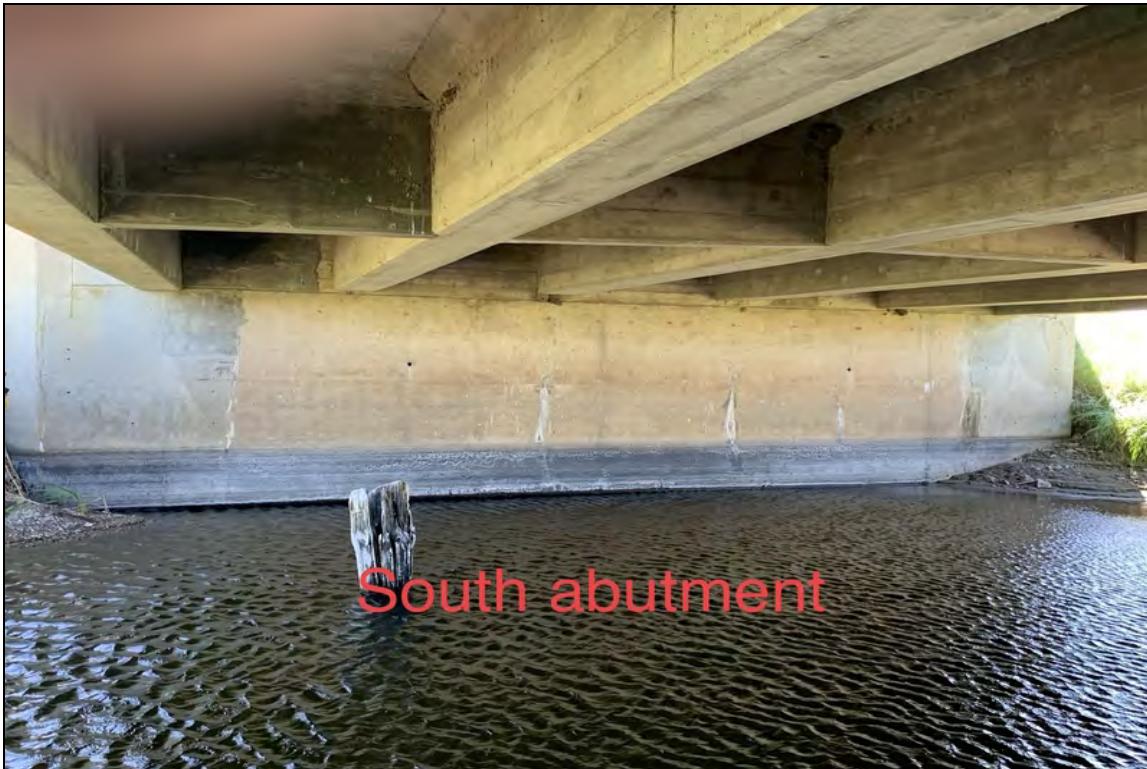
| ELEM | DESCRIPTION | UNITS | TOTAL | CS1 | CS2 | CS3 | CS4 |
|---|---|---|---|---|---|---|---|
| | The North abutment has approximately 5 cracks that average approximately 0.010 in width. The South abutment has approximately 5 cracks that range from approximately 0.004 to 0.006 inn width. 1September2020 | | | | | | |

North abutment crack .010

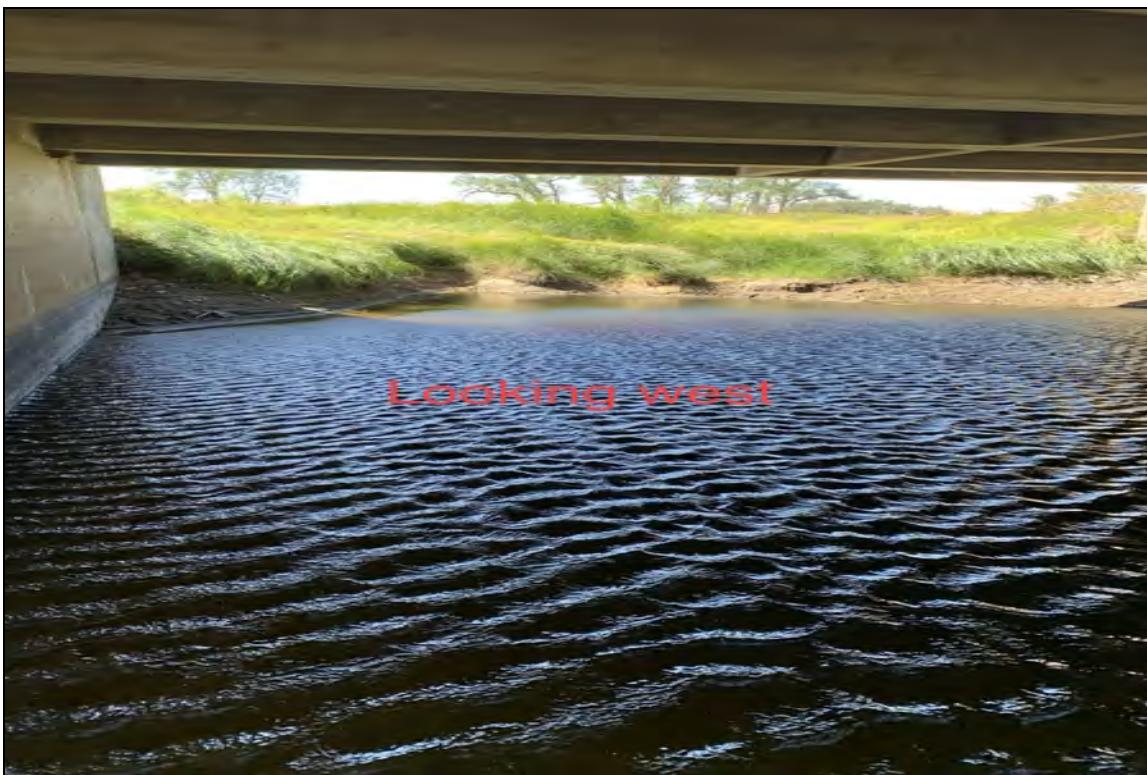
South abutment crack .004
