Experimental Study MR 97-01

**Practice of Unsealed Joints in New
Portland Cement Concrete Pavements**

Final Evaluation Report

January 2009

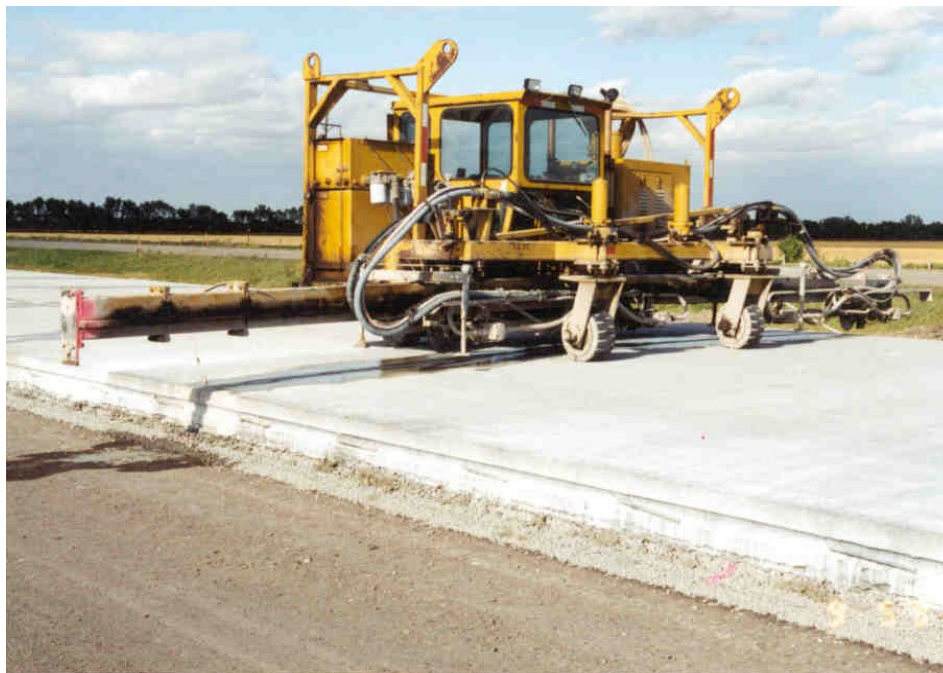
The process is virtually the same as for sealed joints except that the widening process is omitted along with the process of installing the sealant. Photo 1 depicts a view of a typical gang sawing machine that was used on project IM-6-029(027)161 in the Grand Forks District. The gang saw shown was equipped with four individual 1/8" wide saws spaced approximately 8' apart.

Photo 1 - Typical gang sawing machine used on project IM-6-029(027)161 in the Grand Forks District.

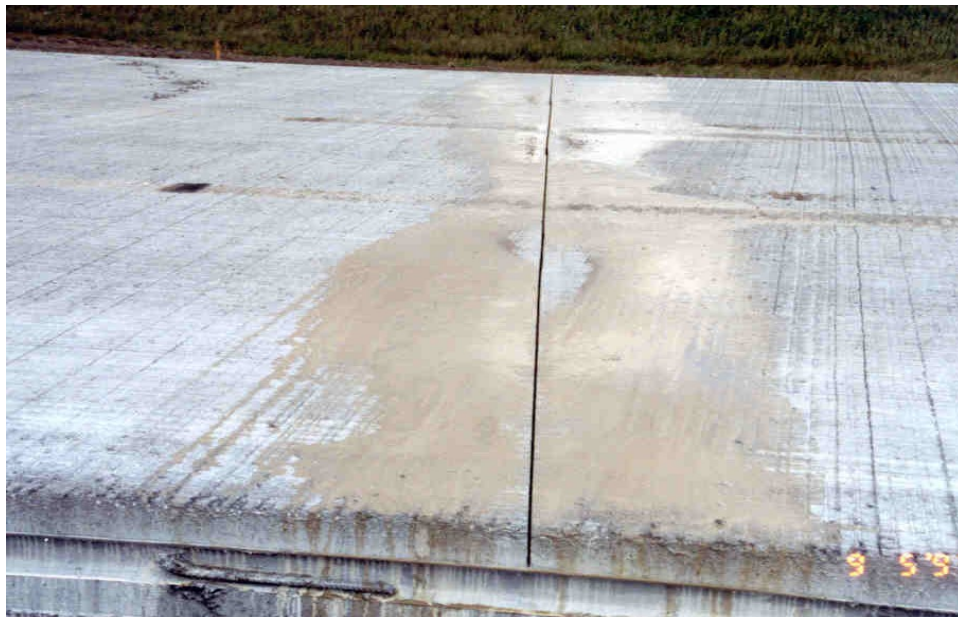
Photo 2 depicts a view of a typical sawed joint.

Photo 2 - Typical sawed joint.

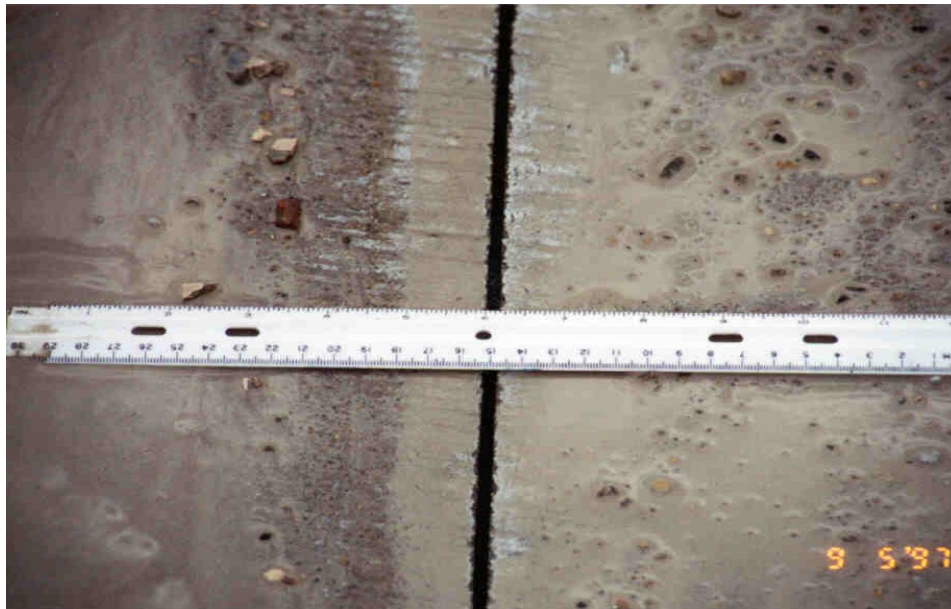
In nearly all cases the contractor managed to produce a finished saw width ranging from 1/8" to 1/4" as shown in photo 3.

Photo 3 - Width of a typical joint.

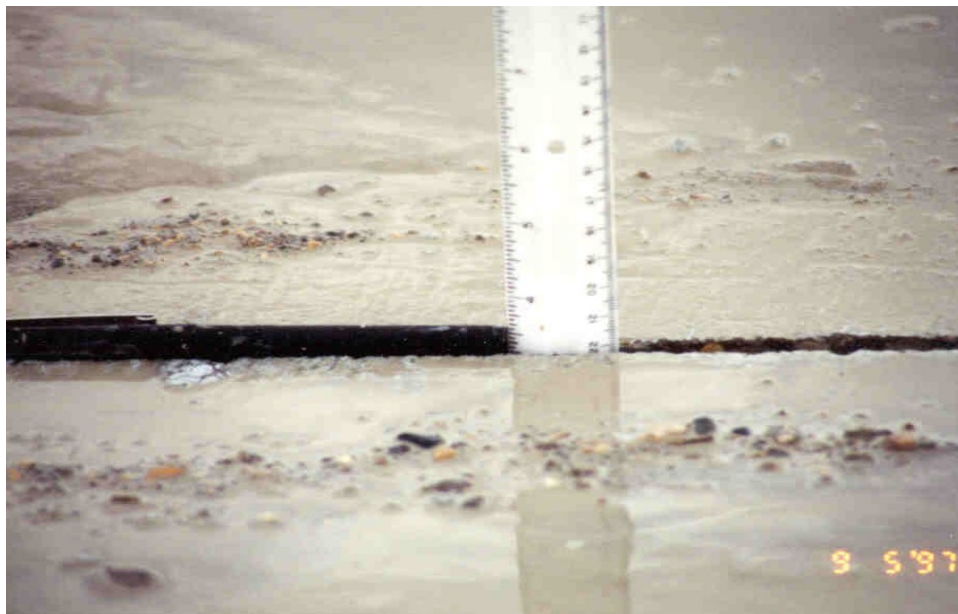
The average saw depth was approximately 3-3/8" deep as shown in photo 4.

As previously mentioned the saw depth on project IM-6-029(027)161 was T/3. The PCC pavement thickness on project IM-6-029(027)161 is 10". During the joint sawing process there were some problems that developed. Photos 5 and 6 depict the sawing process as it commences from right to left. Please note that photos 5 and 6 were taken from the same location. In photo 7, the end saw overlaps an area

Photo 4 - Saw depth is approximately 3-3/8" deep.

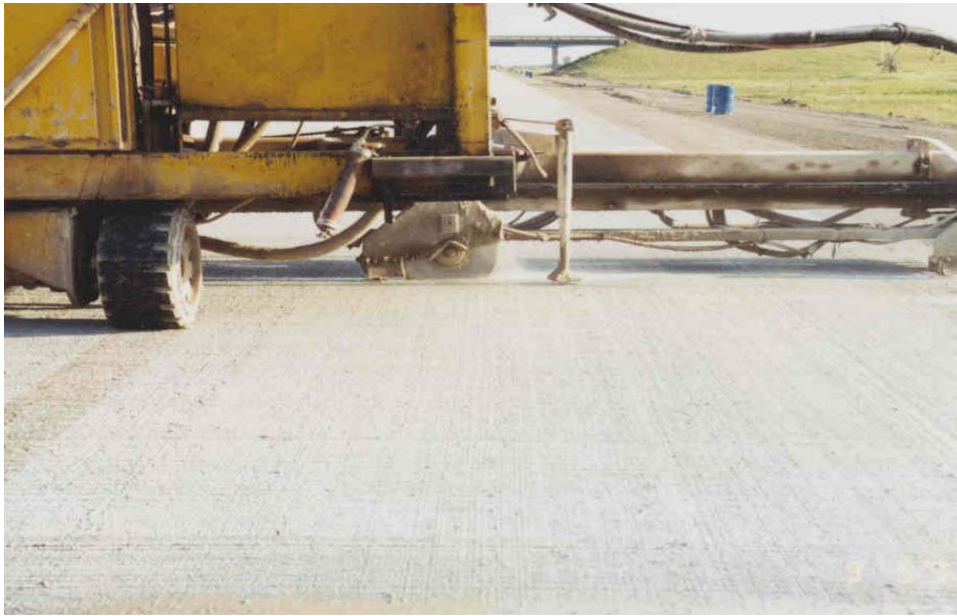
Photo 5 - Sawing process as it commences from right to left.

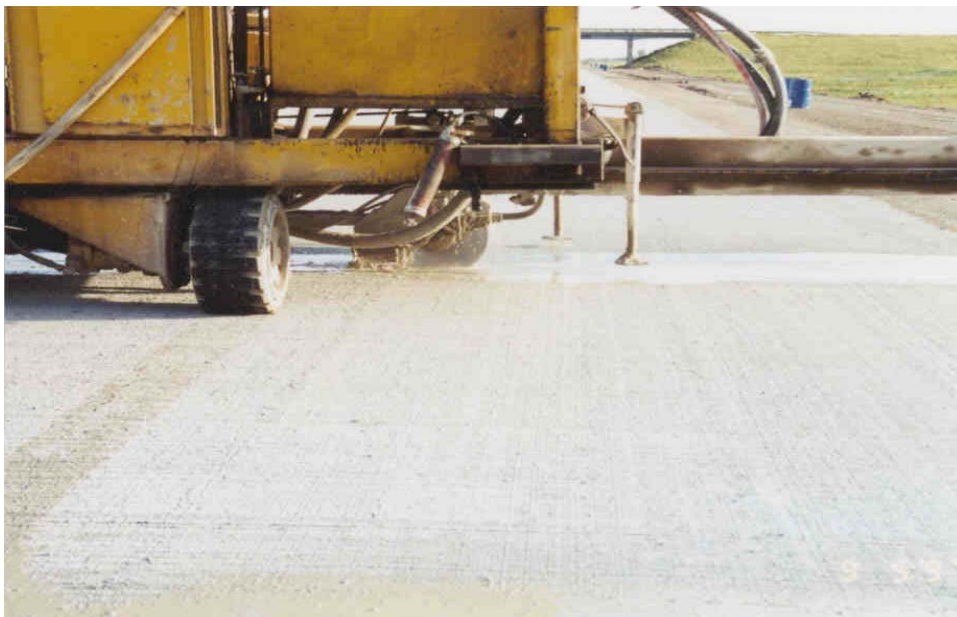
Photo 6 - Sawing process as it finishes from right to left.

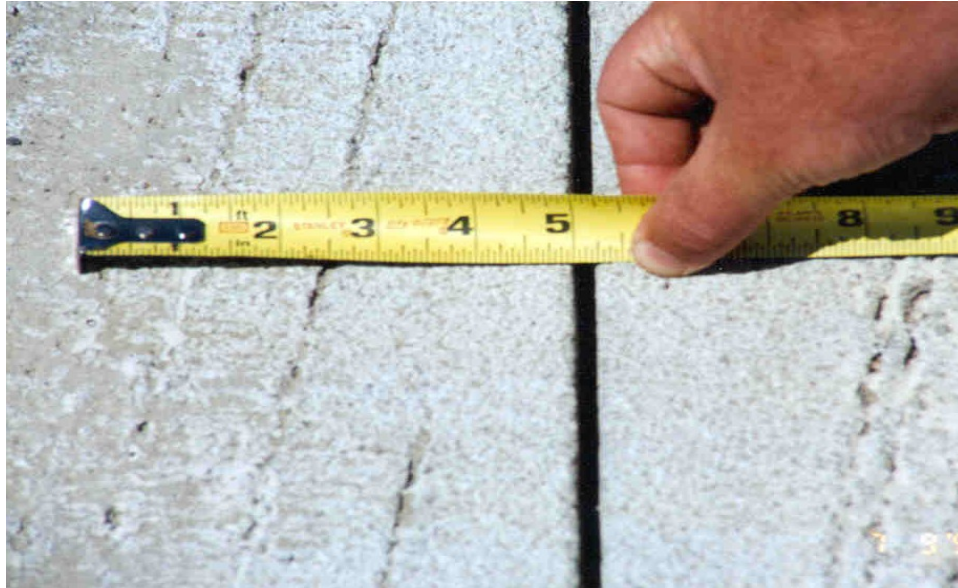
Photo 11 on the next page depicts a close-up view of a portion of an unsealed joint that was sawed correctly. It appears from the measurement taken in photo 11 that the joint is approximately 1/4" in width.

Photo 11 - Close-up view of a portion of an unsealed joint that was sawed correctly.

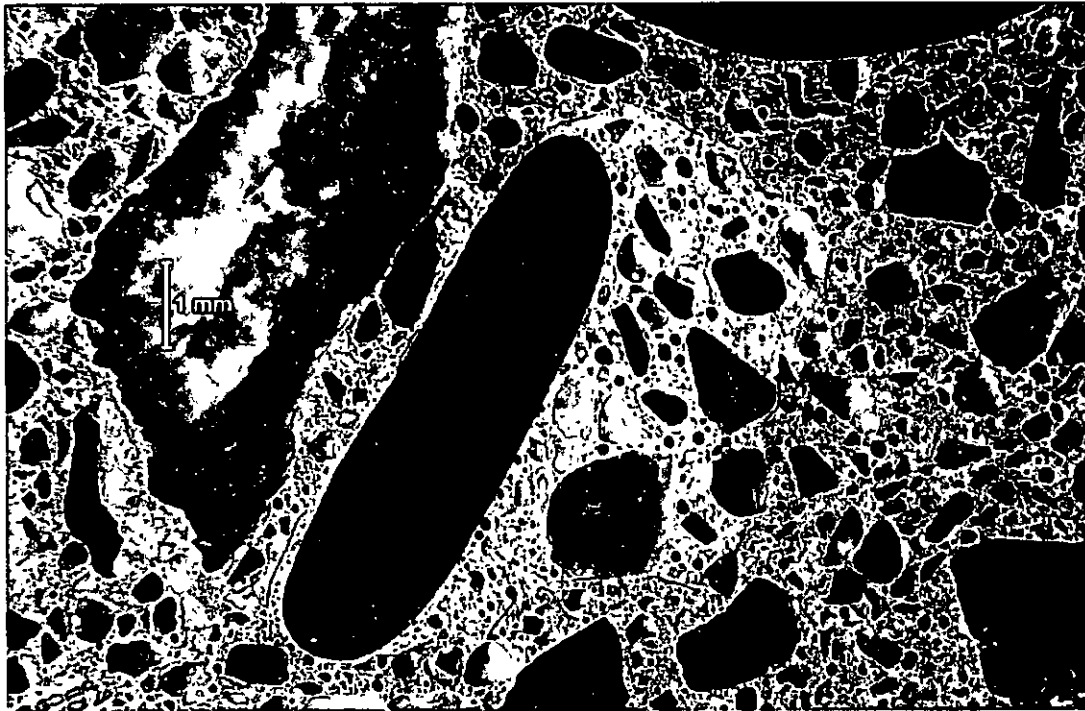
SAMPLE ID: 10 DESCRIPTION: An apparent recycled concrete aggregate particle; outlined in red dash line.

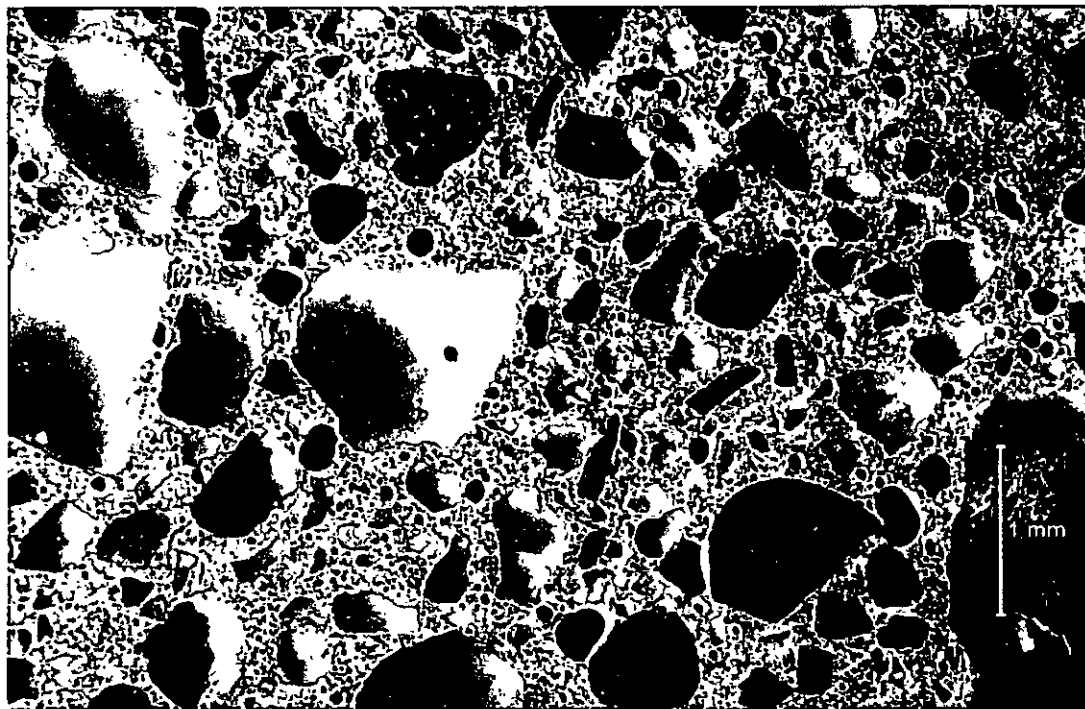
SAMPLE ID: 10 DESCRIPTION: Overall hardened air content is 4.3%.
