Experimental Study MR 97-04

**Evaluation of Dowel Bar Retrofit  
Using Minnesota Specified 3U18 Patch Mix**

**Final Report**

Project IM-8-029(006)000

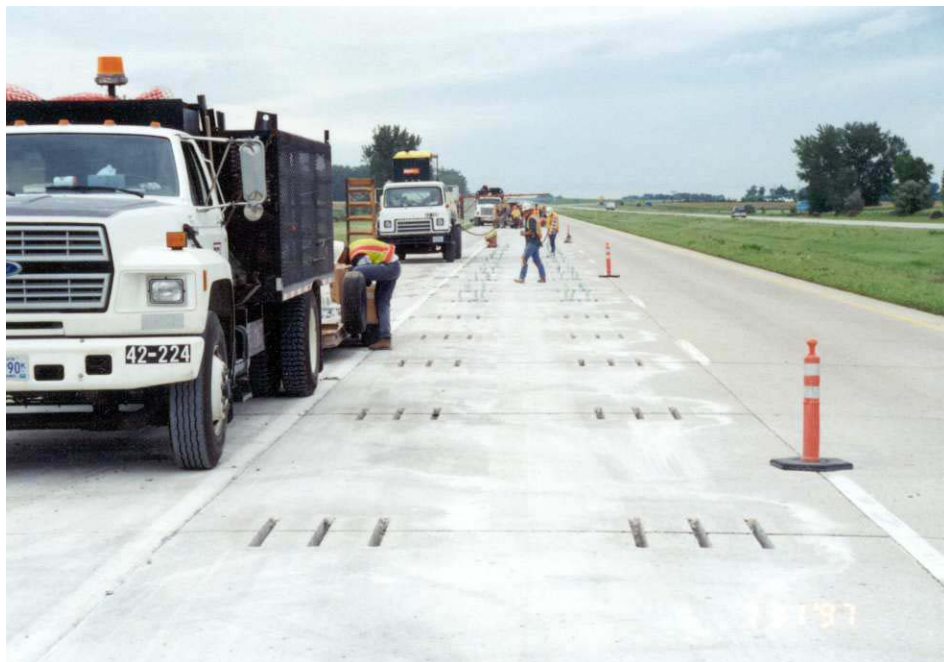
**Photo 1 - Overview of the dowel bar retrofit operation.**

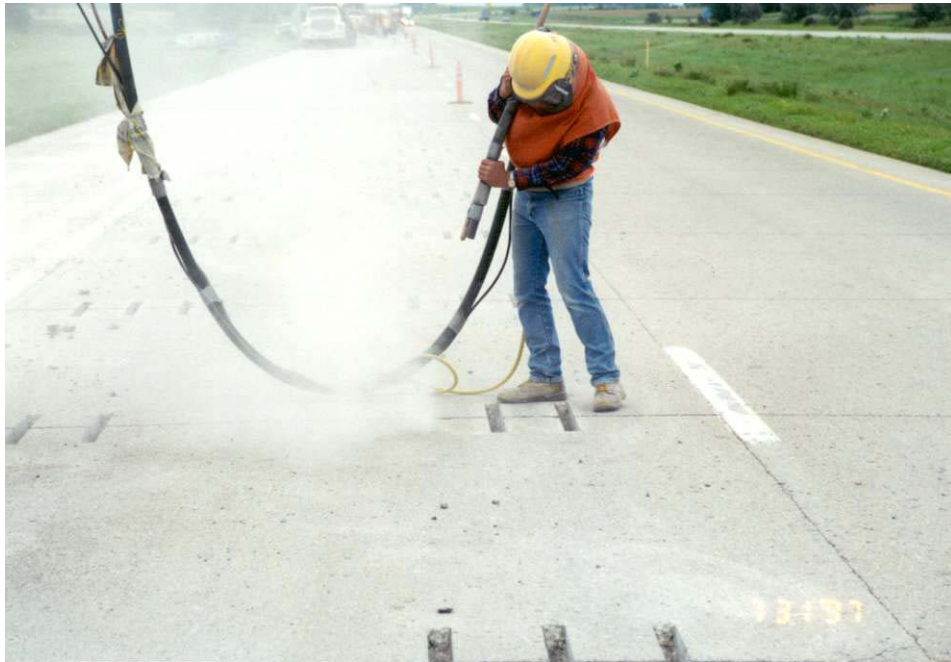
Photo 2 shows the slots being sand blasted prior to placing of the caulk. □

**Photo 2 - View of the sandblasting process.**

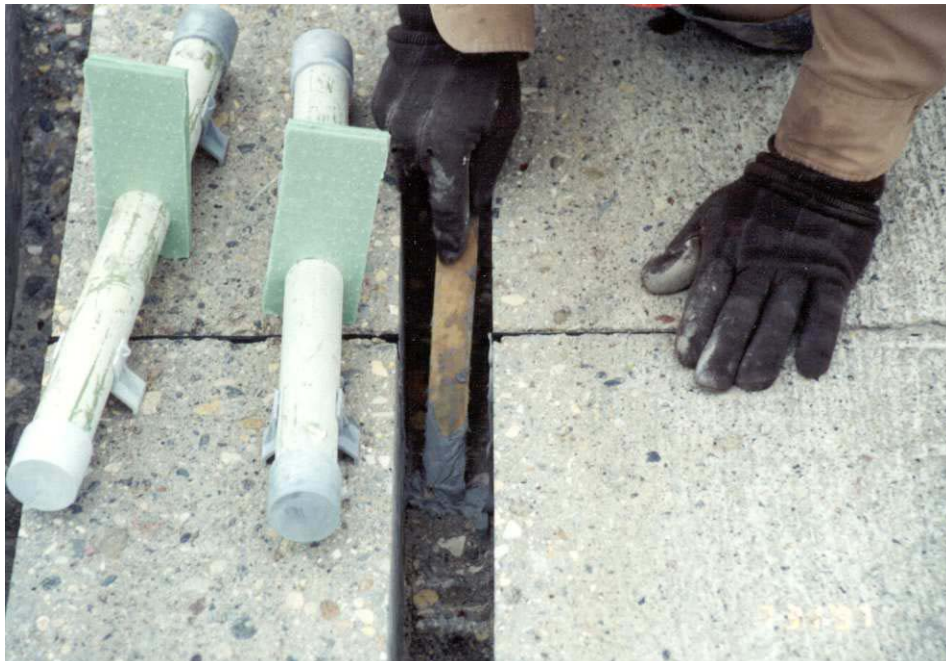
After the sand blasting process was completed, a mechanical caulking dispenser was used to seal the existing transverse joint crack at the bottom and sides of the slot. Photo 3 illustrates caulking being worked outward approximately 1/2" from the existing joint.

**Photo 3 - View of caulking process.**

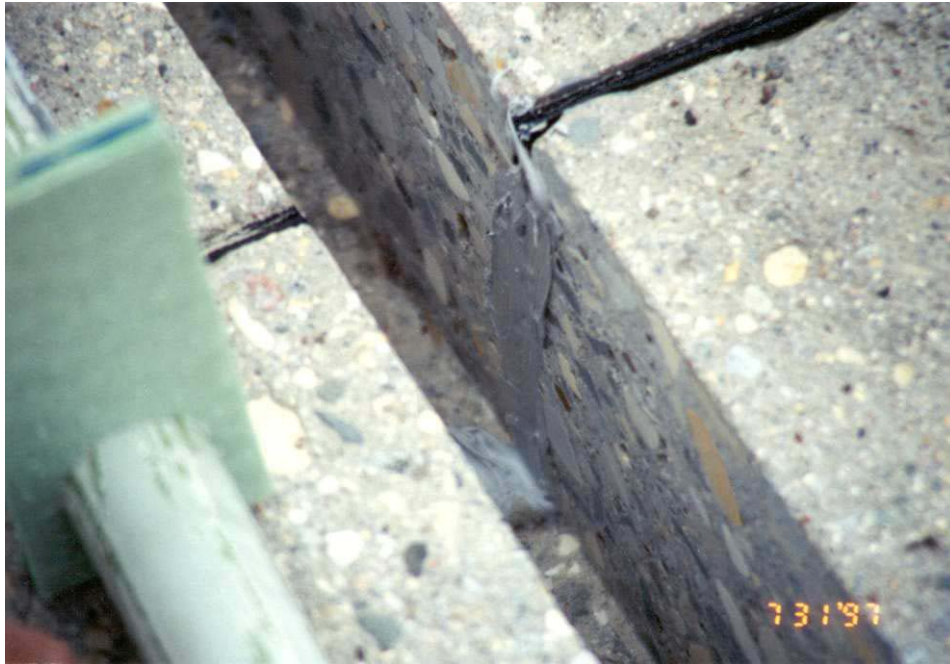
Photo 4 is a close-up of the joint after the caulking process has been completed □

**Photo 4 - Close-up view of the joint after the caulking is finished.**  
and photo 5 shows the core board fabrication process.

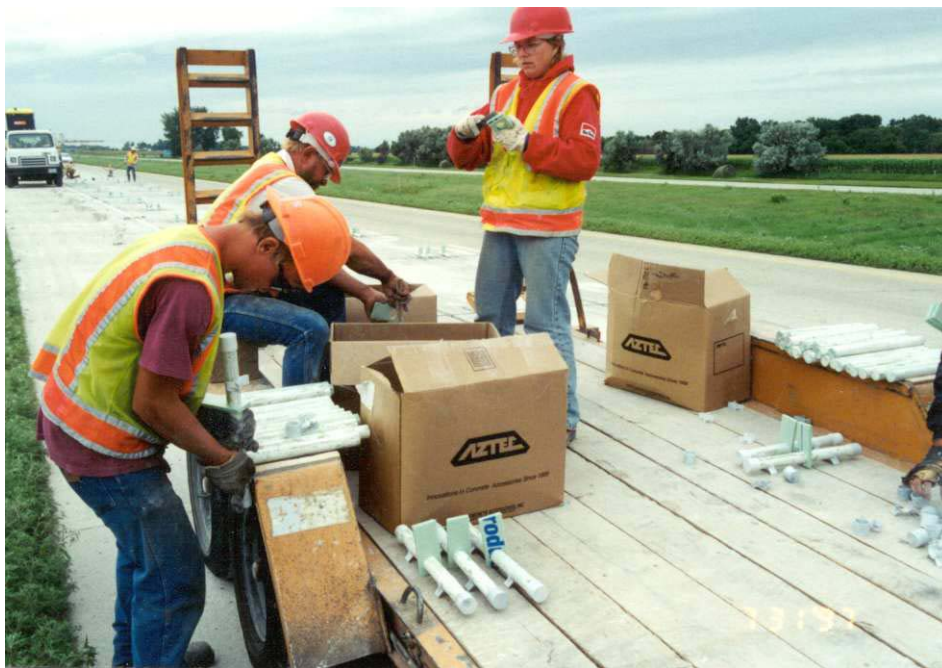
**Photo 5 - View of the core board fabrication process.**

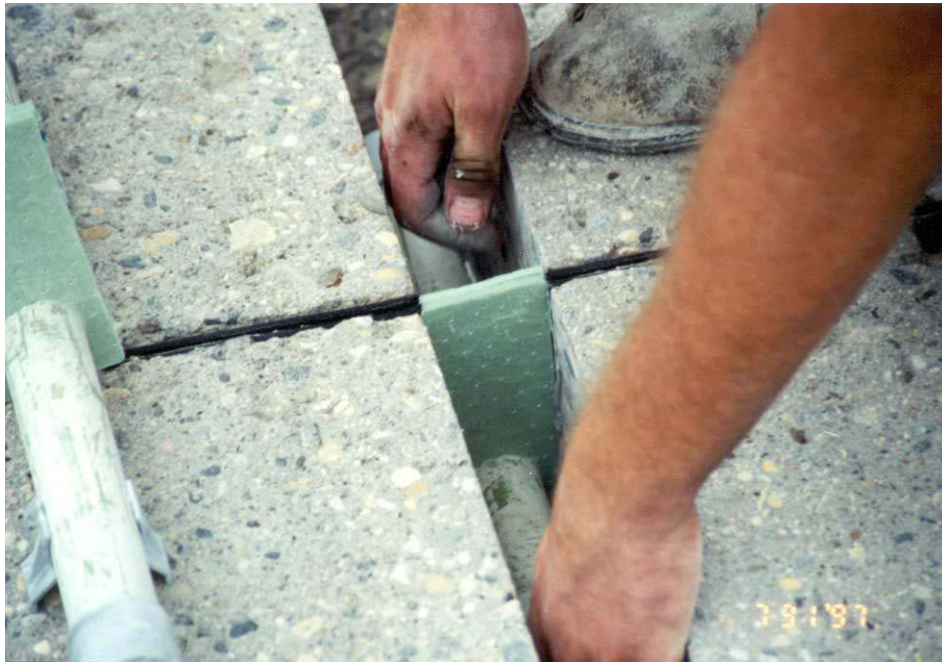
Photo 6 shows the installed dowel bar and core board. Note the two 1/4" core boards that are glued together.

**Photo 6 - View of the dowel bar and core board installed in the slot prior to the mix being placed.**

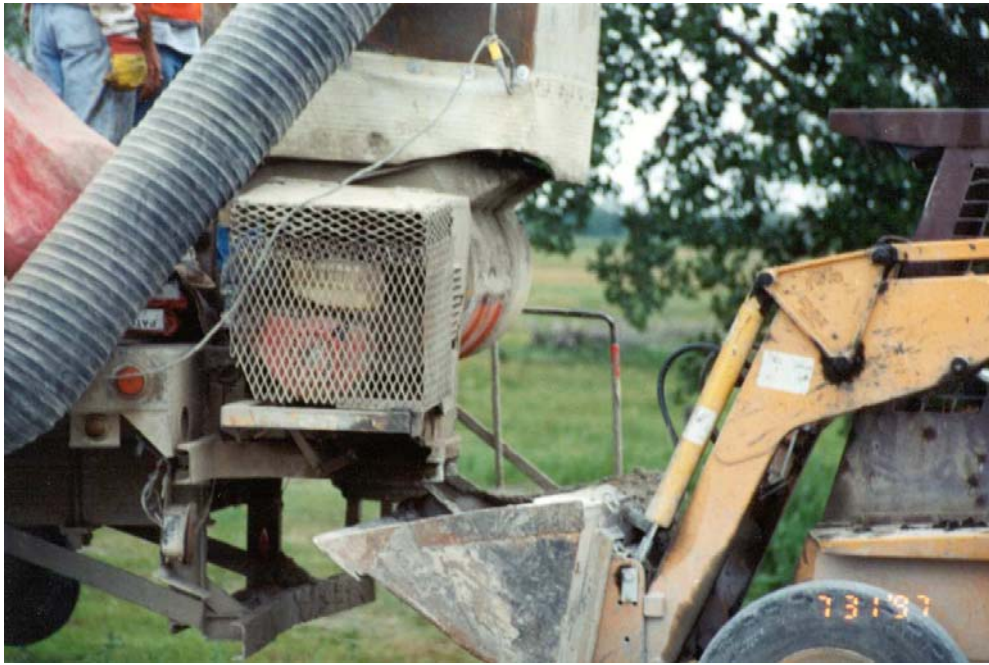
Photo 7 on the next page shows a partial view of the batch mix unit on the left side of the picture. The contractor continuously batched small amounts of patch mix as the process went on. The contractor commented that he preferred using a batch mix unit as opposed to a mobile mixer unit because better control and consistency of the mix could be achieved. Prior to placement of the 3U18 patch mix, tests were performed for air, slump, and temperature. Cylinders were also taken of the mix. Several mixes had to be batched to obtain the desired air.

**Photo 7 - View of the batch mix unit used to batch the 3U18 patch mix.**

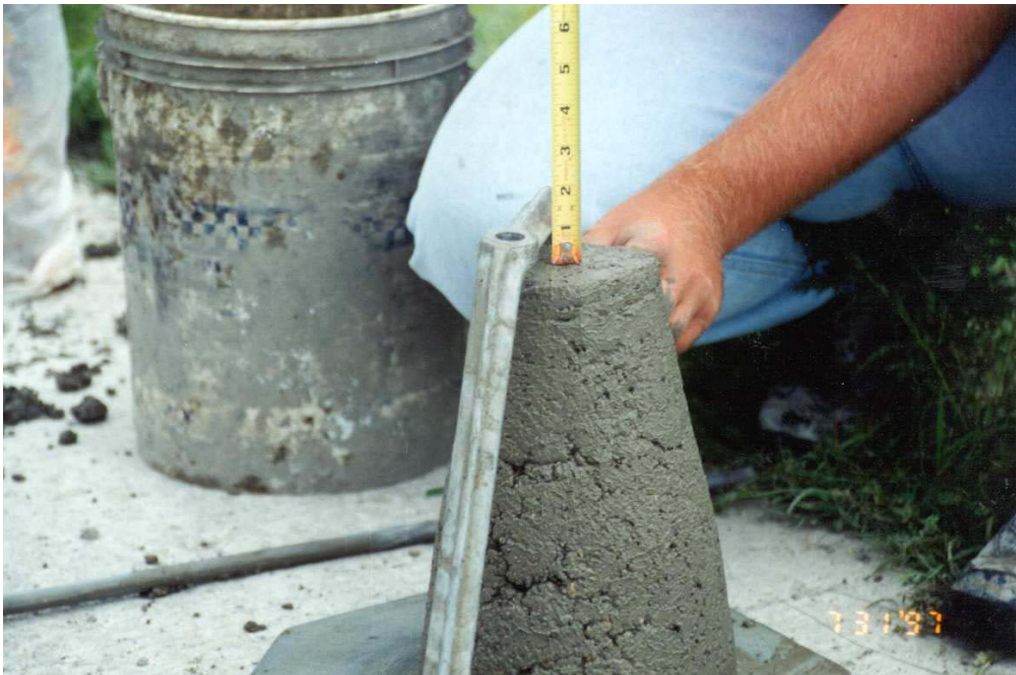
Photo 8 indicates the final slump was 3/4". The contractor commented that 3/4" or less was desired for this type of mix to aid in reducing shrinkage in the mix. Water reducers/accelerators were added to improve workability.

**Photo 8 - View of a slump test being performed on the 3U18 mix.**

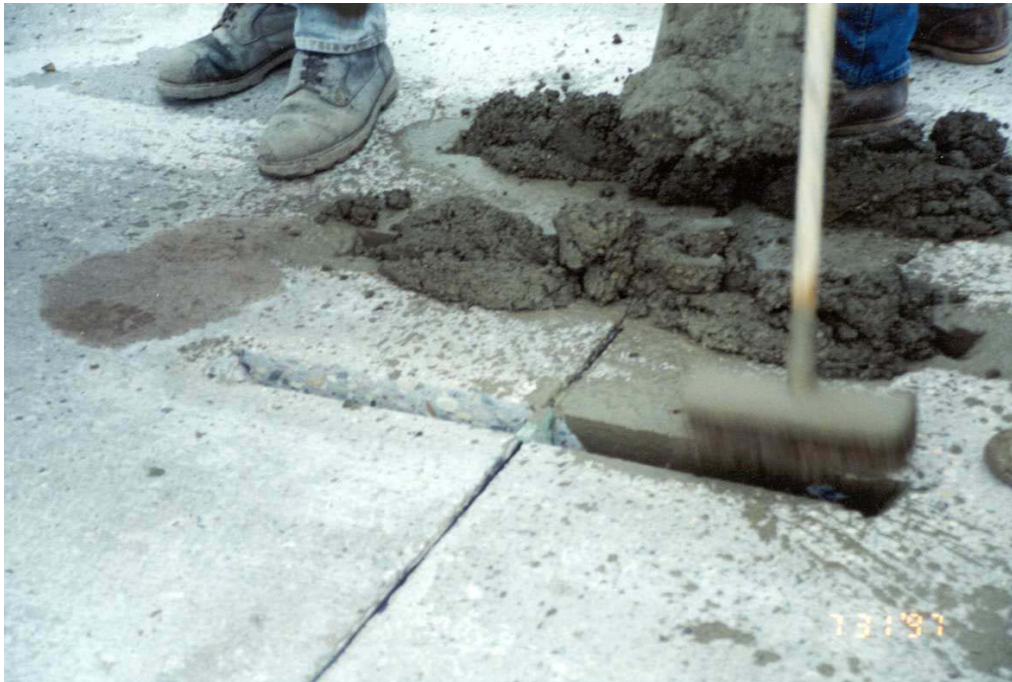
As previously mentioned, the existing concrete grout served as an absorbing agent to fill any empty pore spaces in the existing concrete. The contractor believed it would reduce the chance for shrinkage cracks. Care was taken to apply the grout just before the placing of the patch mix. Photo 9 illustrates the grout composed of sand, water, and cement being broomed into the slot prior to placing the 3U18 patch mix.

**Photo 9 - View of the grout being applied to the dowel bar retrofit slot.**

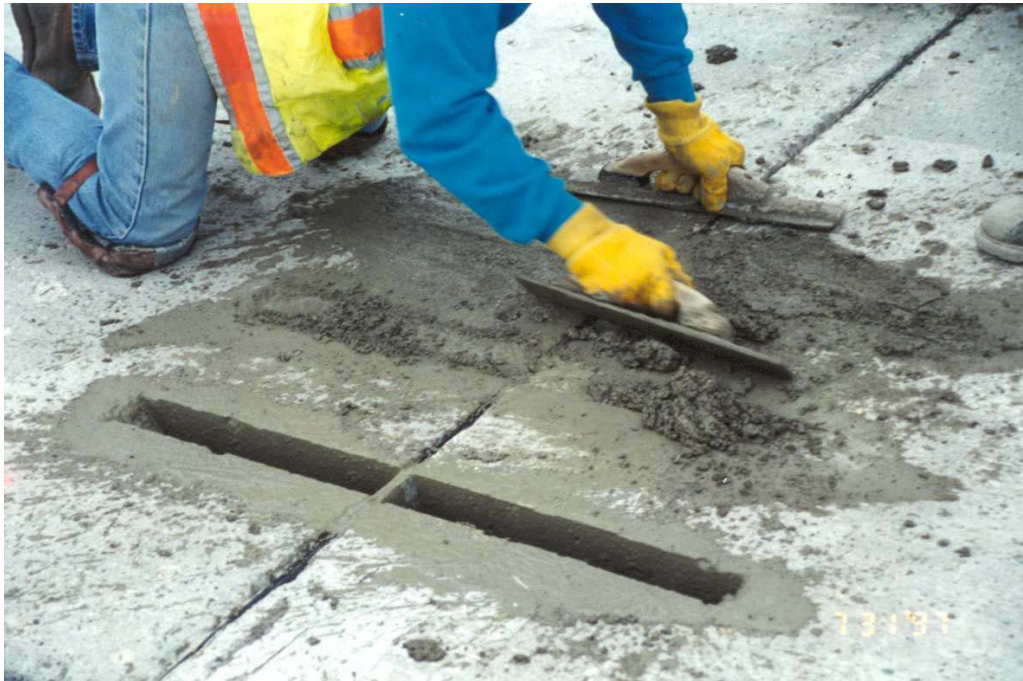
Photo 10 shows the patch mix being troweled and finished.

**Photo 10 - View of the 3U18 patch mix being troweled and finished.**

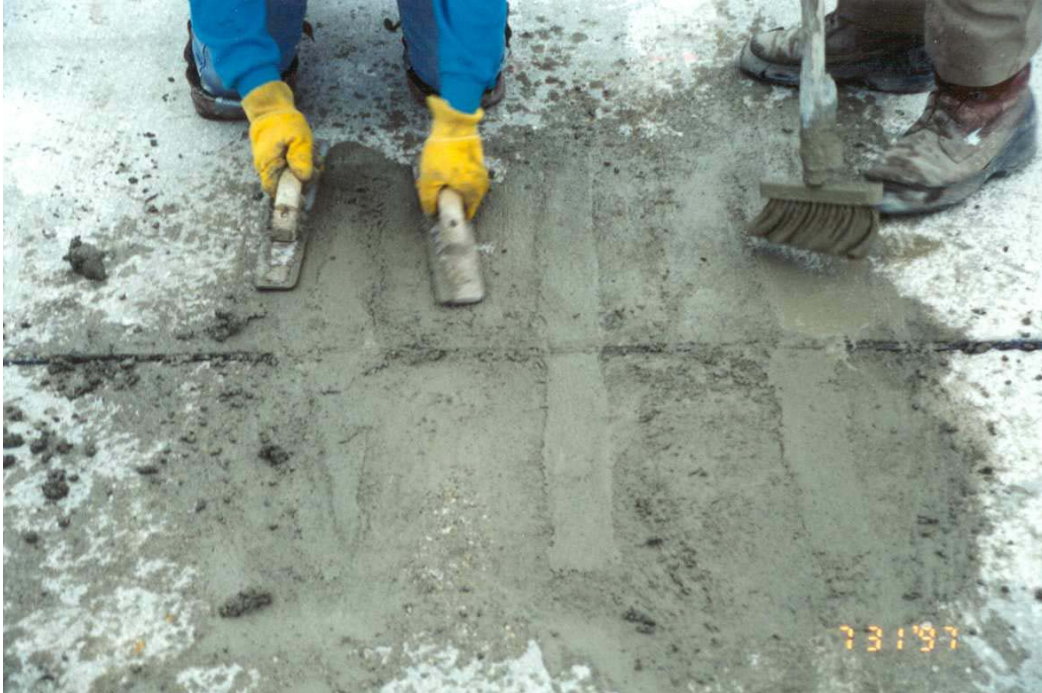
Photo 11 shows grout being applied just after the patch mix was finished. The contractor commented that placing the grout on the edge between the new mix and the existing concrete would also reduce the chance of shrinkage cracks.

**Photo 11 - View of the grout being applied to a finished 3U18 patch mix.**

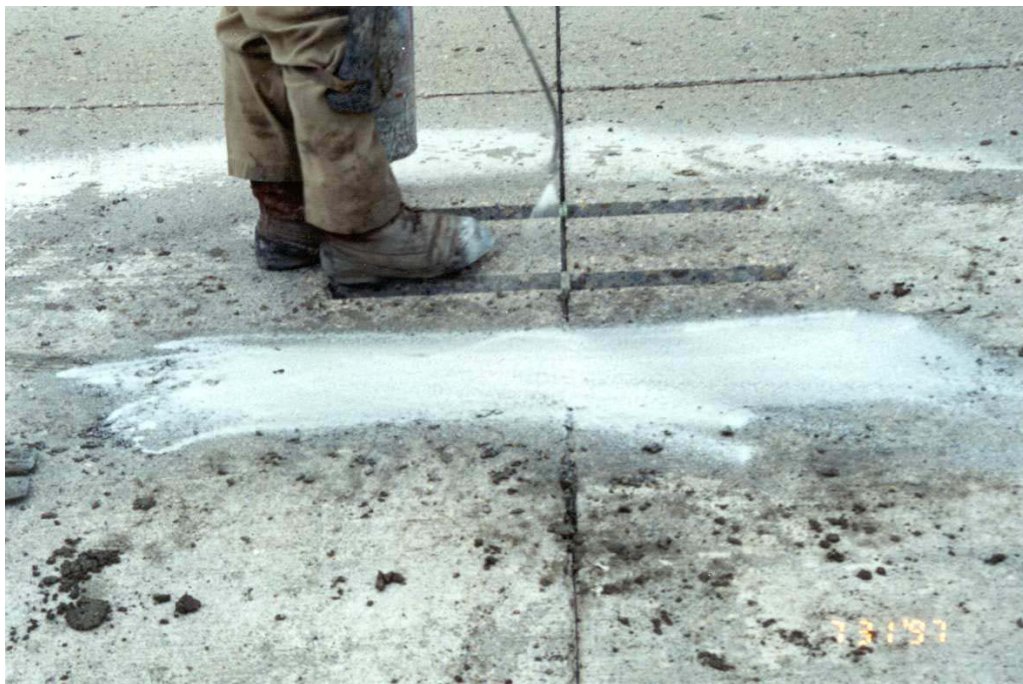
Photo 12 shows the curing compound being applied to a finished slot. The contractor believed very strongly that the oil-based cure used here will do more to aid in reducing the chance for shrinkage cracks than a water-based cure.

**Photo 12 - View of the oil based curing compound being applied to the finished and grouted 3U18 patch mix.**

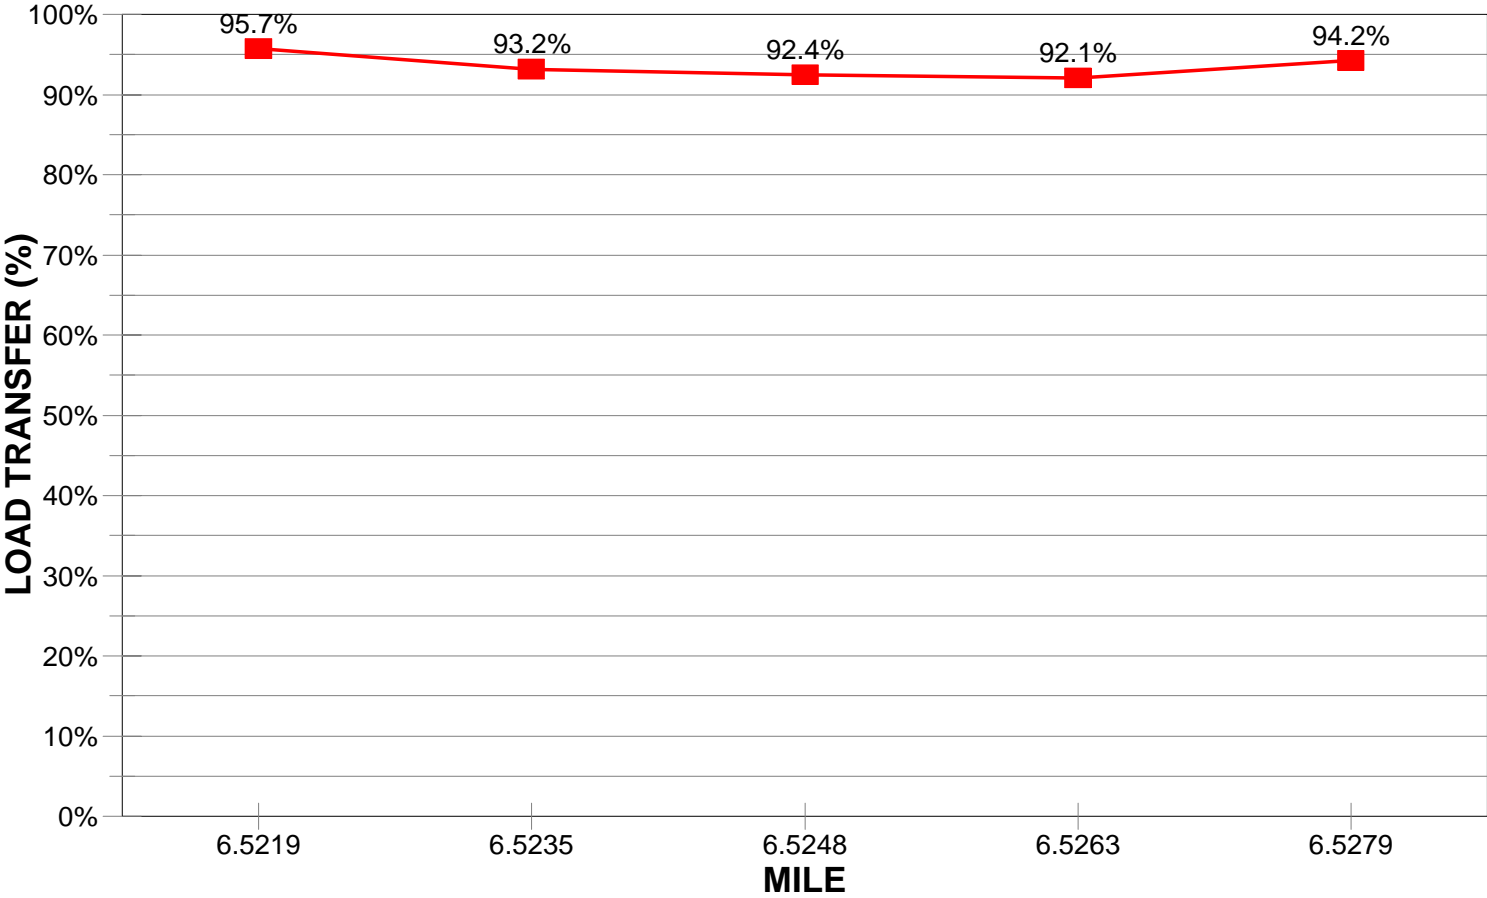
LOAD TRANSFER-South Bound

The 3U18 mix has some hairline cracks between the existing concrete and the patch mix in some of the dowel bar slots. These cracks do not appear to be affecting the load transfer efficiency as dictated by an average load transfer of 92.6%. The other distress that is occurring in the 3U18 mix is minor aggregate popouts. The surrounding pavement also has popouts.

08/20/02		Average
PROJ AVE	93.4%	3U18 Mix	92.6%
STD DEV	0.0	Patchroc	94.7%
