Experimental Study MR97-06

**Crafco Experimental Sealant to Level Depressed  
Cracks and PCCP Spall Repair Material**

**First Annual Report**

March 1998

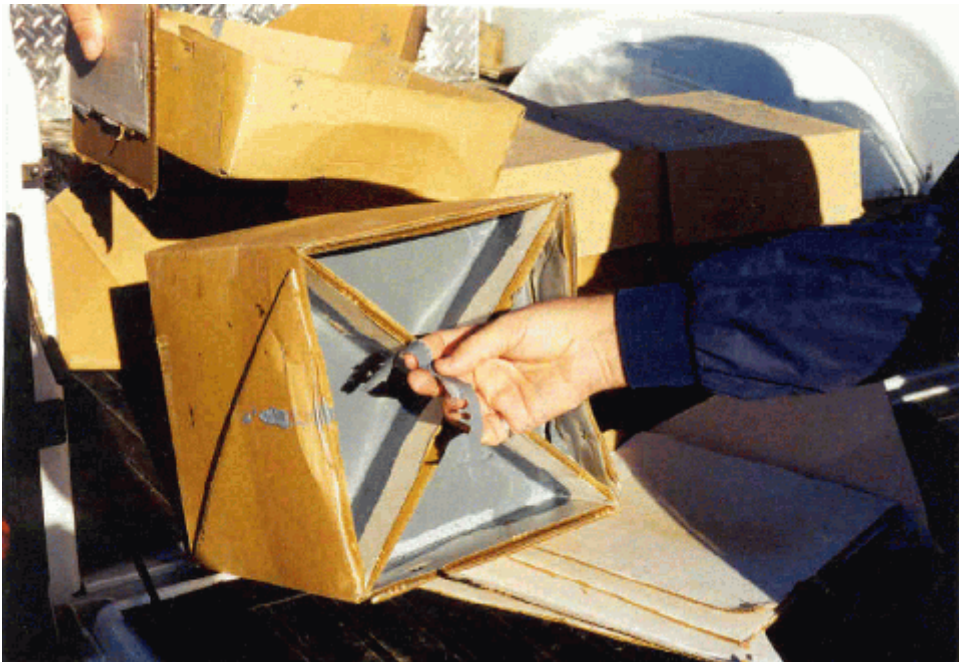
**Photo 9 -- CrafcO experimental warm weather spall patch material**

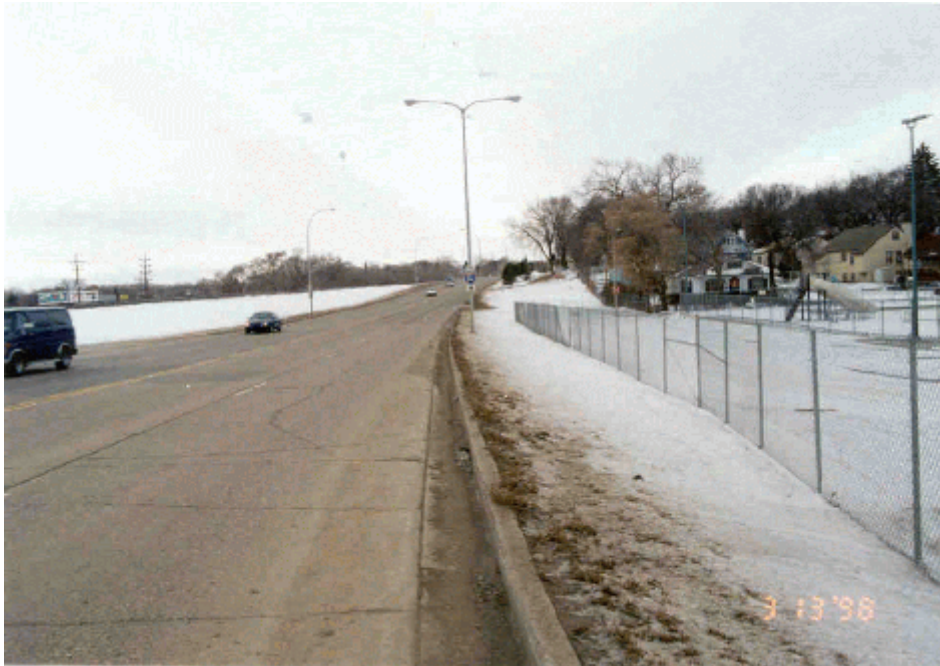
This part of the experimental project was evaluated on March 13, 1998. Some of the repaired spalls were covered with frozen sand and ice. As the temperature increased, most of the spalls were cleaned and swept. The repair material has a very smooth surface. This would present a slick condition in large spall areas. Most of the spall repair material is still in place. Small pieces have been removed by the snowplows. Much of the material is slightly below the concrete surface and protects it from plows.

Photo 13 -- Overview of test section--driving lane
