**Evaluation of Stratagrid's A-100
Ability to Strengthen an Asphalt Overlay**

Final Report

Projects
ST-6-032(017)191 & NH-4-002(046)130

October 1997

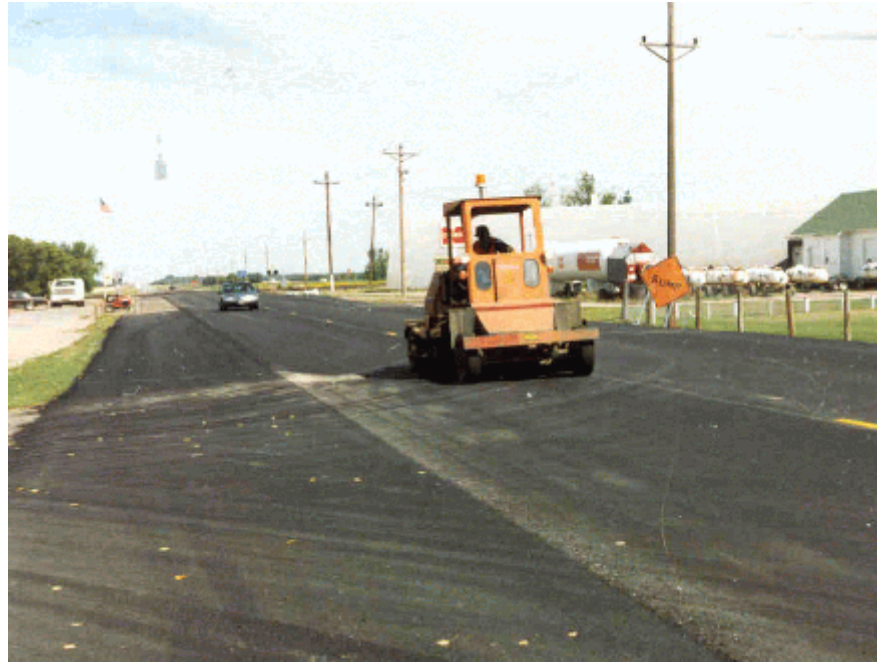
Photo 1. View of the sweeping process on Hwy 32.

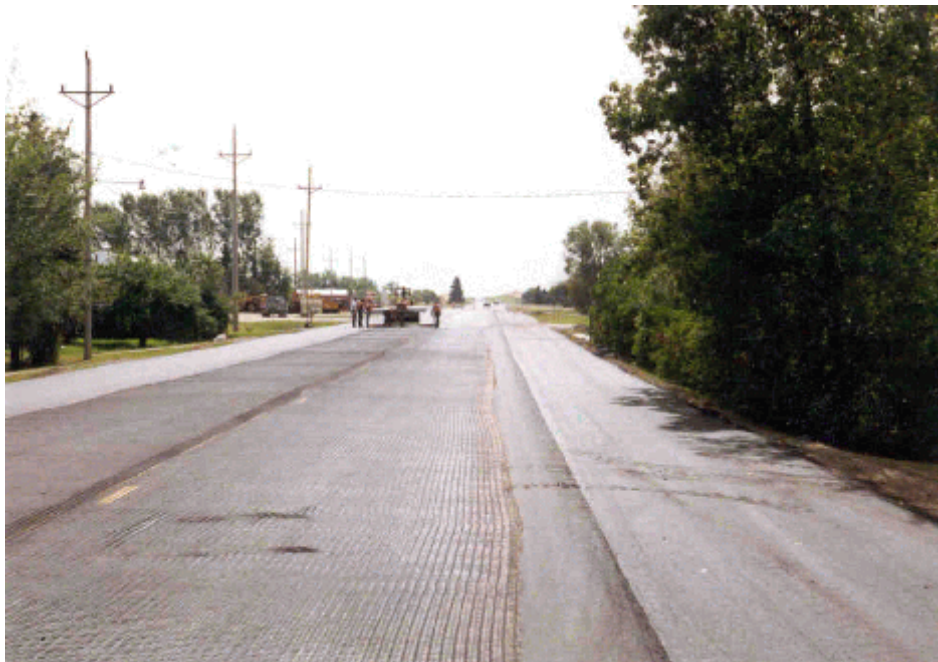
Photo 2. View of the geogrid rolled out.

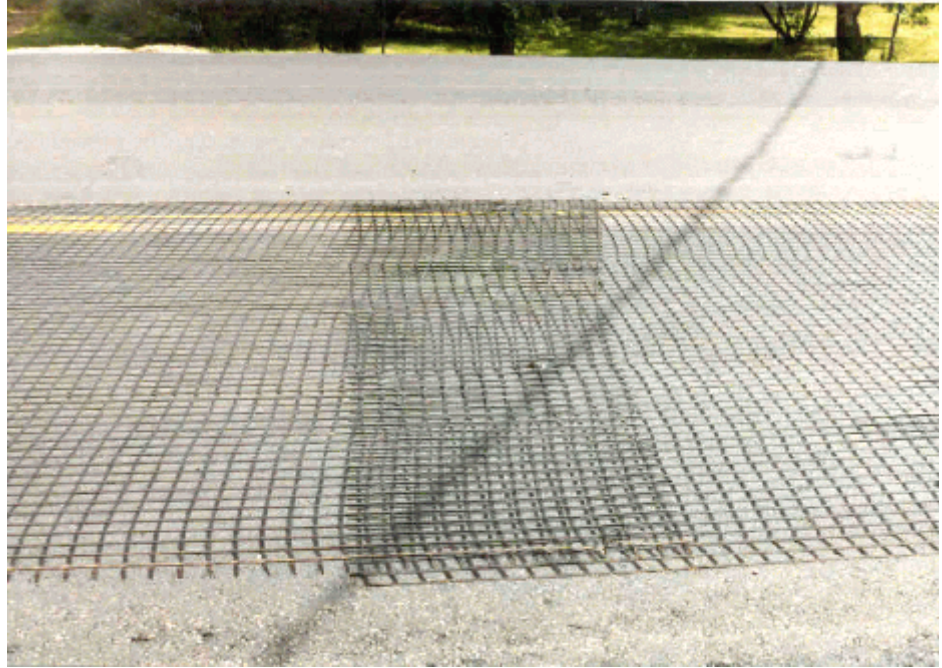
started it became necessary to overlap the geogrid ends. In this case a minimum of 20" was used as shown in photo 3.

Photo 3. View of the geogrid overlap.

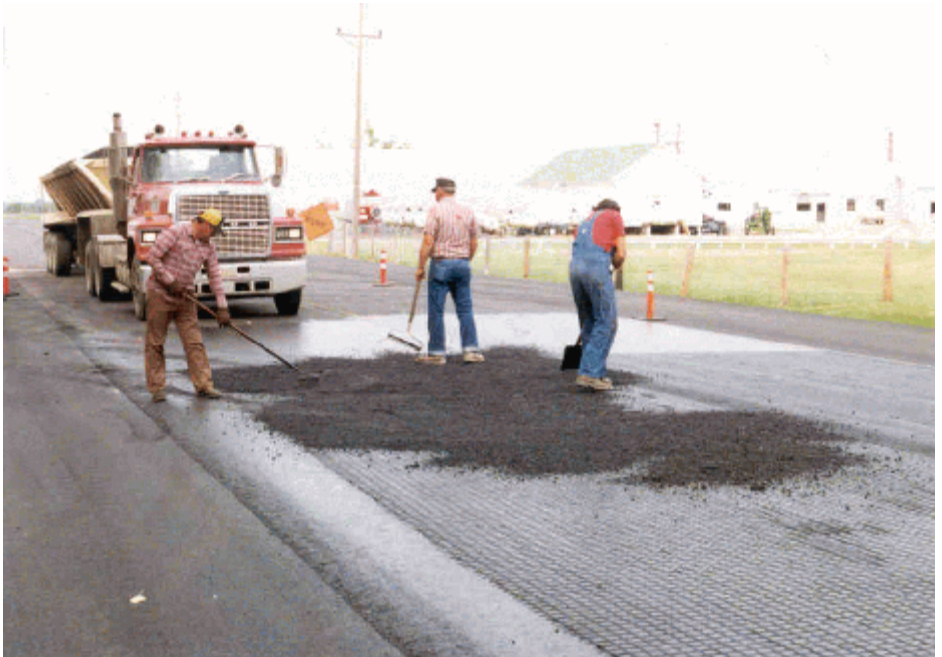
Photo 4. View of workers spreading hot mix on the leading edge of the geogrid to ensure it would stay in place.

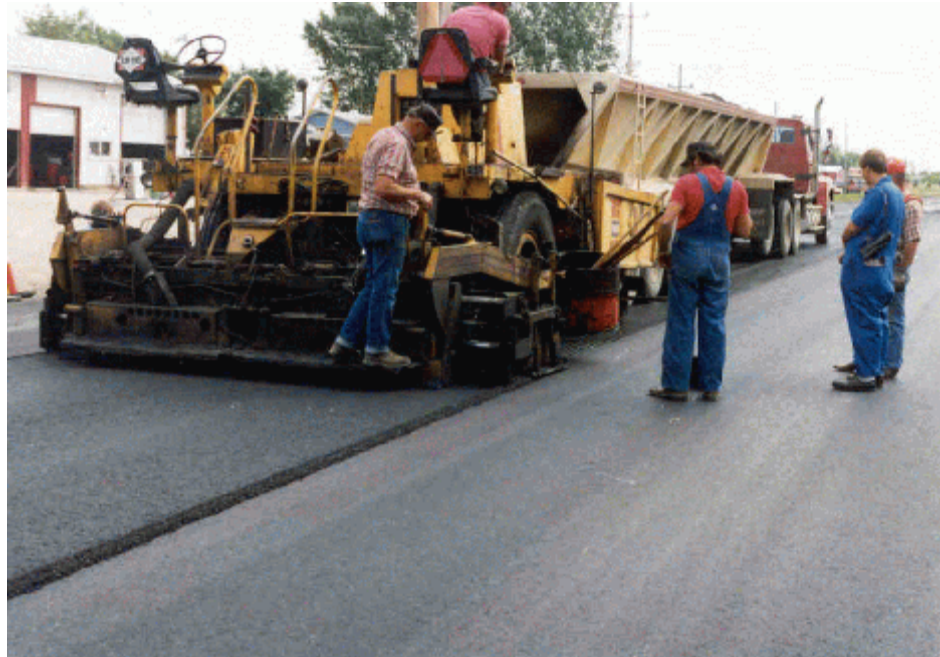
Photo 5. View of the second lift of HBP being applied over the geogrid.

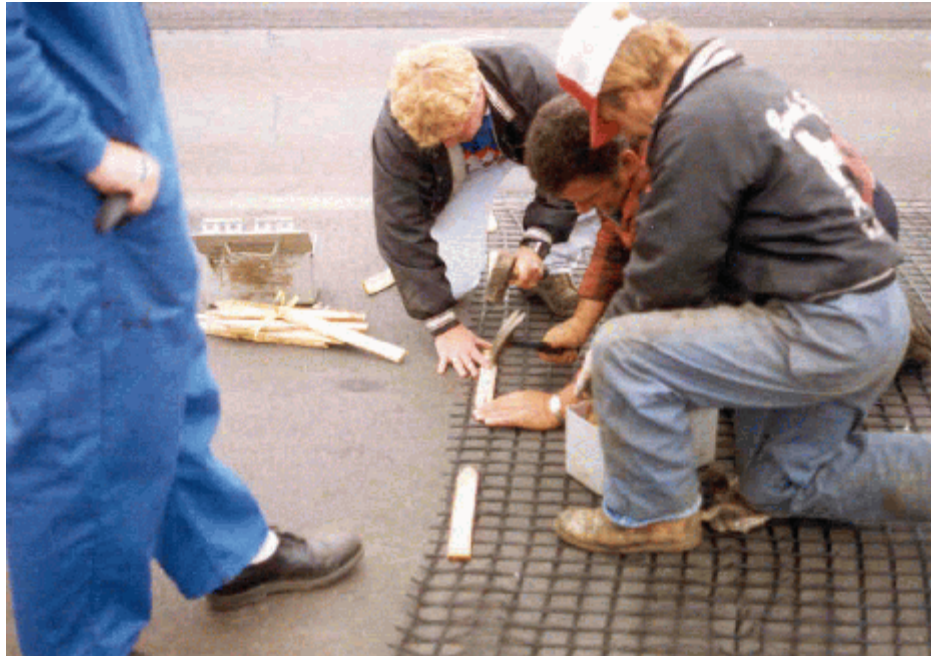
Photo 7. View of the lathe-nail system.

Highway 2 from station 150+00 to 156+00. Many of the construction practices that were applied to project ST-6-032(017)191 were applied on this project also. One exception to the Edinburg project was in the fastening of the geogrid to the leveling course prior to the laying of the final lift. A lathe-nail system was used for this purpose as opposed to u-shaped nails. The lathe-nail system is shown in photo 7. There were also similar problems encountered with the geogrid sticking to the wheel of the paver. The tack coat material when applied, formed a sticky surface on the fabric which in turn adhered to the paver wheels. As a result the fabric would lift up allowing the asphalt to work its way under the fabric. There was one incident where the fabric actually lifted high enough that the fabric climbed up onto the wheel of the paver.

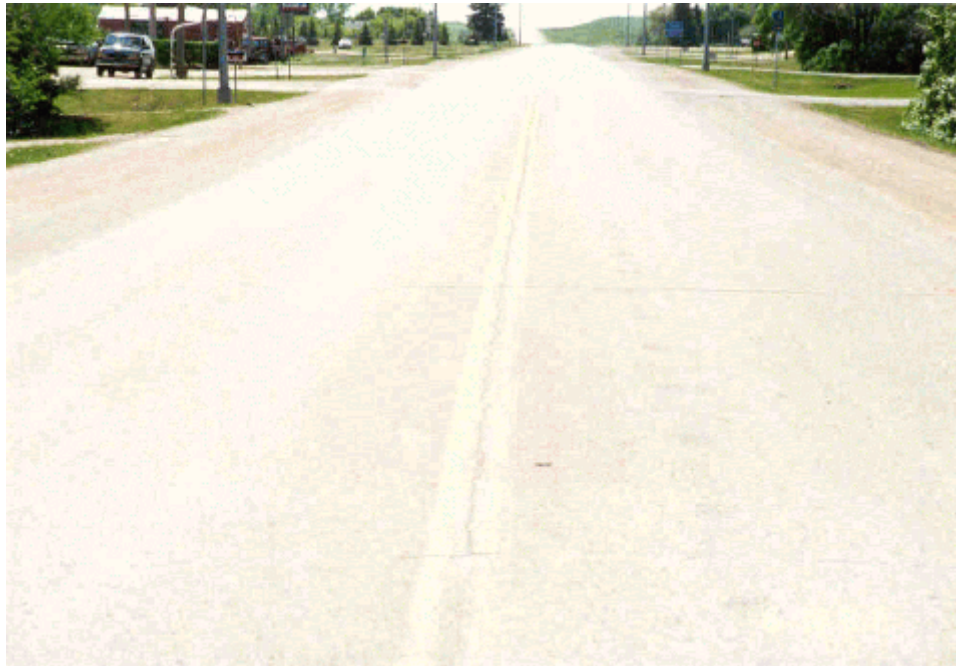
In general the distresses do not appear to be getting worse in the test section. Materials and Research registered approximately 9 full length transverse cracks, 3 half-length transverse cracks, and 1 longitudinal crack in the test section. Photo 8 is an overview of the test

Photo 8. Overview of the test section looking north.

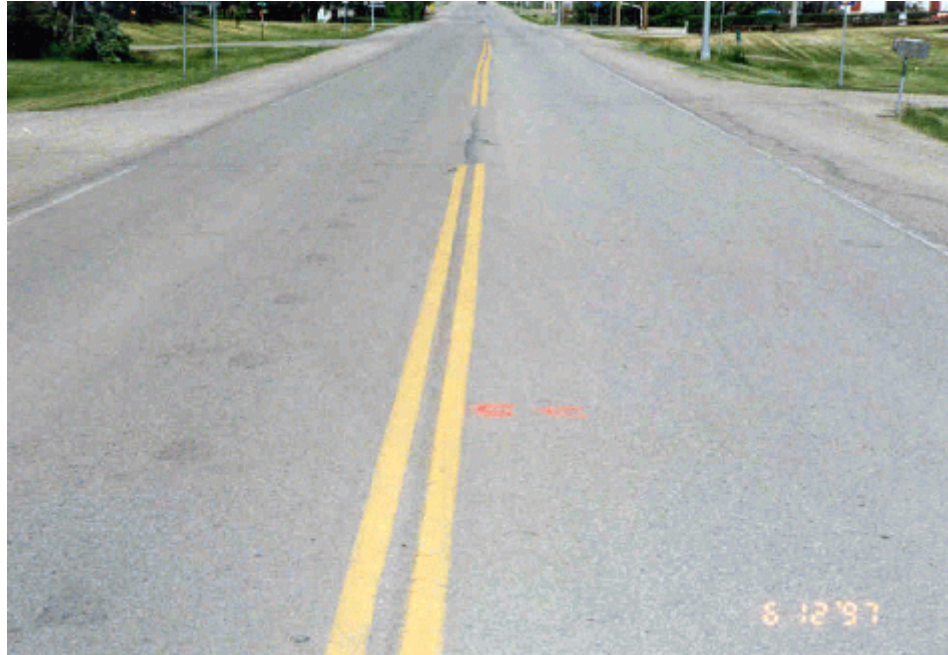
The control section registered approximately 32 transverse cracks, 16 of which were characterized as full length. There were also 7 longitudinal cracks of various lengths.

Photo 12. View of the control section looking north.

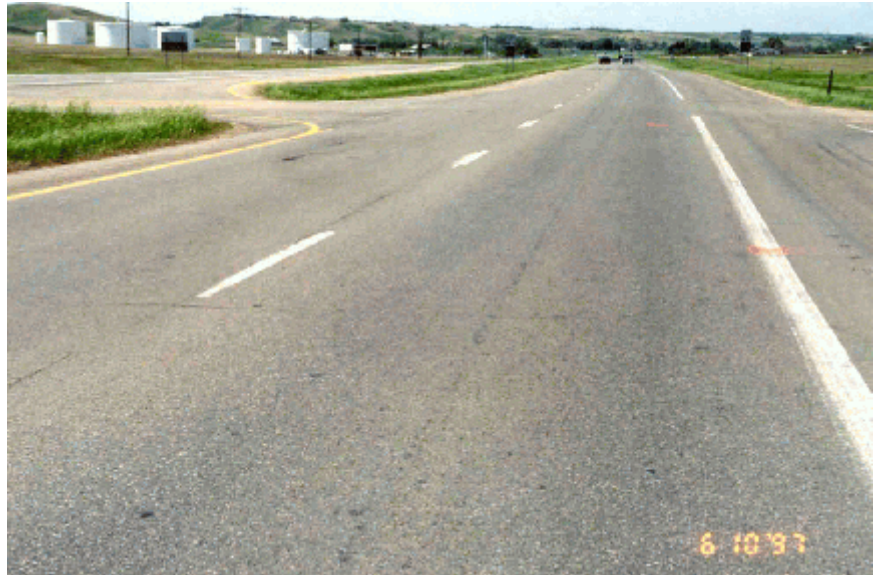
The test section registered nine full length transverse cracks and one longitudinal crack approximately 30' in length located along one of the shoulders. Photo 17 shows a view of the Stratagrid test section. Photo 18 shows a view of a typical crack in the test section.

Photo 17. An overview of the stratagrid test section

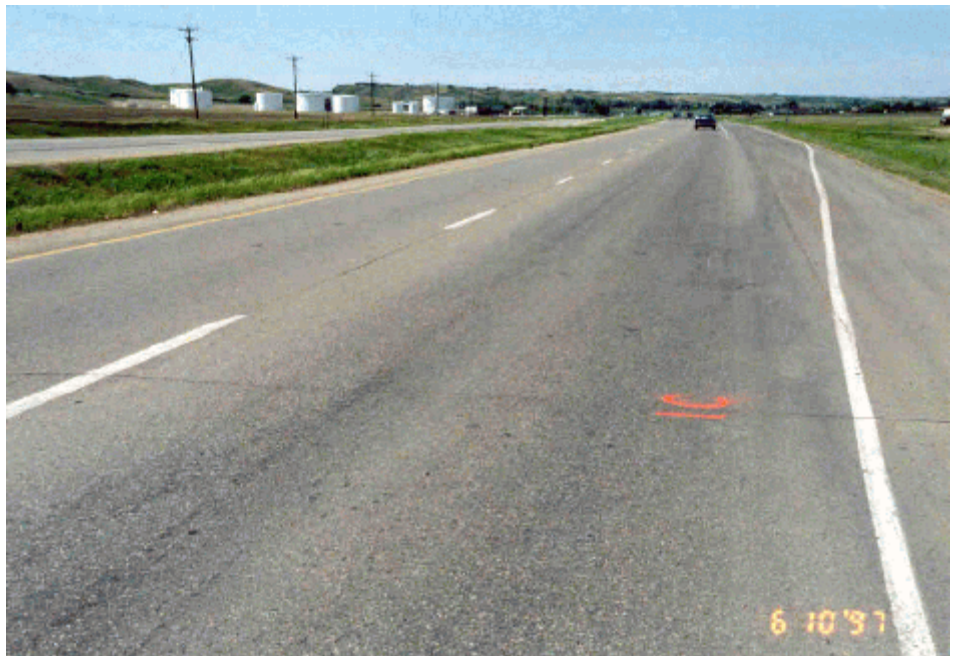
Photo 21 shows an overview of the east control section. The east control section registered 12 full transverse cracks and a 30' longitudinal crack in the shoulder. Photo 22 shows a typical crack located in the east control section.

Photo 21. An overview of the east control section.

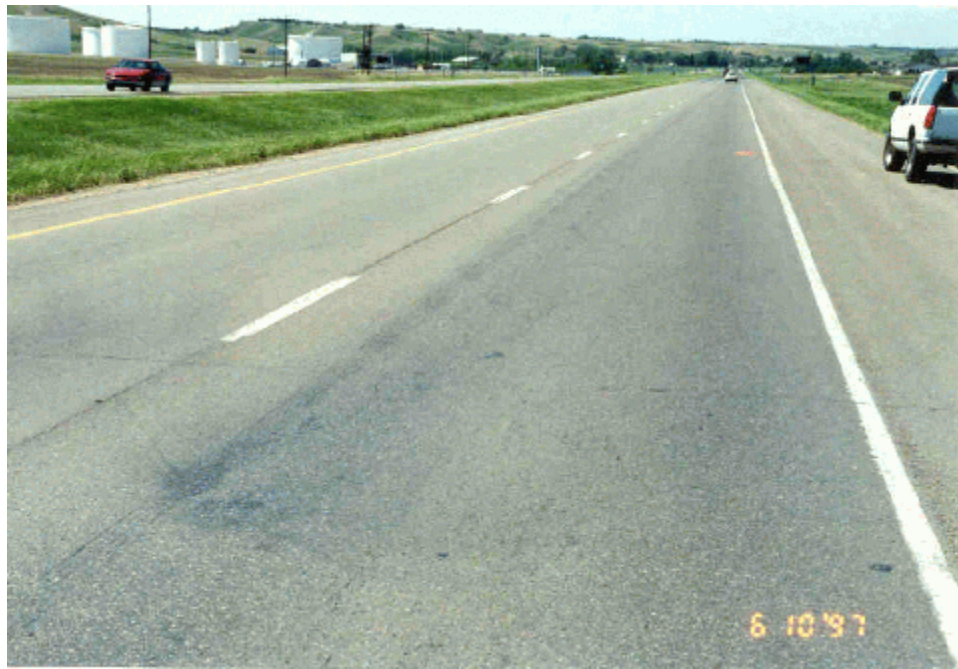
Photo 23 shows an overview of the west control section. The west control section registered eight full transverse cracks and a 30' longitudinal crack in the passing lane. Photo 24 shows a typical crack located in the west control section.

Photo 23. An overview of the west control section.

Compared to last year's evaluation, all of the cracks, in general, do not appear to be widening to any appreciable amount.
