Experimental Study ND 94-07

**Scoping Edge Drains with
an Optical Camera**

Final Report

Project IM-8-094(005)331

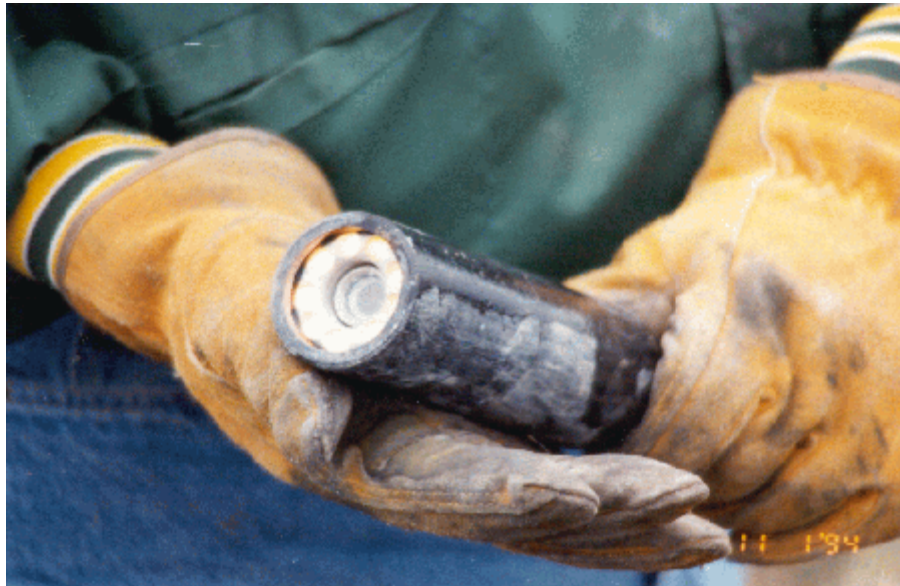
Photo 1: View of the P217 color optical camera.

Photo 1 depicts the P217 color optical camera. The diameter of the camera is about 1½". This enables the camera to enter into pipes that are small in diameter, such as the 4" edge drain pipes. It can also be used on larger diameter pipes when equipped with skids. This camera is equipped with several small lights that make a ring around the camera lens. The camera is designed to give high quality pictures with a minimum of light.
