Experimental Study ND 98-01

**Evaluation of Portland Cement Concrete  
as a Rehabilitation Option for  
Overlaying an Existing Asphalt Roadway**

**Final Evaluation Report**

Project NH-2-052(012)244

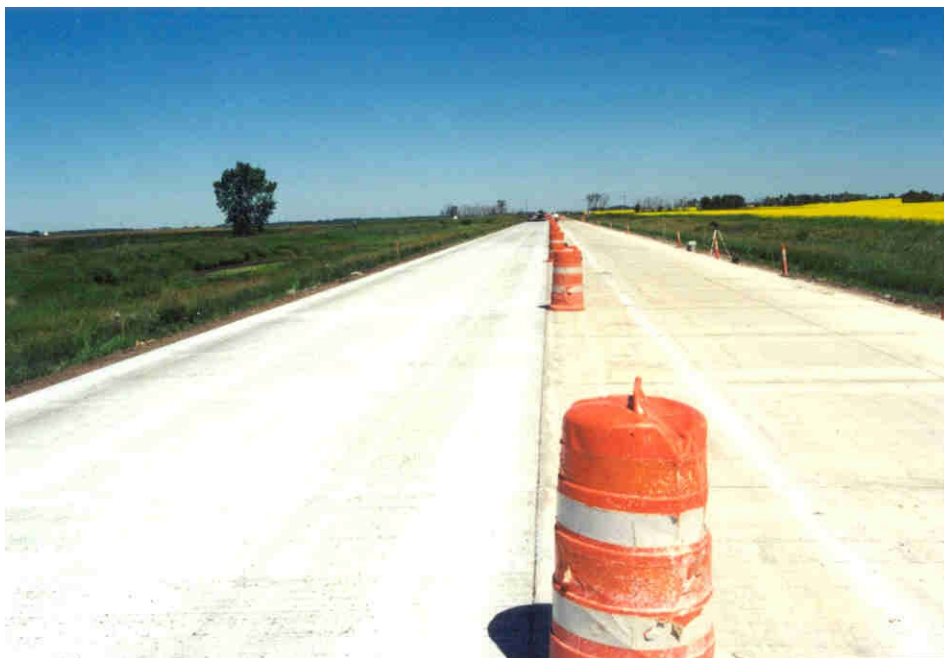
**Photo 7 - Overall view of test section 1.**

Photo 7 depicts an overall view of test section 1. A representative of the Materials and Research Division visited the site a few weeks after construction. The test sections were free of distresses except for a longitudinal crack located in the northbound lane near the beginning of test section 1. Photo 8 depicts a view of this distress which spans approximately 40'.
