Experimental Study ND 2002-02

Performance of HBP vs. PCC Pavement

Final Evaluation

Project NH-8-013(030)380

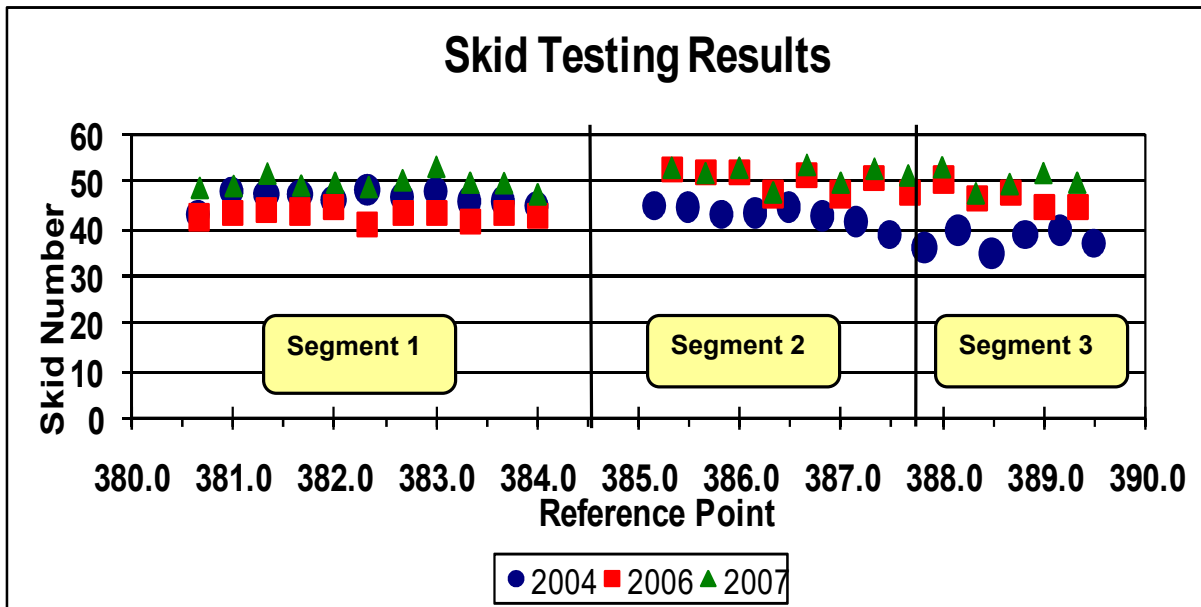
Chart 3, Skid Testing Results

Section	2004	2006	2007
	Average	Average	Average
1 (HBP)	46.5	43.3	49.8
2 (PCC/HBP shoulders)	43.1	50.1	51.6
3 (PCC/PCC Shoulders)	37.9	46.9	50.3
