Experimental Study ND 2013-03

Spraywall Pipe Liner
Evaluation

SOIA-5-094(084)023

March, 2016

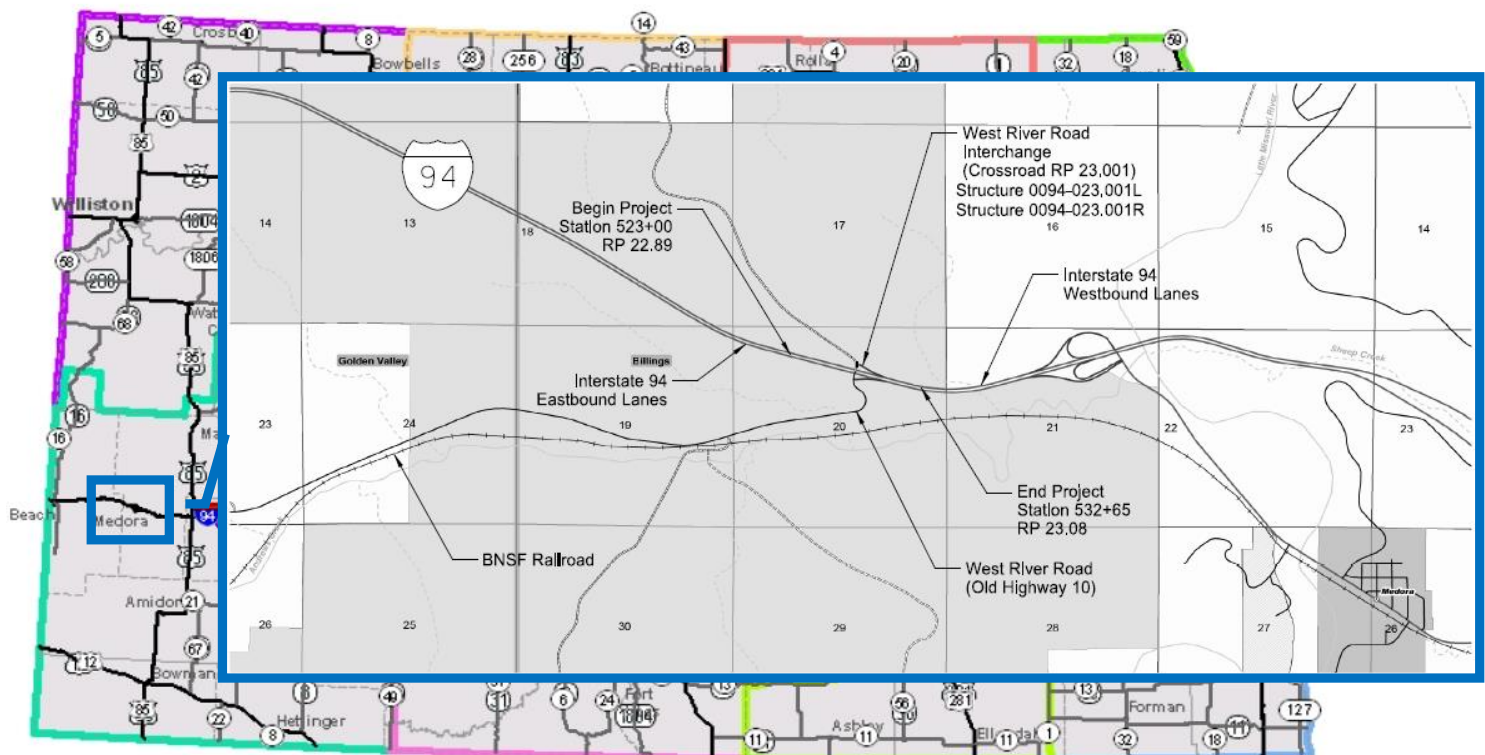
The location of the pipe is on the Interstate 94 West River Interchange near Medora, at approximately reference point 23. The north 124 LF of the pipe will be lined with the Spraywall.

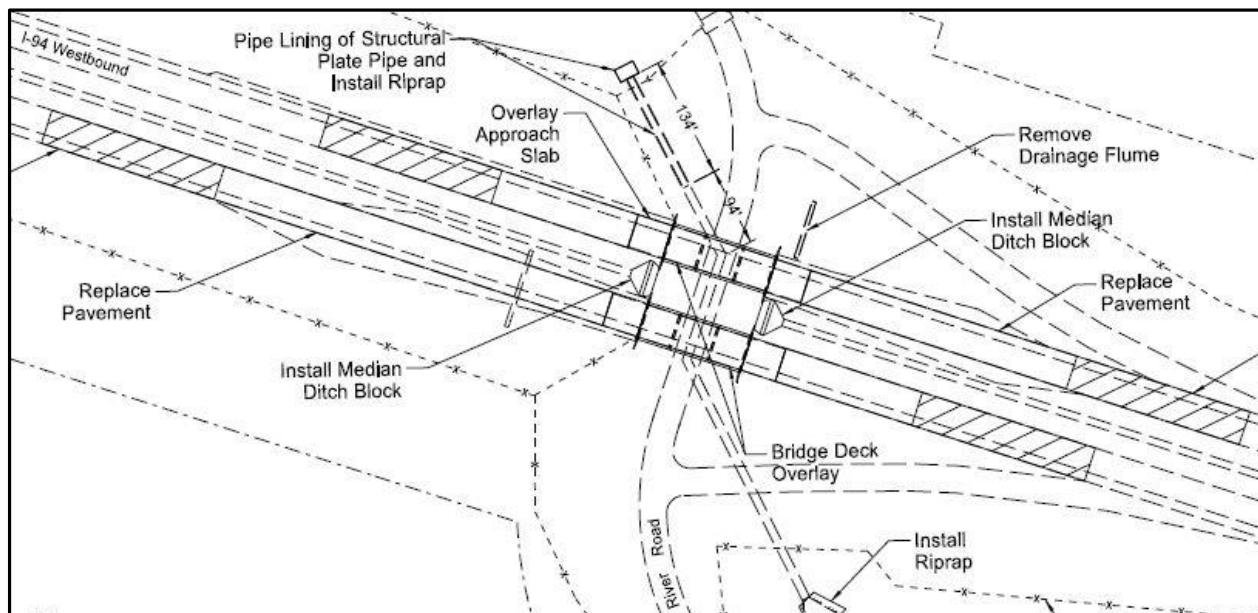
Original scope of work for pipe.

The Spraywall liner shall be applied to the pipe according to the manufacturer's recommendations. The coating shall be designed to restore the structural integrity of the pipe. The original plans called for the 124' of Structural Plate Pipe to be replaced and riprap to be installed. The design provided by the manufacturer is to line 134' of the pipe with 500 mils of the Spraywall liner, providing a 50 year design life to the rehabilitated portion of the pipe.

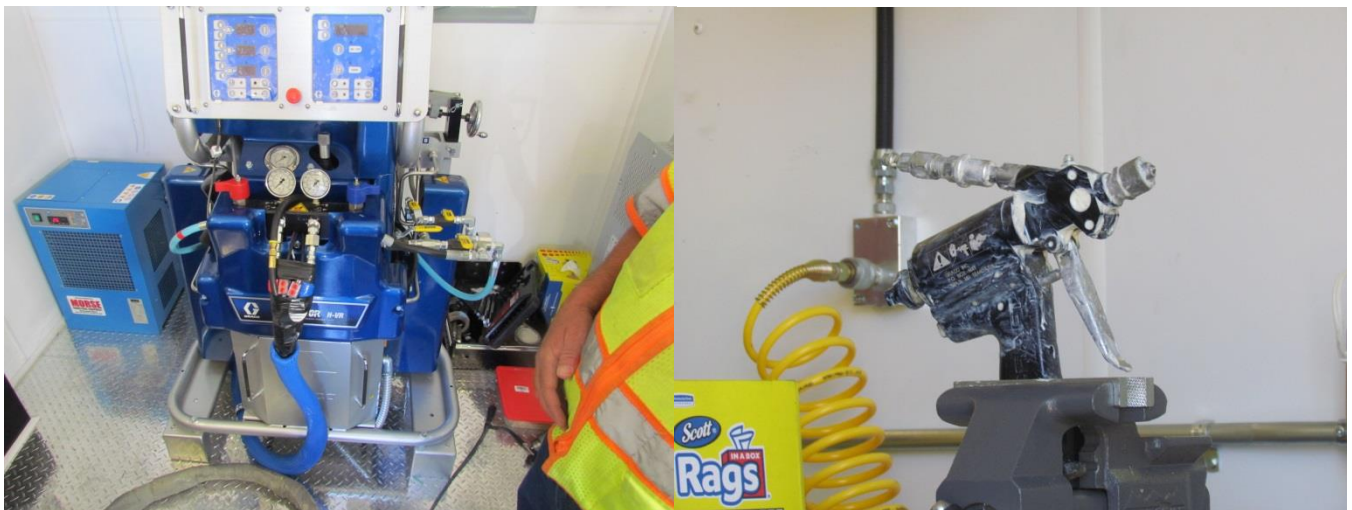
Photo 6 – Pump and spray nozzle used for Spraywall application.

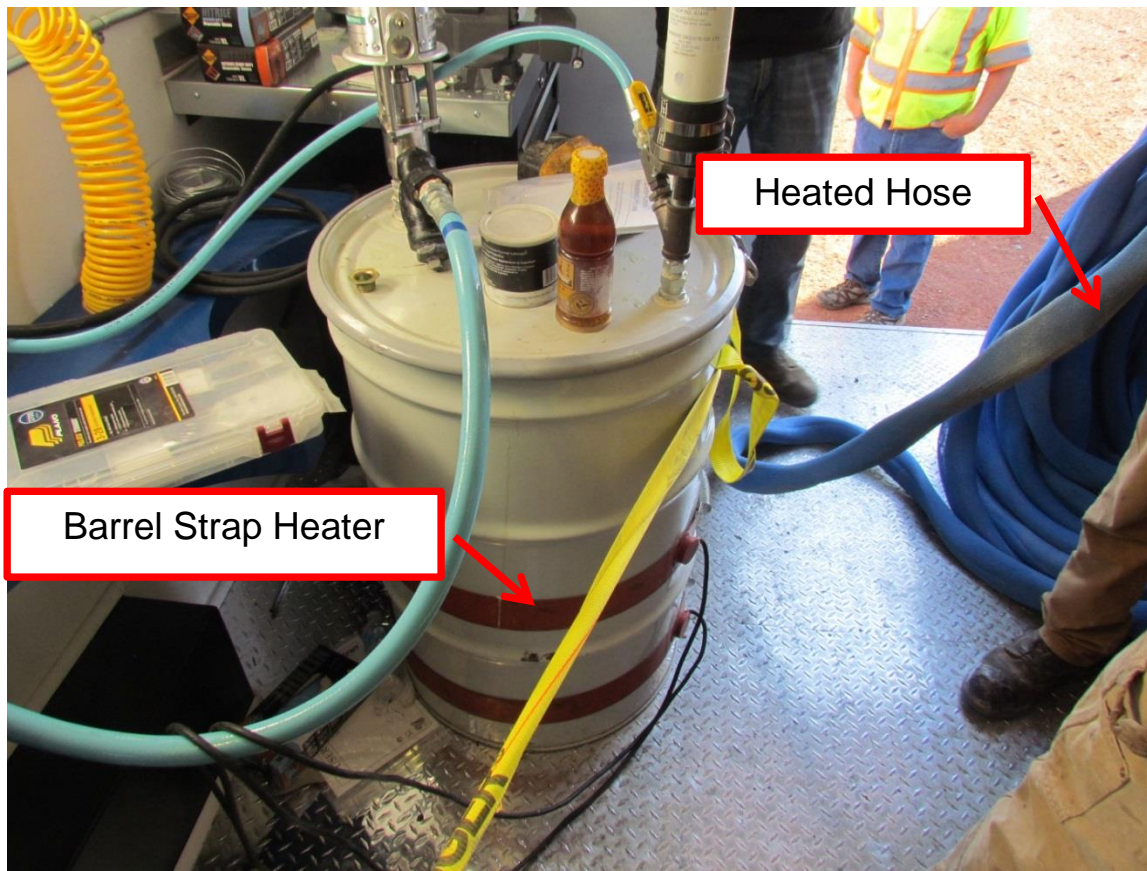
Photo 7 – Temperature controls used with the Spraywall application.

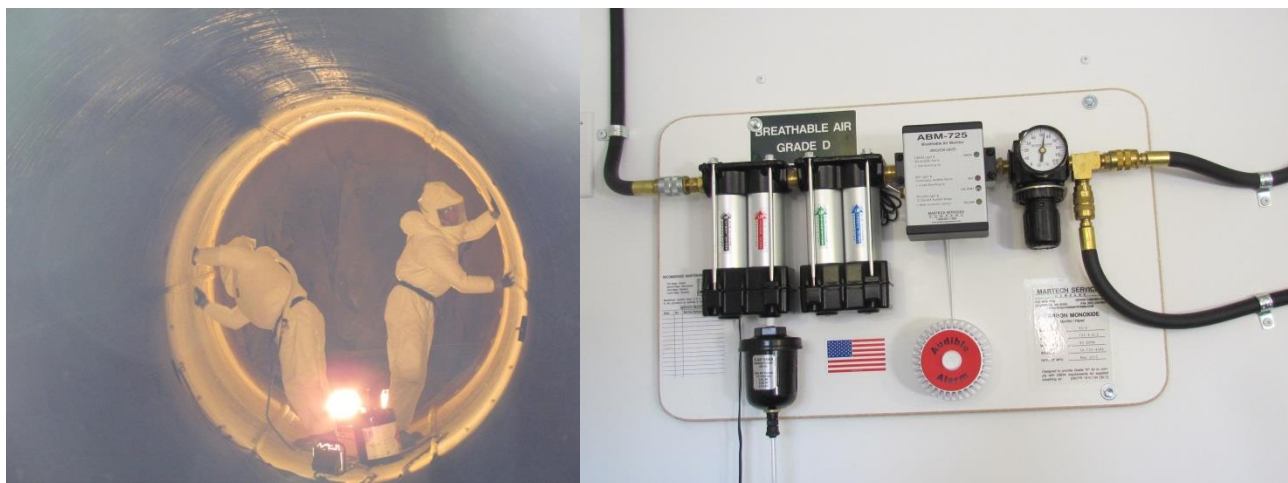
Photo 8 – Full body suit and breathable air regulator.

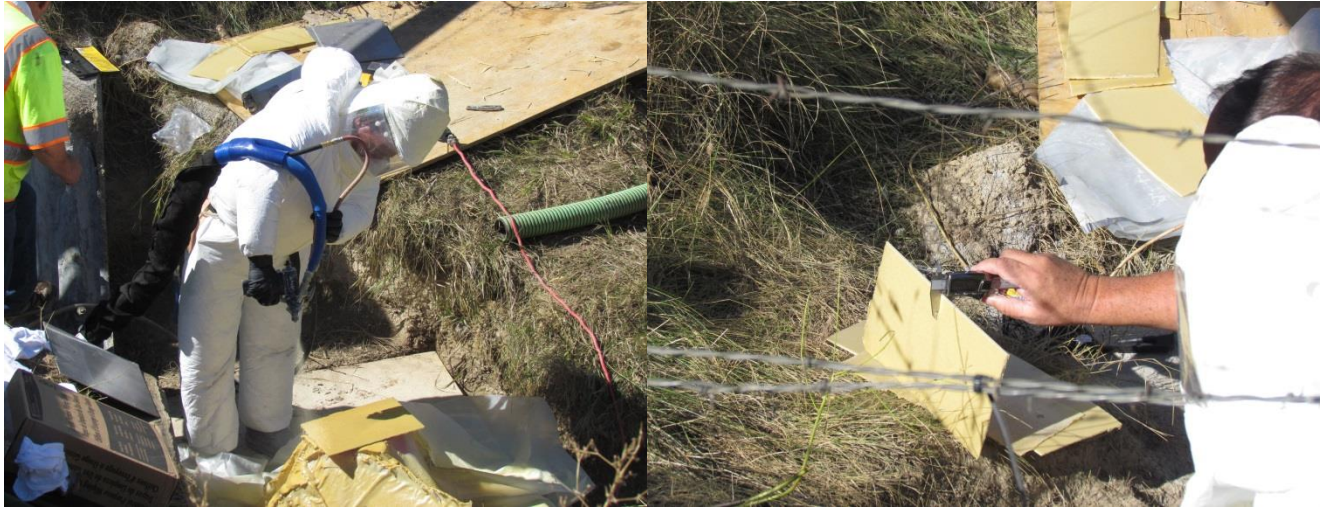
Photo 9 – Spraywall test panel and thickness measurement.

The Spraywall application began on September 11, 2013. Prior to any application of Spraywall to the pipe a test panel was applied with Spraywall to adjust the equipment and spray passes to achieve the correct thickness. The test panels have a wax release agent to allow the Spraywall material to be removed.

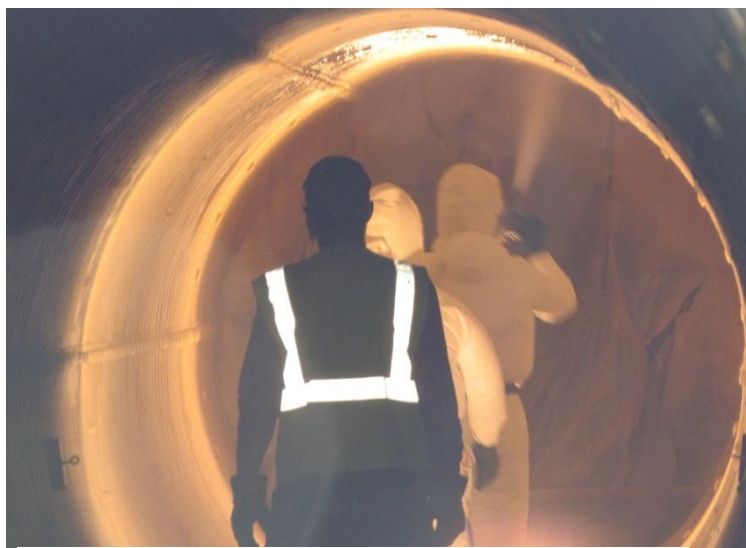
Photo 10 – Application of Spraywall.

After the test panels have been completed the contractor began application of Spraywall to the pipe. The contractor would mark the pipe every 12.5' with a marker. This was used to aid the contractor in knowing how much material was being used, with the amount of passes used to cover the area. Photo 10 displays the contractor applying the Spraywall liner onto the pipe.

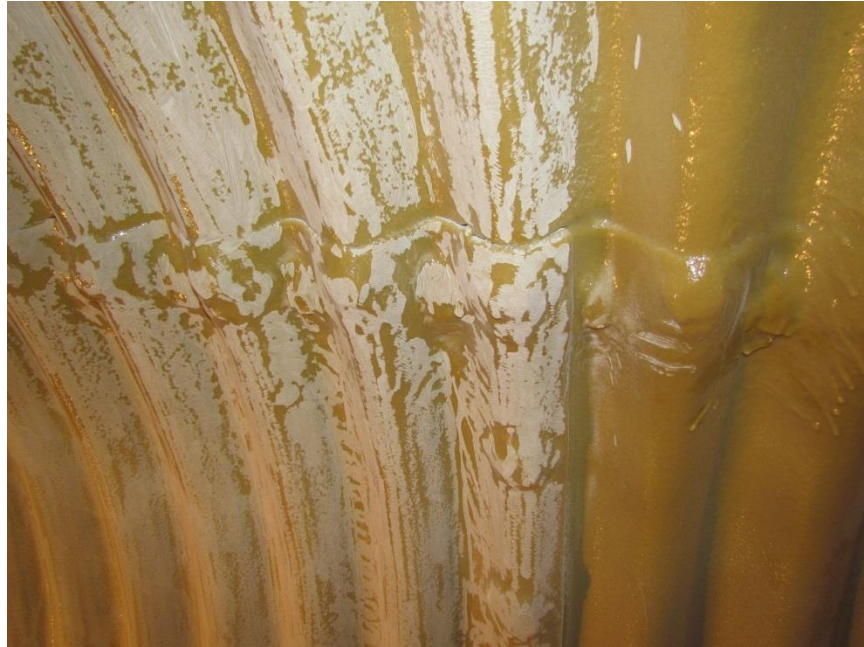
Photo 11 – Spraywall Liner scuffed for overlap preparation.

The contractor was unable to complete the installation within one day. This required the contractor to quit and begin the process the following day after the Spraywall liner has cured. To begin the installation the following day the Spraywall liner is overlapped over the existing Spraywall liner. The Spraywall liner being overlapped is scuffed for proper adhesion with wire brush attached to a grinder as shown in Photo 11.
