# GRANT MARSH BRIDGE REHABILITATION

North Dakota Department of Transportation

Brian Raschke, PE  
NDDOT Bridge Design  
April 23, 2025

Curtis Schroeder, PhD, PE  
Associate Principal  
Wiss, Janney, Elstner Associates

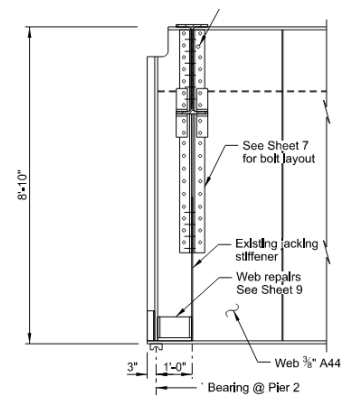
SECTION C-C  
(BOLTS NOT SHOWN FOR CLARITY)

- Replace floor trusses adjacent to expansion joint with floor beam
  - Avoids patching individual areas of section loss
  - Lower fabrication cost than a replacement floor truss
- Extend jacking stiffener as new floor beam connection using back-to-back angles
  - Moves floor beam further from expansion joint to allow support of finger joint and provide for drainage
  - Removes deterioration at ends of stringer
- Floor beam elevation shifted to deck level to directly support finger joint
  - Avoids concrete end beam under finger joint

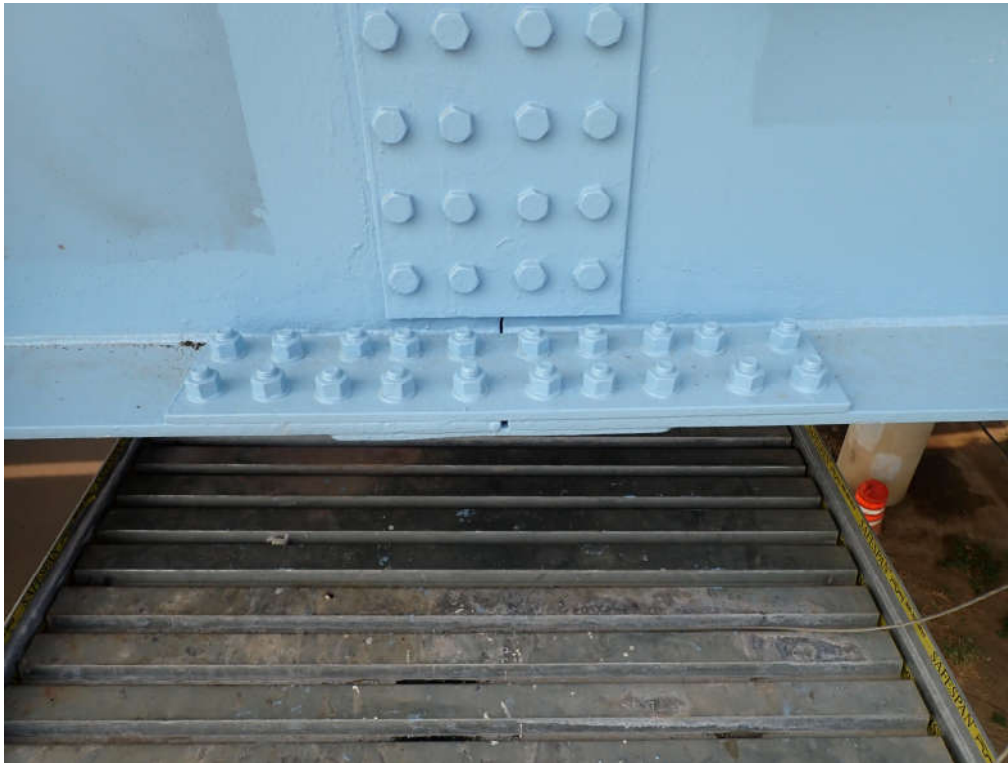
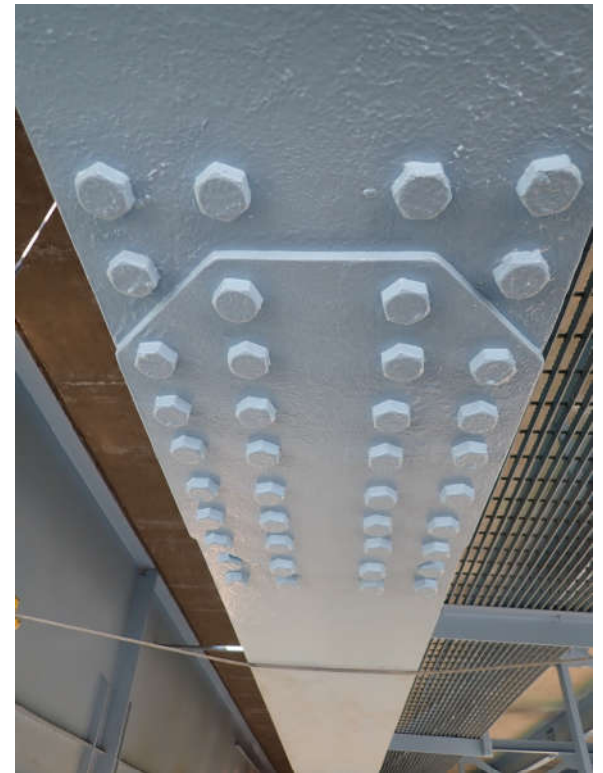
# BOLTED FIELD SPLICE REPAIRS

- Removal and replacement of bottom flange splice plates
  - Staged to avoid release of locked-in dead load
- Construction sequence
  - Remove one inside splice plate by one-by-one replacing bolts with drift pins installed in bolt holes to bear on outside splice plate
  - Clean and install a new, longer inside splice plate with 3 bolts fully pretensioned to bottom flange only on each end
  - Flip drift pins to bear on inside splice plate
  - Repeat on other inside splice plate
  - Remove outside splice plate, install new outside splice plate, remove drift pins one-by-one and install pretensioned bolts
