Experimental Study MR 2004-01

Effects of HBP Paver Motion on Ride Quality

Final Report

AC-HPP-4-052(045)058

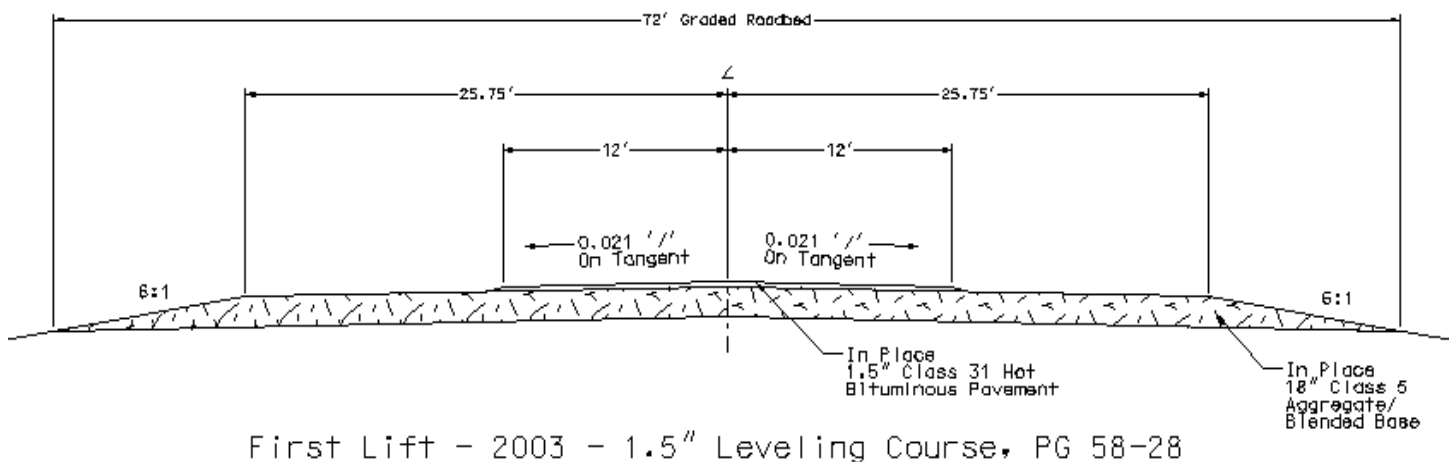
Figure 2 – First lift that was used to protect base and subgrade over 1st winter.

The project was re-graded and widened in the 2003 construction season. 1.5" of Hot Bituminous Pavement (HBP) Class 31 (using 58-28 binder) was placed until the intermediate and final lifts of hot bituminous pavement could be constructed in the spring of 2004. The intermediate lift was constructed with 2" of Class 31 (using 58-28 binder) HBP and the final lift was 2" of Class 31 (using 58-34 binder) HBP. A cross section of the roadway can be seen in the Figures 2, 3, & 4 below.

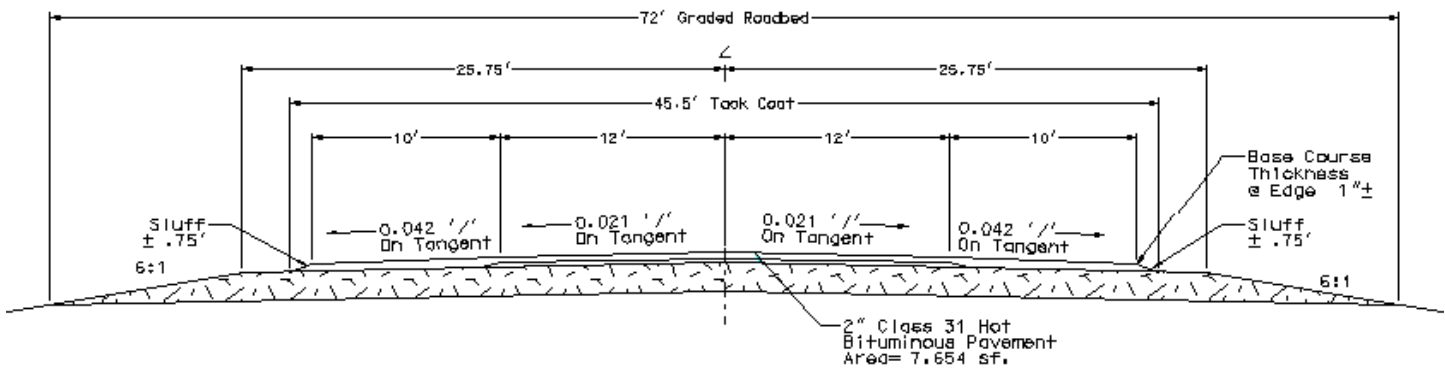
Intermediate Lift - 2004 - 2" Base Course, PG 58-28
10' shoulder shall be paved with 12' adjacent lane.

Figure 3 - Intermediate lift put down the following construction season.

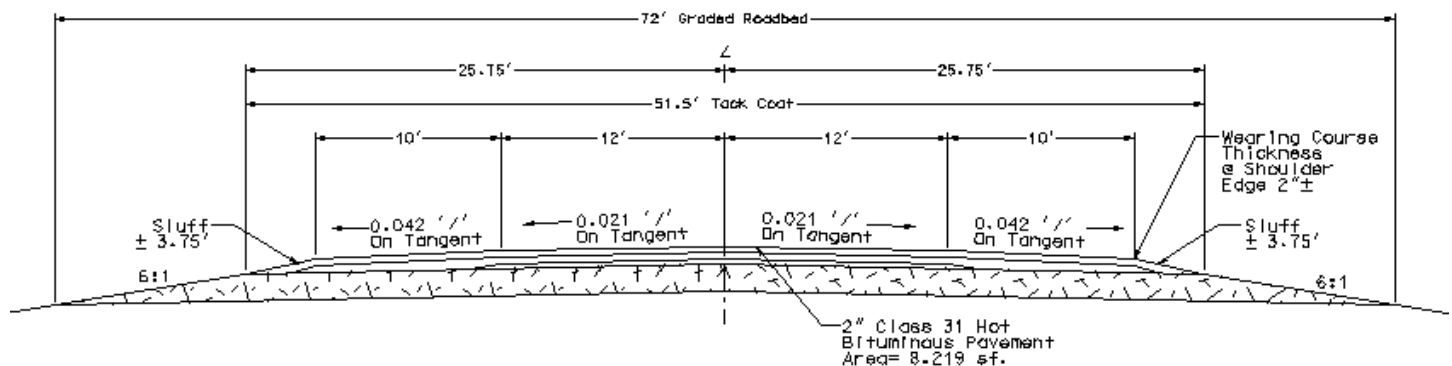
Final Lift - 2004 - 2" Wearing Top Course, PG 58-34
10' shoulder shall be paved with 12' adjacent lane.

Figure 4 - Final lift put down after intermediate lift was finished.

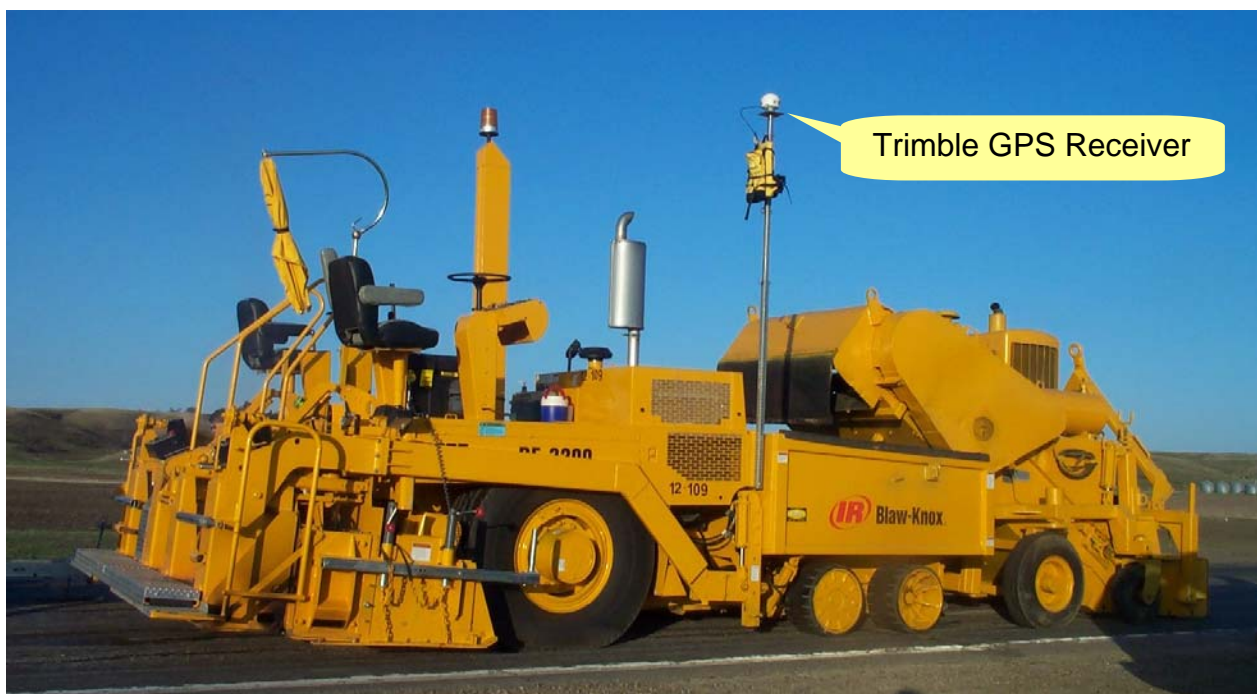
Photo 1 – Photo of Blaw-Knox paver with Trimble GPS receiver attached.

May 18, 2004 Mayo Construction began to pave the intermediate lift with a new Blaw-Knox, model PF-3200 Paver. On the first day a sensor for the screed failed and had to be replaced. Other than a failed sensor there were no equipment problems. A photo of the paver can be seen in Photo 1. The GPS unit can be seen attached to the paver. There were delays throughout the paving of both lifts caused by rain. On June 2, the intermediate lift was finished. Paving for the final lift began June 3 and was finished June 14.

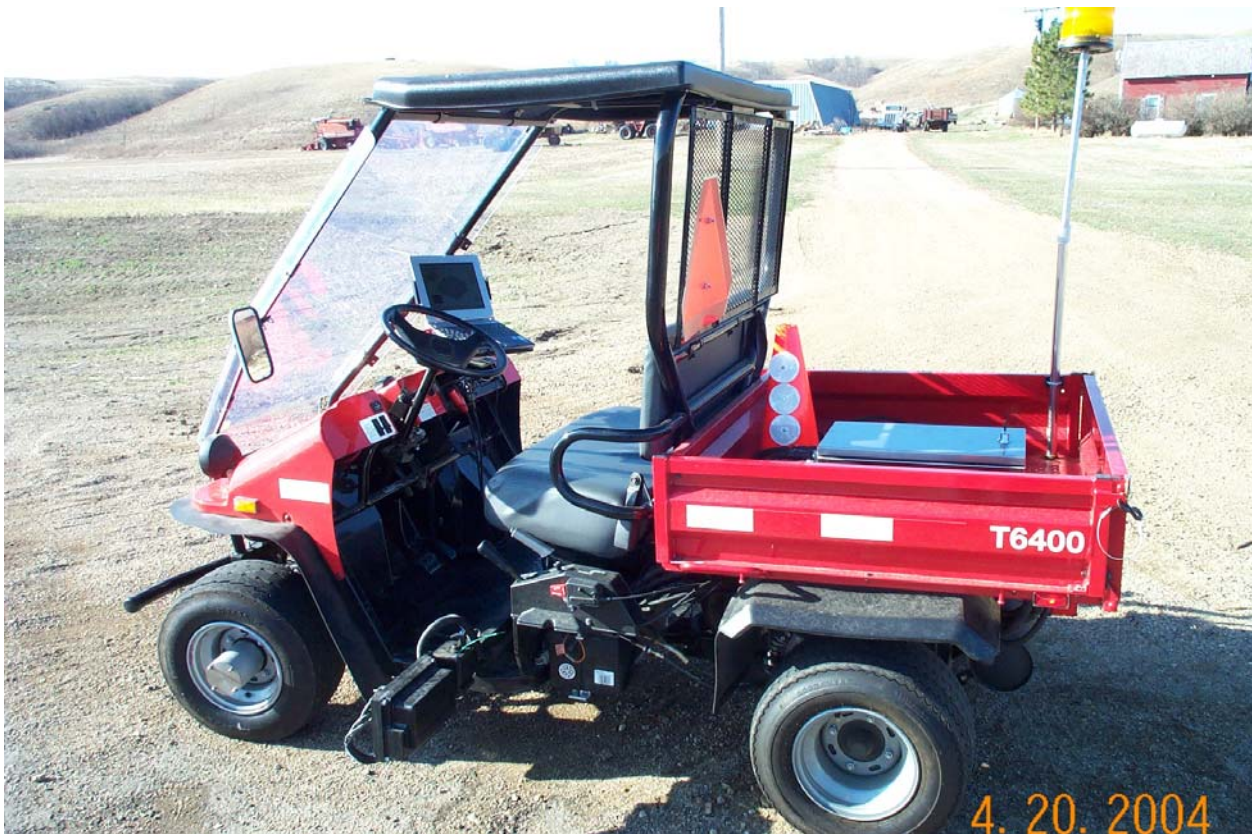
Photo 2 – SDDOT's lightweight profiler.

The profile of the road was measured using a Light Weight Inertial Profiler (Dynatest model 6400). The lightweight profiler is mounted onto a Kawasaki Mule Model 500 series. The lightweight profiler collects both wheel paths of a lane on one run of the roadway. Photo 2 displays the lightweight profiler.

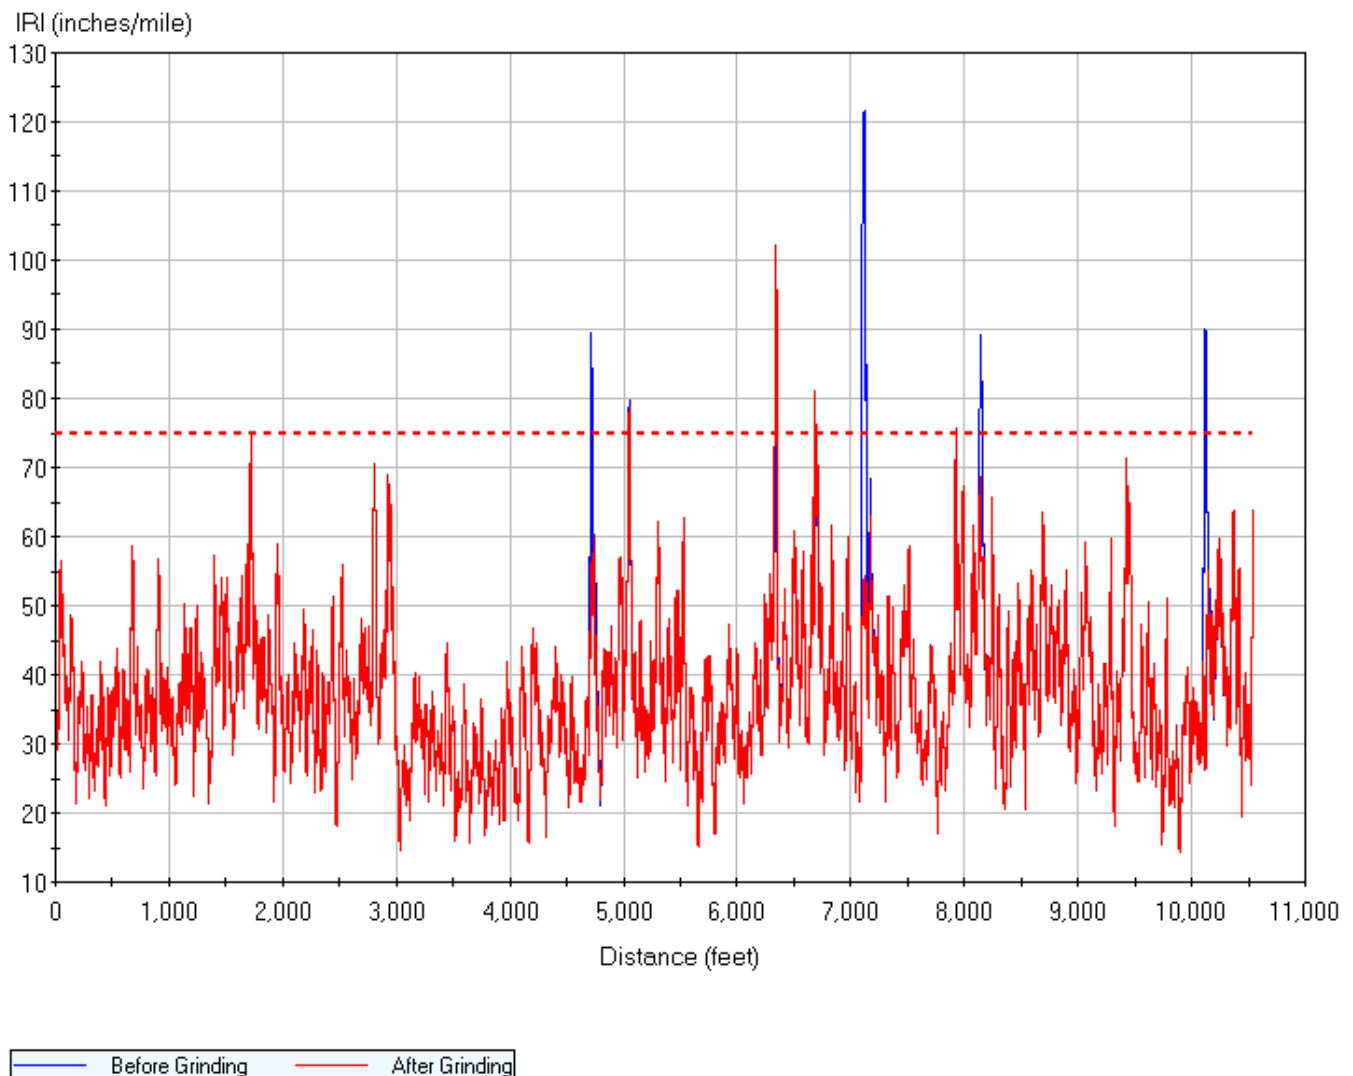
Figure 5 - An example of a graph from ProVal

ProVal 2.5, a beta version software, was used to analyze the data from the light weight profiler. ProVal has two programs that were used to convert the raw data from the profiler into a continuous IRI value for the roadway. The programs on ProVal are “Bumpfinder and Grinding” and “Ride Stats Continuous”. A threshold for the IRI is chosen for the two programs and then the software identifies any area on the roadway that exceeds an IRI chosen for the threshold. Figure 5 displays an example of a graph that ProVal 2.5 provides from using the “Bumpfinder and Grinding” and “Ride Stats Continuous” programs.

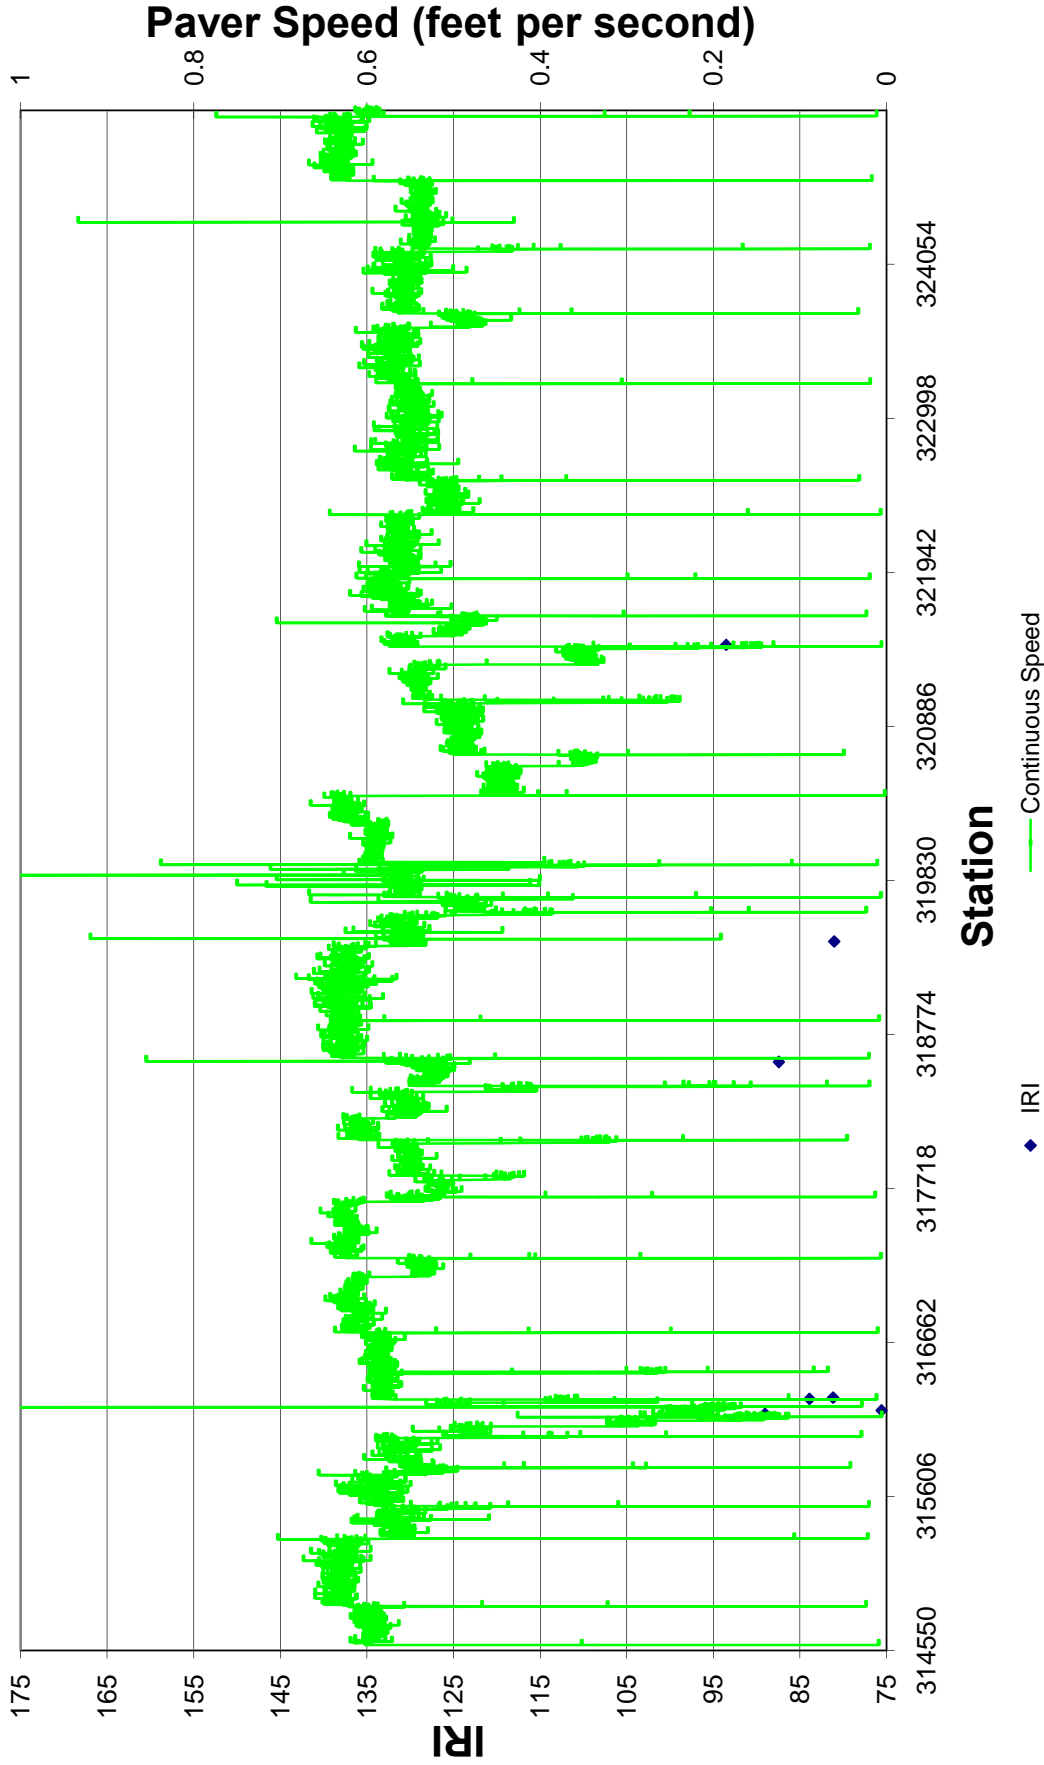
Centerline Westbound Wheel Path

Average Paver Speed Westbound
Final Lift = 0.5079 Feet Per Second

Paving Direction
←

Sta. 3145+50 to Sta. 3251+09

Appendix A displays the speed and location for all of the areas where the IRI threshold exceeds 75. In Appendix A, a graphical representation can be seen of the paver speed and the areas with an IRI value exceeding 75. From these graphs it appears that there are many areas where the stopping of the paver may affect the ride. It also displays areas with an IRI problem when the paver was at a constant speed. These areas with the constant paver speed may be caused by a variety of reasons, such as mix control, temperature of mix, and compaction from rollers.

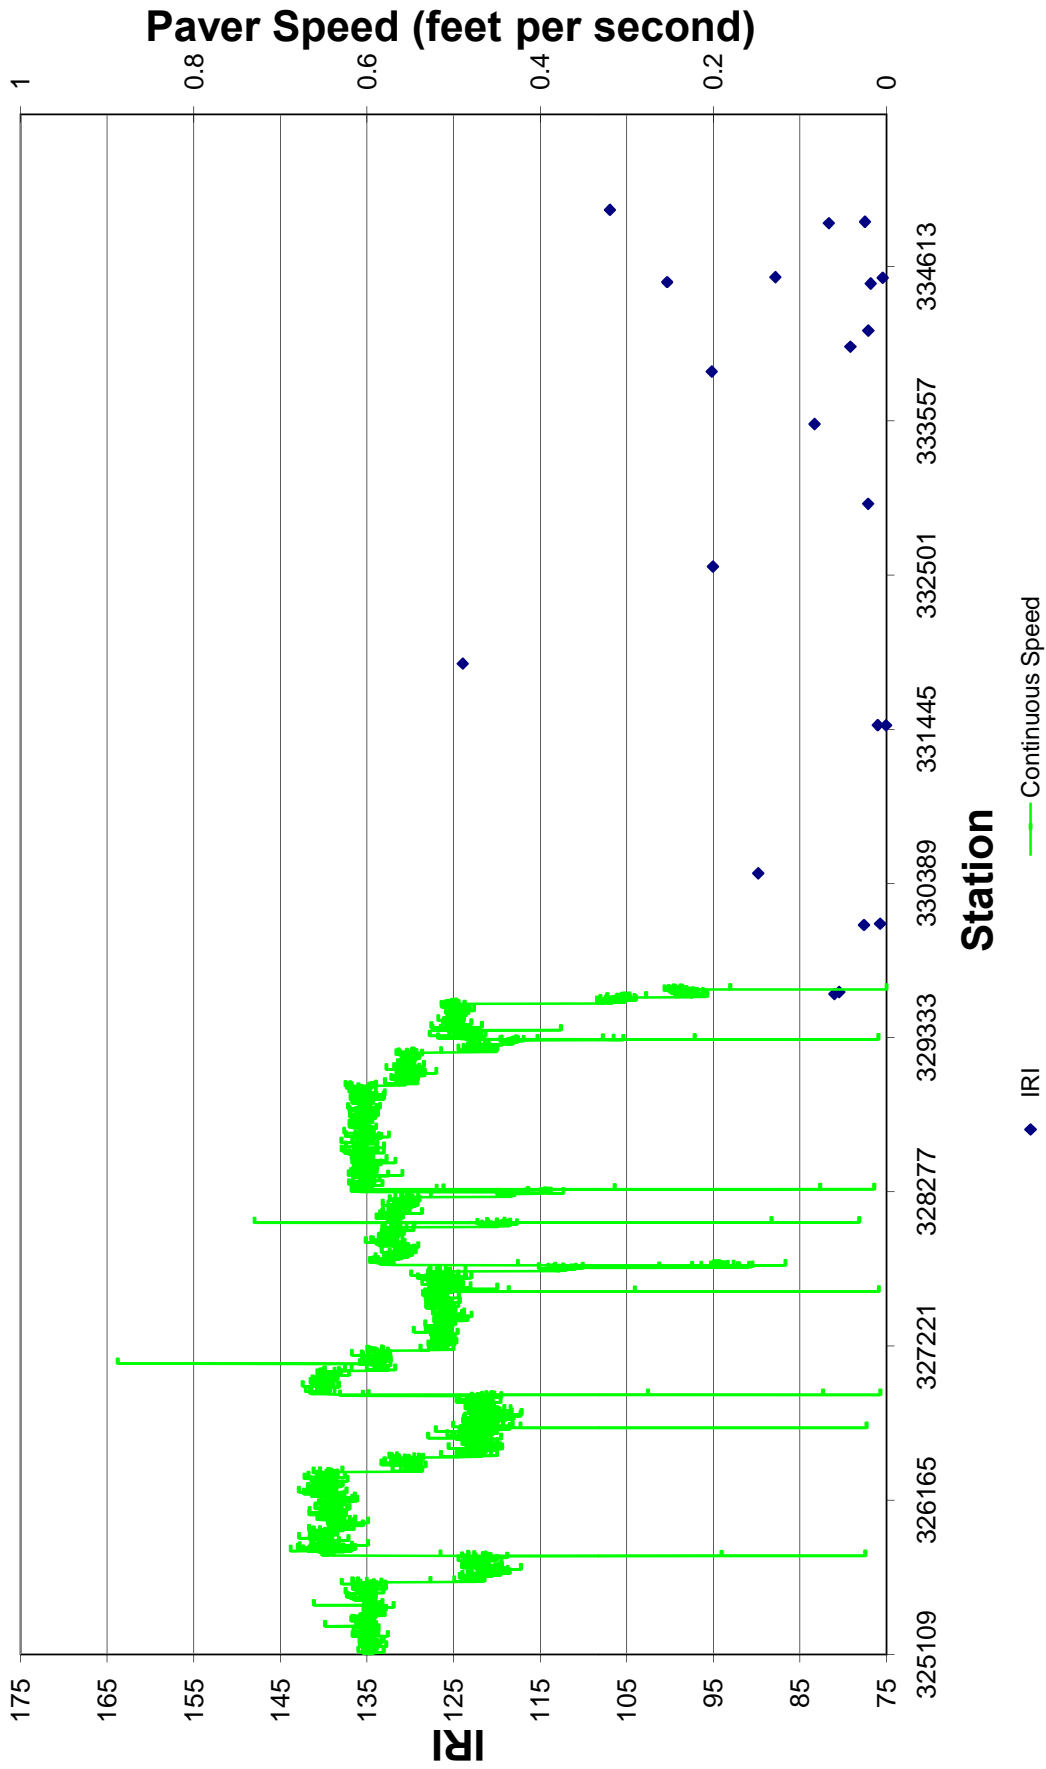
Centerline Westbound Wheel Path

Average Paver Speed Westbound
Final Lift = 0.5079 Feet Per Second

Paving Direction
↓

Sta. 3251+09 to Sta. 3356+55

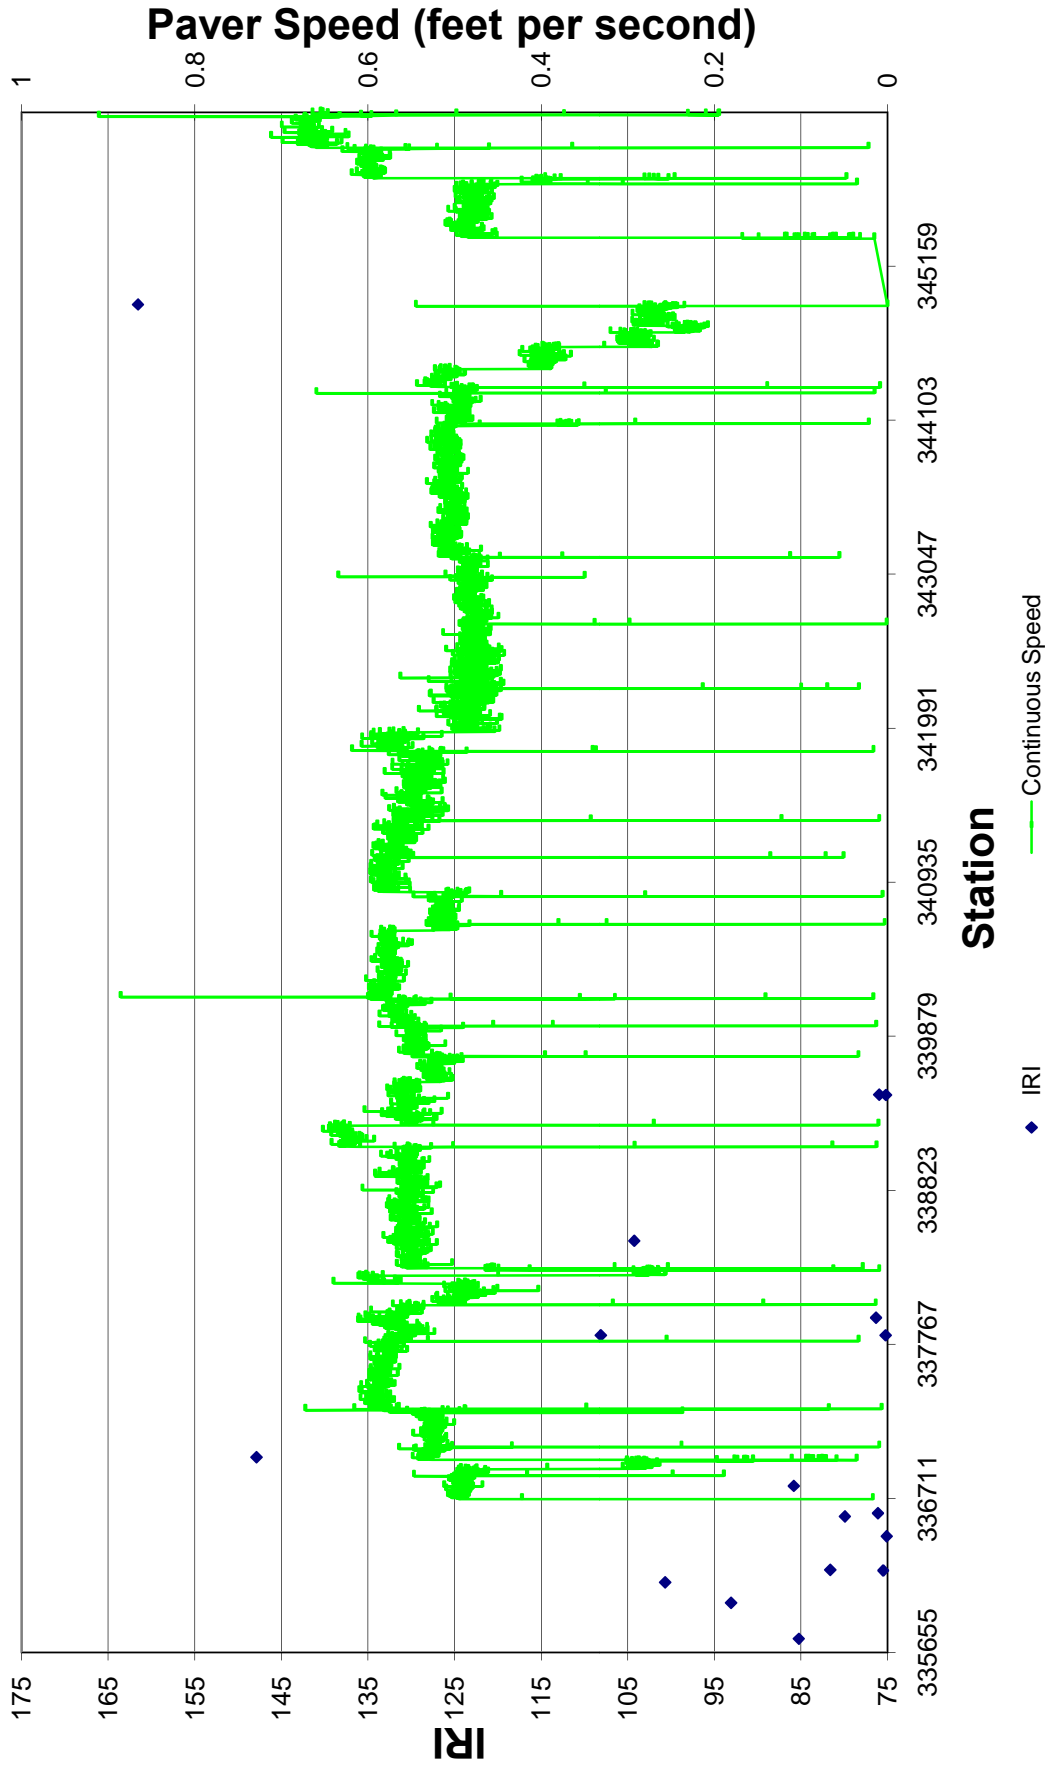
Centerline Westbound Wheel Path

Average Paver Speed Westbound
Final Lift = 0.5079 Feet Per Second

Sta. 3356+55 to Sta. 3462+12

Paving Direction
←

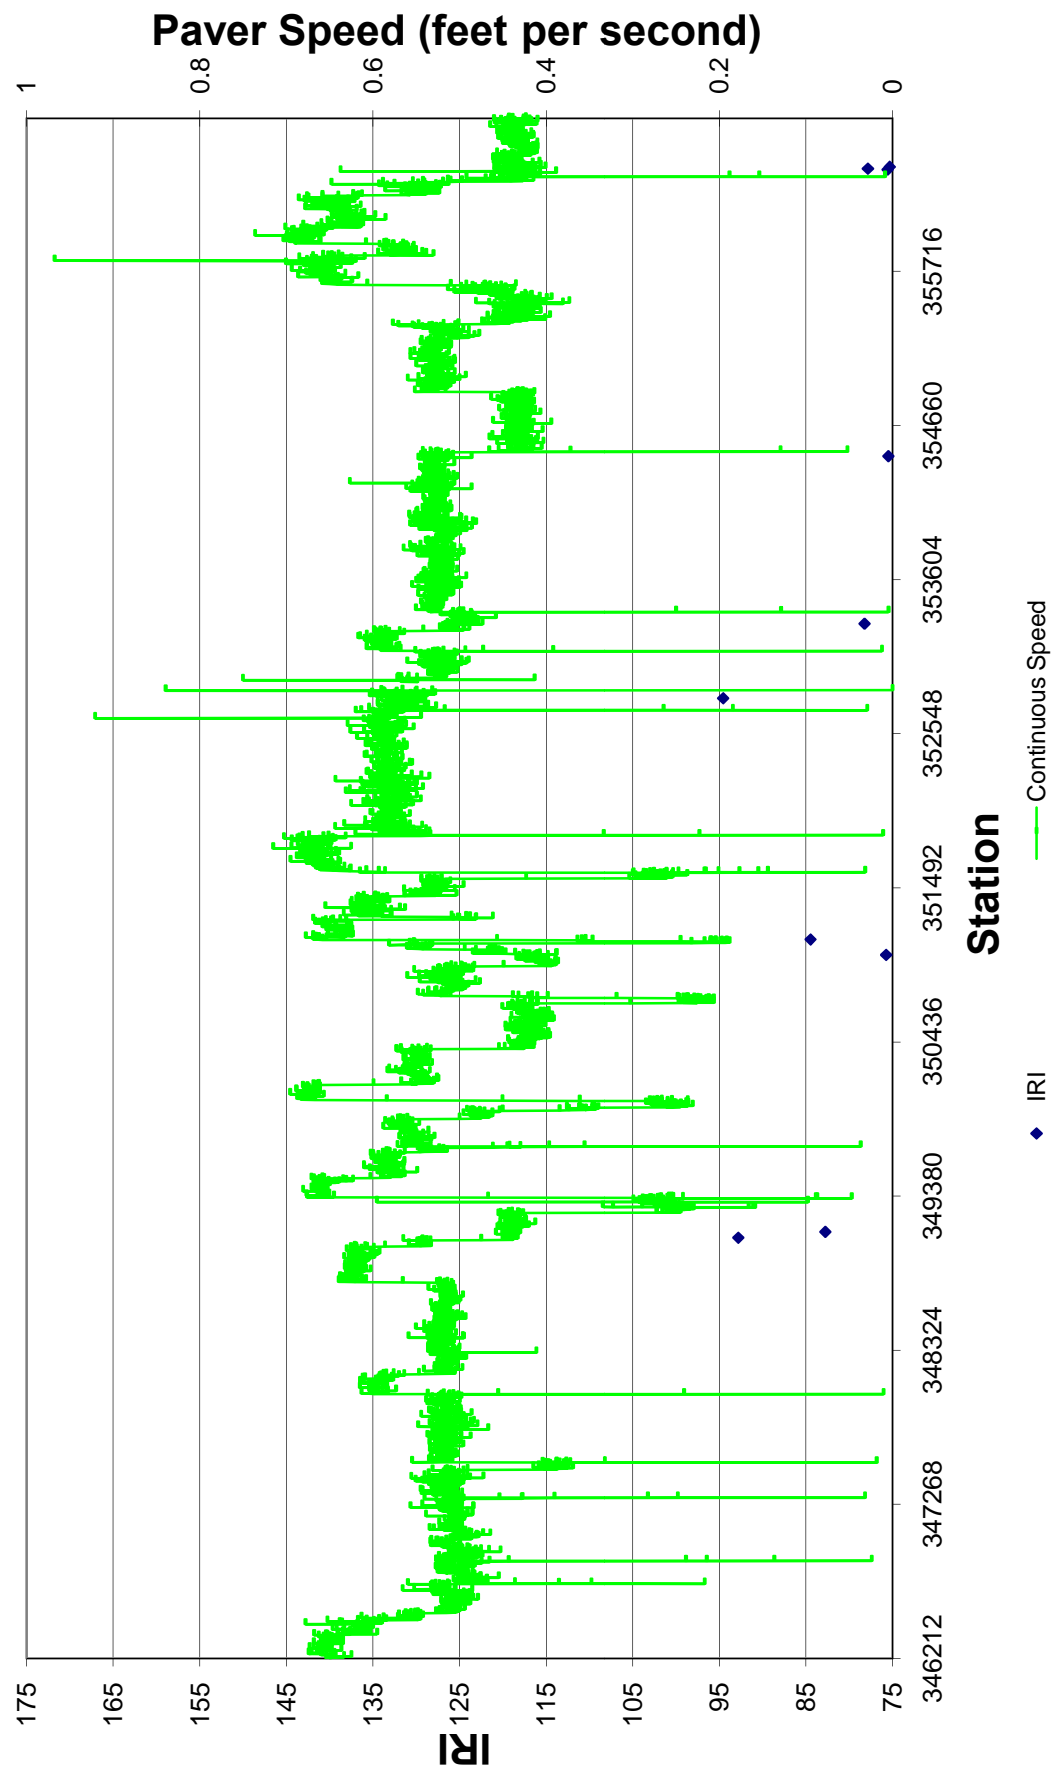
Centerline Westbound Wheel Path

Average Paver Speed Westbound
Final Lift = 0.5079 Feet Per Second

Sta. 3462+12 to Sta. 3567+64

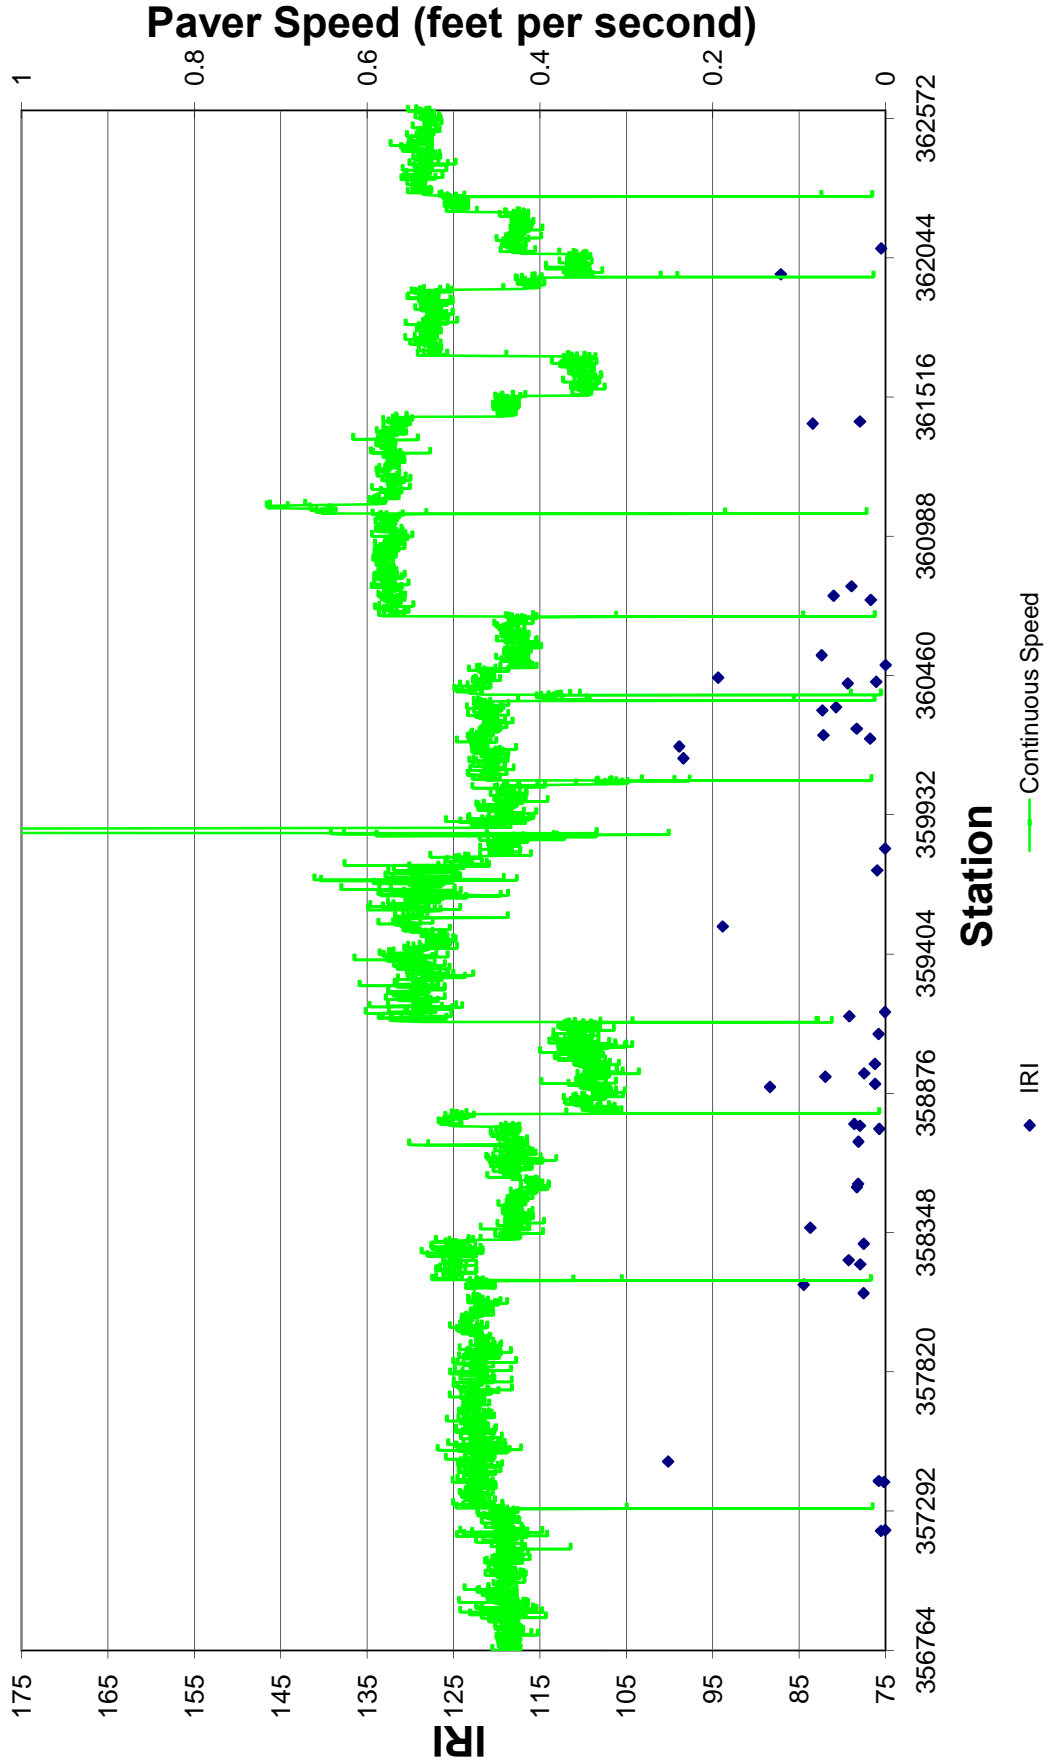
Centerline Westbound Wheel Path

Sta. 3567+64 to Sta. 3626+03

Average Paver Speed Westbound
Final Lift = 0.5079 Feet Per Second

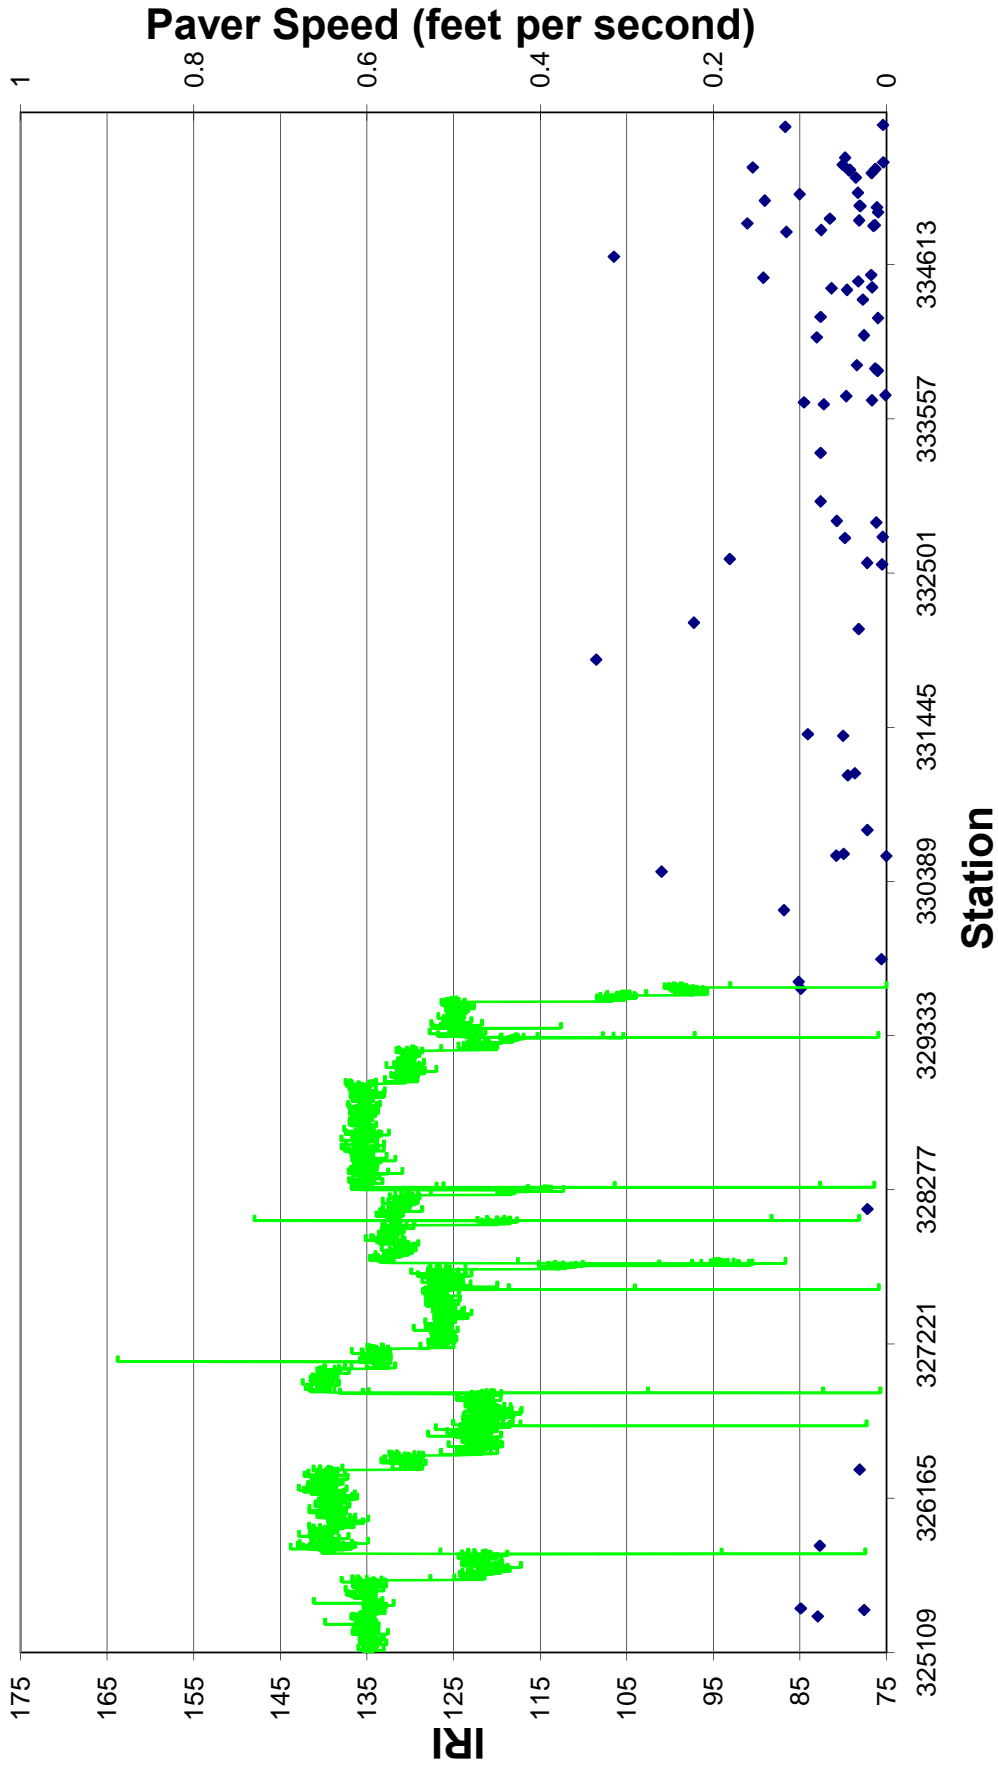
Shoulder Westbound Wheel Path

Average Paver Speed Westbound
Final Lift = 0.5079 Feet Per Second

Sta. 3251+09 to Sta. 3356+55

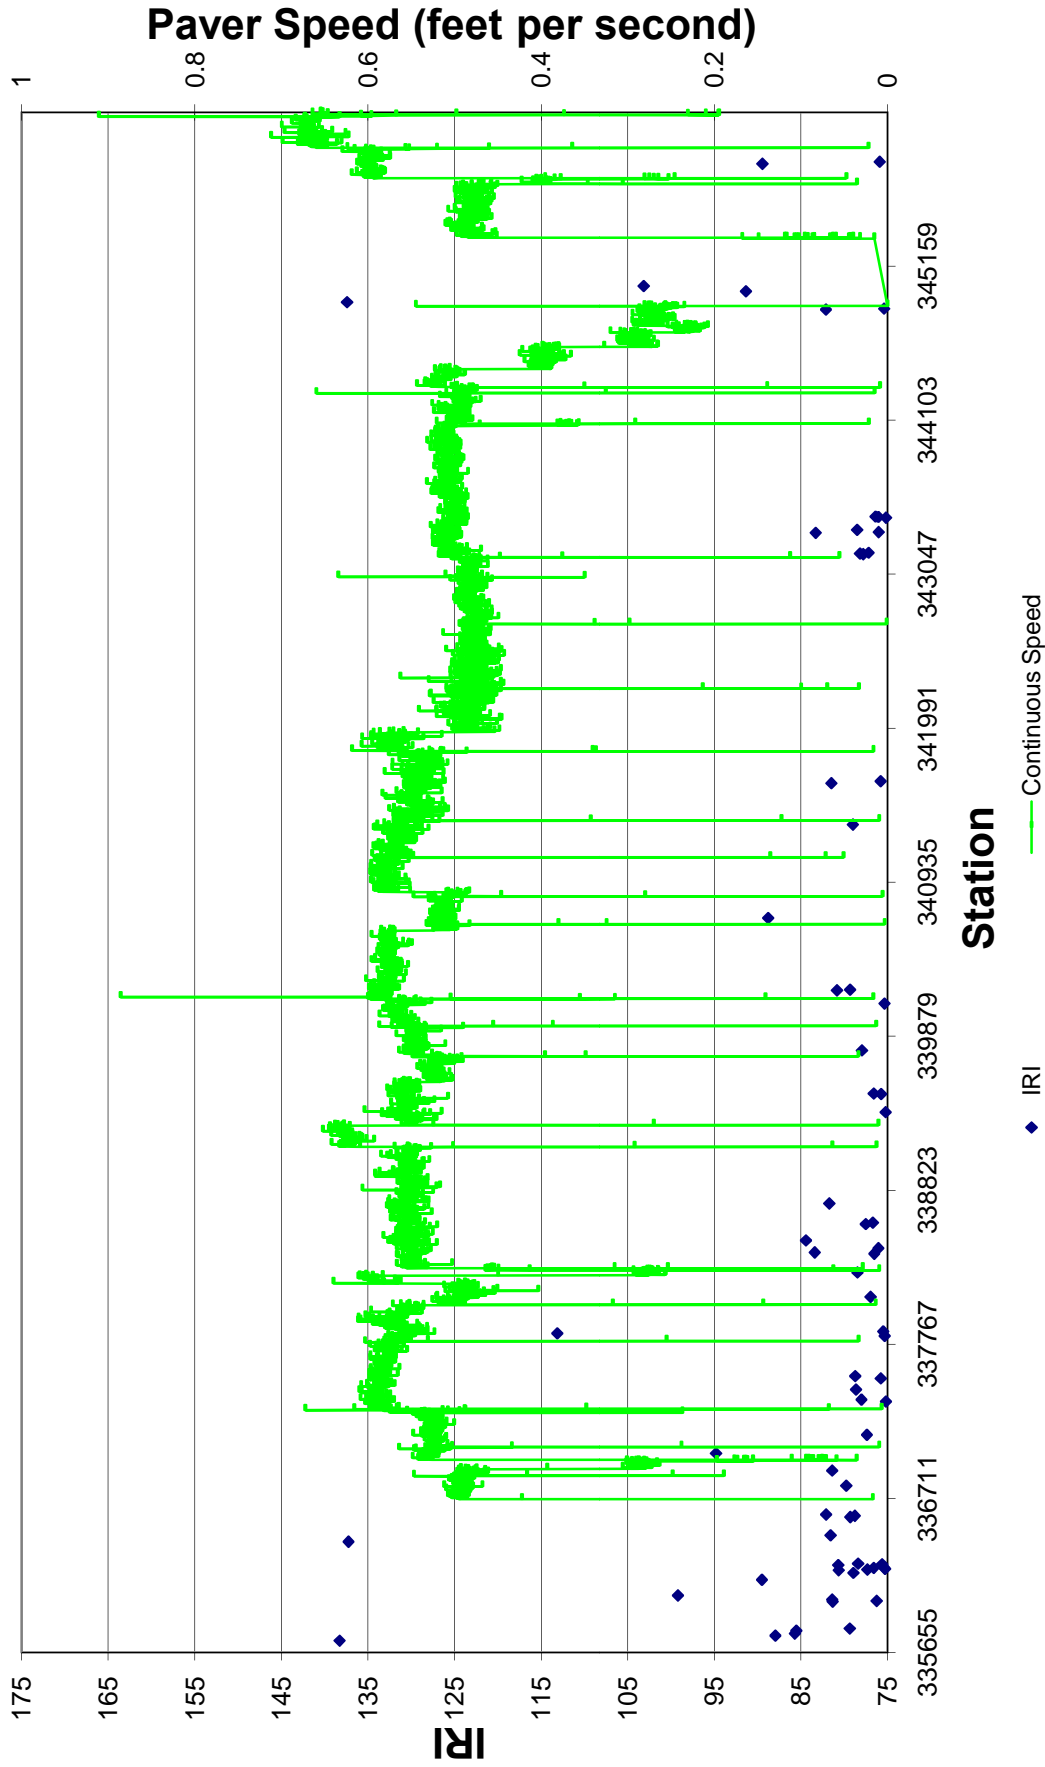
IRI Continuous Speed

Shoulder Westbound Wheel Path

Sta. 3356+55 to Sta. 3462+12

Paving Direction
←

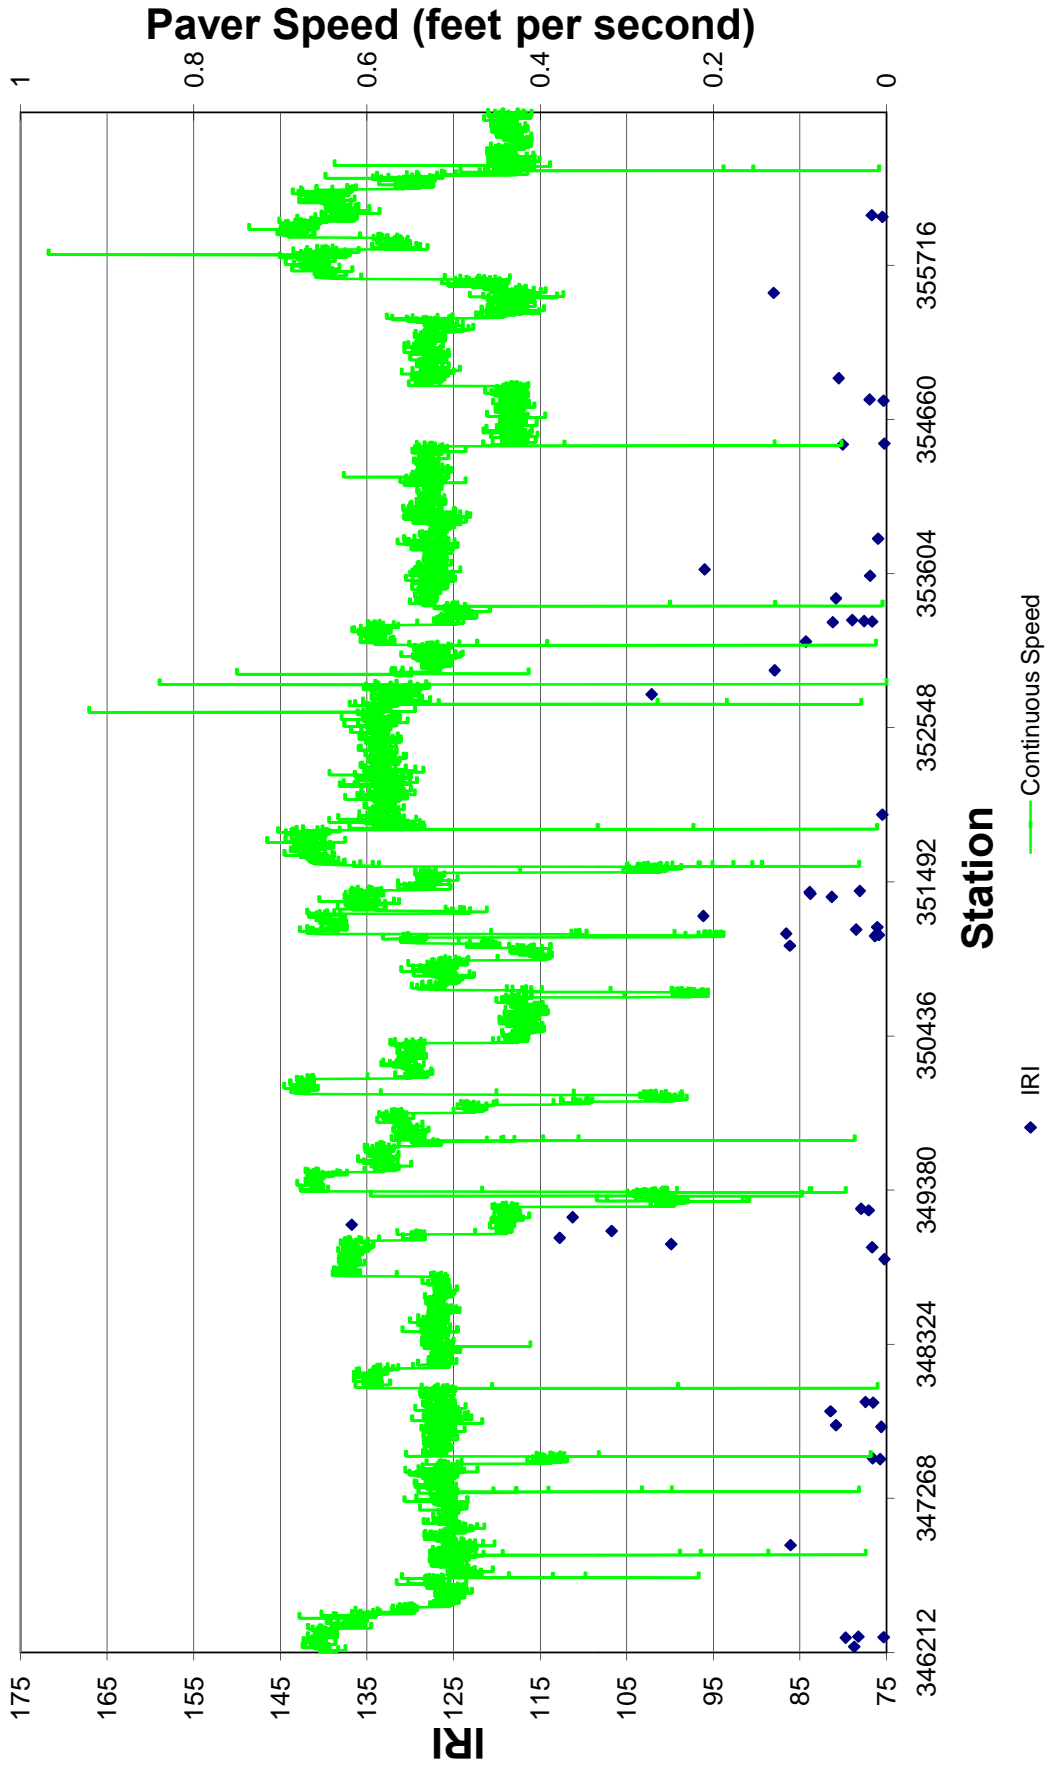
Shoulder Westbound Wheel Path

Average Paver Speed Westbound
Final Lift = 0.5079 Feet Per Second

Sta. 3462+12 to Sta. 3567+64

Paving Direction
←

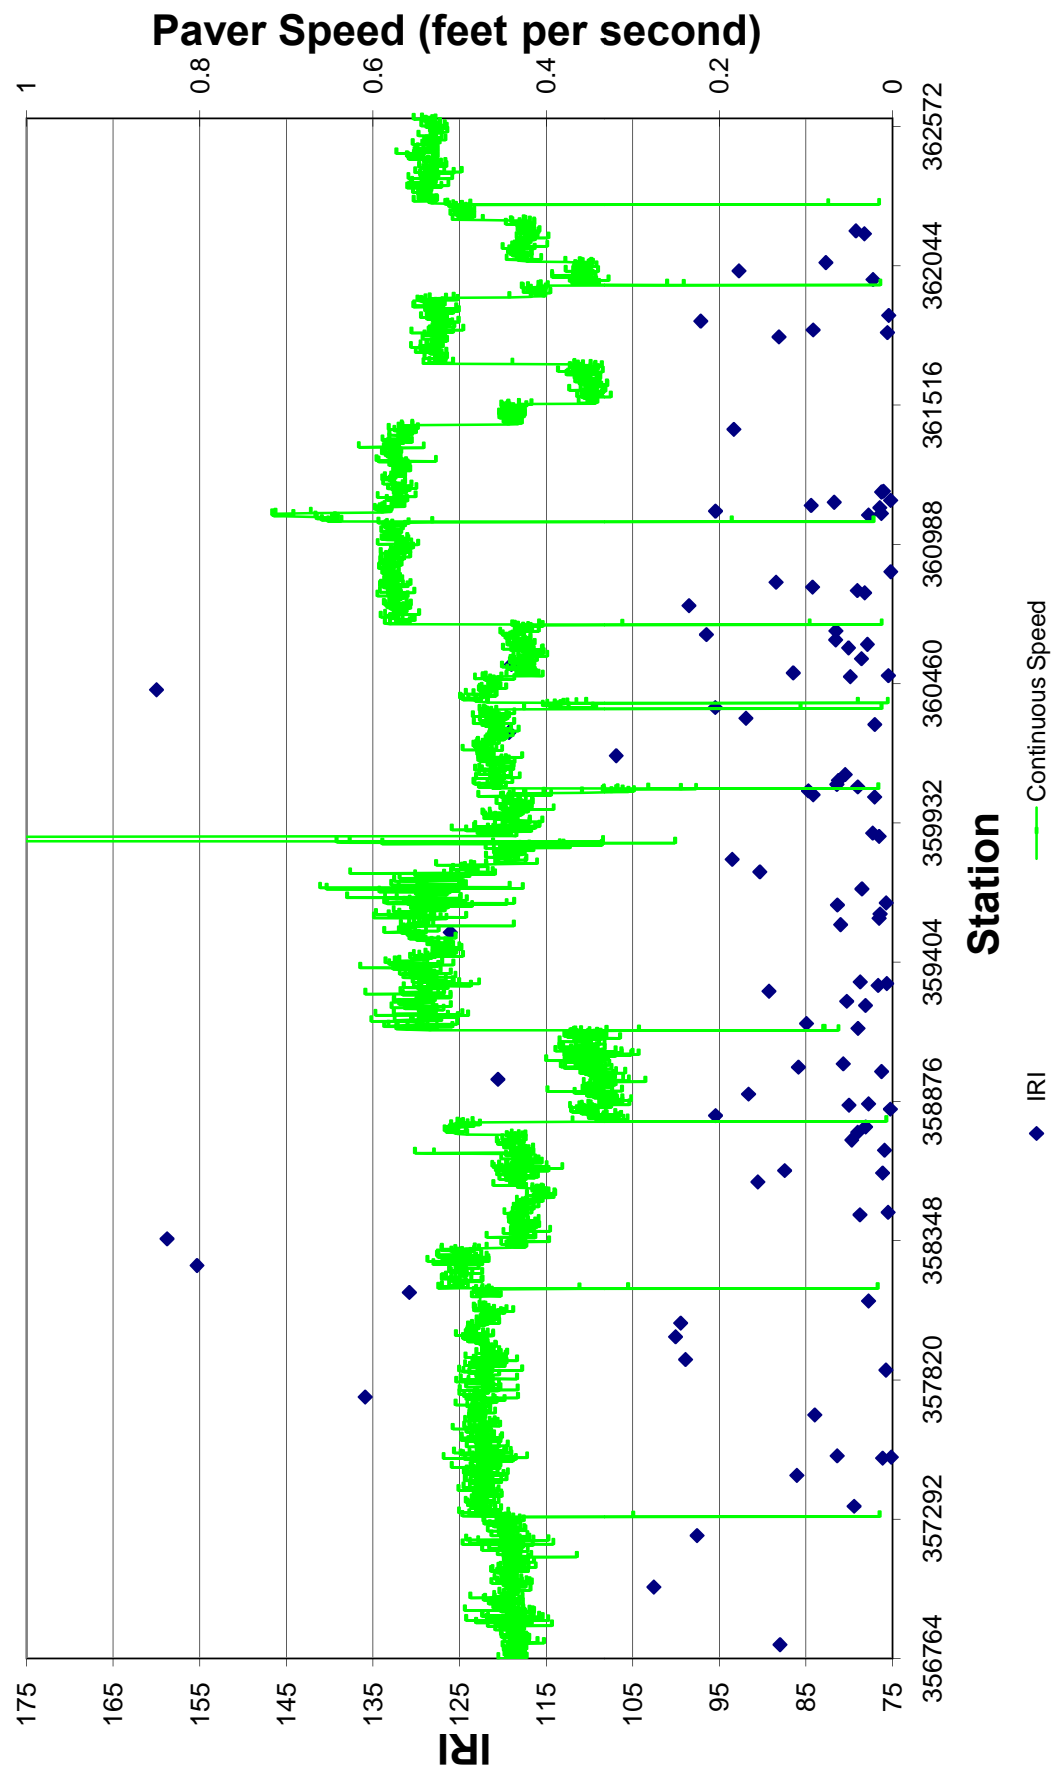
Shoulder Westbound Wheel Path

Average Paver Speed Westbound
Final Lift = 0.5079 Feet Per Second

Paving Direction
←

Sta. 3567+64 to Sta. 3626+03
