Experimental Study MR 2004-01

Effects of HBP Paver Motion on Ride Quality

Final Report

AC-HPP-4-052(045)058

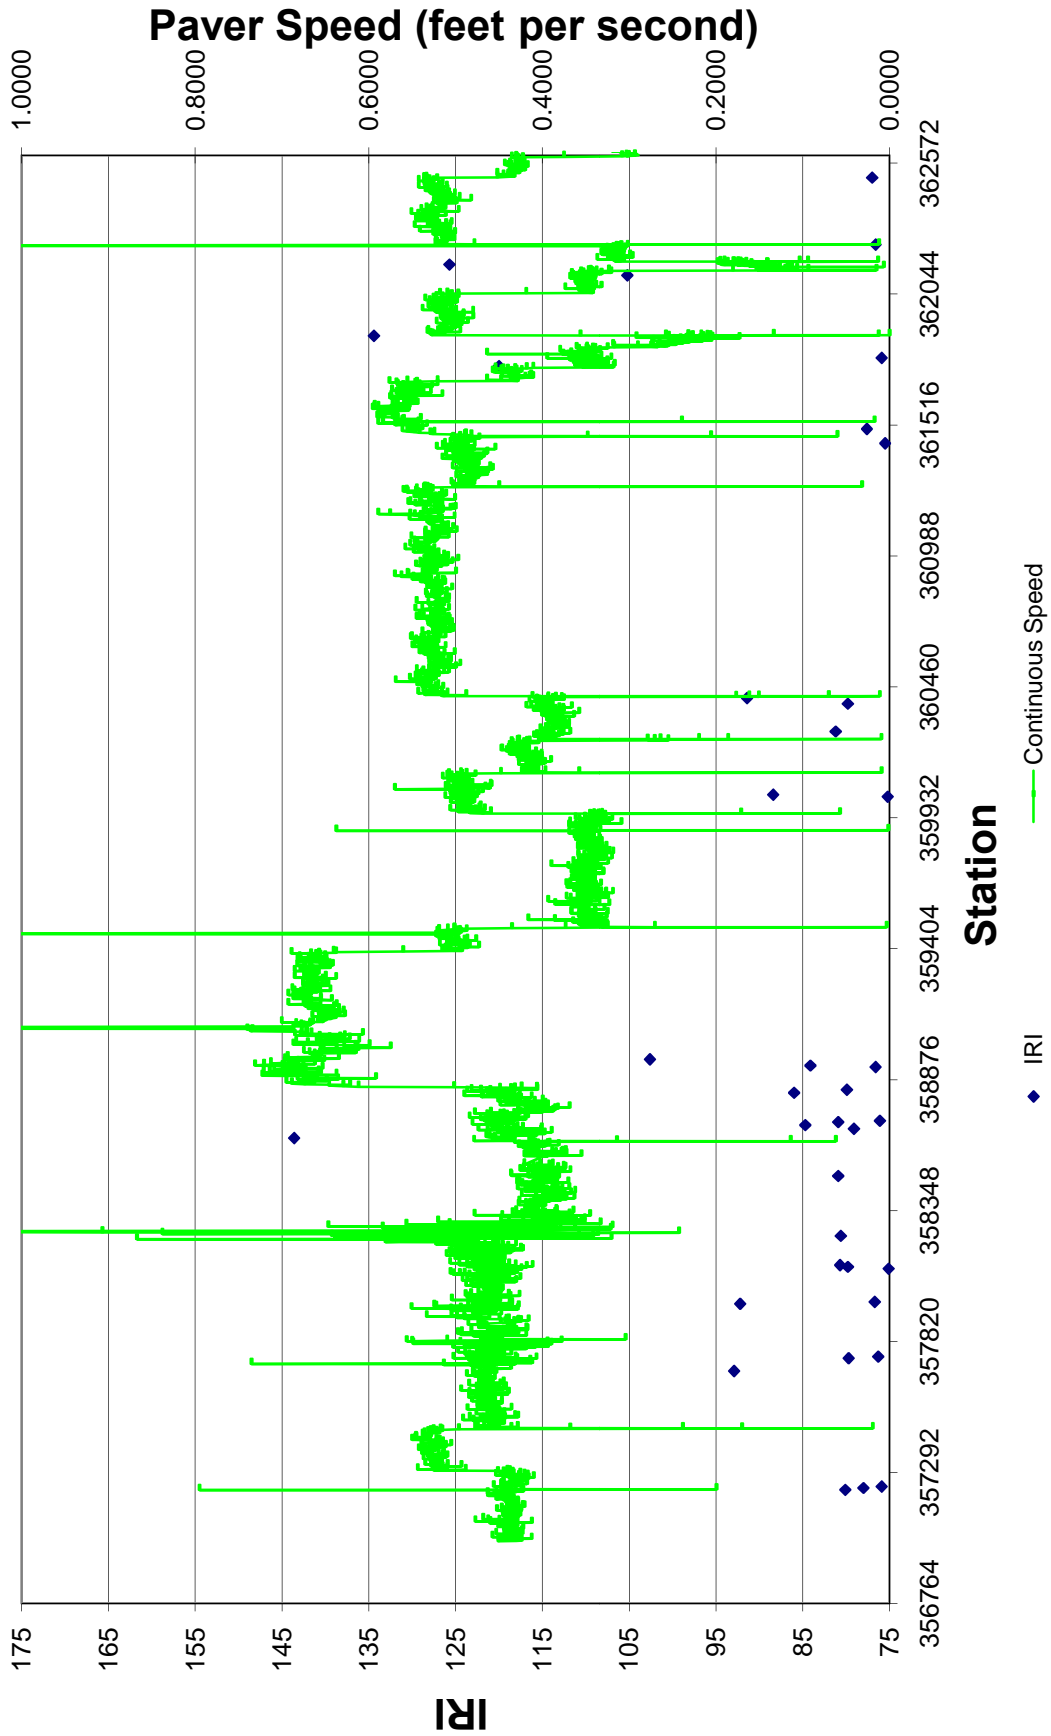
Centerline Eastbound Wheel Path

Average Paver Speed Eastbound
Final Lift = 0.5163 Feet Per Second

Paving Direction
←

Sta. 3567+64 to Sta. 3626+03

Appendix A displays the speed and location for all of the areas where the IRI threshold exceeds 75. In Appendix A, a graphical representation can be seen of the paver speed and the areas with an IRI value exceeding 75. From these graphs it appears that there are many areas where the stopping of the paver may affect the ride. It also displays areas with an IRI problem when the paver was at a constant speed. These areas with the constant paver speed may be caused by a variety of reasons, such as mix control, temperature of mix, and compaction from rollers.

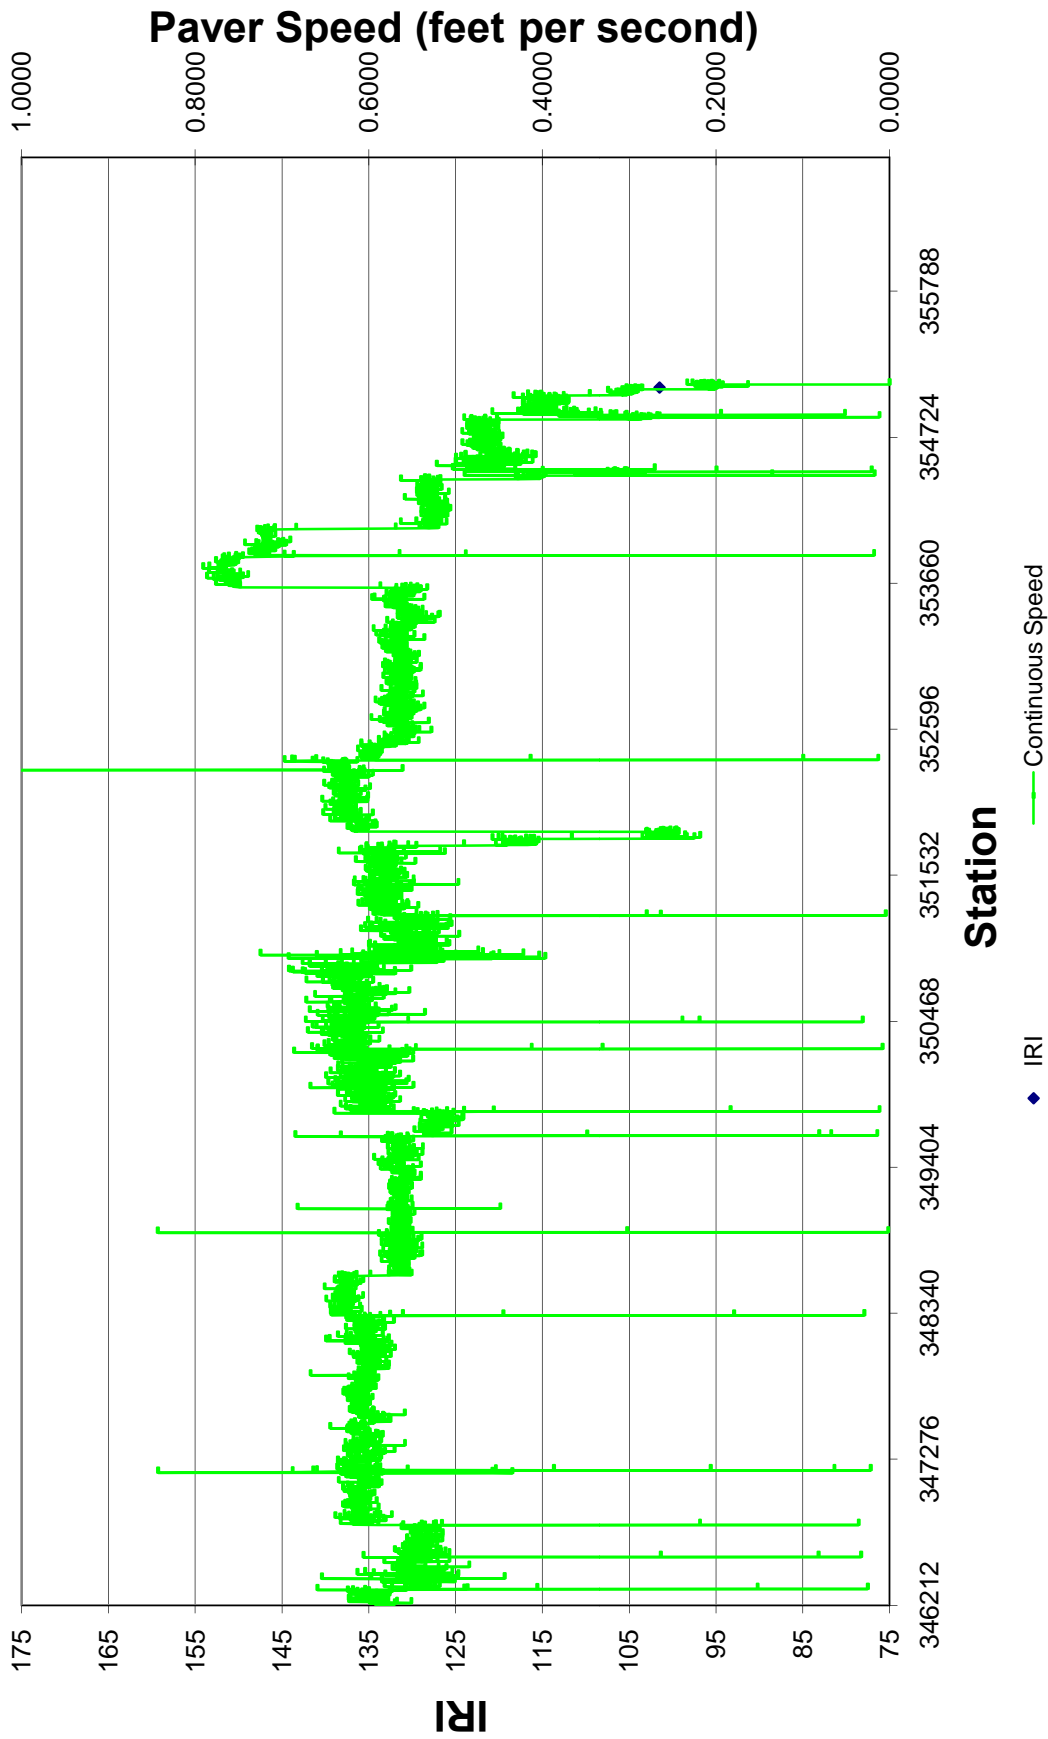
Centerline Eastbound Wheel Path

Average Paver Speed Westbound
Final Lift = 0.5163 Feet Per Second

Sta. 3462+12 to Sta. 3567+64

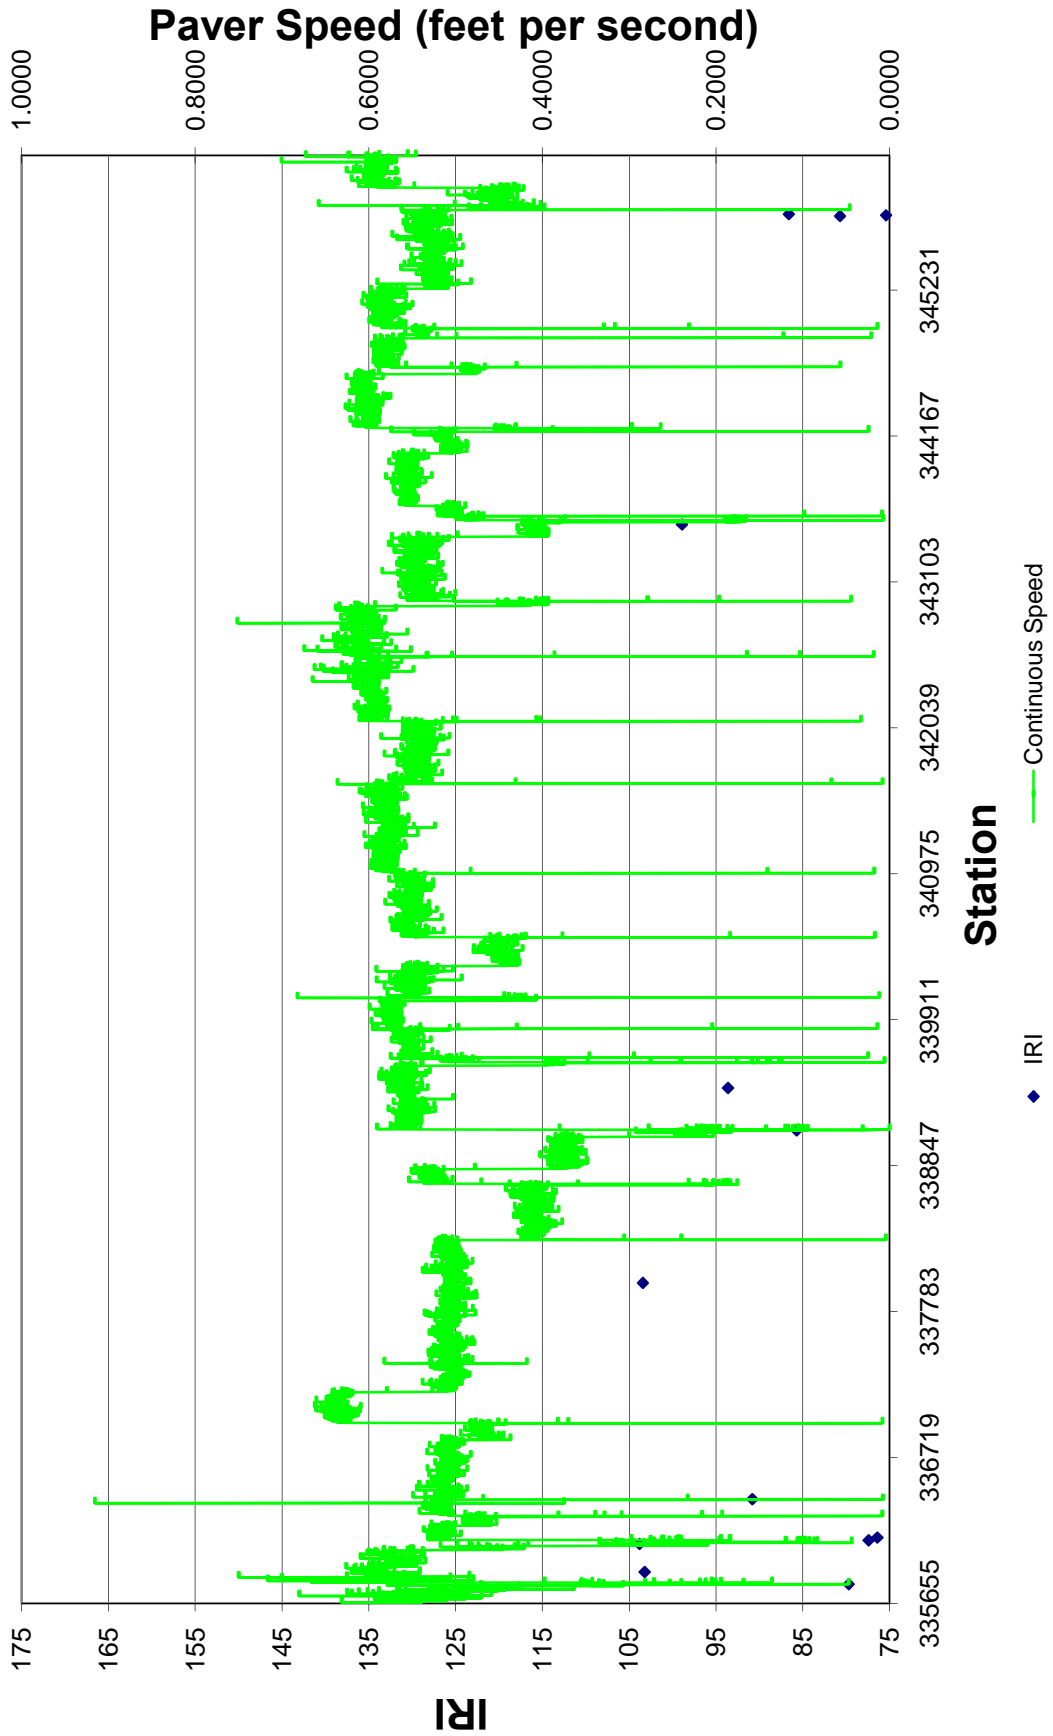
Centerline Eastbound Wheel Path

Average Paver Speed Eastbound
Final Lift = 0.5163 Feet Per Second

Sta. 3356+55 to Sta. 3462+12

Paving Direction
←

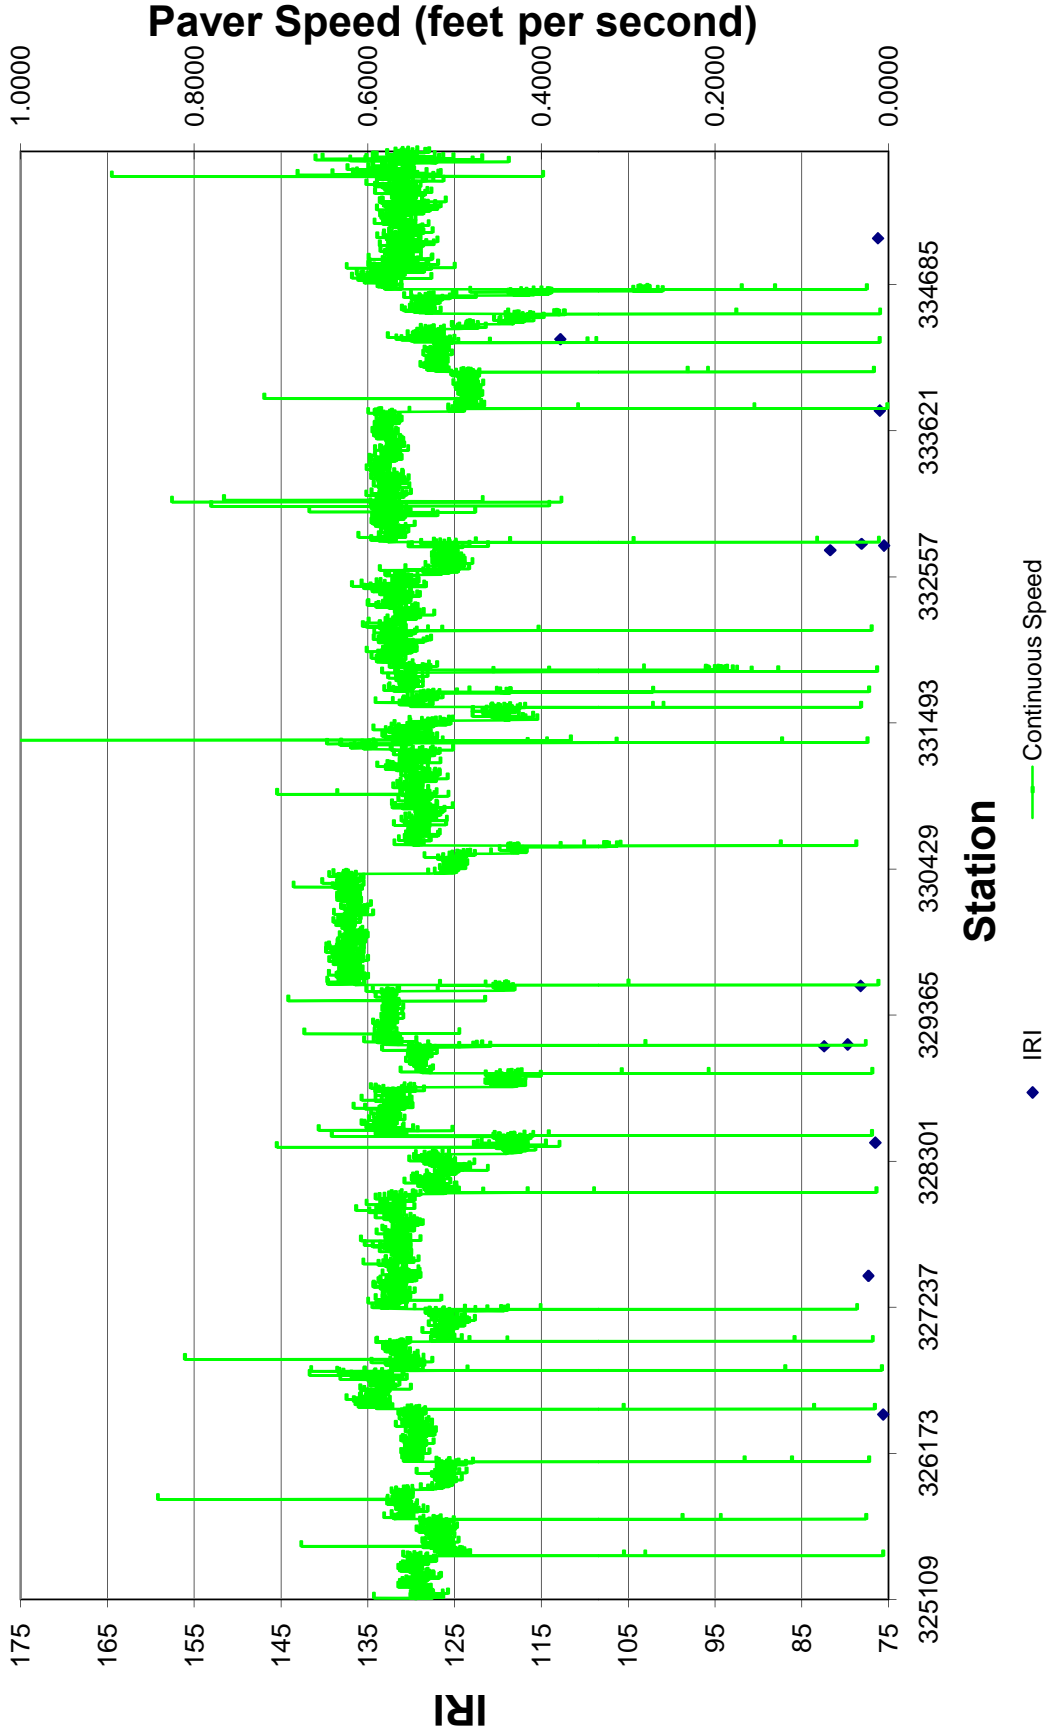
Centerline Eastbound Wheel Path

Average Paver Speed Eastbound
Final Lift = 0.5163 Feet Per Second

Paving Direction
←

Sta. 3251+09 to Sta. 3356+55

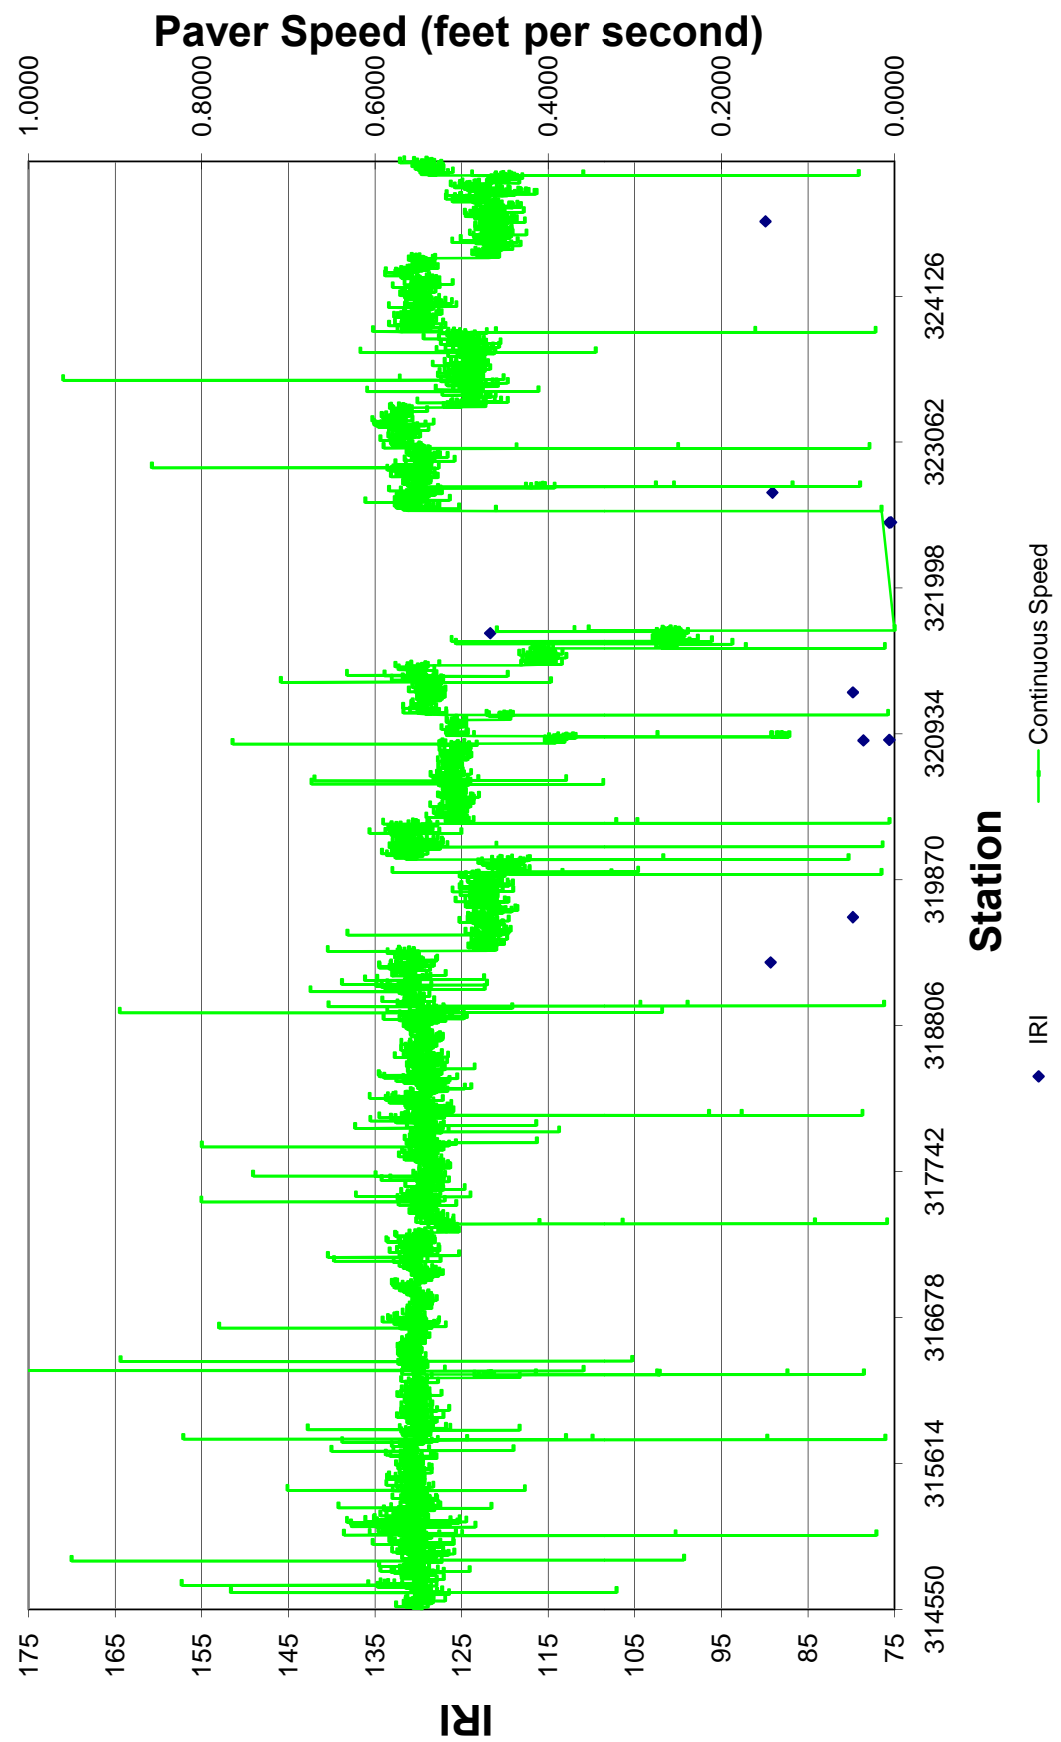
Average Paver Speed Eastbound
Final Lift = 0.5163 Feet Per Second

Centerline Eastbound Wheel Path

Sta. 3145+50 to Sta. 3251+09

Paving Direction
←

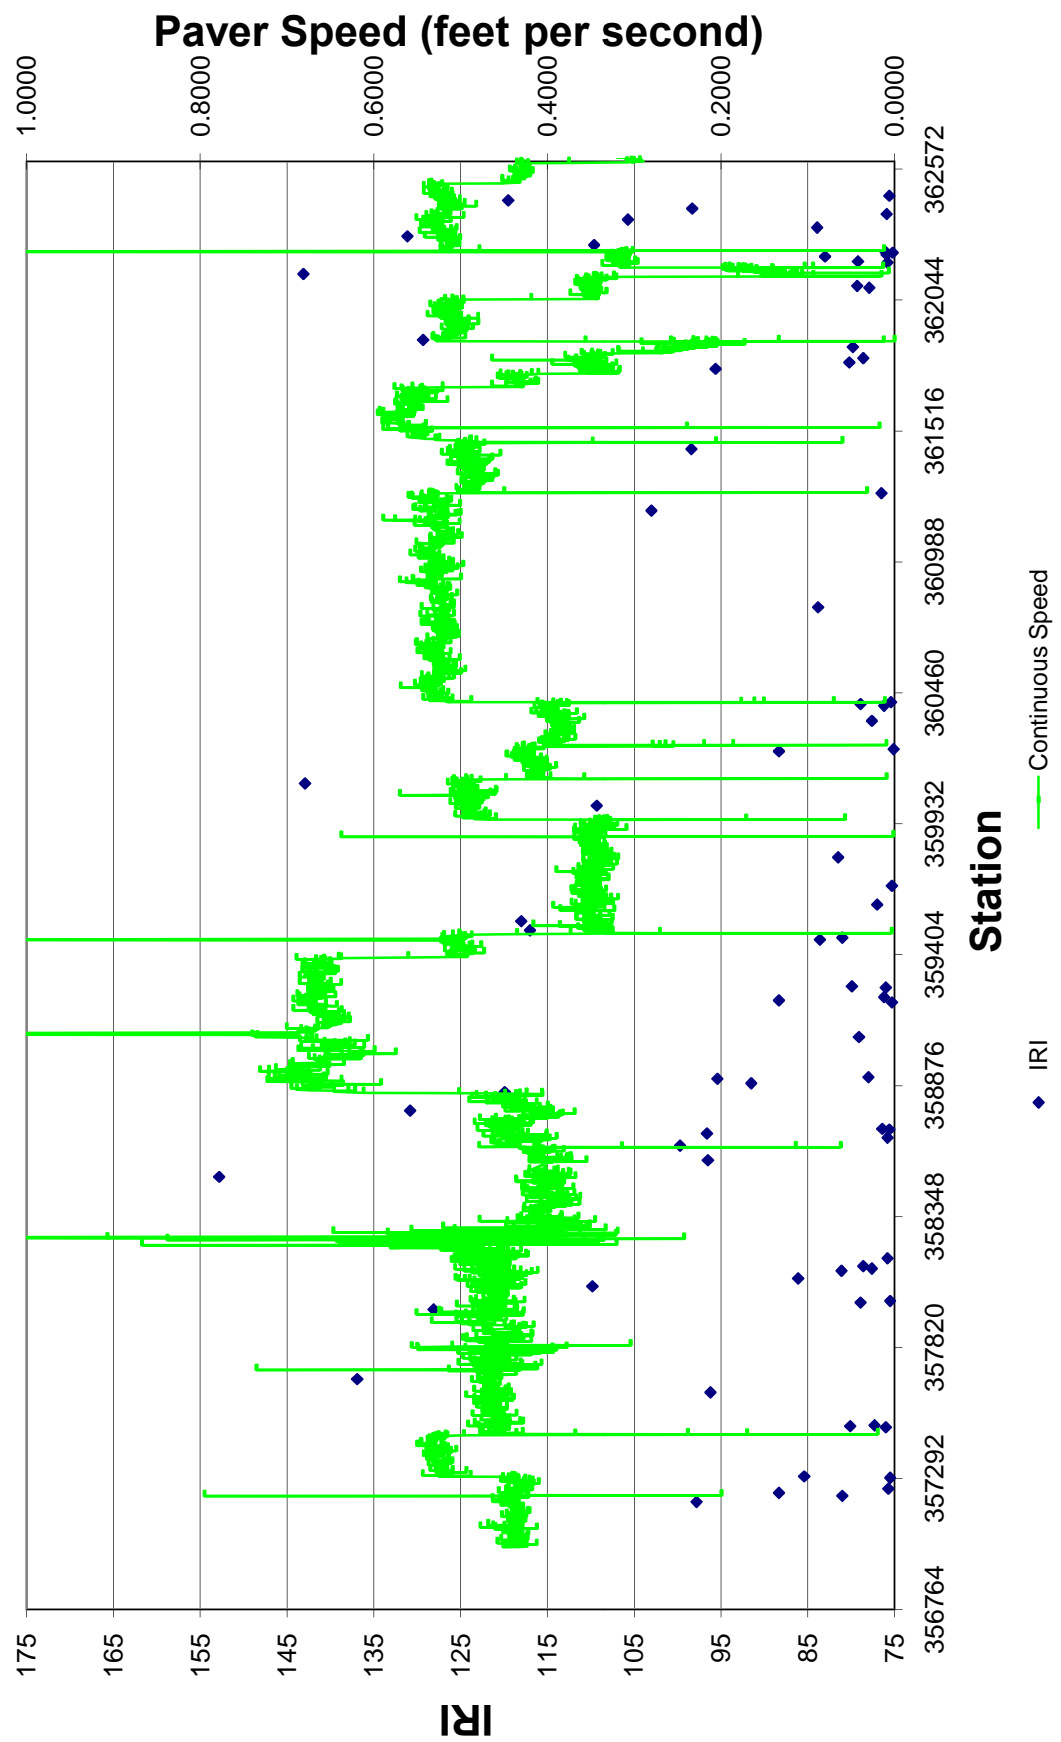
Paving Direction
↓

Shoulder Eastbound Wheel Path

Average Paver Speed Eastbound
Final Lift = 0.5163 Feet Per Second

Sta. 3567+64 to Sta. 3626+03

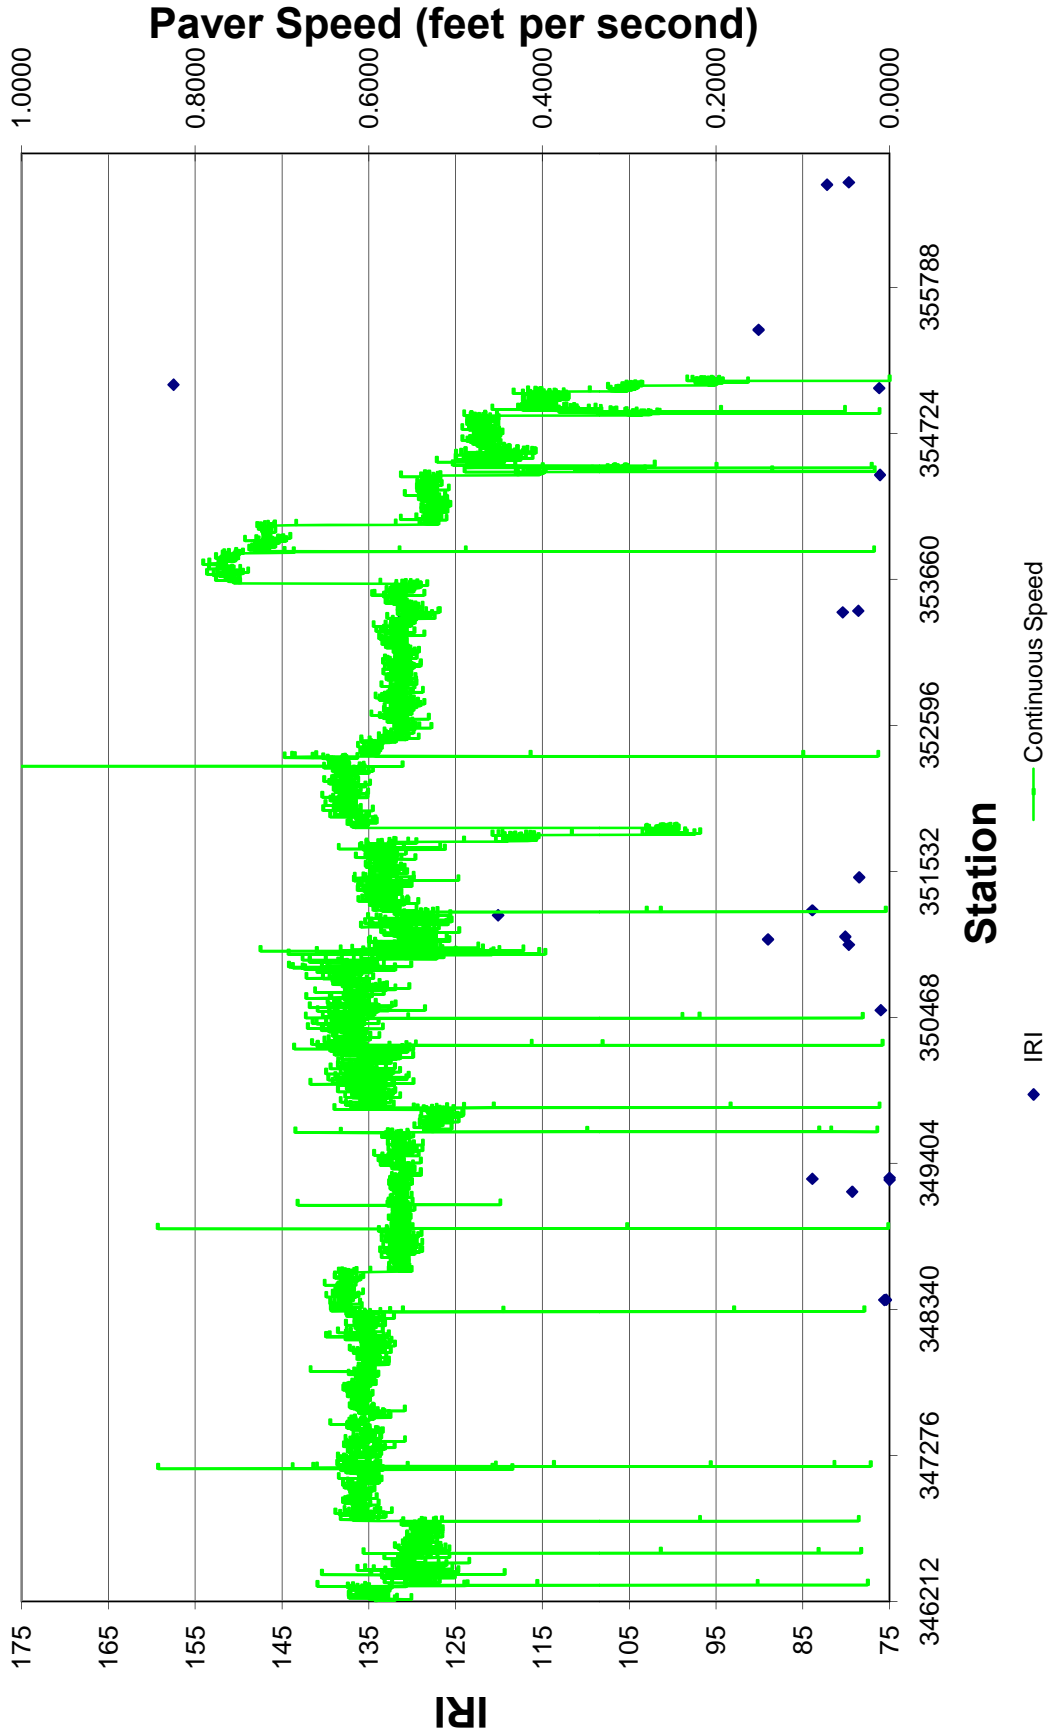
Shoulder Eastbound Wheel Path

Average Paver Speed Eastbound
Final Lift = 0.5163 Feet Per Second

Paving Direction
←

Sta. 3462+12 to Sta. 3567+64

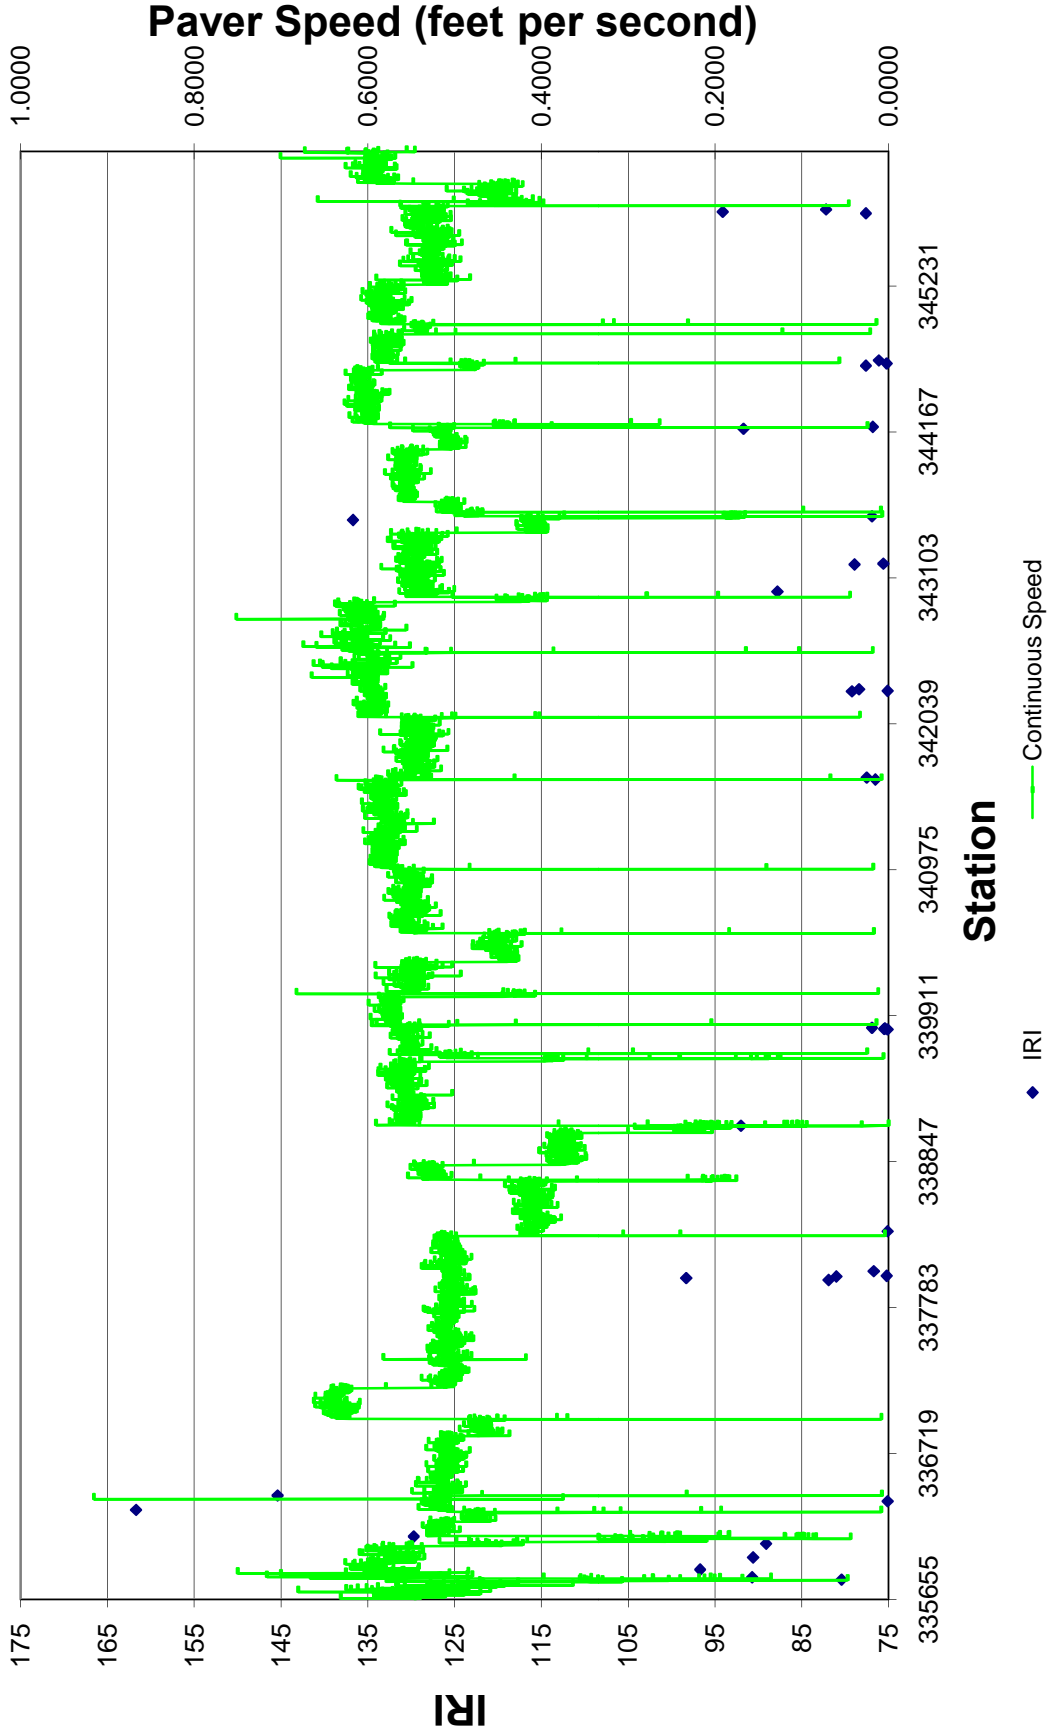
Shoulder Eastbound Wheel Path

Average Paver Speed Eastbound
Final Lift = 0.5163 Feet Per Second

Sta. 3356+55 to Sta. 3462+12

Paving Direction
←

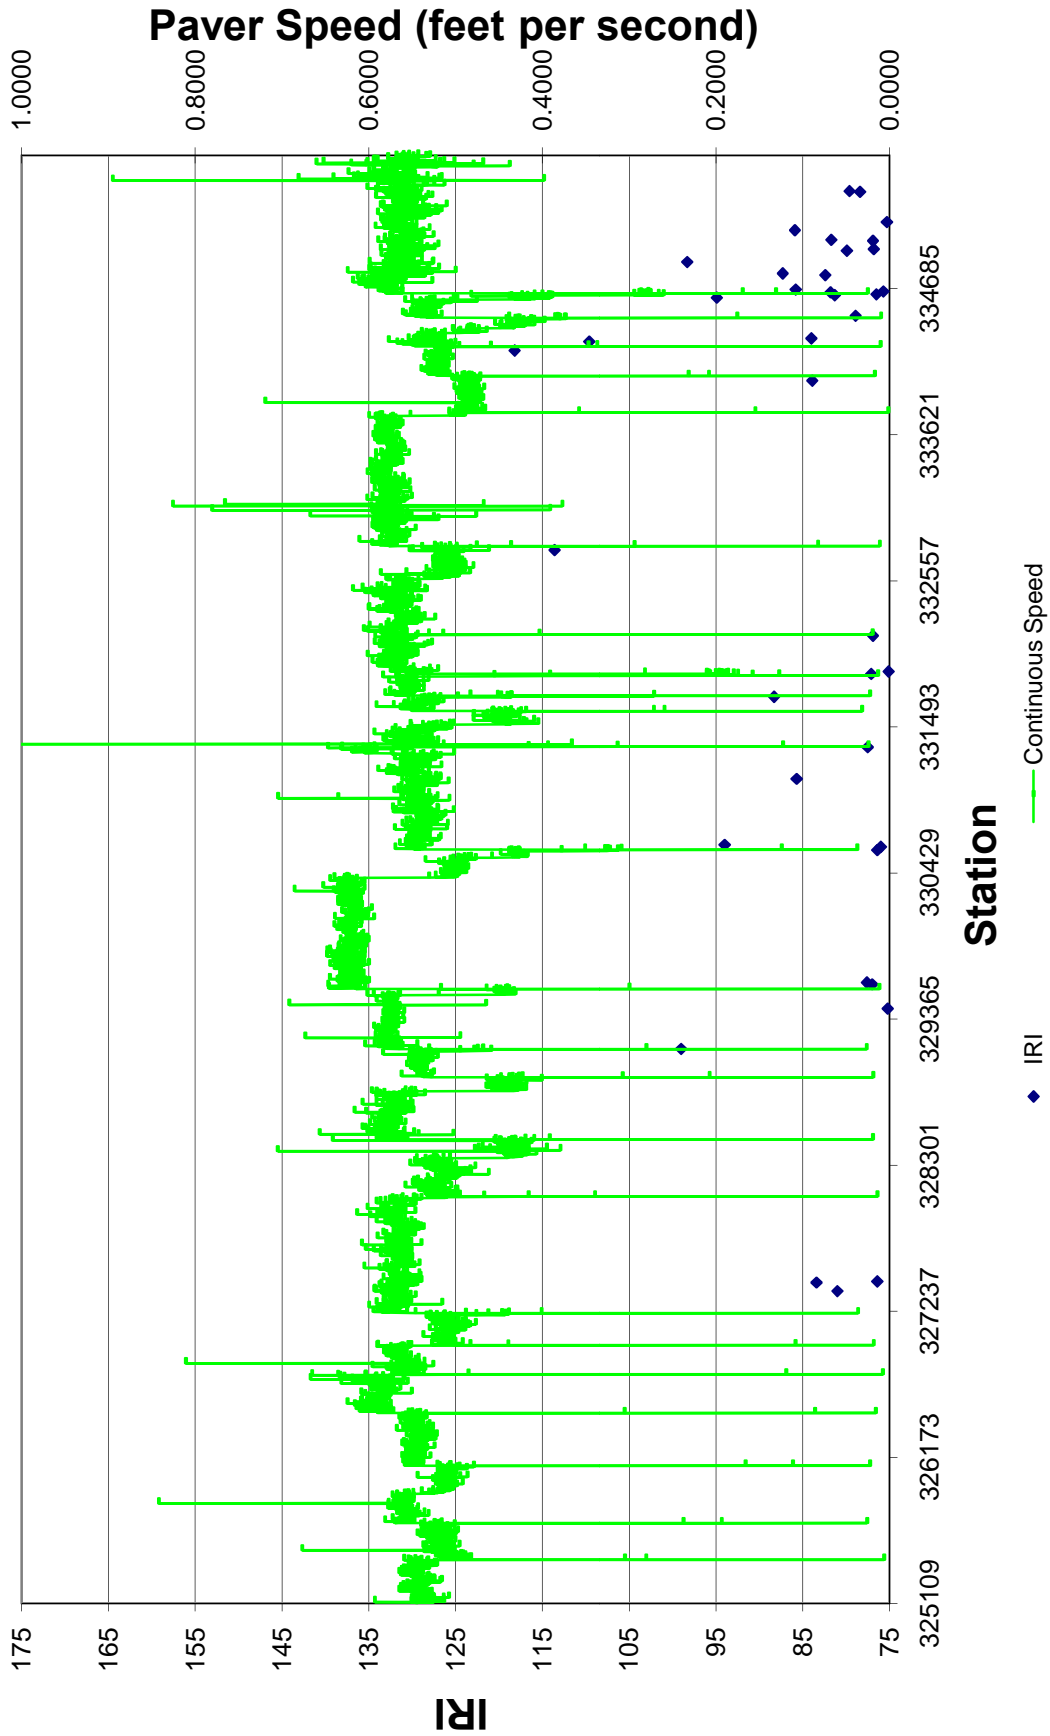
Shoulder Eastbound Wheel Path

Average Paver Speed Eastbound
Final Lift = 0.5163 Feet Per Second

Paving Direction
←

Sta. 3251+09 to Sta. 3356+55

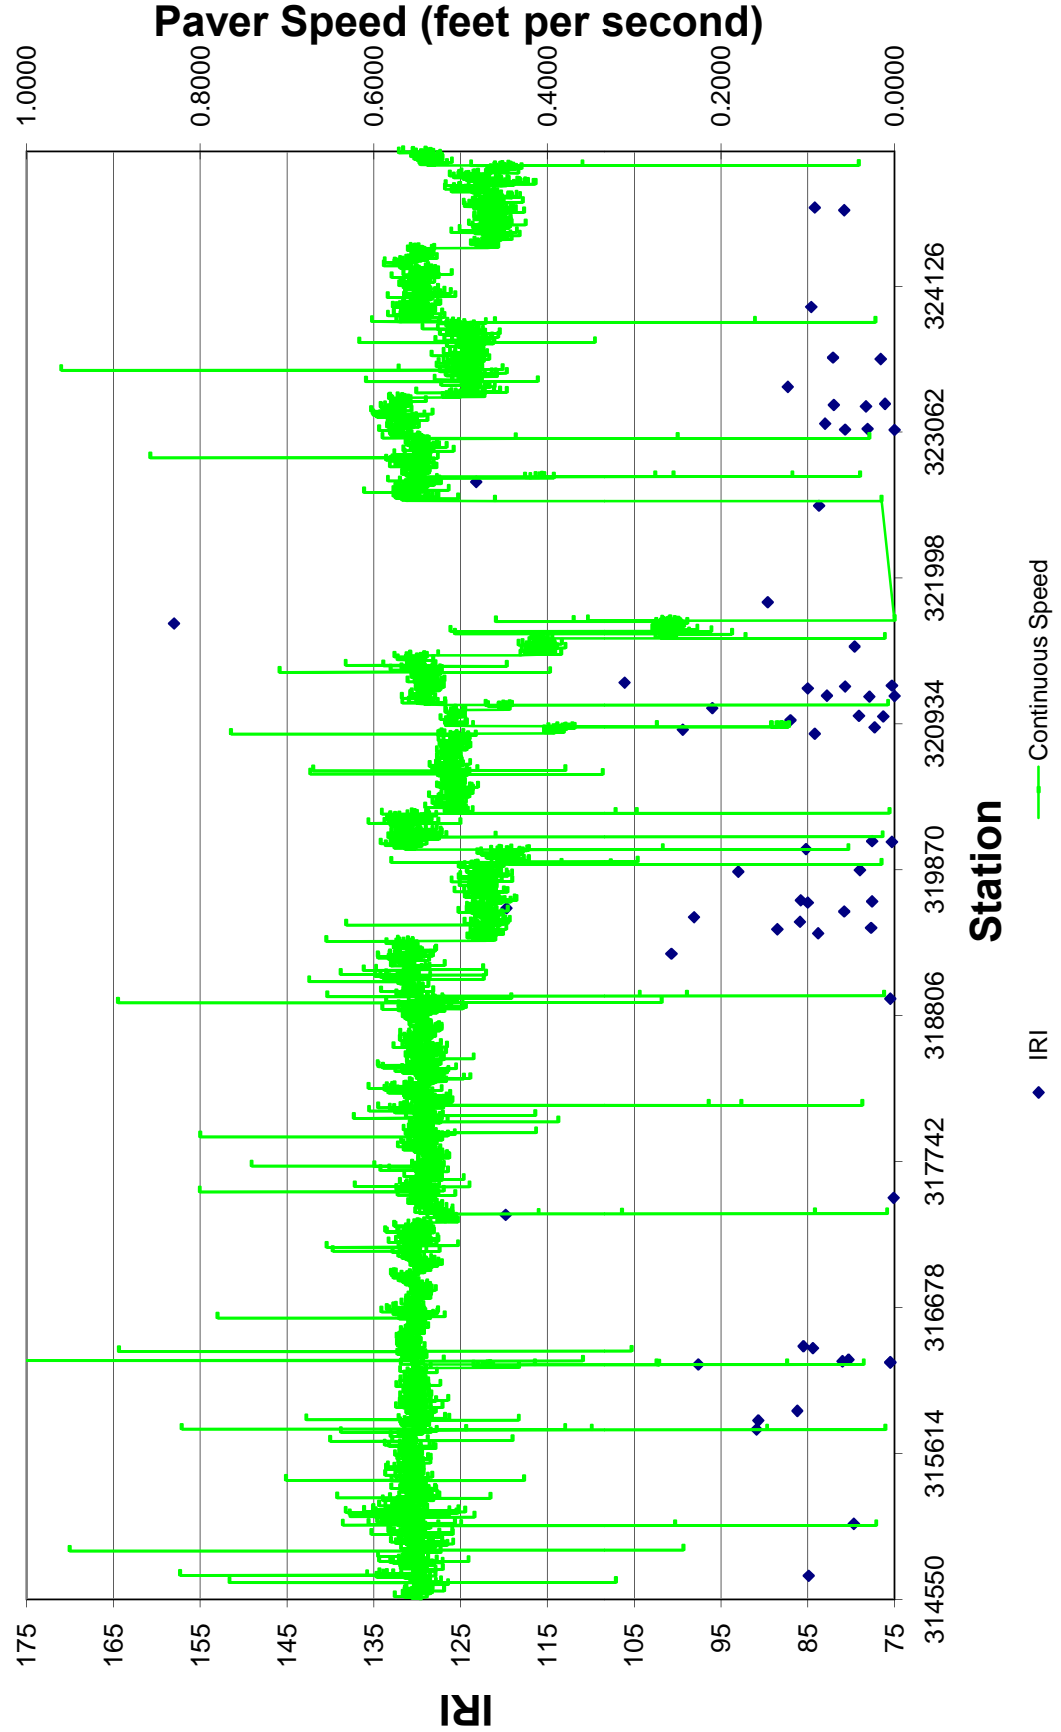
Shoulder Eastbound Wheel Path

Average Paver Speed Eastbound
Final Lift = 0.5163 Feet Per Second

Sta. 3145+50 to Sta. 3251+09

Paving Direction
↓
