Experimental Study ND 2012-01

***Evaluation of Ultra Guard™ Safety System  
on Guardrails and Barrier Walls***

**Final Evaluation**

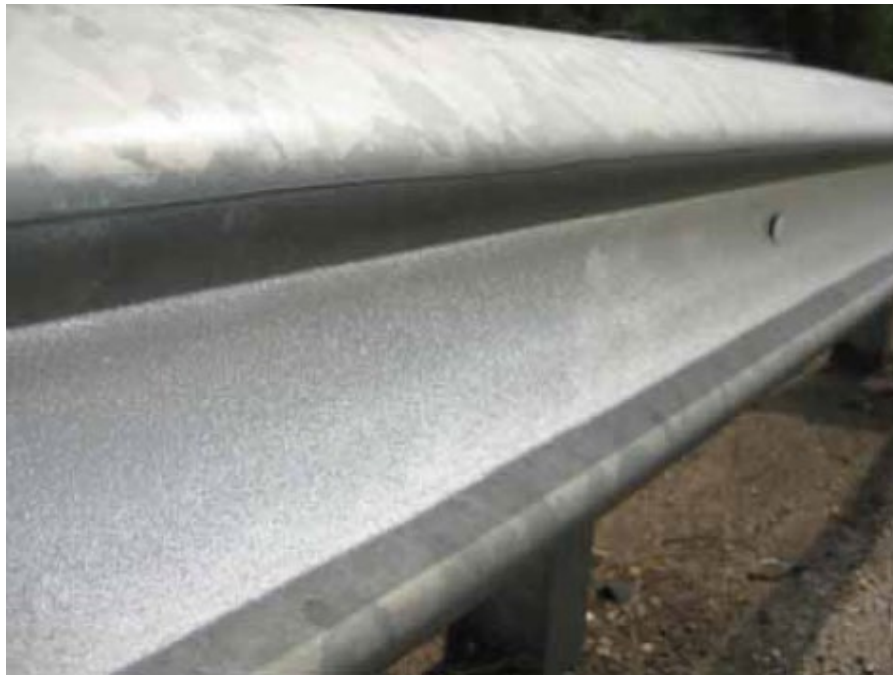
**Photo 1 - Ultra Guard™ placed on a guardrail. Photo courtesy of Potters Industries Inc.**

Roadway navigation during low light or night time condition through structures and curves can pose a danger to the driving public. Guardrail and barrier delineation has been identified as a possible method to reduce crashes. Potters Industries Inc. has developed the Ultra Guard™ system to provide additional visibility to guardrail, jersey barriers and bridge railing. The system uses a waterborne paint and glass beads, comparable to those used for pavement marking, to provide nighttime retroreflectivity. Photo 1 below shows Ultra Guard™ on a Guardrail.
