Experimental Study ND 97-02

**Evaluation of an Experimental  
Portland Cement Concrete Pavement Project**

**Final Evaluation Report**

Project IM-6-029(027)161

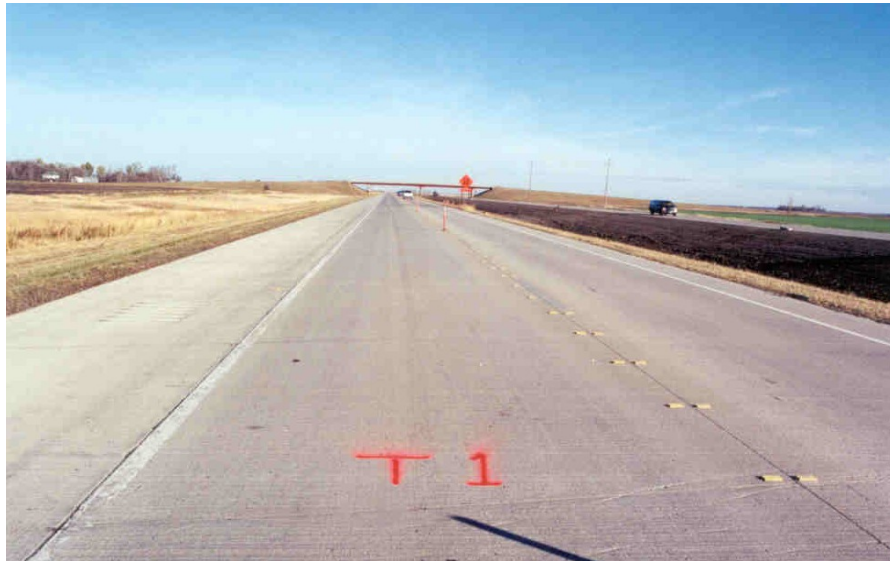
Test Section 1 was constructed with a concrete mix containing gap-graded aggregates without the use of water reducing admixtures.

**Photo 6 - Overall view of Test Section 1.**

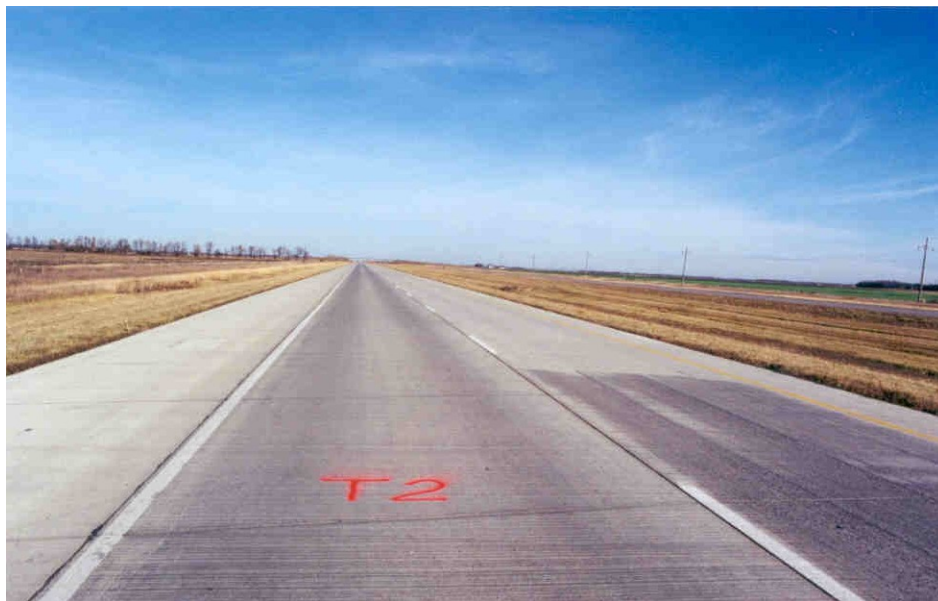
Test Section 2 was constructed with a concrete mix containing gap-graded aggregates with water reducing admixtures.

**Photo 8 - Overall view of Test Section 2**

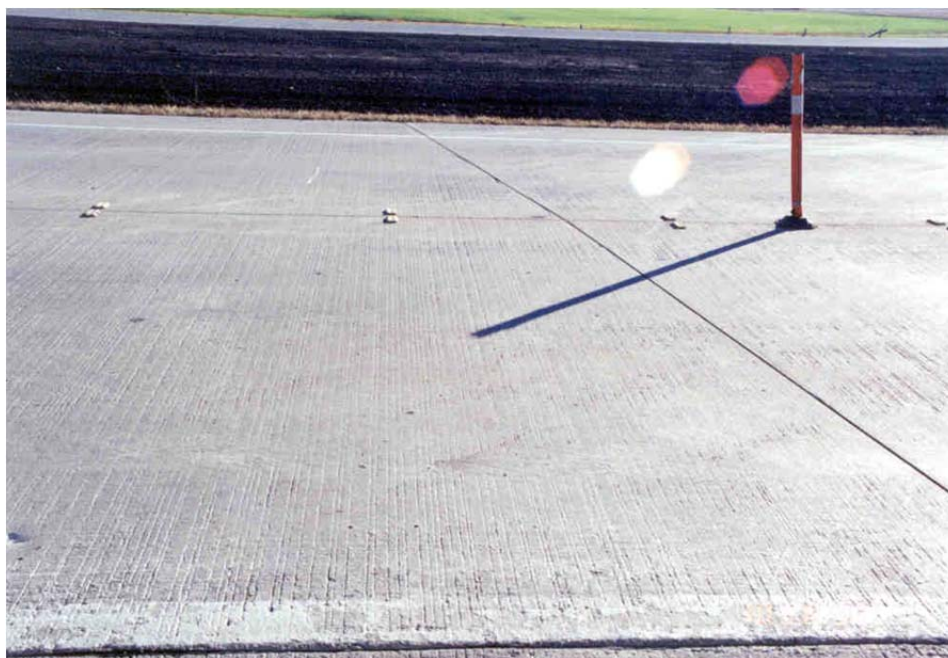
The first evaluation on October 19, 1999 indicated limited distress of the pavement. The distresses present consisted of corner cracking (approximately 12" x 12" at the shoulder) and occasional aggregate pop-outs. Very little of the original tining remained in the area of Station 8930+00; however the condition of the tining improved

within the section. Photo 9 provides a view of the condition of the tining at Station 8930+00.

**Photo 9 - Tining in Test Section 2 at Station 8930+00**

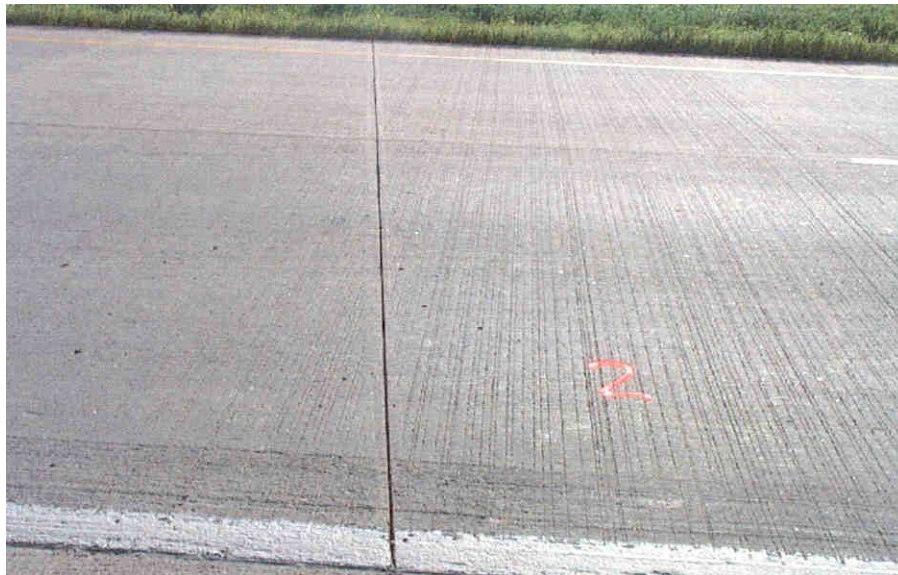
The results of the fifth and final evaluation on November 25, 2008 were similar to prior evaluations. There was a slight increase in the number of transverse joints affected by spalling, pop-outs were minor, and the overall condition and ride of the pavement remained good. Table 17 contains a summary of the distresses for Test Section 2.

**Photo 10 - Typical transverse joint in Test Section 2 and pop-outs.**

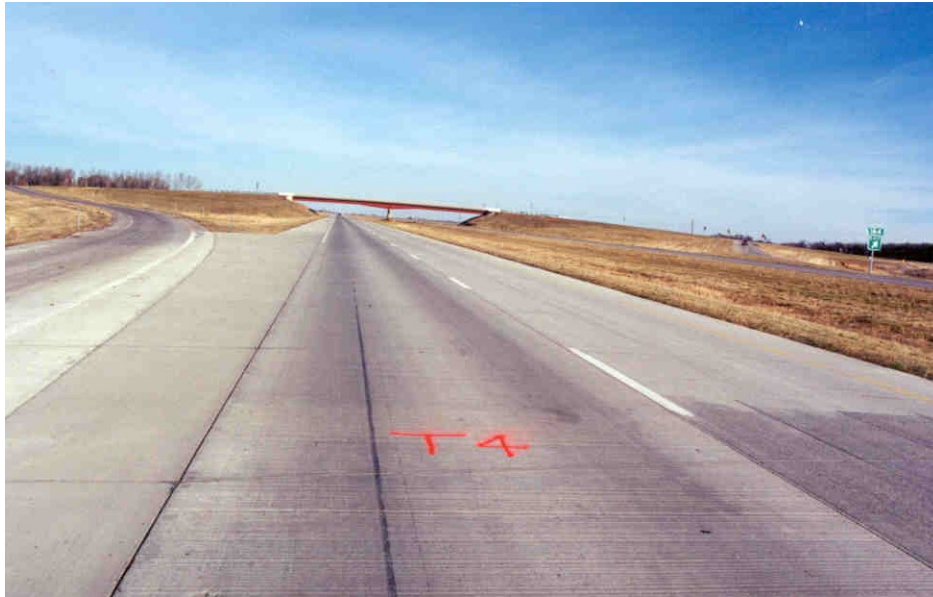
Test Section 4 was constructed with a concrete mix containing well-graded aggregates without the use of water reducing admixtures.

**Photo 12 - Overall view of Test Section 4**
