Experimental Study MR 96-01

**Evaluation of Epoxy-Coated
Reinforcing Steel**

Final Evaluation Report

Project IM-1-094(017)156

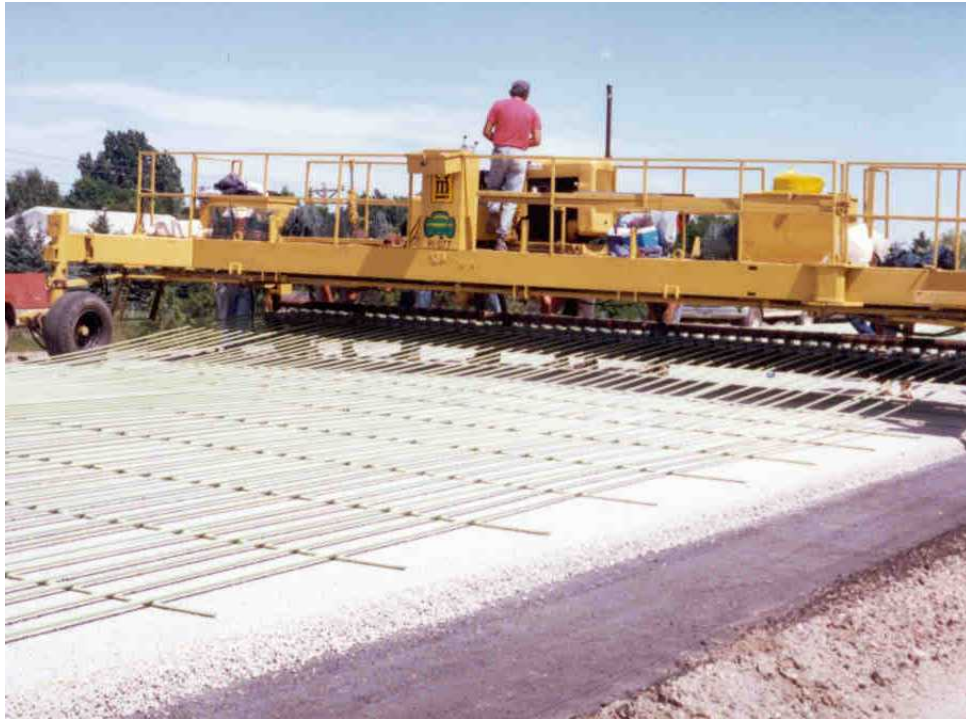
Photo 1 – Photo of the epoxy-coated reinforcing steel lying on top of the stabilized base.

Photo 1 depicts a view of the transverse and longitudinal bars, lying on top of the permeable stabilized base, just prior to being picked up by a rebar alignment machine. The longitudinal steel was then run through an alignment machine, while

the transverse steel was left lying on the roadway. Workers tied the transverse steel to the longitudinal steel and the epoxy-coated steel chairs to the reinforcing steel with epoxy-coated ties.

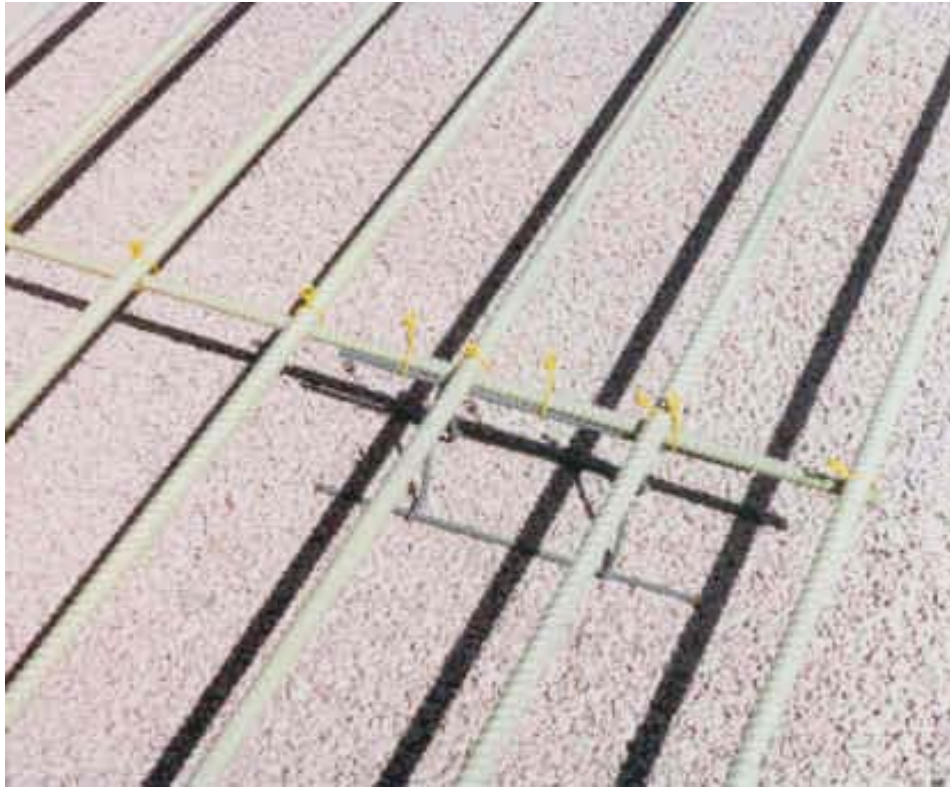
Photo 2 – View of finished product placed and fastened.

Photo 2 shows the finished product placed and fastened prior to the placing of the concrete.

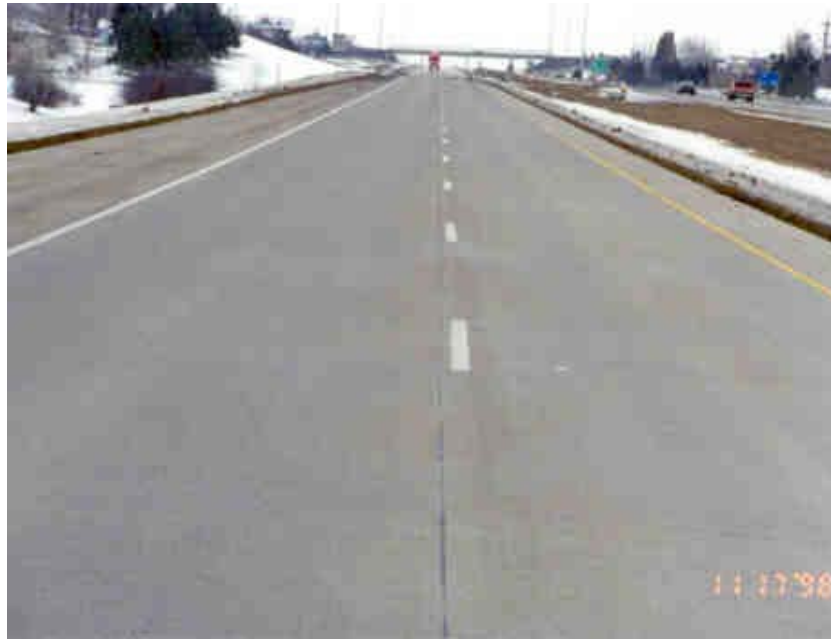
Photo 3 – Depicts an overall view of the test section looking east.

The first evaluation was conducted on November 17, 1998. Photo 3 shows an overall view of the test section looking east. The cracks were counted as being either fully or partially across the width of the driving lane. The width of the cracks ranged from 0.10 mm to 0.60 mm.

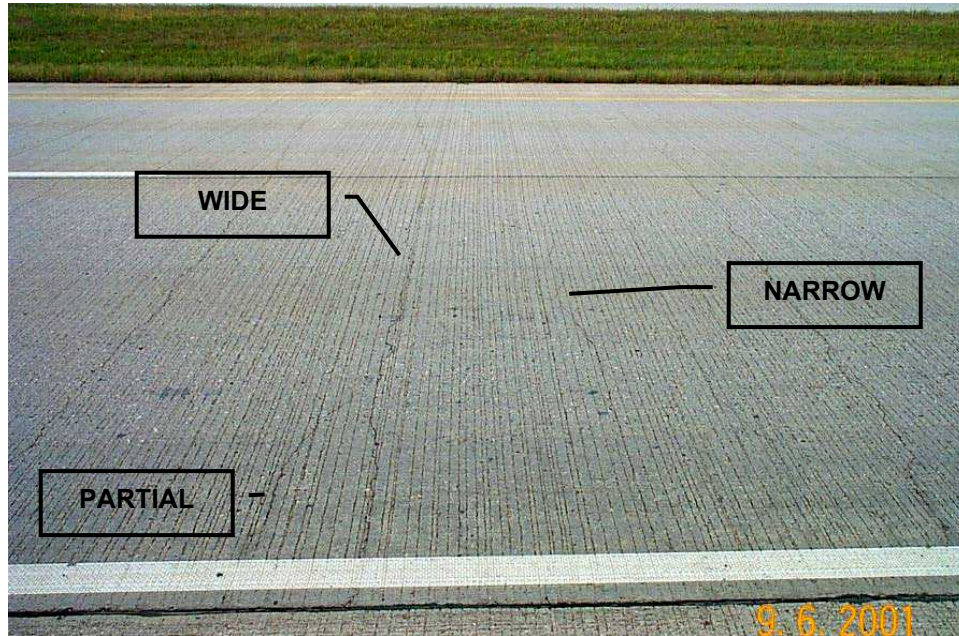
Photo 4 – Depicts the narrow, wide and partial transverse cracks in the test section.

The second evaluation occurred on September 6, 2001. For this evaluation full width cracks were further classified as wide or narrow cracks. The determination of whether a crack was narrow or wide was performed subjectively as each crack's width was not measured to classify it. Photo 4 shows the difference between the narrow, wide, and partial transverse cracks located in the test section.

The third evaluation was performed on December 31, 2002. The number of narrow cracks in the experimental section decreased to 25 from 27 in 2001. Because the total number of cracks in the experimental section increased from 2001 to 2002, it appears that the number of narrow cracks decreased because some cracks were counted as narrow in 2001 and then counted as wide in 2002.

The fourth evaluation occurred on September 17, 2003. The widths of the cracks continued to range from 0.10 mm to 0.60 mm. In the experimental segment the number of narrow cracks decreased from 25 in the previous evaluation to 19. Because the number of wide cracks increased during this period, it is likely that the number of narrow cracks decreased because some cracks were counted as narrow in 2002 and then counted as wide in 2003. A total of 95 transverse cracks were counted in the 150 foot control segment. This is a decrease from 103 transverse cracks that were counted in 2002. The number of partial cracks and wide cracks both increased from 2002 but the number of narrow cracks decreased to 19 from 37 in 2002. The number of narrow cracks counted may have decreased because; some were counted as wide cracks, warm temperatures at the time of the evaluation may

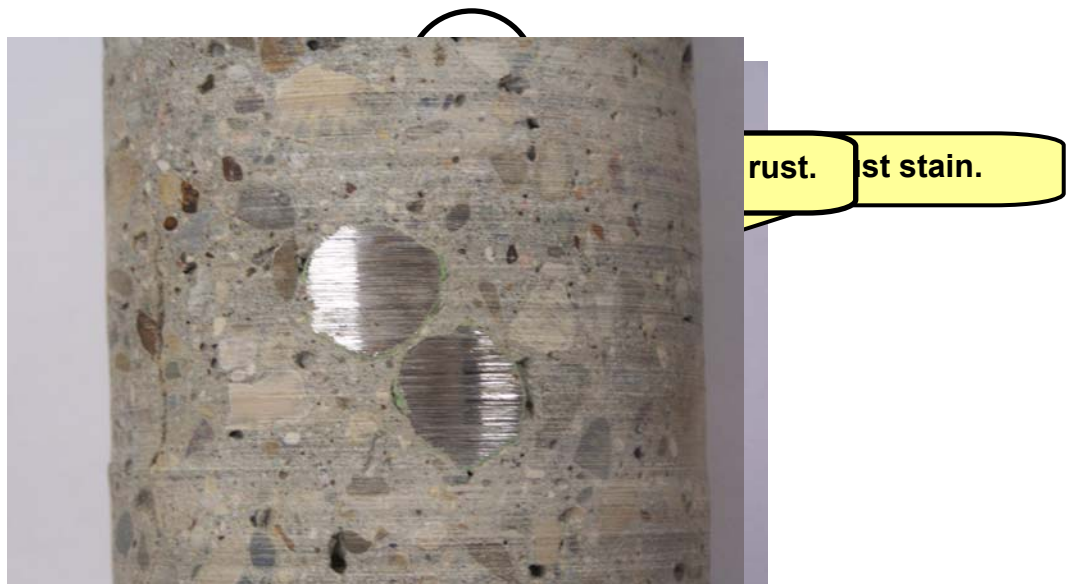
Photo 7 – Core containing epoxy coated reinforcing steel.

The cores are shown in Photos 5, 6, 7, and 8. Both of the cores containing regular reinforcing steel showed some evidence of rust. The cores containing epoxy coated reinforcing steel showed no evidence of rust or corrosion.

Cores taken in the control and experimental segments show that the regular reinforcing steel has evidence of rust and the epoxy coated reinforcing steel does not.

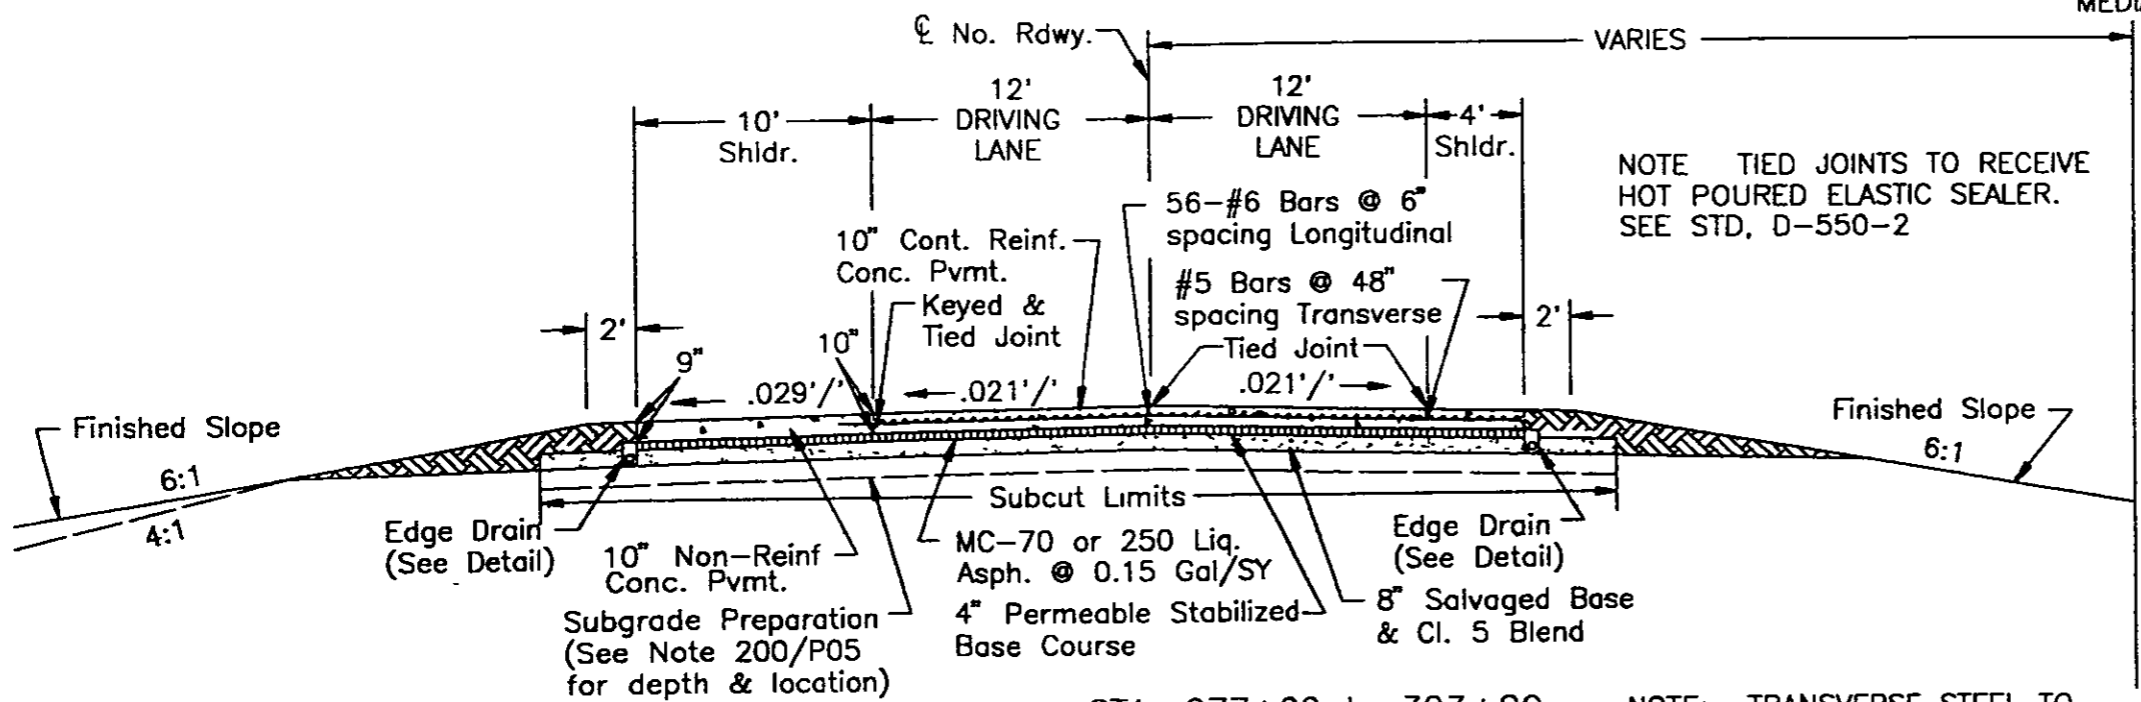
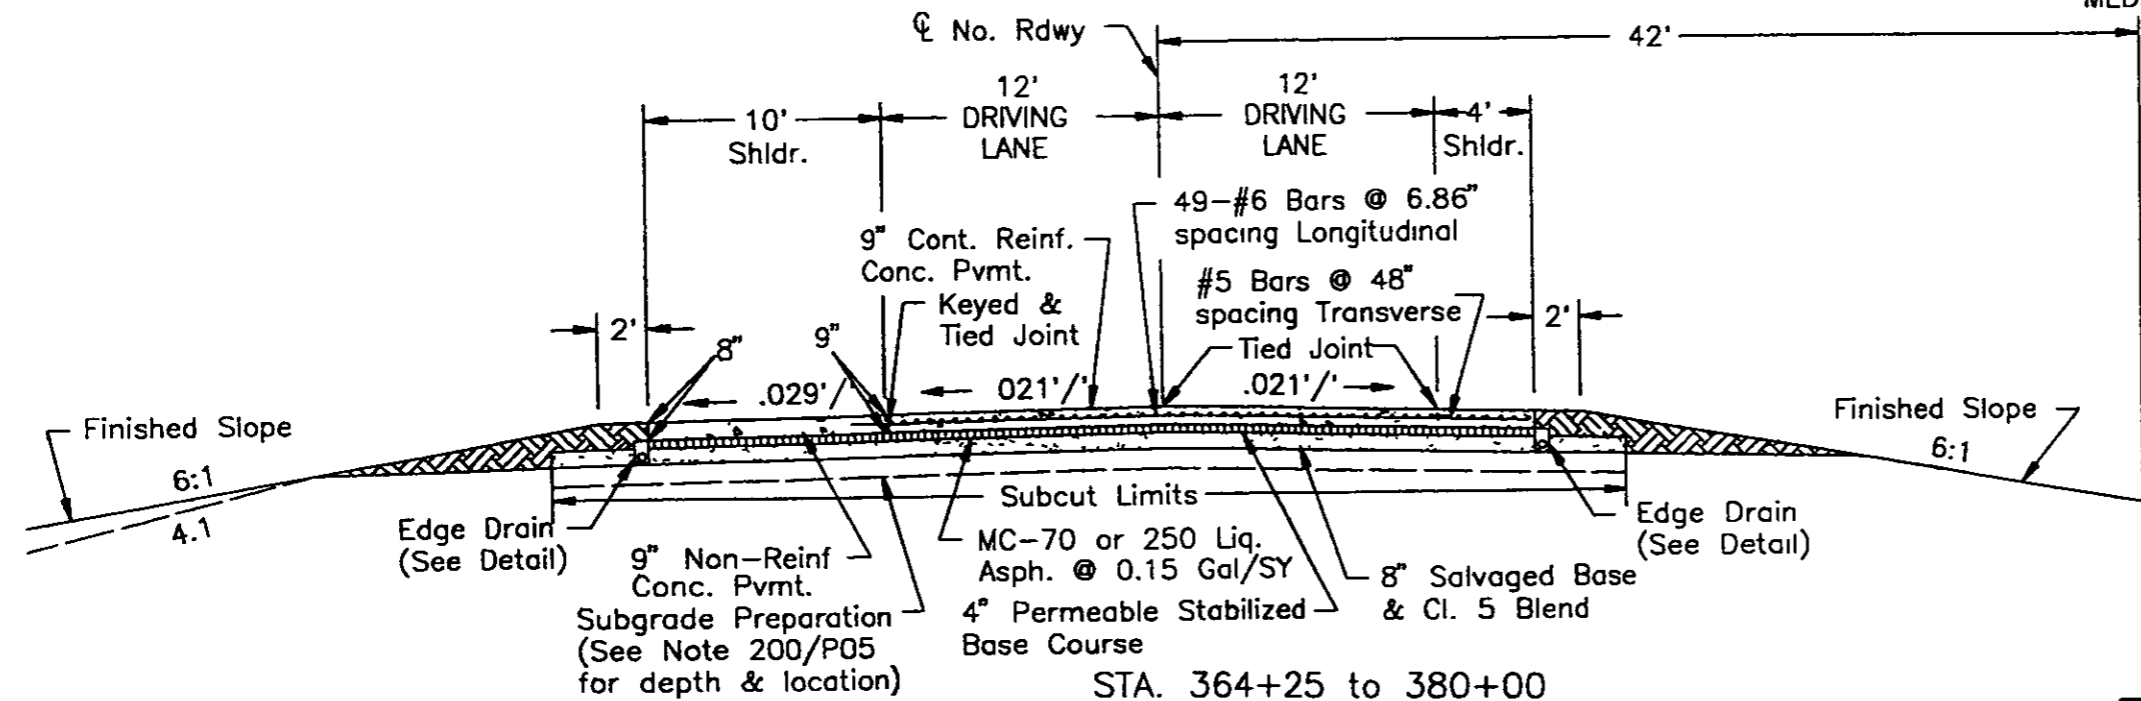
TYPICAL SECTIONS

Tie bars to be inserted directly below longitudinal steel.

NOTE: TRANSVERSE STEEL TO TERMINATE 3" FROM VERTICAL EDGE OF C.R.C. PVMT.

REINF. STEEL PLACED @ A DEPTH OF 4.25" FROM TOP OF 10" PVMT. TO MID-POINT OF STEEL.

REINF STEEL PLACED @ A DEPTH OF 3.75" FROM TOP OF 9" PVMT. TO MID-POINT OF STEEL.

LONGITUDINAL STEEL SHALL BE PLACED ON TOP OF TRANSVERSE STEEL.

The design of the epoxy-coated reinforcing steel section of this project was the same as the conventional reinforcing steel section. Both the epoxy-coated reinforcing steel section and the control section are 9" of CRCP with #6 longitudinal bars spaced 6.86" apart and #5 transverse bars spaced 48" apart. The longitudinal bars were spliced with a minimum 19" overlap. Typical sections are given in Appendix A.
