Experimental Study ND 96-03

**Modified Chip Seal Surface Treatments vs.
Conventional Chip Seal Surface Treatments**

Final Report

Projects SS-3-003(018)224 & SNH-6-002(050)337

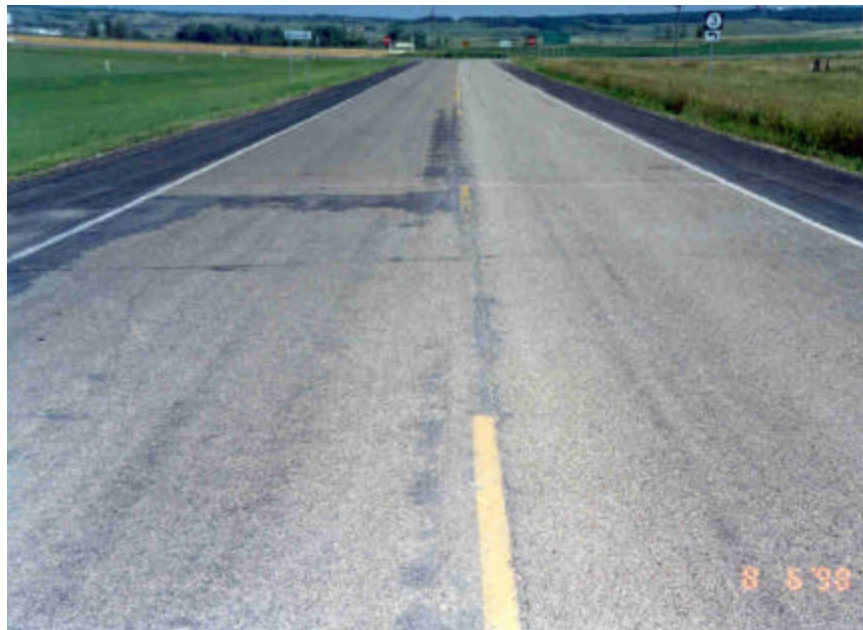
Photo 3 - Overview of section 1.

Photo 3 shows an overview of section 1. One of the items that is very contrasting about Section 1 is the surface appearance as opposed to other test sections. The modified single seal coat method exhibits the darkest surface of all the methods in the experimental project.

There appears to be slight bleeding in this section as indicated by the darkening in the wheel tracks. The driving surface has a noticeably smoother texture as compared to

One of the main concerns with section 1 was the distresses occurring in the roadway as shown in photos 3 & 4. These distresses are notably large spalls that may have been caused by snowplow blades. Most of the distresses present in section 1 are most always one-lane wide and approximately 3' to 6' long.

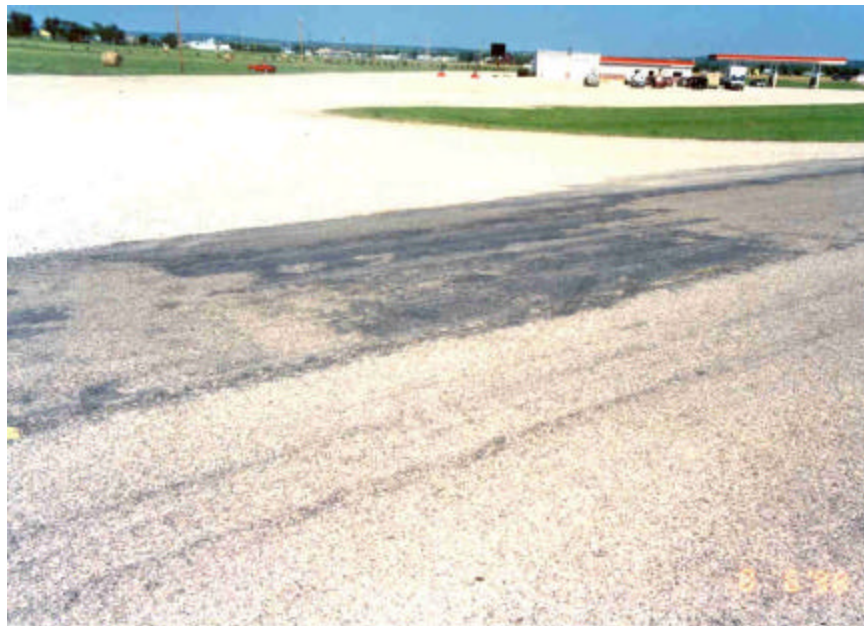
Photo 4 - View of distress located in the vicinity of approach.

Notice in photo 4 that whatever caused the distress took the entire seal off the roadway. The distresses shown in photo 4 are isolated instances however. The majority of the distresses seen in this section appear to only affect the top layer leaving most of the first layer of oil and chips intact.

There was much discussion as to what would cause distresses such as these. The general consensus of the research team is that the problems may be in the construction of the seal coat itself. The Devils Lake District believes the distresses happened immediately after the first major snowfall in late October of 1996. One possibility is that the contractor accidentally applied multiple layers of chips on the roadway. This may have easily happened when the contractor was switching dump trucks or beginning or finishing up a section.

application of the blotter sand will encompass as many of the Class 43 chips as possible. If the Class 43 chips are applied too thick, causing multiple layers, there will be a shear plane between the loose chips on top and the chips adhered to the initial coat of oil. It is possible that traffic or snowplowing operations may remove the excess chips all at once because of the common adherence to the topcoat of oil and sand. Most of the research team agreed with this statement and that the distresses were not related to the oil itself. Another possibility discussed was the application of the sand. If the sand was applied too heavily in some areas, the excess sand may have absorbed too much of the second coat of oil before it was allowed to flow down around the chips. The chips would then have to rely on the initial application of oil, which alone is not sufficient to hold down the chips.

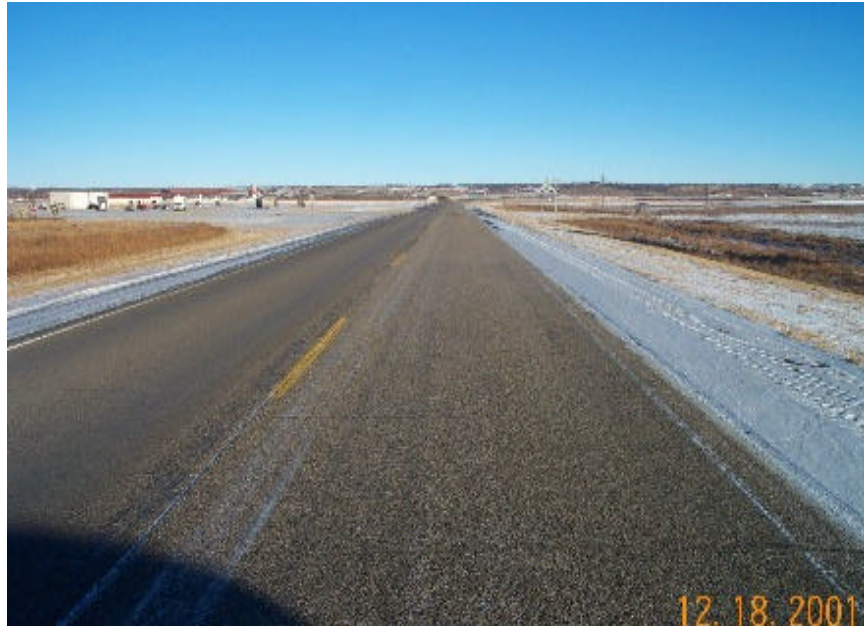
Photo 5 - Overview of section 1.

Photo 5 shows a current overview of section 1. Note the darker appearance.

Some of the same distresses noted in the last evaluation appeared to have remained in the same condition and have not worsened. The general condition of this section is good. The surface looks uniform with minimal chip loss. The transverse tracks are less noticeable and appear to be tighter than the other cracks in sections 1 through 5.

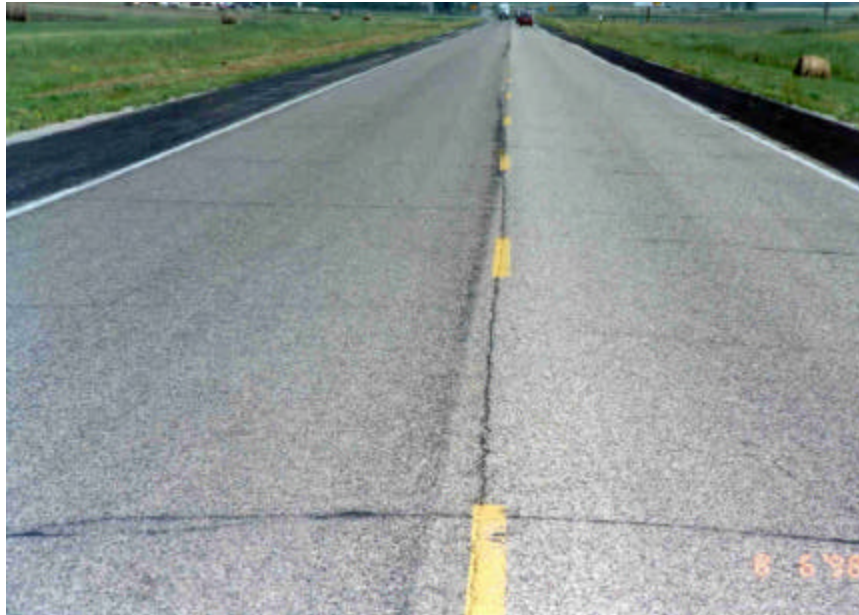
Photo 6 - Overview of section 2.

In general the research team thought the seal coat was performing well.

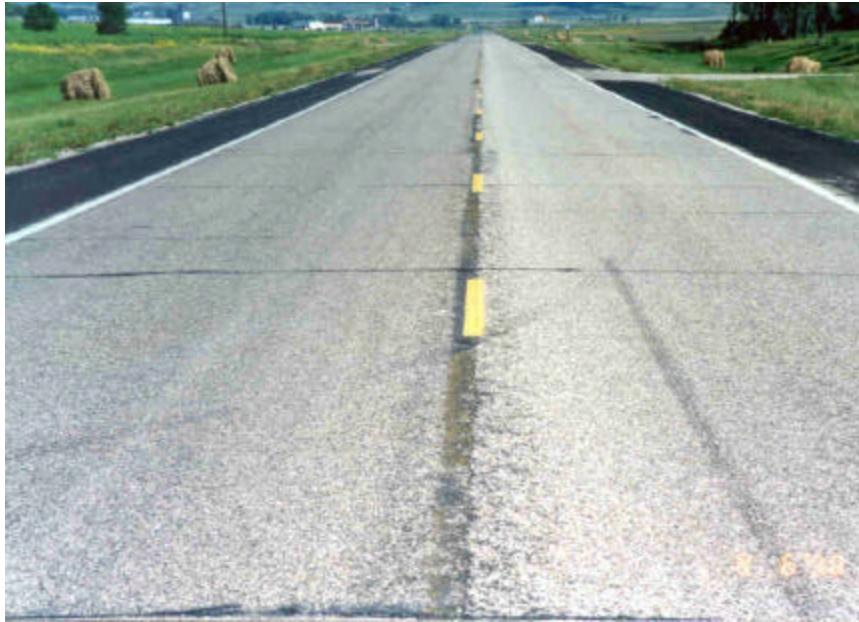
Photo 8 - Overview of section 3.

Photo 8 depicts an overall view of section 3. This section was constructed using NDDOT's standard seal coat method. The surface was much rougher than the previous two sections. There was some isolated chip loss in the mainline. The surface was very light in color.

The general consensus of the team was that except for some chip loss, the section was performing well.

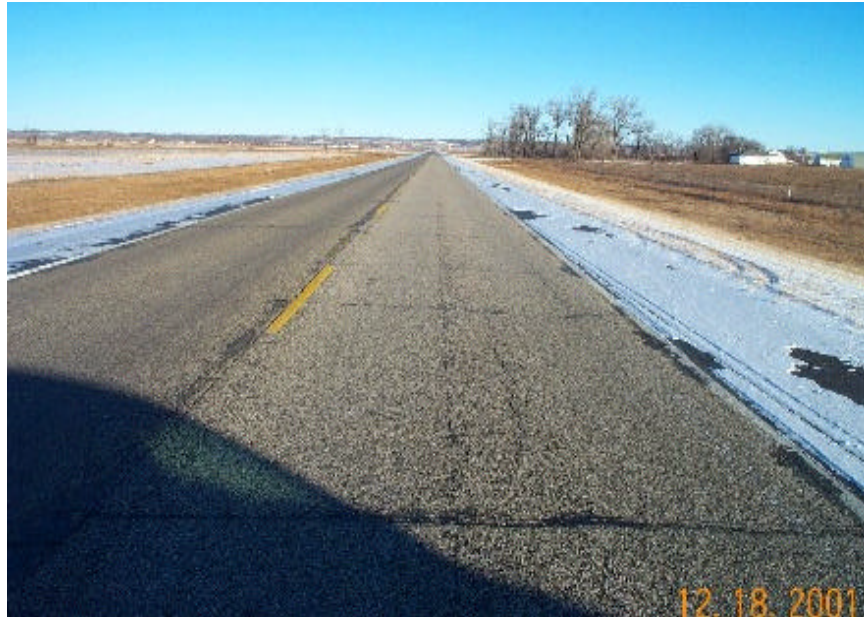
Photo 9 - Overview of section 3.

Photo 9 shows a current view of section 3. As can be seen in photo 9, there is chip loss at centerline, along the edge, between the wheel paths, and even along some of the transverse cracks. The chip loss is moderate throughout the section but between the wheel paths, chip loss is great. The chip density appears light due to the loss of chips. The chip loss may be attributed to the light oil application. This section is performing fair.

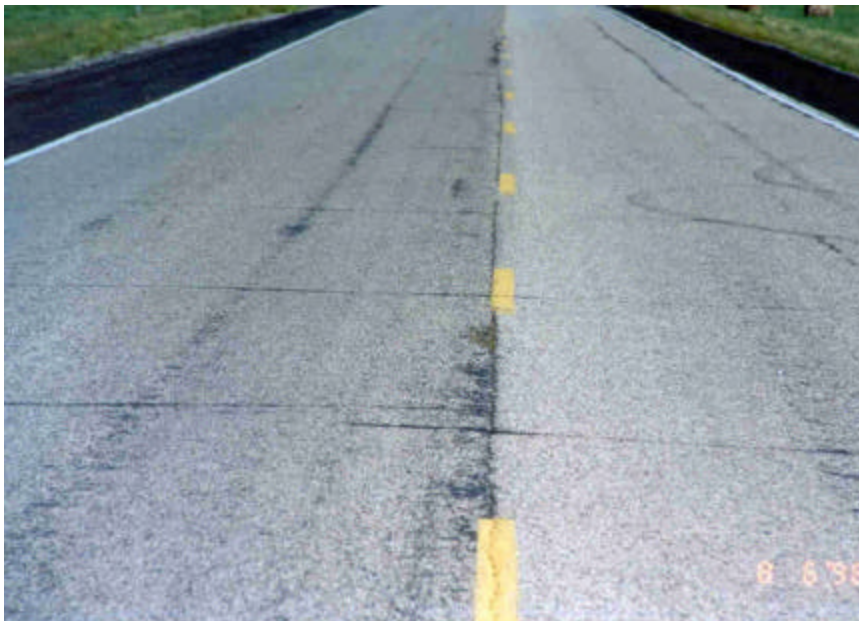
Photo 10 - Overview of section 4.

Photo 10 depicts an overall view of section 4. This section called for only 15 pounds of chips, however, 19 pounds were actually applied. Photo 10 depicts a track that proceeded for nearly the entire length of the section.

During construction the contractor had problems with his machinery rolling up with oil and chips. The general consensus was the track shown in photo 10 was construction related and not the result of traffic or snowplow damage. The section was gray in color.

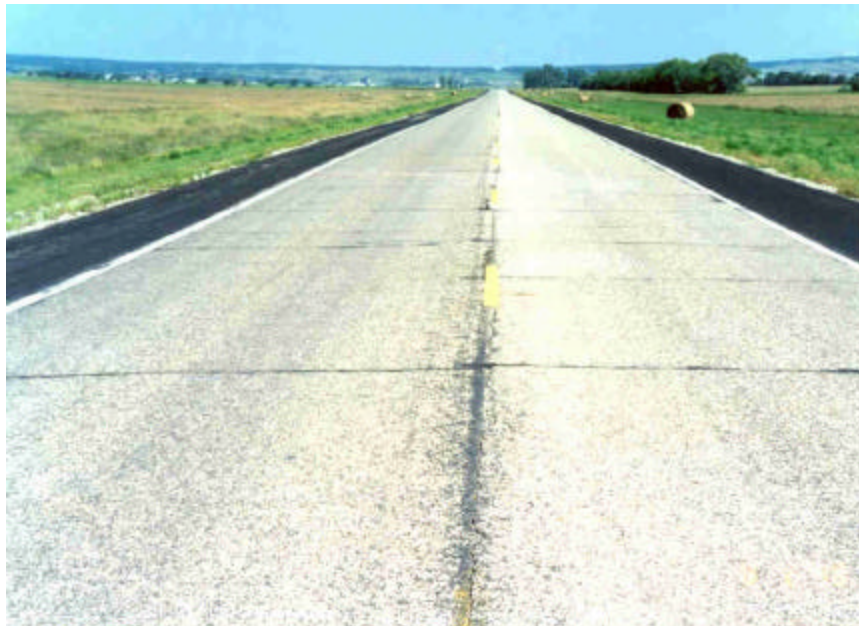
Photo 12 - Overview of section 5.

Photo 12 depicts an overall view of section 5. Like the previous four sections, section 5 was constructed with a high float rapid set polymer modified asphalt emulsion. There was some concern that the non-crushed chips used in this section were not holding as well as the crushed chips used in the earlier sections. Some members believed that the surface appeared slightly rougher in texture. They believed that the rougher texture may have been caused by the non-crushed chips tending to shift due to the roundness of some of the chips.

The general consensus is that the section was not performing quite as well as similar sections containing chips that have been through a crushing process.

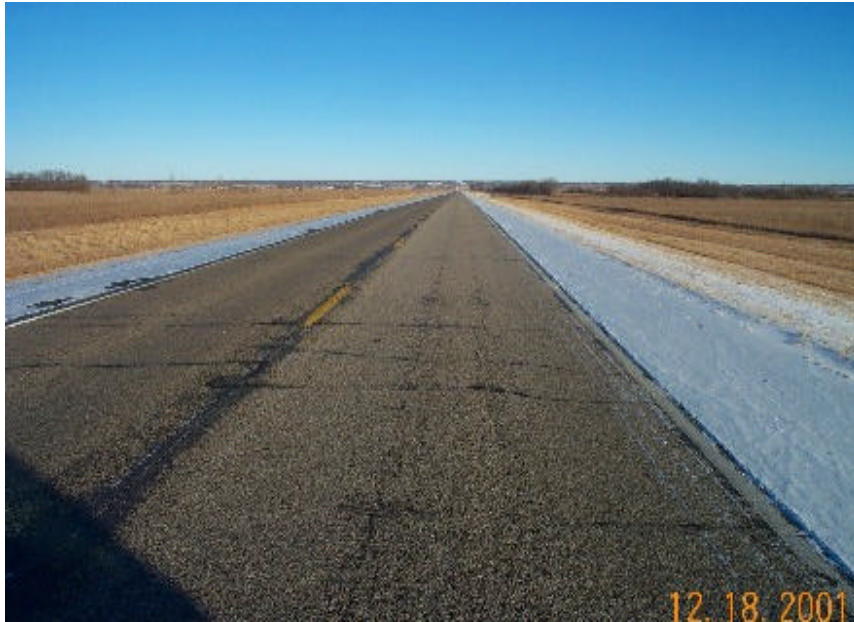
Photo 13 - Overview of Section 5.

Photo 13 shows a current view of section 5. Notice in photo 13 the chip loss throughout the entire section. Chip loss is estimated at 40% to 50%. The chip loss is attributed to the light oil application and the non-crushed (screened) chips. This section's performance is poor.

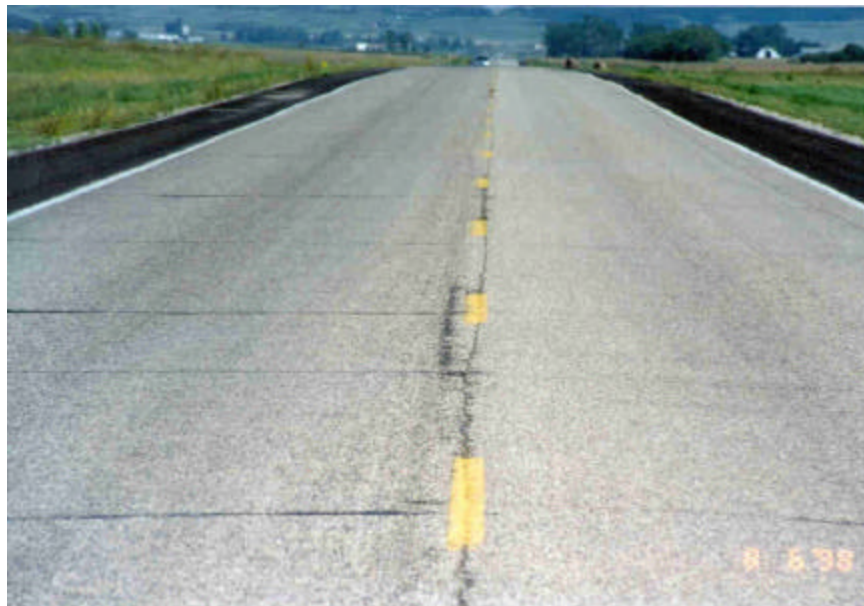
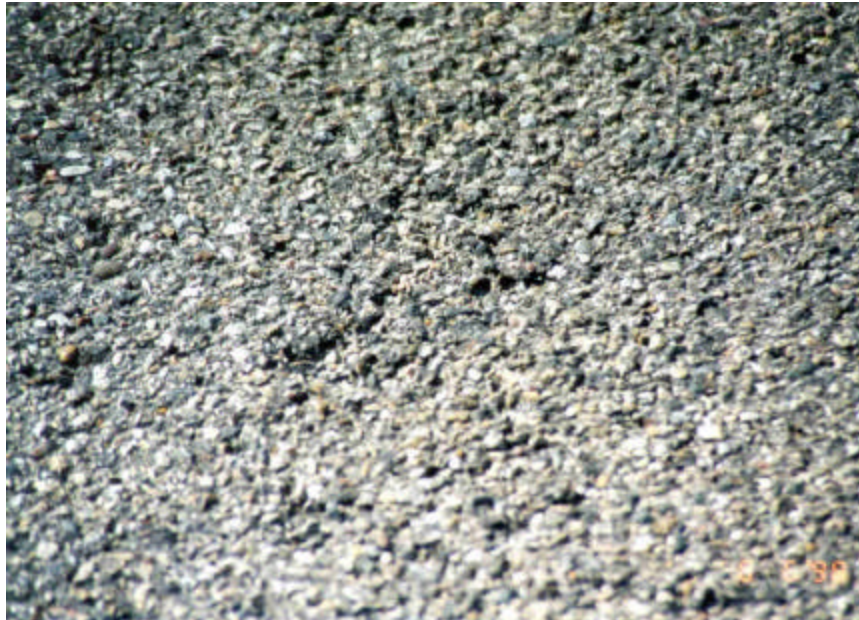
Photos 14 and 15 depict an overall view of section 6. Section 6 is constructed with a high float medium set asphalt emulsion (HFMS-2). There was some concern in this section, as in section 5, that the non-crushed chips were not holding as well as crushed chips.

Photo 14 - Overview of section 6.

Photo 15 - Close up view of section 6.

Some members believed that the surface appeared slightly rougher in texture. They believed that the rougher texture may have been caused by the non-crushed chips tending to shift due to the roundness of some of the chips. Photo 15 depicts a close-up view of section 6. Notice the chips appear to be bunched together in several places. Section 6 appeared slightly darker in color than some of the other sections except sections 1 and 7. The general consensus is that the section was not performing quite as well as similar sections containing chips that have been through a crushing process.

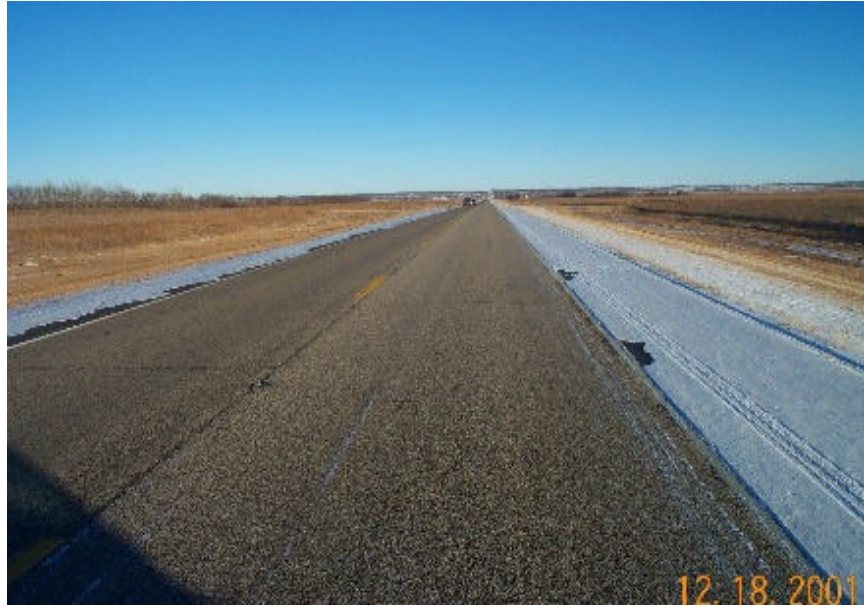
Photo 16 - Overview of section 6.

Photo 16 shows a current view of section 6. Section 6 has experienced moderate chip loss throughout the section. There was also chip loss at centerline that is not evident in photo 16. The research team felt that construction related problems were the likely cause of chip loss at centerline. Some of the same distresses noted in the last evaluation were noted in this evaluation but does not appear to have worsened. The overall performance of this section is fair.

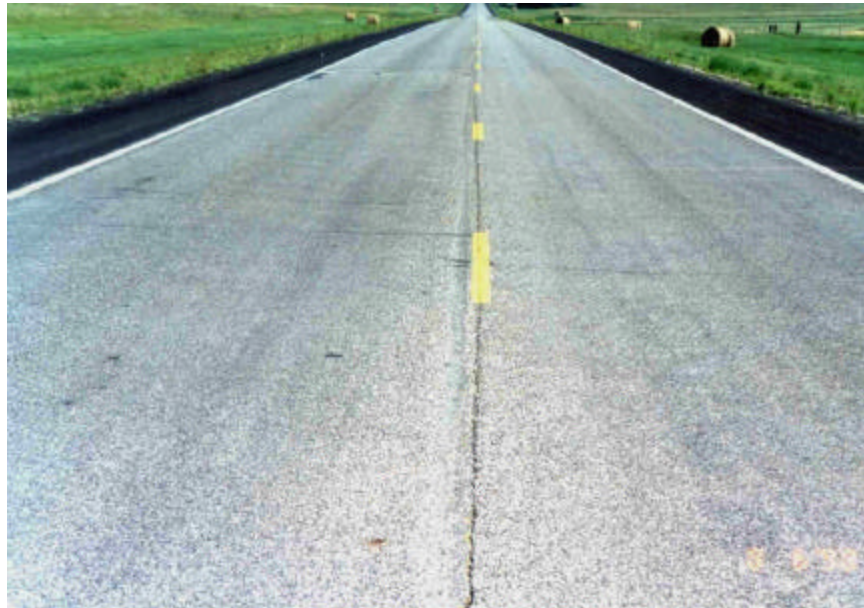
Photo 17 - Overview of section 7.

Photo 17 depicts an overall view of section 7. Notice in photo 17 that the surface appears dark in color as seen in section 1.

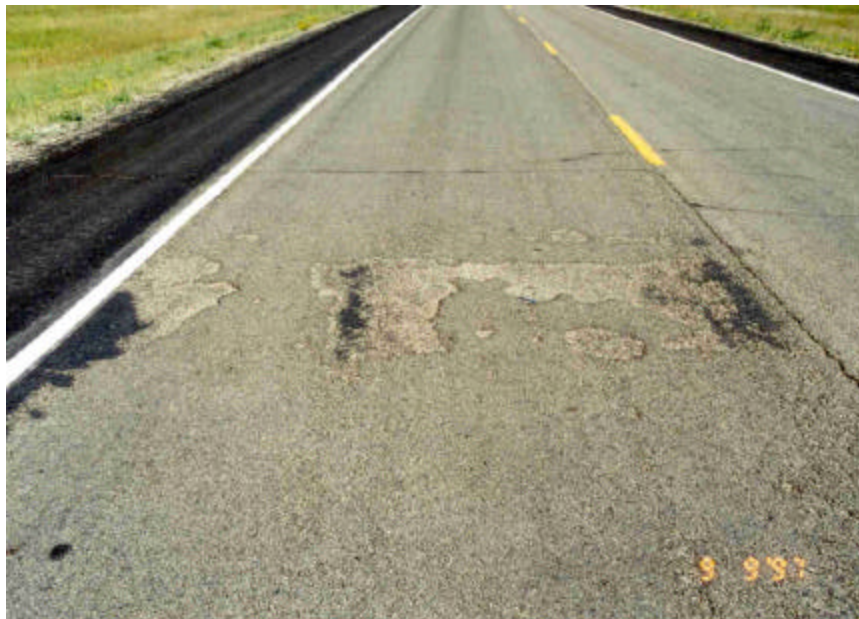
One of the main concerns with section 7 was the distresses occurring in the sealcoat. As in section 1 the sealcoat is suffering from large spalls that have occurred possibly from snow plow blades. In most cases the distresses encompass the entire width of the lane as shown in photo 18. The length of the distresses are approximately 3' to 6'. In the previous photos it is important to note that the lighter colored areas show the distress. It is within these lighter colored areas that part of the seal coat is missing.

Photo 18 - Typical distress associated with section 7.

The Devils Lake District believes these distresses, as in section 1, happened immediately after the first major snowfall in late October of 1996.

There was much discussion as to what would cause distresses such as these. The general consensus of the research team is that the problems may be in the construction of the seal coat itself. One possibility is that the contractor accidentally applied multiple layers of chips on the roadway. This may have easily happened when

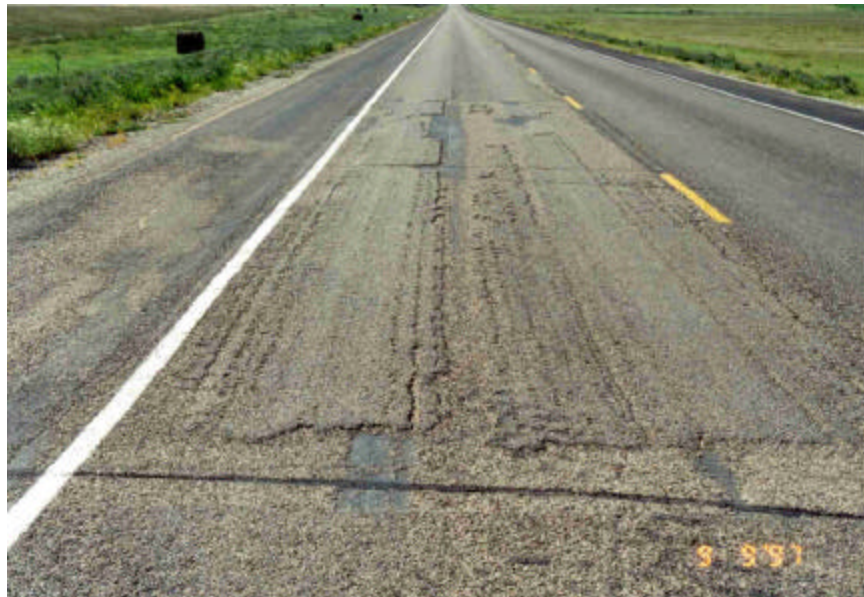
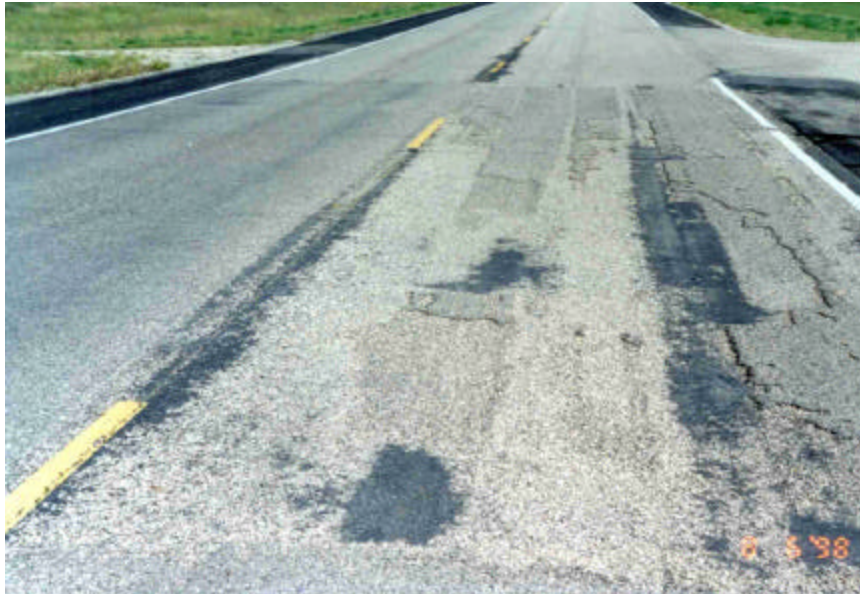
Photos 19 and 20 depict an abnormally large spalled area in section 7 taken during the 1997 and the 1998 evaluation respectively. These photos, however, were taken at opposite ends of the distress.

Photo 19 - Large spalled area near the end of section 7 taken during the summer of 1997.

Photo 20 - View of spalled area shown in photo 19 during the summer of 1998.

It appears from photos 19 and 20 that the contractor may have had problems regulating the application of either the Class 43 chips or the sand. It is also possible that the contractor may be having problems with his distributor as shown by the bleeding in photo 19. Photo 21 depicts a close-up view of a pencil bridged across a distressed area (lighter color). Notice also in the background of photo 20 that the seal coat has been completely removed from the surface leaving just the initial coat of oil. The distress shown in photos 19 and 20 are approximately 70' long.

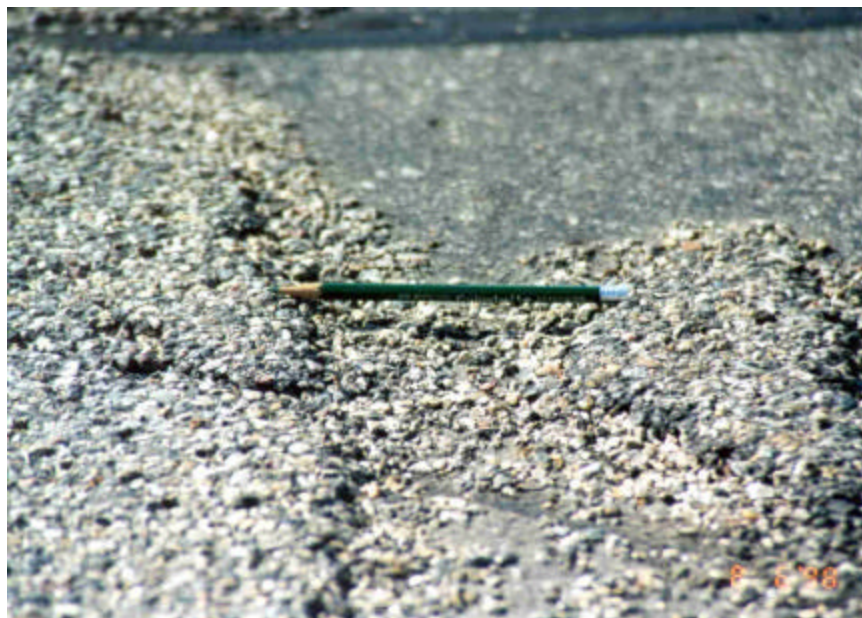
Photo 21 - Distress area shown in the two previous photos.

It is apparent after closely examining these two photos that no significant amount of deterioration has taken place within the distress over the past year.

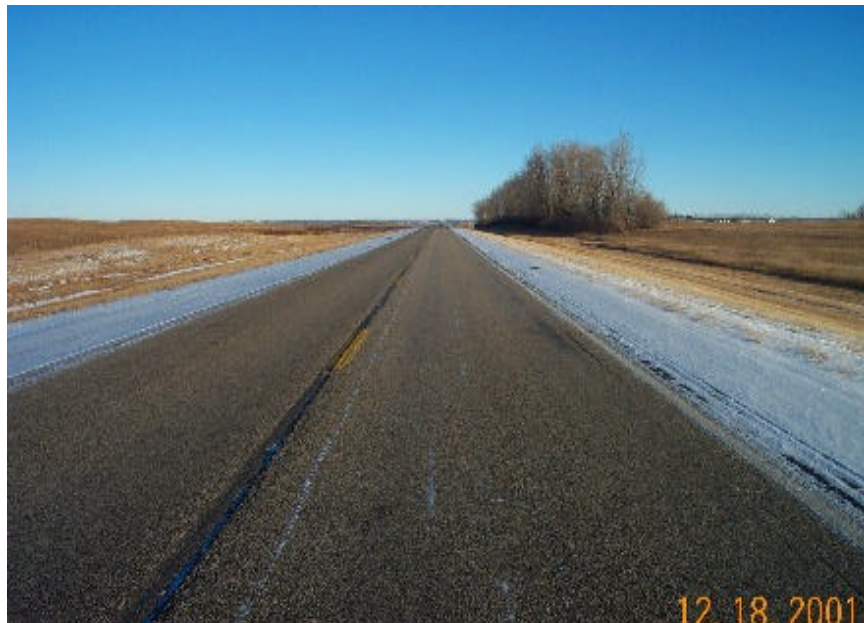
Photo 22 - Overview of section 7.

Photo 22 shows a current view of section 7. Some of the distresses noted in the previous evaluation were not as noticeable this evaluation. Traffic and weather has probably had an effect on these areas to make them less noticeable over time.

As can be seen in photo 22, chip loss is prevalent at centerline however this may be a construction related problem. Overall, this section is performing good.

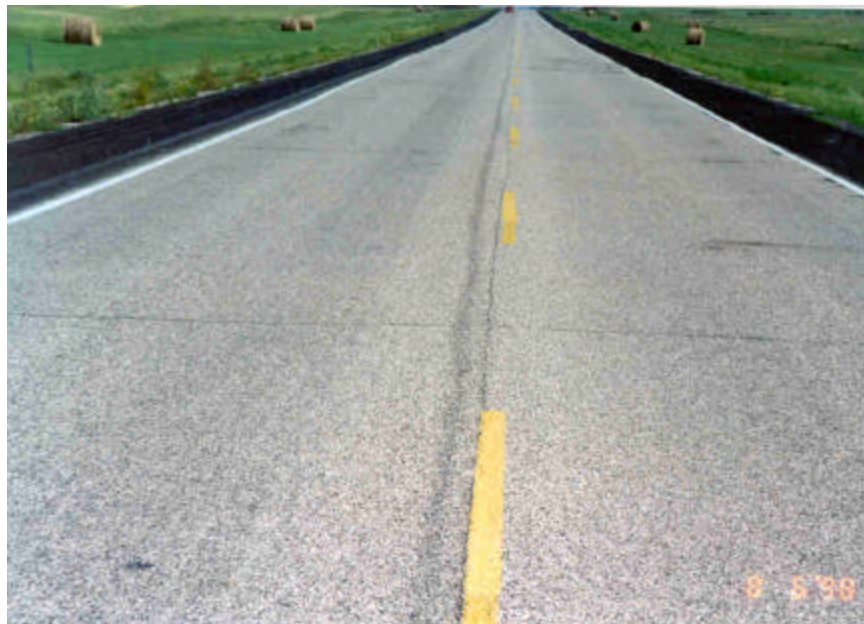
Photo 23 - Overview of section 8.

In general the research team thought the seal coat was performing well.

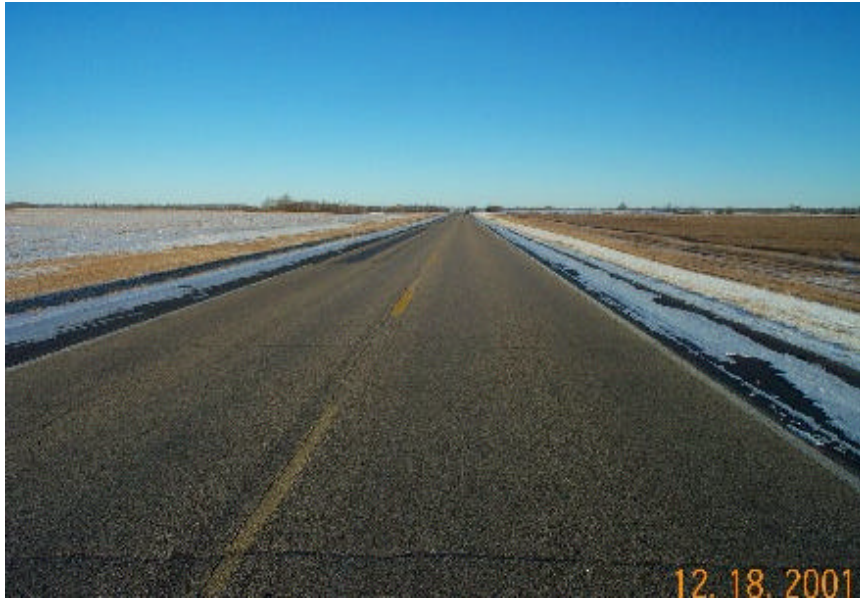
Photo 24 shows a current view of section 8. Section 8 had a very tight, uniform appearance to the surface. Chip loss was minimal in this section.

Photo 24 - Overview of section 8. The bleeding in section 8 is the result of a scotch patch, not the original chip seal.

Photo 24 also indicates that chip loss at centerline is not seen in this section. The transverse cracks appear tighter and not depressed as seen in other sections. One item that is not evident in photo 24 is the light color of the surface. This section had the lightest color of all sections. The light color of this surface is able to reflect more light for nighttime driving increasing the drivers ability to see better for safer night driving.

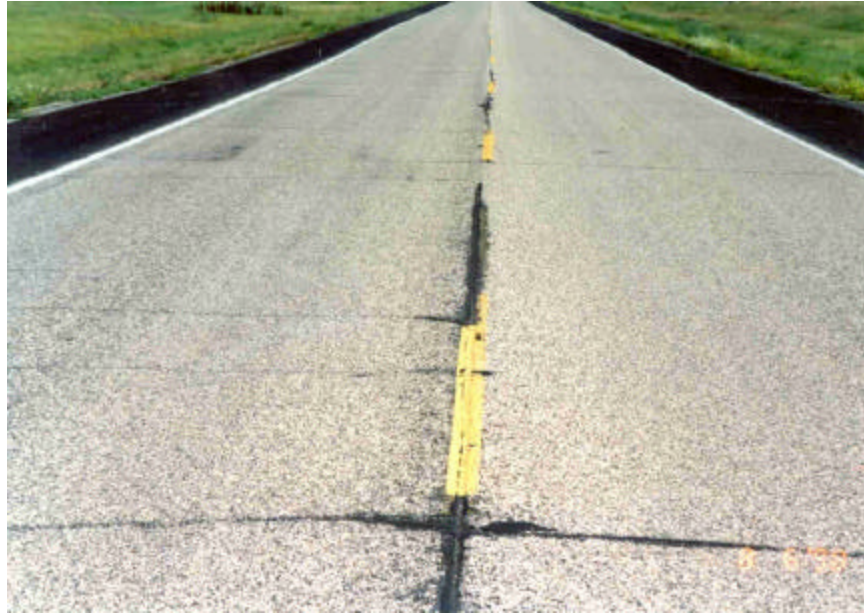
Photo 25 - Overview of section 9.

Photo 25 depicts an overall view of section 9. This section was constructed very close to the NDDOT's standard seal coat method, as was used in section 3, but with a High Float Medium Set asphalt (HFMS-2). There was some isolated chip loss in the mainline. The general consensus of the team was that except for some chip loss the section was performing well.

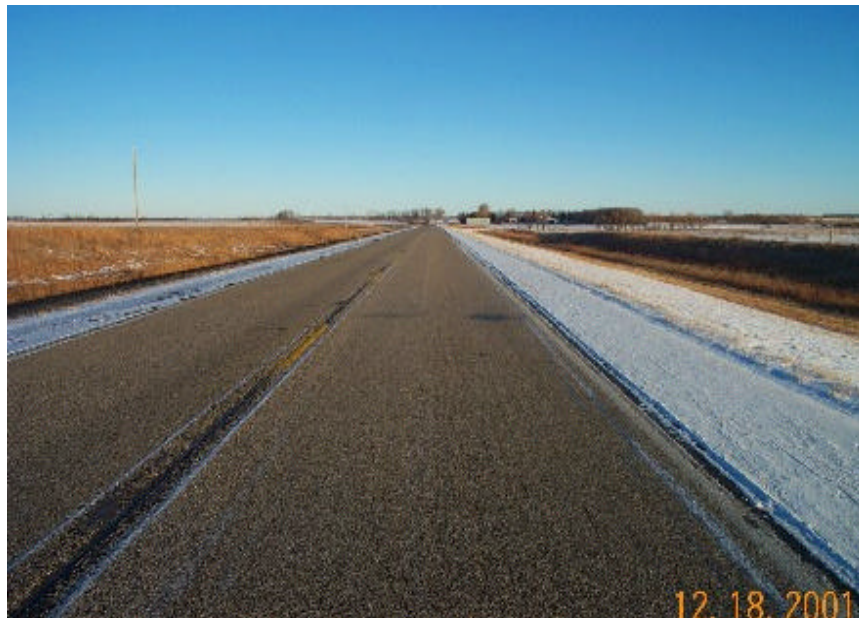
Photo 26 - Overview of section 9.

Photo 26 shows a current view of section 9. Section 9 has minor chip loss throughout the section. Chip loss at centerline is the major distress noted in this section. Overall, chip density is good and this section is performing well.

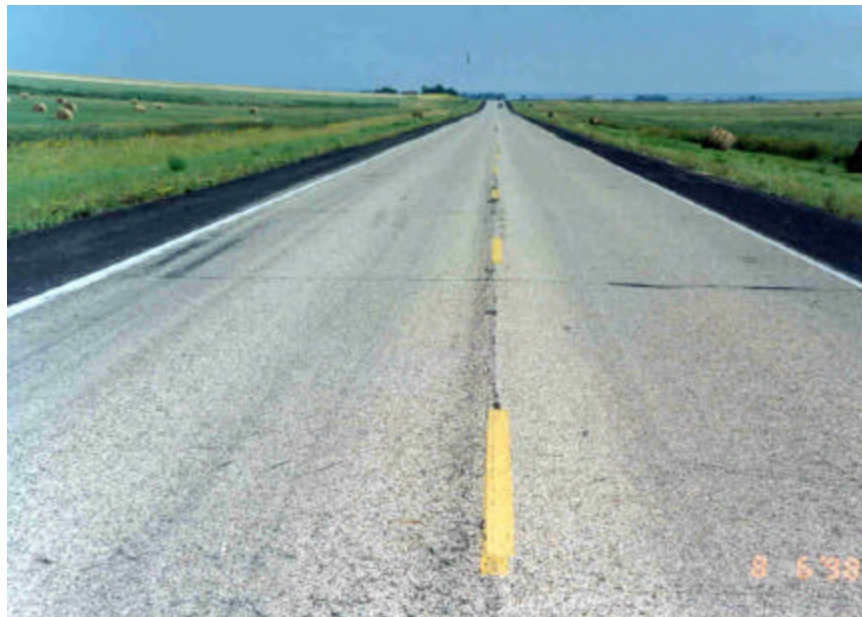
Photo 27 - Overview of section 10.

Photo 27 depicts an overall view of section 10. This section called for only 15 pounds of chips and slightly less oil as compared to a conventional seal. In a significant portion of section 10 the southbound lane is slightly darker than the northbound lane. After examination the research team concluded that many more chips were missing in this lane. Just after construction of this section the traffic was allowed to travel over the southbound lane causing the chips to pick-up on the tires. The project engineer made a decision to sand the southbound lane in an effort to resolve the problem.

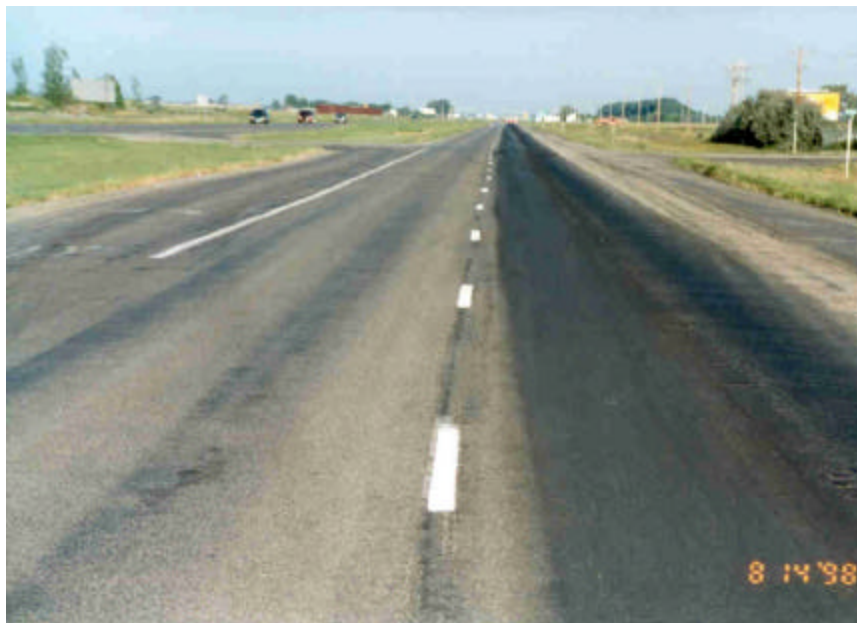
Photo 29 - Overview of Highway 2 test section.

Photo 29 shows an overview of the test section. Notice in photo 29 the surface of the test section, barring the wheel tracks, appears moderately light in color. The application of the fog coat did not appear to significantly change the surface color of a conventional chip seal. After construction of this project, neither Webster, Foster, & Weston nor the Grand Forks district received any complaints about flying chips from the driving public. Up to this point in the evaluation there still has been no complaints about

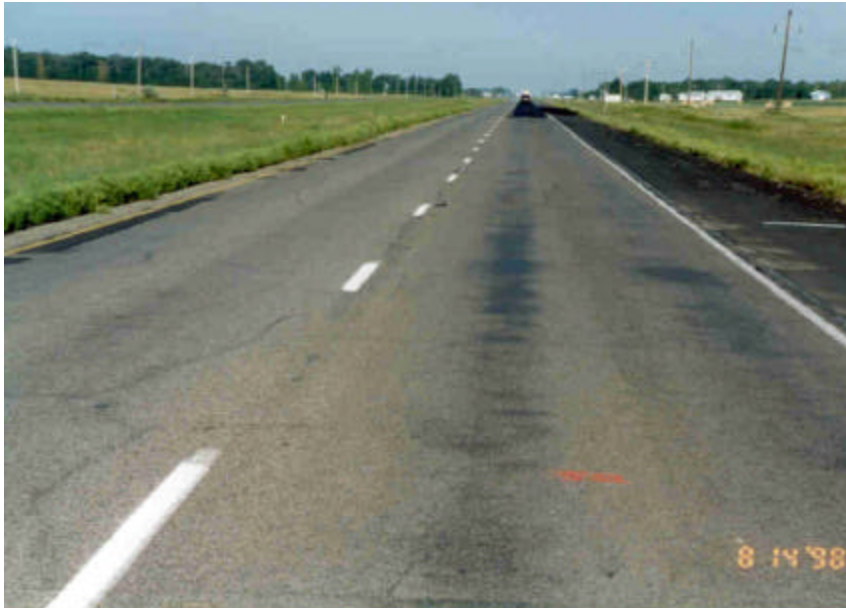
Photo 30 - Overview of Highway 2 where patching has been done.

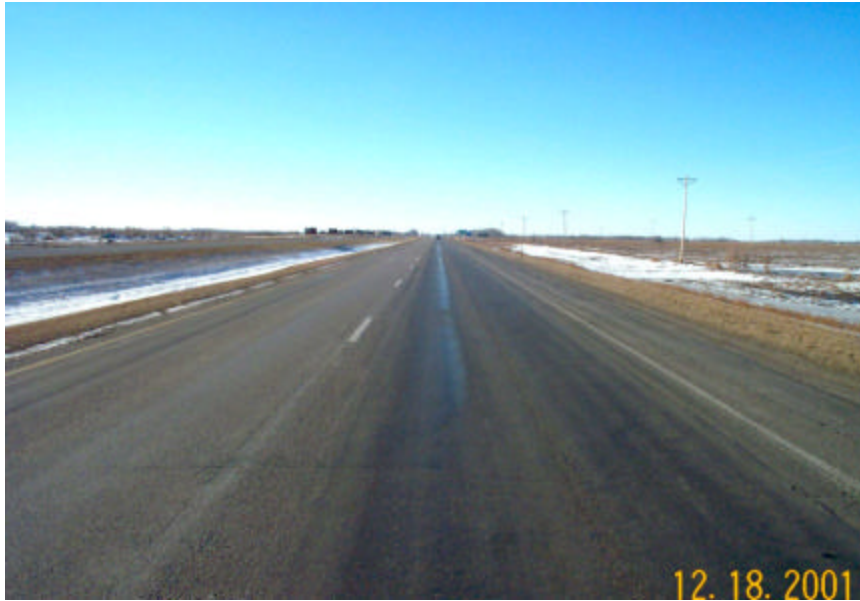
Photos 31 and 32 show an overview of the Highway 2 segment in this research project. Photo 31 is taken in the segment from the city of Grand Forks to the Grand Forks Air Force Base. Photo 32 is taken from the Grand Forks Air Force Base to Turtle River State Park.

Photo 31 - Bleeding on Highway 2. City of Grand Forks to the Grand Forks Air Force Base.

The photos indicate bleeding in one segment that is not present in the other segment. The segment in photo 31 has a traffic flow of 3,000 more vehicles on a daily basis. However, the bleeding may be a result of the asphalt surface below (as noted above, rutting is occurring in this segment and has had maintenance done to correct this problem).

Bleeding is thought to be the result of the poor condition of the existing asphalt mat. Within two years of the seal coat application, maintenance was done to correct rutting and shoving in the existing mat.

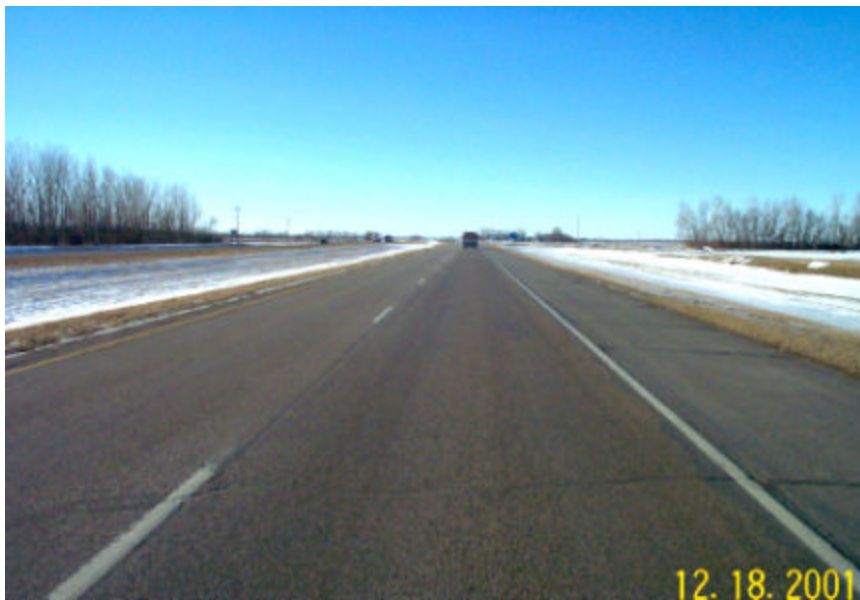
Photo 32 - Highway 2, Grand Forks Air Force Base to Turtle River State Park.
